United States
Department of Labor
Mine Safety and Health Administration
Office of the Administrator
Coal Mine Safety and Health

Report of Investigation
Underground Coal Mine Explosion
No. 21 Mine - I.D. No. 40-00524
Grundy Mining Company, Incorporated
Whitwell, Marion County, Tennessee
December 8, 1981

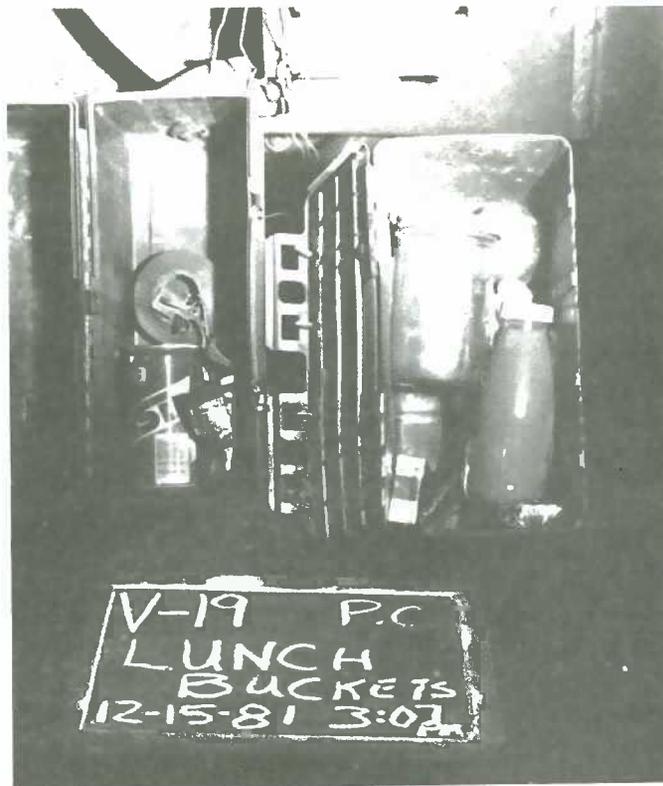
Smoking materials and a cigarette lighter were observed in underground areas of the No. 21 Mine during the investigation. One lunch bucket found on the roof bolting machine in 003 section contained two packages of cigarettes, one opened and one not opened. Another package of cigarettes (not opened) was observed in a lunch bucket investigators found on the three-wheel personnel carrier in a crosscut between Nos. 2 and 3 entries of 003 section. A cigarette lighter was observed in the No. 1 entry of 003 section just in by No. 62 crosscut during the recovery operations on 003 section. This observation was made by an MSHA inspector and was witnessed by an MSHA supervisor and two company officials on December 8, 1981, during the recovery operation. Also, an MSHA inspector found a full package of cigarettes and an empty cigarette package in a lunch bucket that was on a battery-powered tractor in the 007 section of the No. 21 Mine. This observation was made on December 12, 1981, as mine recovery operations were in progress. Also, possessions of four victims (one management official and three miners) that were inventoried at the funeral home included five cigarette butts, eight cigarettes and two lighters. During interviews,

- (28) Cigarettes were found in two of the victims lunch buckets on the 003 section during the investigation (Appendix F, Photograph No. 2). Also, cigarettes were found in a lunch bucket in a personnel carrier from the 007 section.

PHOTOGRAPH 2. - Two packages of Winston cigarettes in lunch bucket found in deck of the roof bolting machine on 003 section

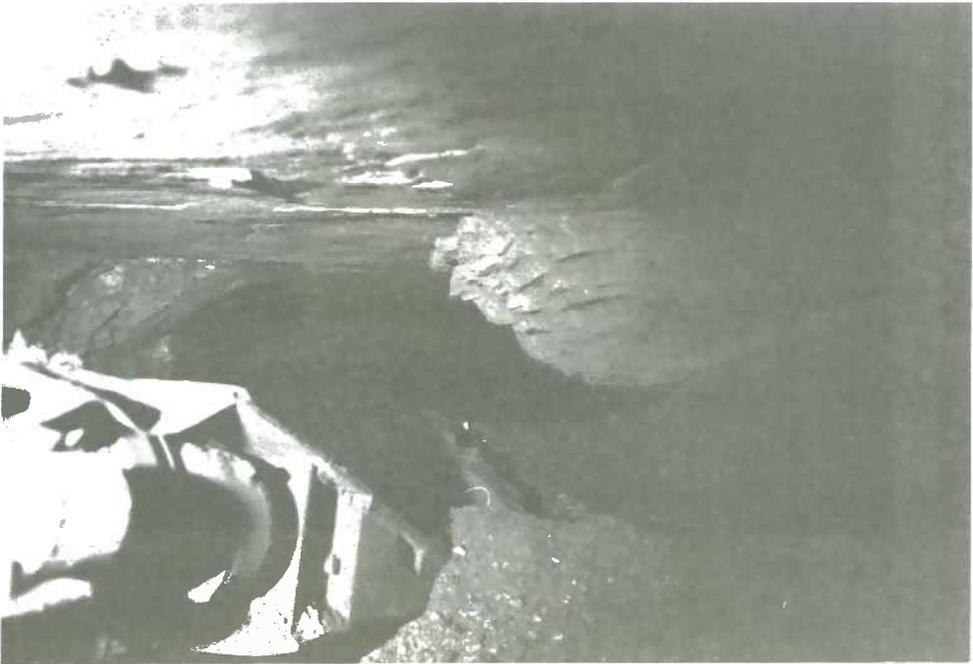
The investigators conclude that methane accumulations in the Nos. 2 and 3 left gob off 5 right flowed through the 4 foot by 7 foot hole and test boreholes in Nos. 2 and 3 entries of 003 section. Because intake air to the section was short-circuited from the faces at a crosscut between Nos. 2 and 3 entries (3 crosscuts outby the faces), methane migrated into the 003 section from the faces of Nos. 2 and 3 entries. It is concluded that a miner used a cigarette lighter igniting the methane-air mixture causing the explosion. Apparently the miners saw the burning gases just after ignition. This observation is supported by the fact that 12 of the 13 miners (victims) were headed outby when they were overcome by the explosion. In further support of this conclusion, personal effects (miners hats, a hammer, two flame safety lamps and a jacket) were located inby the bodies of the respective victims. These observations indicate to the investigators that the miners were traveling away from the ignition source.

PHOTOGRAPH 3. - Loading machine at 4 by 7 foot area which was mined into the gob from the face of No. 2 entry of 003 section

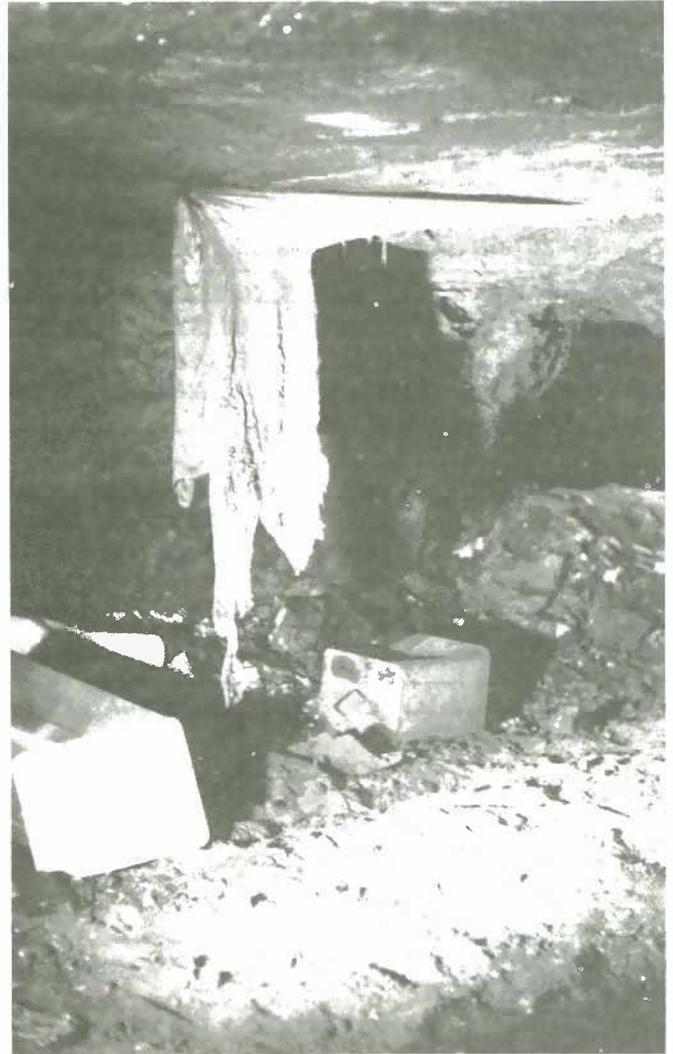
PHOTOGRAPH 7. - Burned and melted remains of a plastic ventilation check curtain outby the last open crosscut in No. 2 entry of 003 section
