REPORT OF INVESTIGATION

Surface Nonmetal Mine
(Sand and Gravel)

Fatal Inundation Accident
June 3, 2016

Harmony Mine & Mill
Green Brothers Gravel Company, Inc.
Crystal Springs, Copiah County, Mississippi
ID No. 22-00650

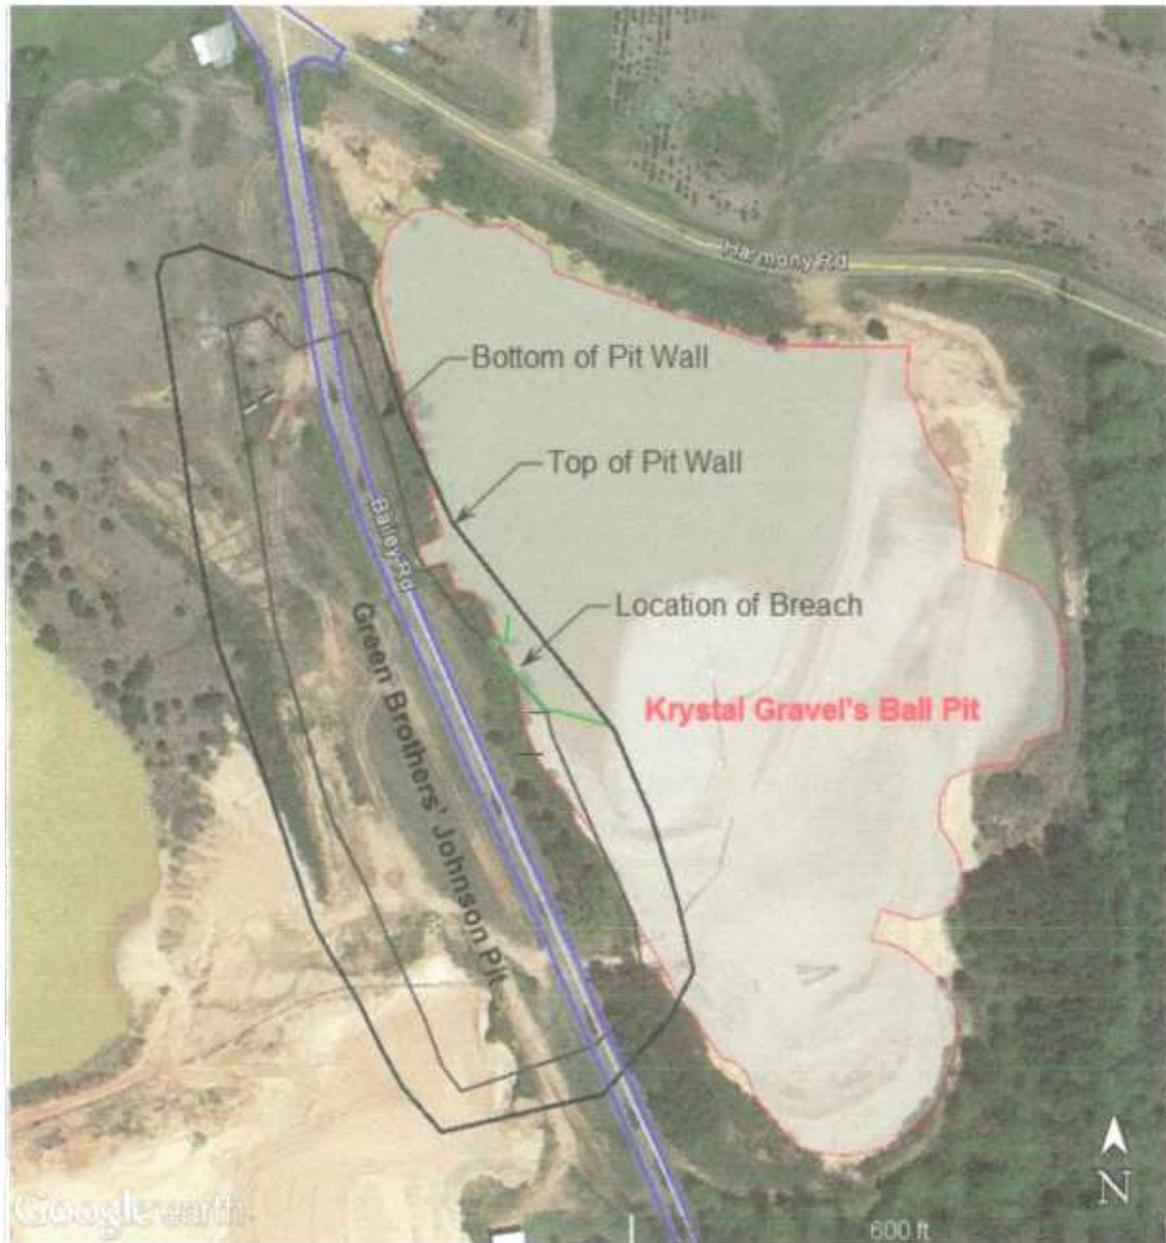
Figure 2 - Outlines the original Ball Pit in relationship to the mining of the Johnson Pit. The area of the Johnson Pit widens where the wall material composition transitions from primarily natural sand and gravel to primarily tailings. The excavator and haul truck were both on the pit bottom near the location of the failure.

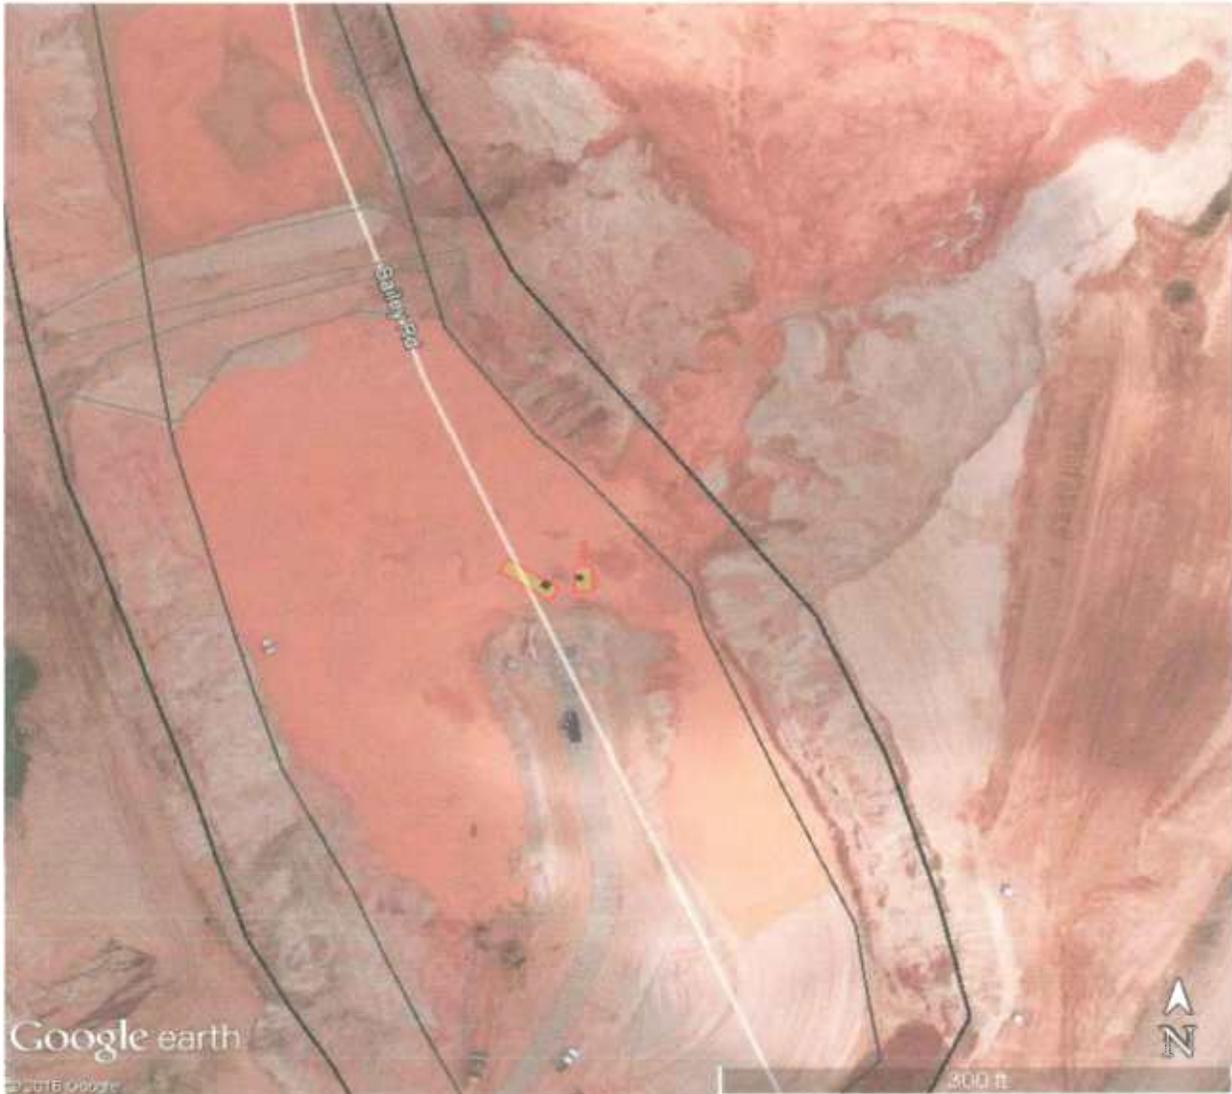
Figure 3 - The excavator was positioned near the east pit wall facing a northern direction at the time of the failure. The truck was on the west side of the excavator, and was facing south to southeast.

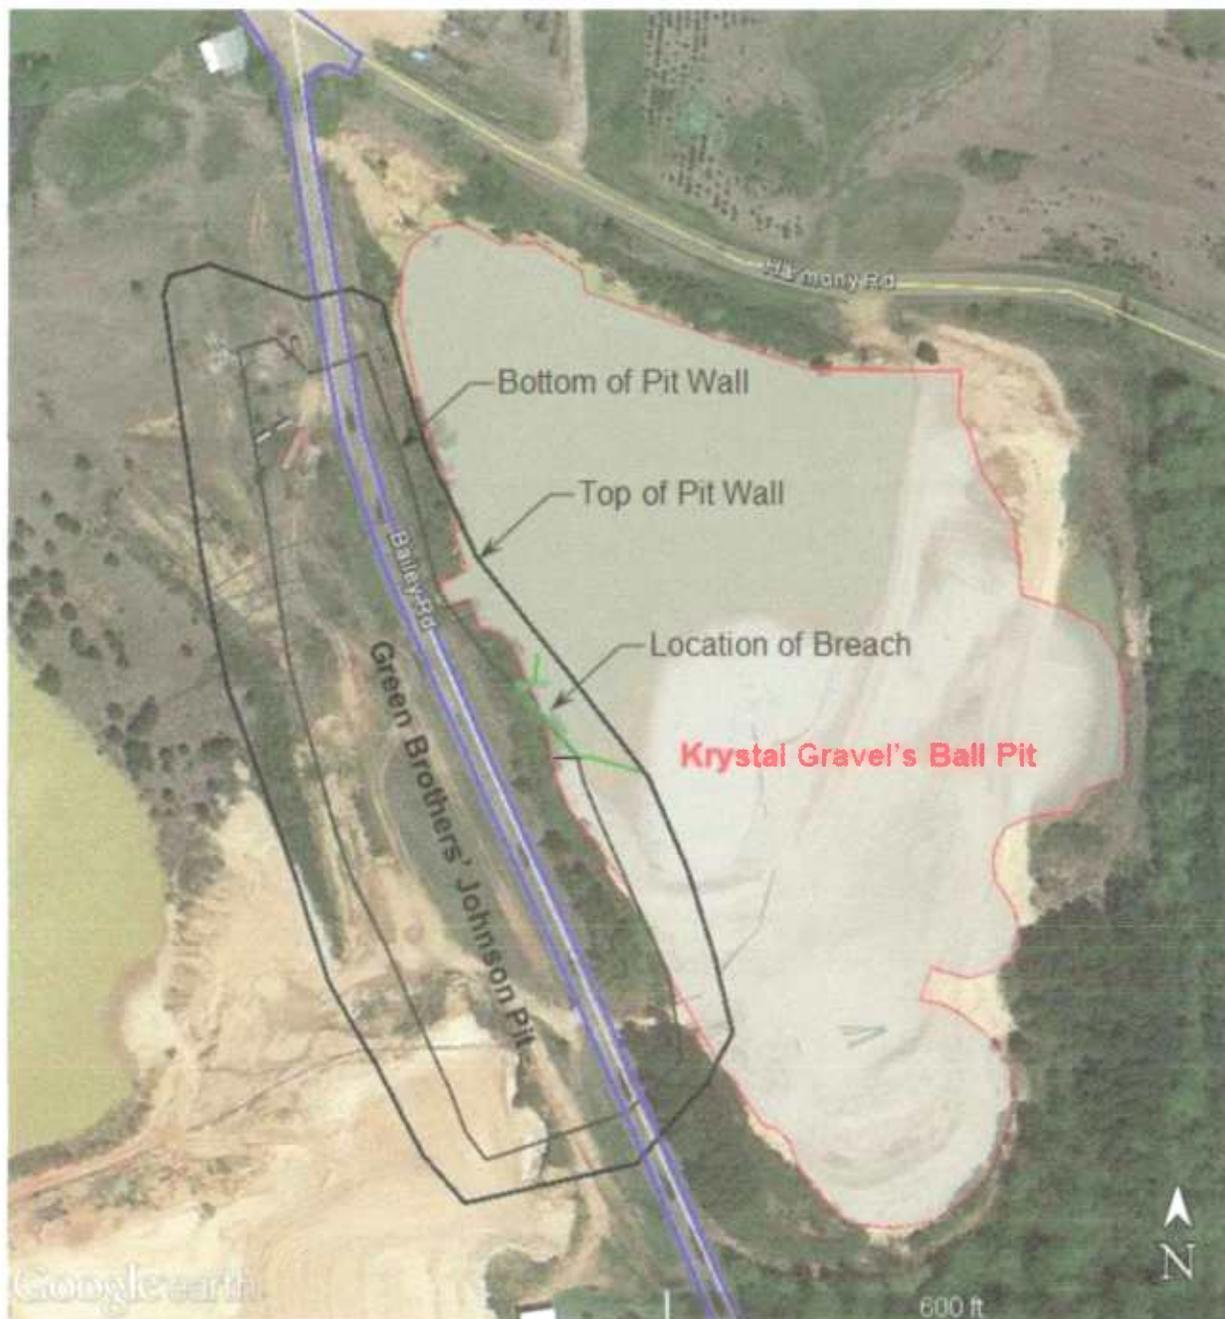
Figure 2 – Location of the Johnson Pit and the breach relative to the Ball Pit as shown on a satellite image dated April 9, 2014, viewed in Google earth.

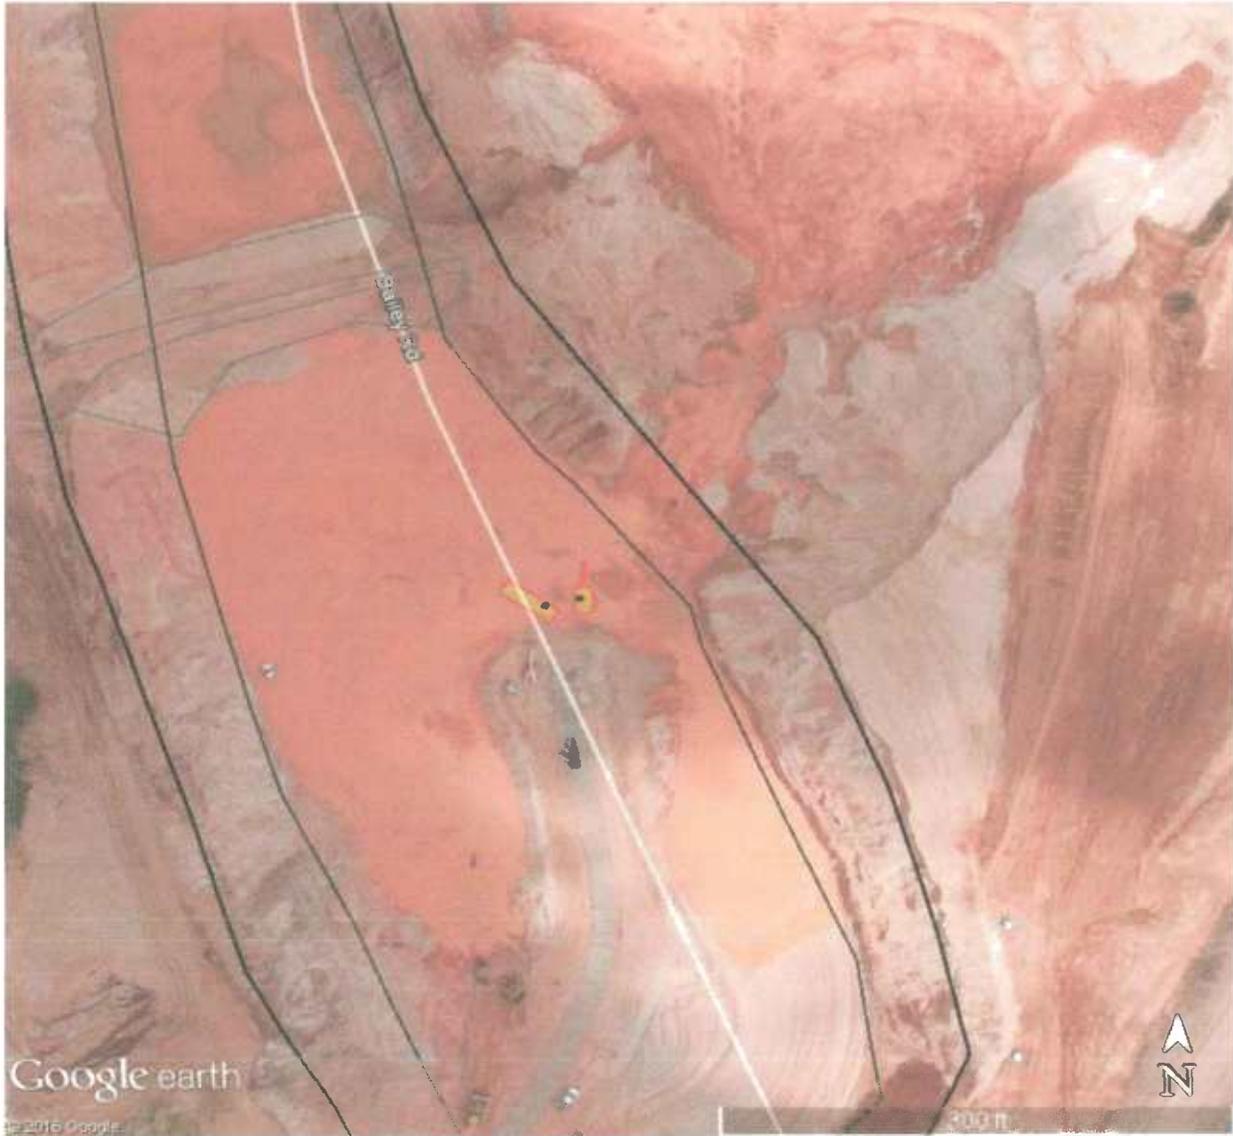
Figure 3 - The excavator was positioned near the east pit wall facing a northern direction at the time of the failure. The truck was on the west side of the excavator, and was facing south to southeast.

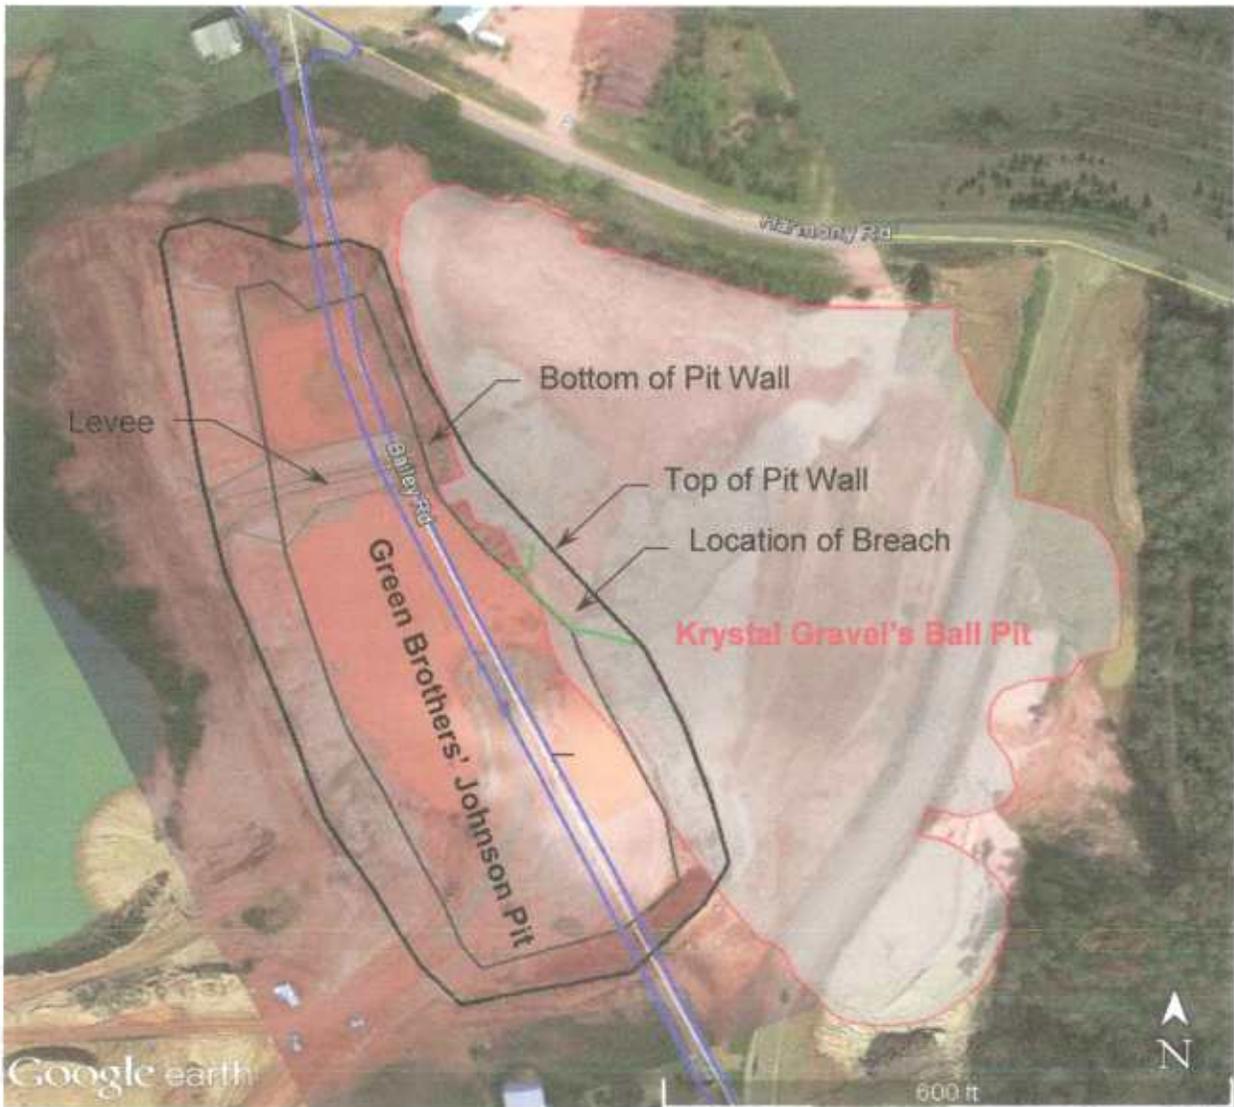
A satellite image obtained from Terraserver.com dated 02/13/2016 shows signs of erosion or other distress on the pit slope where the failure occurred (Figure 6). At that time, there was a pool of water along the east end of the impoundment, similar to the Google image dated 12/14/2015. However, the more recent satellite image showed more waste sand had been pushed into the southwest corner of the impoundment covering the clay tailings, as reported. This image also shows an erosion gully near the northern end of the pit prior to the construction of the levee, and water pooling in the pit.

Figure 6 – Overlay of an aerial image taken by drone on June 6, 2016, on the satellite image dated December 14, 2015, viewed in Google earth.

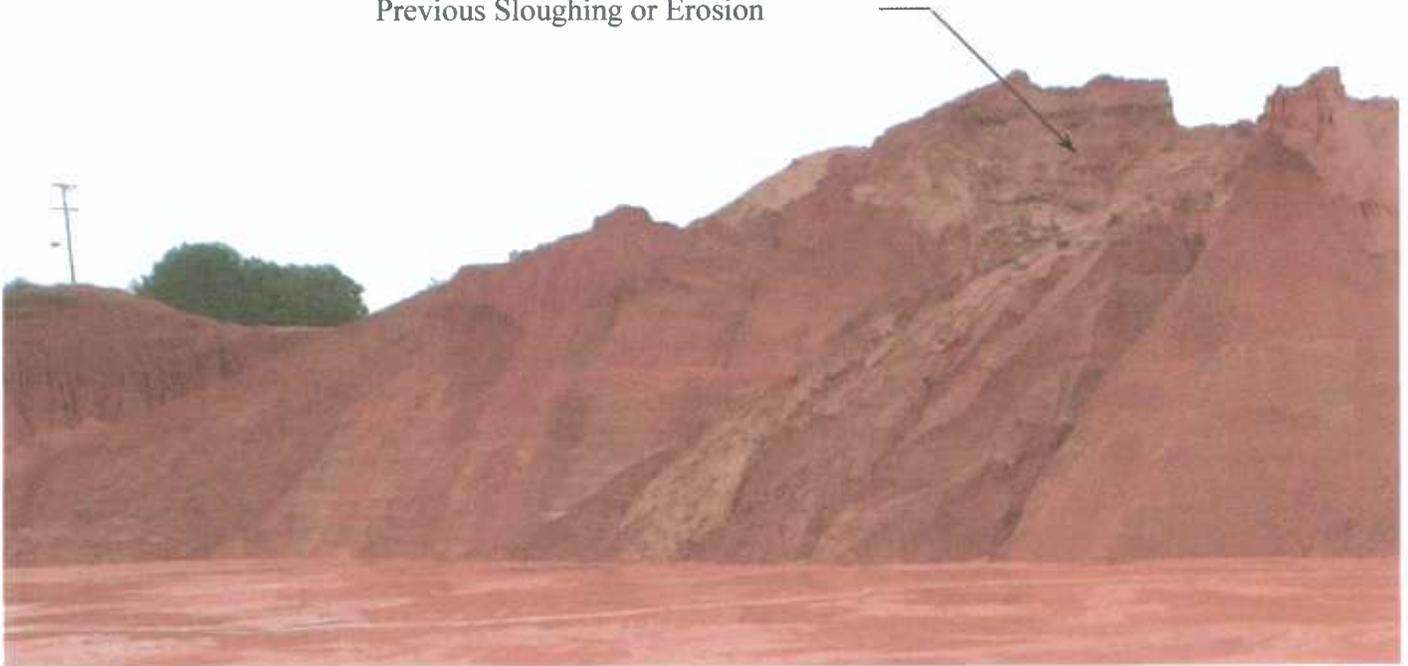
Photo 1 - View of the pit wall on the north side of the failure looking northeast. This view also depicts some previous erosion and sloughing adjacent to the failure.

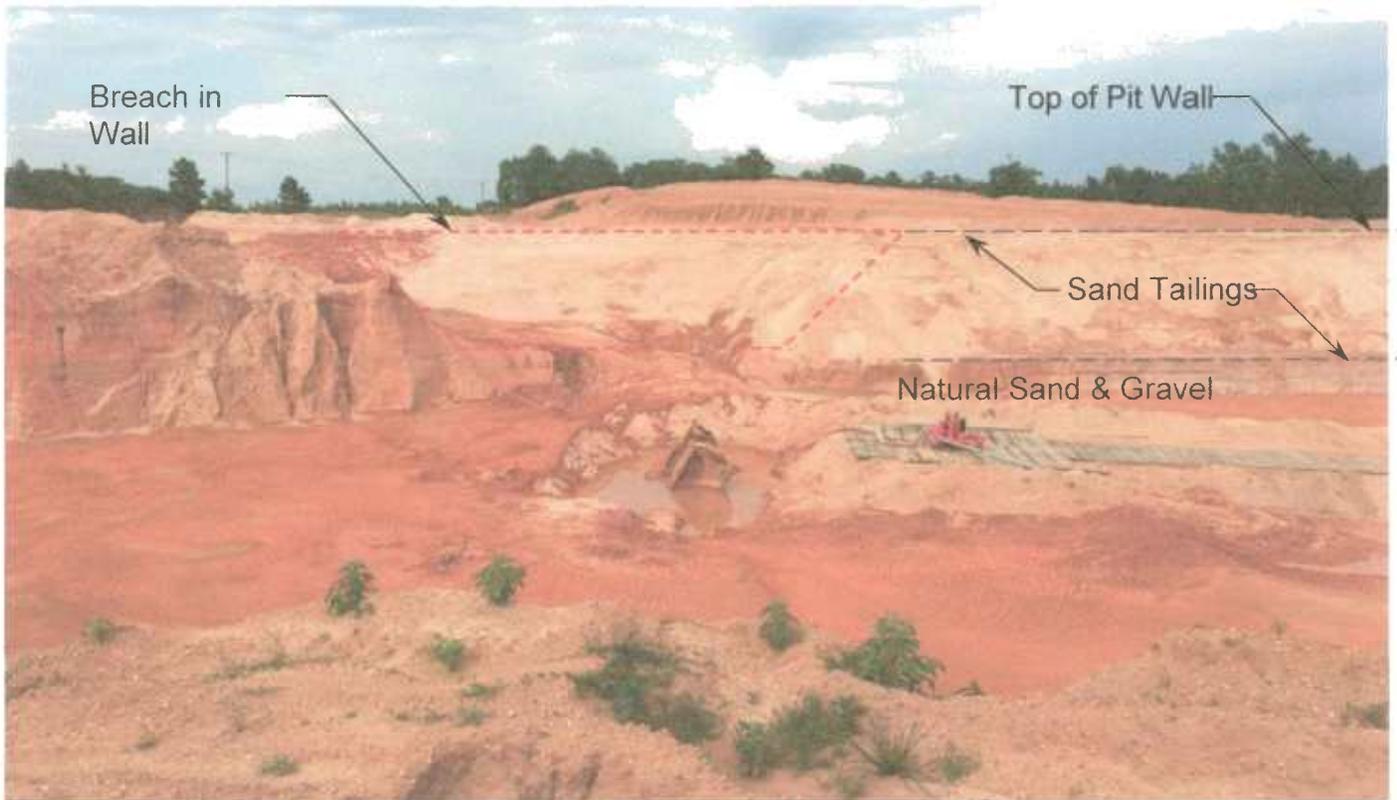
Photo 2 – View of the failure area and breach looking easterly from the west side of the pit.

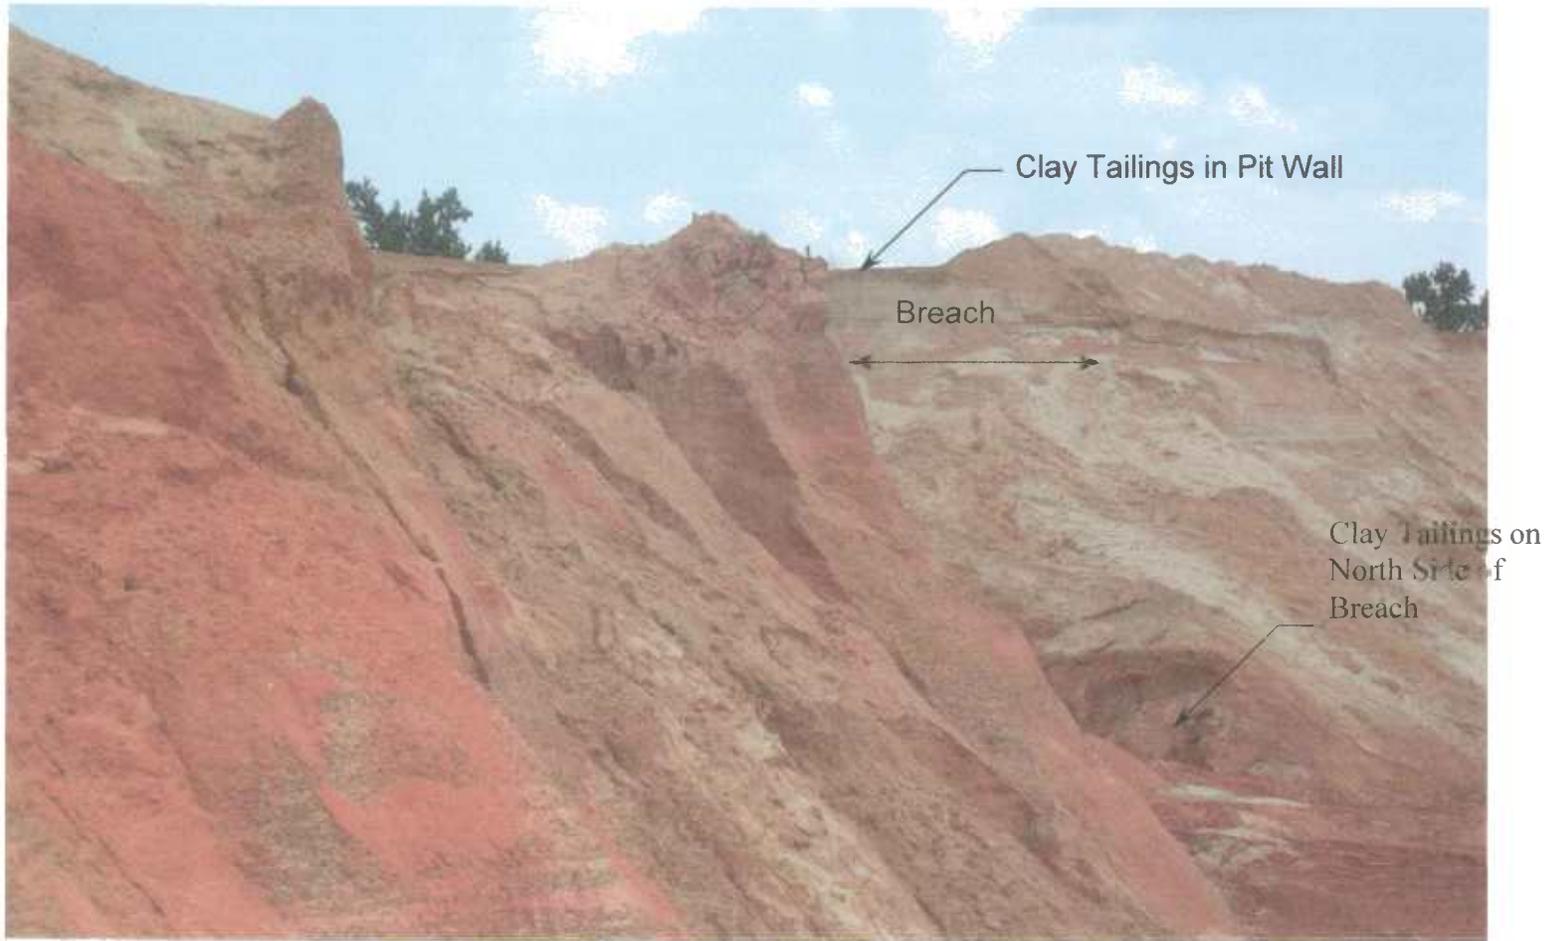
In the immediate area of the failure, the tailings transitioned from sand to clay. The clay can be observed in the upper wedge on the north side of the breach and in the bottom of the south side of the breach. Satellite images over several years of operating the impoundment show that this area was normally upstream of the sand beach. The stripped overburden material that was pushed into the impoundment was an inadequate embankment, failed to displace or retain the clay tailings, and hid the previous pit wall location. The additional waste sand pushed into the southwest corner of the impoundment covered the clay and pushed back the pool water, but it did not stop the seepage, and was inadequate to retain the saturated tailings, and it masked the hazard.

Photo 3 – View of the pit wall adjacent to the failure looking southeast. This shows the clay tailings overlying the natural sand and gravel near the top of the pit wall. It also depicts clay tailings in the lower part of the pit wall on the southern side of the breach.

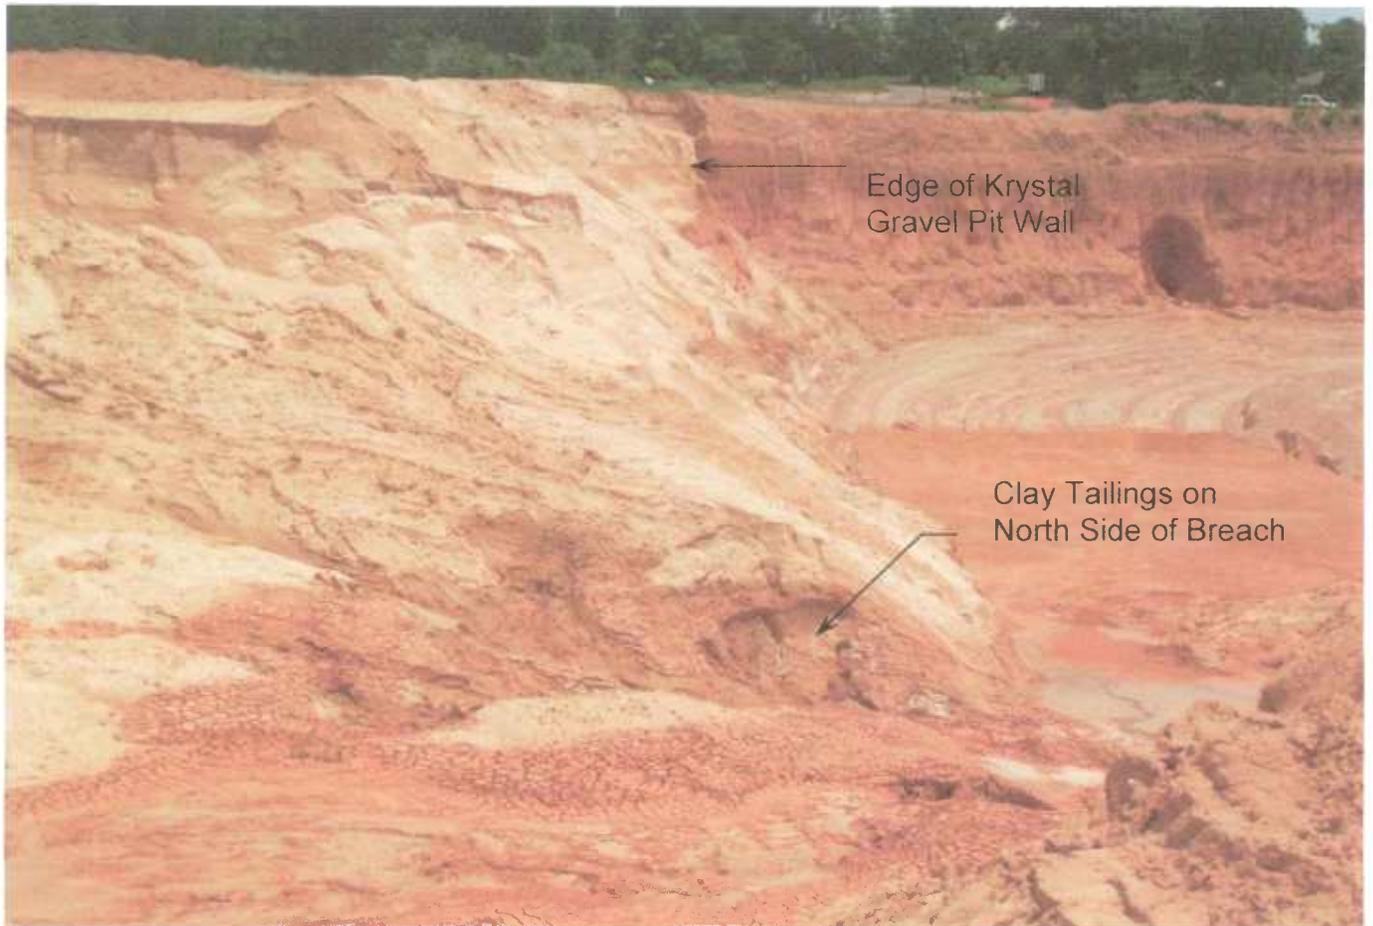
Photo 4 – View of the breach area and the eastern pit wall looking south. This view depicts clay tailings in the lower part of the pit wall on the southern side of the breach and the inside edge of the western wall of Krystal Gravel’s Ball Pit in the background.
