FINAL REPORT OF MAJOR MINE FIRE DISASTER

NO. 22 MINE  
ISLAND CREEK COAL COMPANY  
PINE CREEK, LOGAN COUNTY, WEST VIRGINIA

March 8, 1960

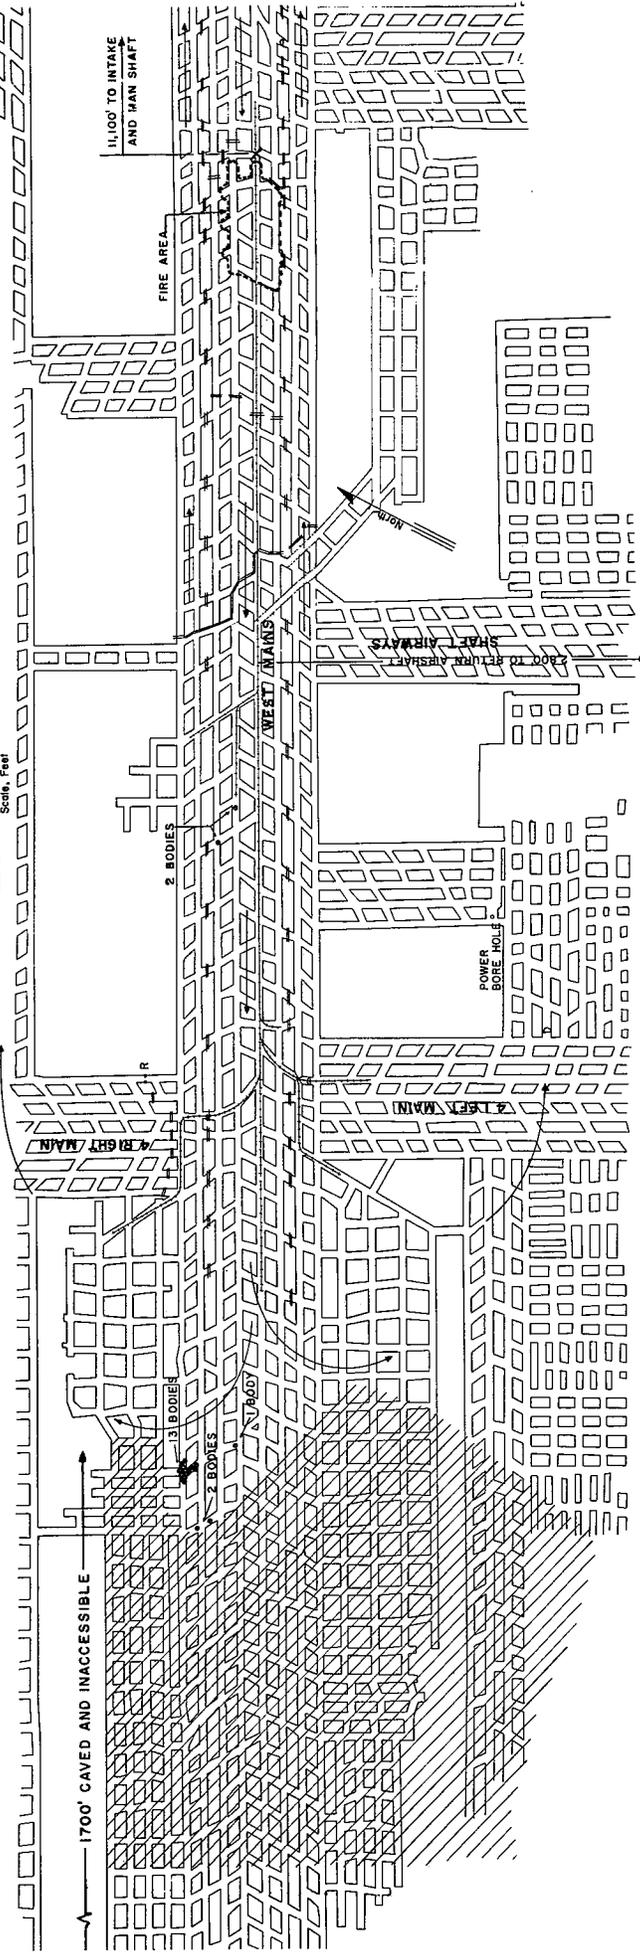
APPENDIX B  
 MAP OF A SECTION OF WEST MAINS NO. 22 MINE, ISLAND CREEK COAL COMPANY,  
 PINE CREEK, LOGAN COUNTY, WEST VIRGINIA, MARCH 8, 1960 MINE FIRE

Point of Origin: The consensus of the investigators of the Bureau of Mines is that the fire originated on No. 4 entry of west main entries (main haulageway) about 5 feet in by the 3-left overcast, when dry wooden crossbars and supporting legs were ignited by electric arcs or sparks from the trolley wire at that location.
