REPORT OF MULTIPLE FATAL ROOF-FALL ACCIDENT
JEFFERSON ISLAND MINE
DIAMOND CRYSTAL SALT COMPANY
JEFFERSON ISLAND, IBERIA PARISH, LOUISIANA

February 19, 1970

Roy Capps
Safety Representative

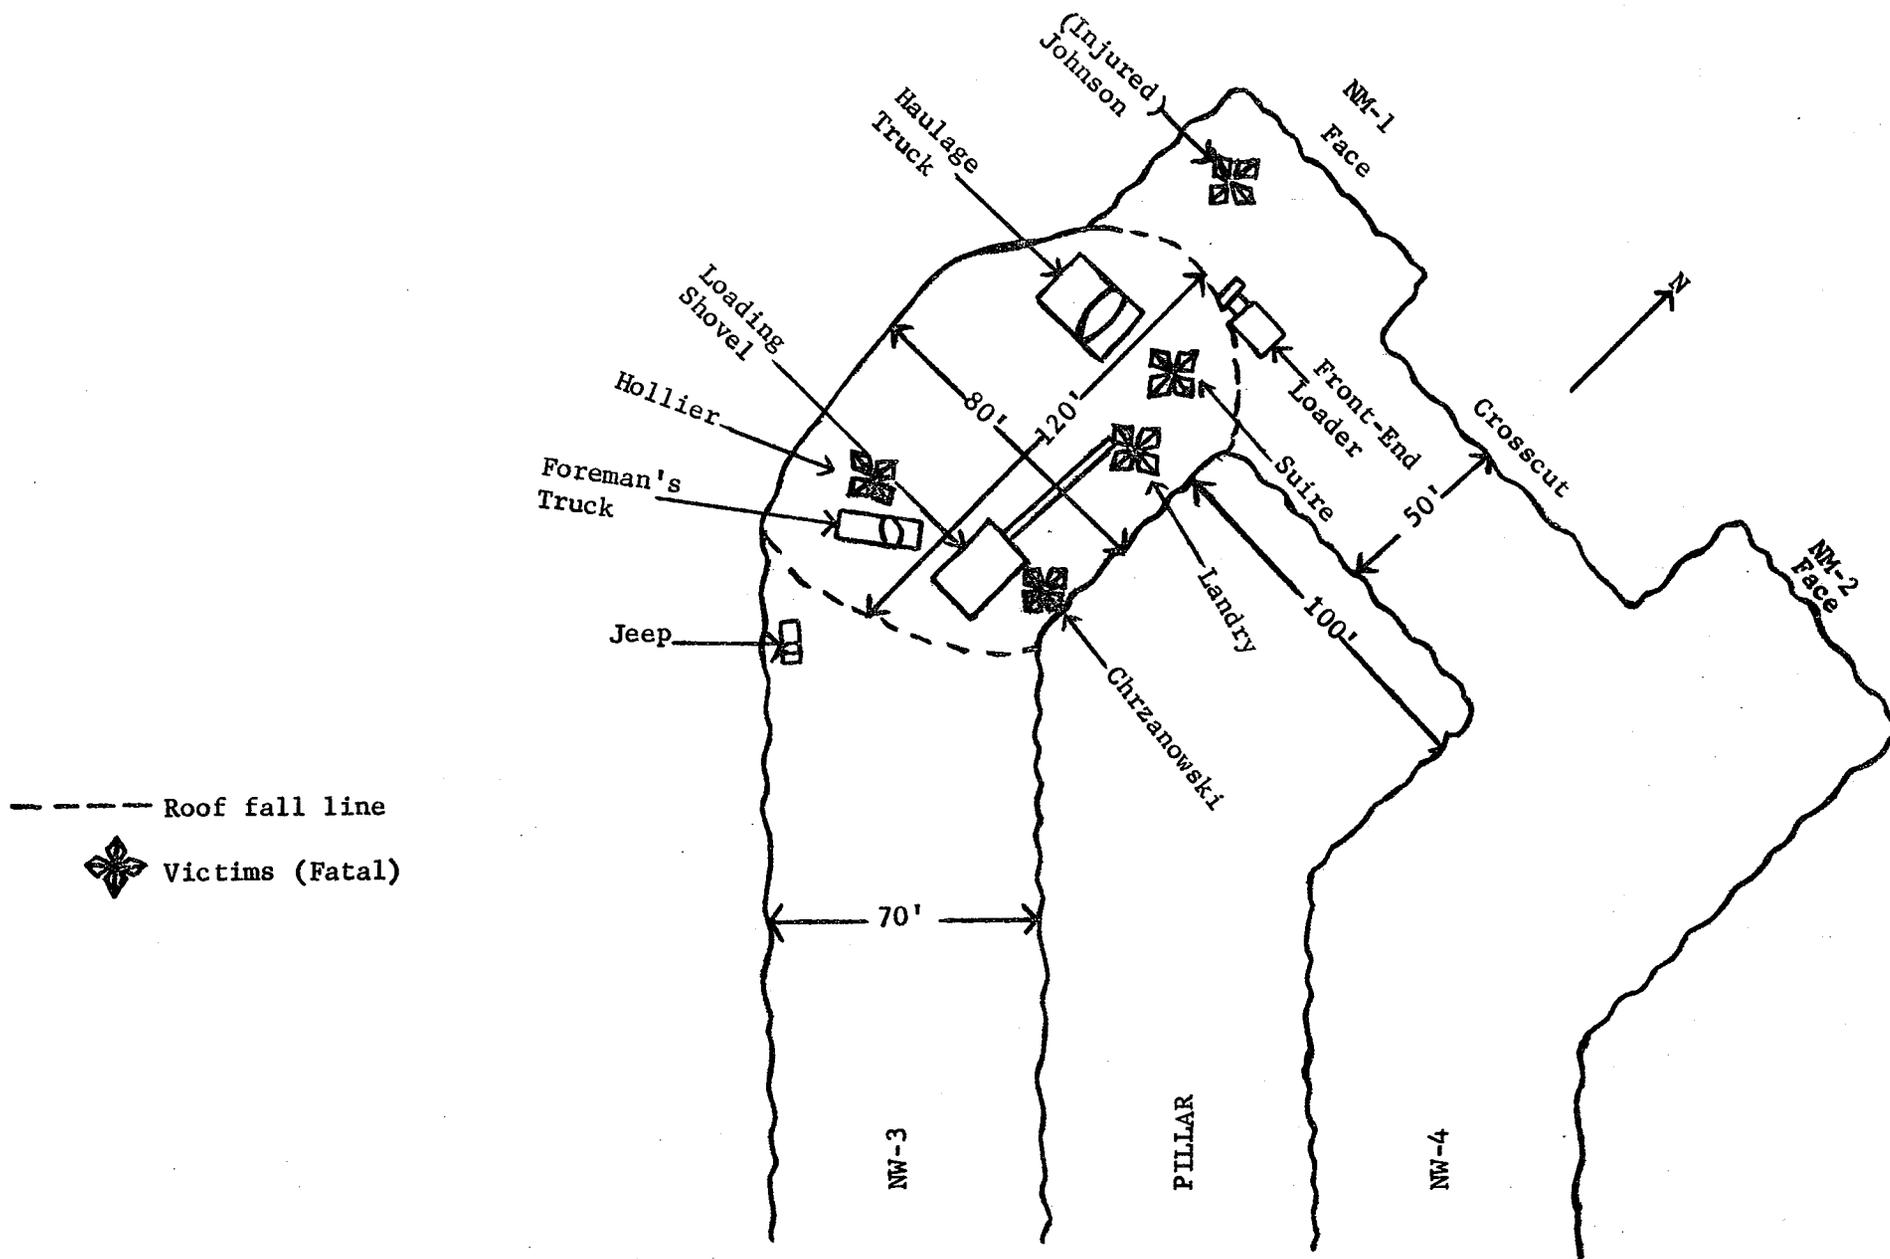
Rivers Johnson (witness), front-end loader operator, was standing by the front-end loader near the face. In the meantime and without warning, an area of roof fell measuring 80 feet wide, 120 feet long, and ranging from 1 to 5 feet in thickness, killing Chrzanowski, Hollier, Suire, and Landry. Johnson received abrasions of the left arm from flying material. A 2-3/4-cubic-yard shovel, a 30-ton haulage truck, and a 1-1/2-ton pick-up truck were crushed by the fall. (See sketch of accident scene.)

An examination of the surface of the fallen salt was made for planes of separation, but none was found. The pillar between the north main No. 1 and the north main No. 2 development entries near the face was 100 feet wide.
