REPORT OF INVESTIGATION  
(UNDERGROUND COAL MINE)

FATAL HOISTING ACCIDENT

Mathies (ID No. 36 00963)  
Mathies Coal Company  
Courtney, Washington County, Pennsylvania

September 19, 1979

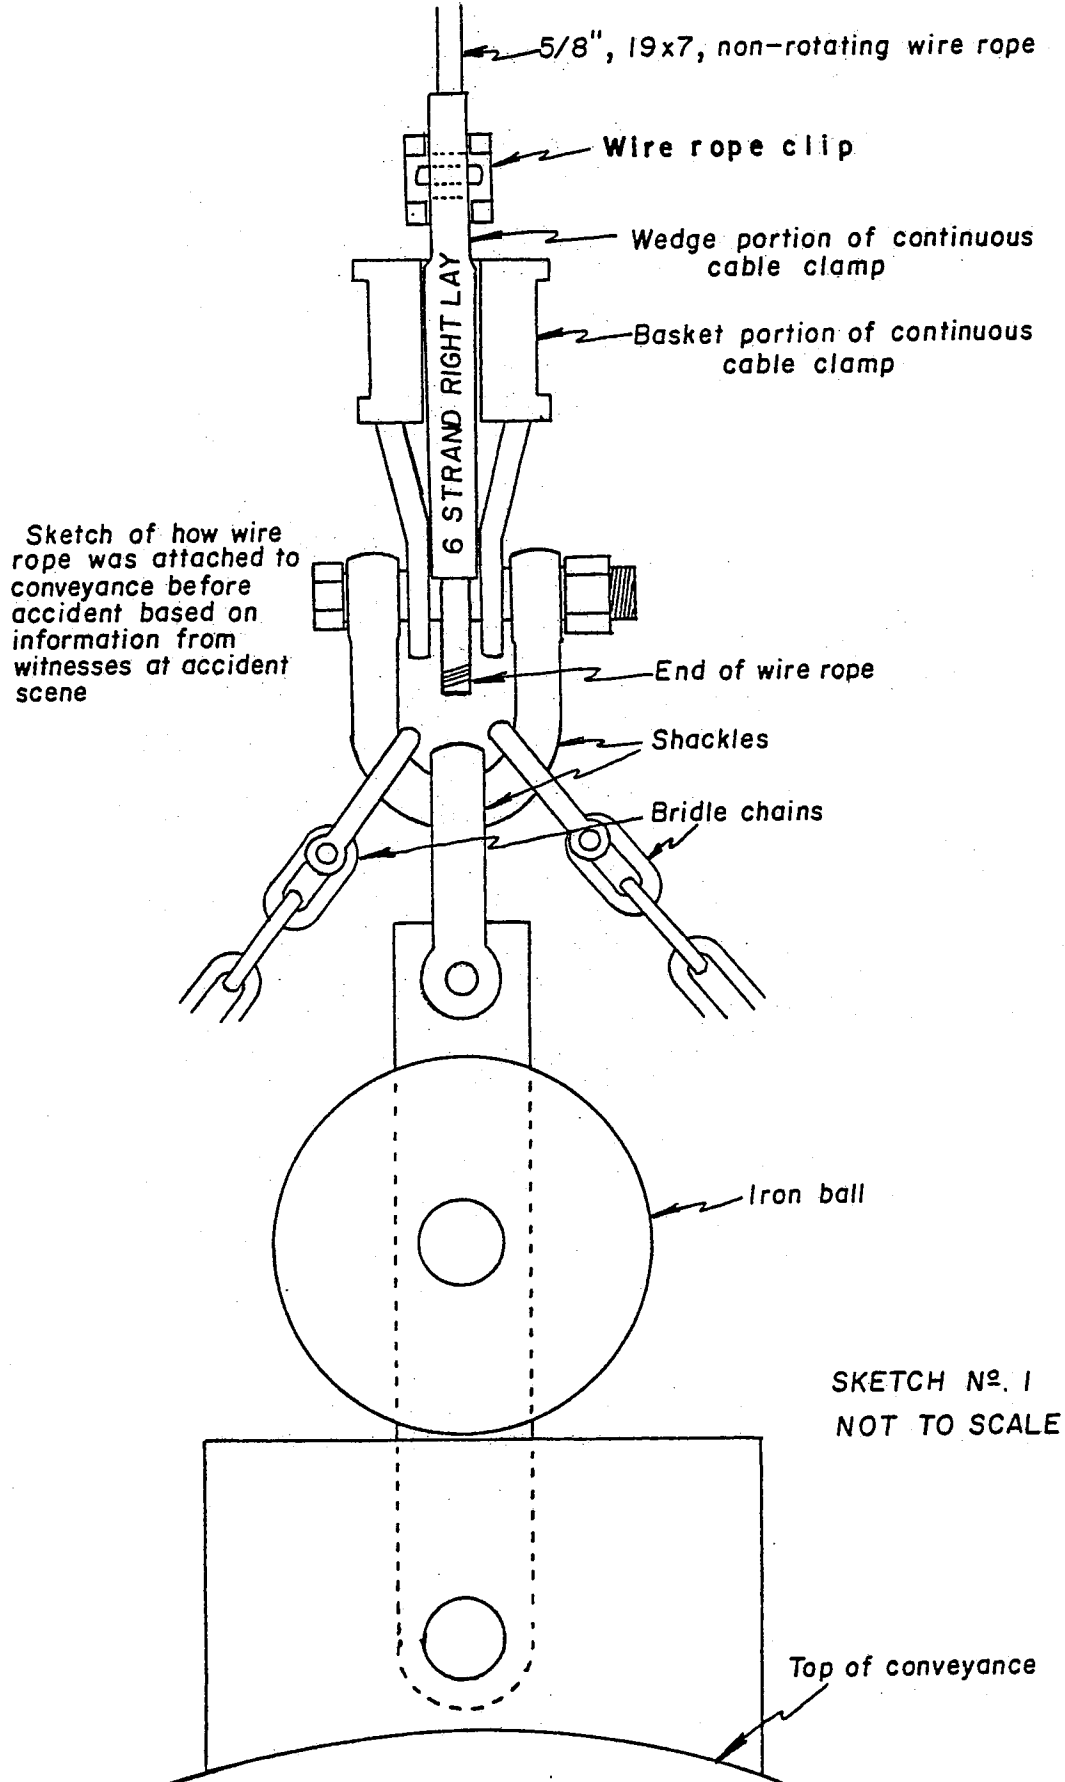
SKETCH No. 1  
NOT TO SCALE

Sketch of how wire rope was attached to conveyance before accident based on information from witnesses at accident scene

The 5/8-inch 19 x 7 nonrotating wire rope used on the emergency escape hoisting facility at Kerr shaft was not properly attached to the conveyance (capsule) in that a continuous cable clamp (Sauerman Bros., Inc., Part Nos. 4193 and W-2136) was used to attach the wire rope to the conveyance. The MSHA District Manager approved the facility on February 11, 1976, when 5/8-inch wire rope clips installed on 4-inch spacings were used to attach the wire rope to the conveyance and he required on April 23, 1979, that four 5/8-inch wire rope clips installed on 3-3/4 inch spacings shall be used to attach the wire rope to the conveyance. A violation of Section 75.1704.

The accident occurred when the victim rode a conveyance which had a continuous cable clamp installed as the only means of attaching the wire rope to the conveyance. The wire rope slipped through the continuous cable clamp and the conveyance fell to the shaft bottom.

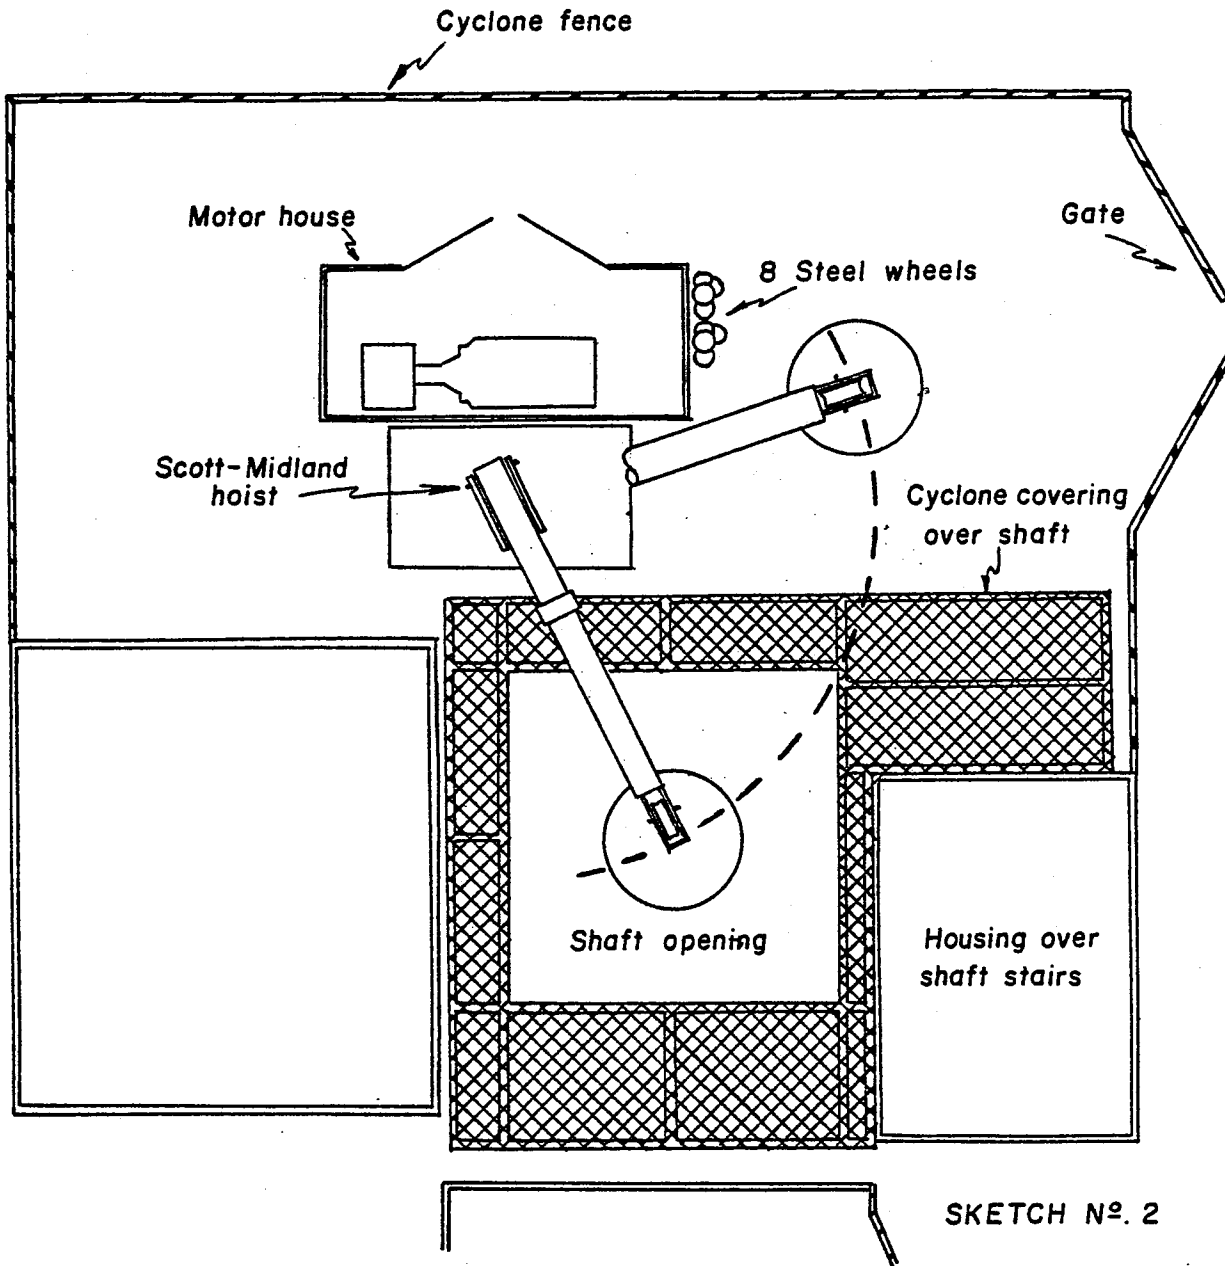
SKETCH N<sup>o</sup>. 2

11. Nogal stated he told Walters to swing the empty conveyance over to the landing area after it reached the surface, and prepare to make a load test. He then walked outside the fence around the shaft to take photographs of the overall installation. (See sketch No. 2). While taking photographs, Marn approached him and asked if there was anything wrong which might affect approval of the facility. Nogal told him that the absence of an external braking system and the way the bridle connection and wire rope was installed might affect approval, and he was not sure if the connection was or wasn't safe. He also told Marn he would review the photographs and diagram with other personnel who had more experience with hoists.
