FINAL REPORT OF MINE EXPLOSION NELLIS NO. 3 MINE, THE AMERICAN ROLLING MILL COMPANY NELLIS, BOONE COUNTY, WEST VIRGINIA

November 6, 1943

UNITED STATES DEPARTMENT OF THE INTERIOR BUREAU OF MINES

FINAL REPORT OF MINE EXPLOSION NELLIS NO. 3 MINE, THE AMERICAN ROLLING MILL COMPANY NELLIS, BOONE COUNTY, WEST VIRGINIA NOVEMBER 6, 1943 By E. H. Brown, F. J. Furin, and R. B. Jones

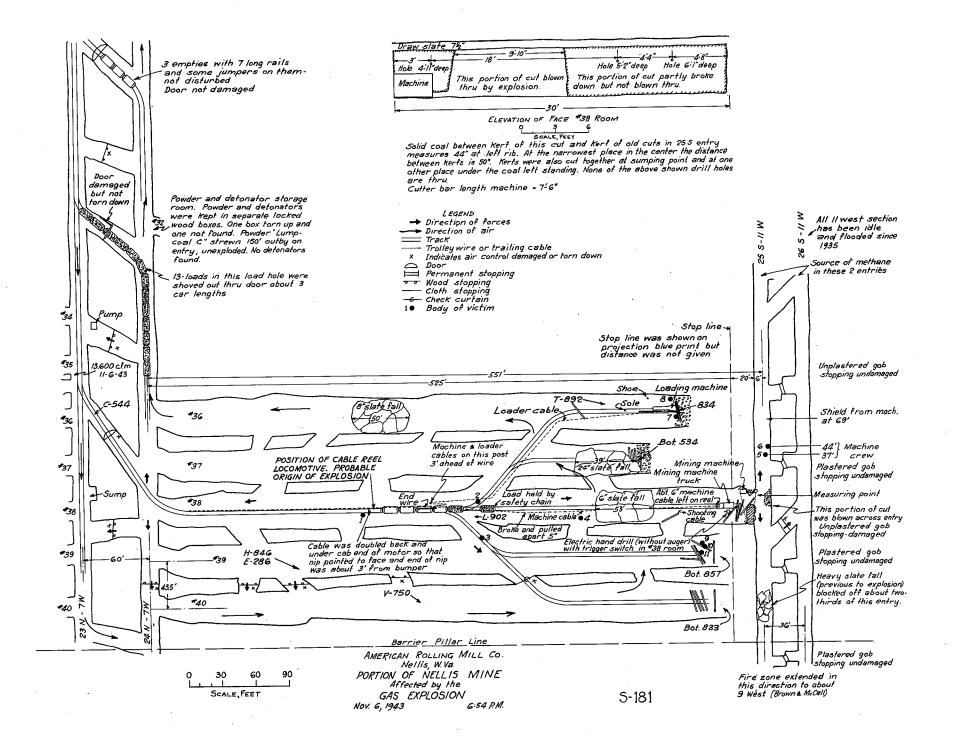
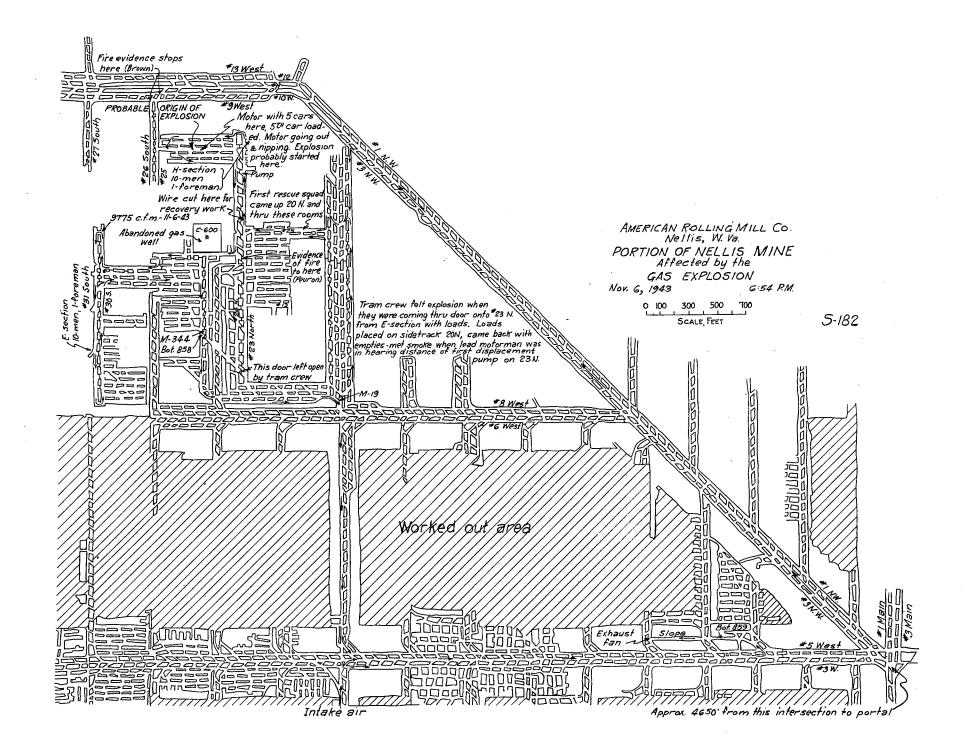
Supplement to Map Showing the Portion of Nellis Mine of the American Rolling Mill Company Affected by the Explosion on November 6, 1943

Machine - Under coal, cut practically completed, controller wide open, bit clutch in, fast feed friction tight, slow feed friction loose and both pipe jacks were in place. Tail rope was loose dead eye having pulled out of drum. Skid, jack handle and shovel blade were on top machine. (Handle for this shovel was found some 50 ft. down 25 S. entry.) Lifting jack and a pick were found just to left of machine. Tamping stick and an auger bit were found to left of machine truck.

Loader - Had been put in position for a new run. Conveyor clutch was out, tram clutch in neutral and control valve was set for lowering the head. Head was down. A glove containing 4 fingers from the operator's hand was found on the right running board. The helper's arm was found 4 ft. ahead of the left digging arm. A watch was found under the loading boom stopped at 6:54.

Shooting box - Two pieces from the end of a powder box, which might have come from the shooter's hand box were found on clearance side of chain pillar between 23 & 24 N. Entries at mouth #38 Room.
