FINAL REPORT ON A GAS AND DUST EXPLOSION IN THE
NELMS MINE OF THE OHIO & PENNSYLVANIA COAL
COMPANY AT NELMS, HARRISON COUNTY, OHIO,
ON NOVEMBER 29, 1940

J. J. Forbes
Supervising Engineer
Safety Division

UNITED STATES
DEPARTMENT OF THE INTERIOR
BUREAU OF MINES

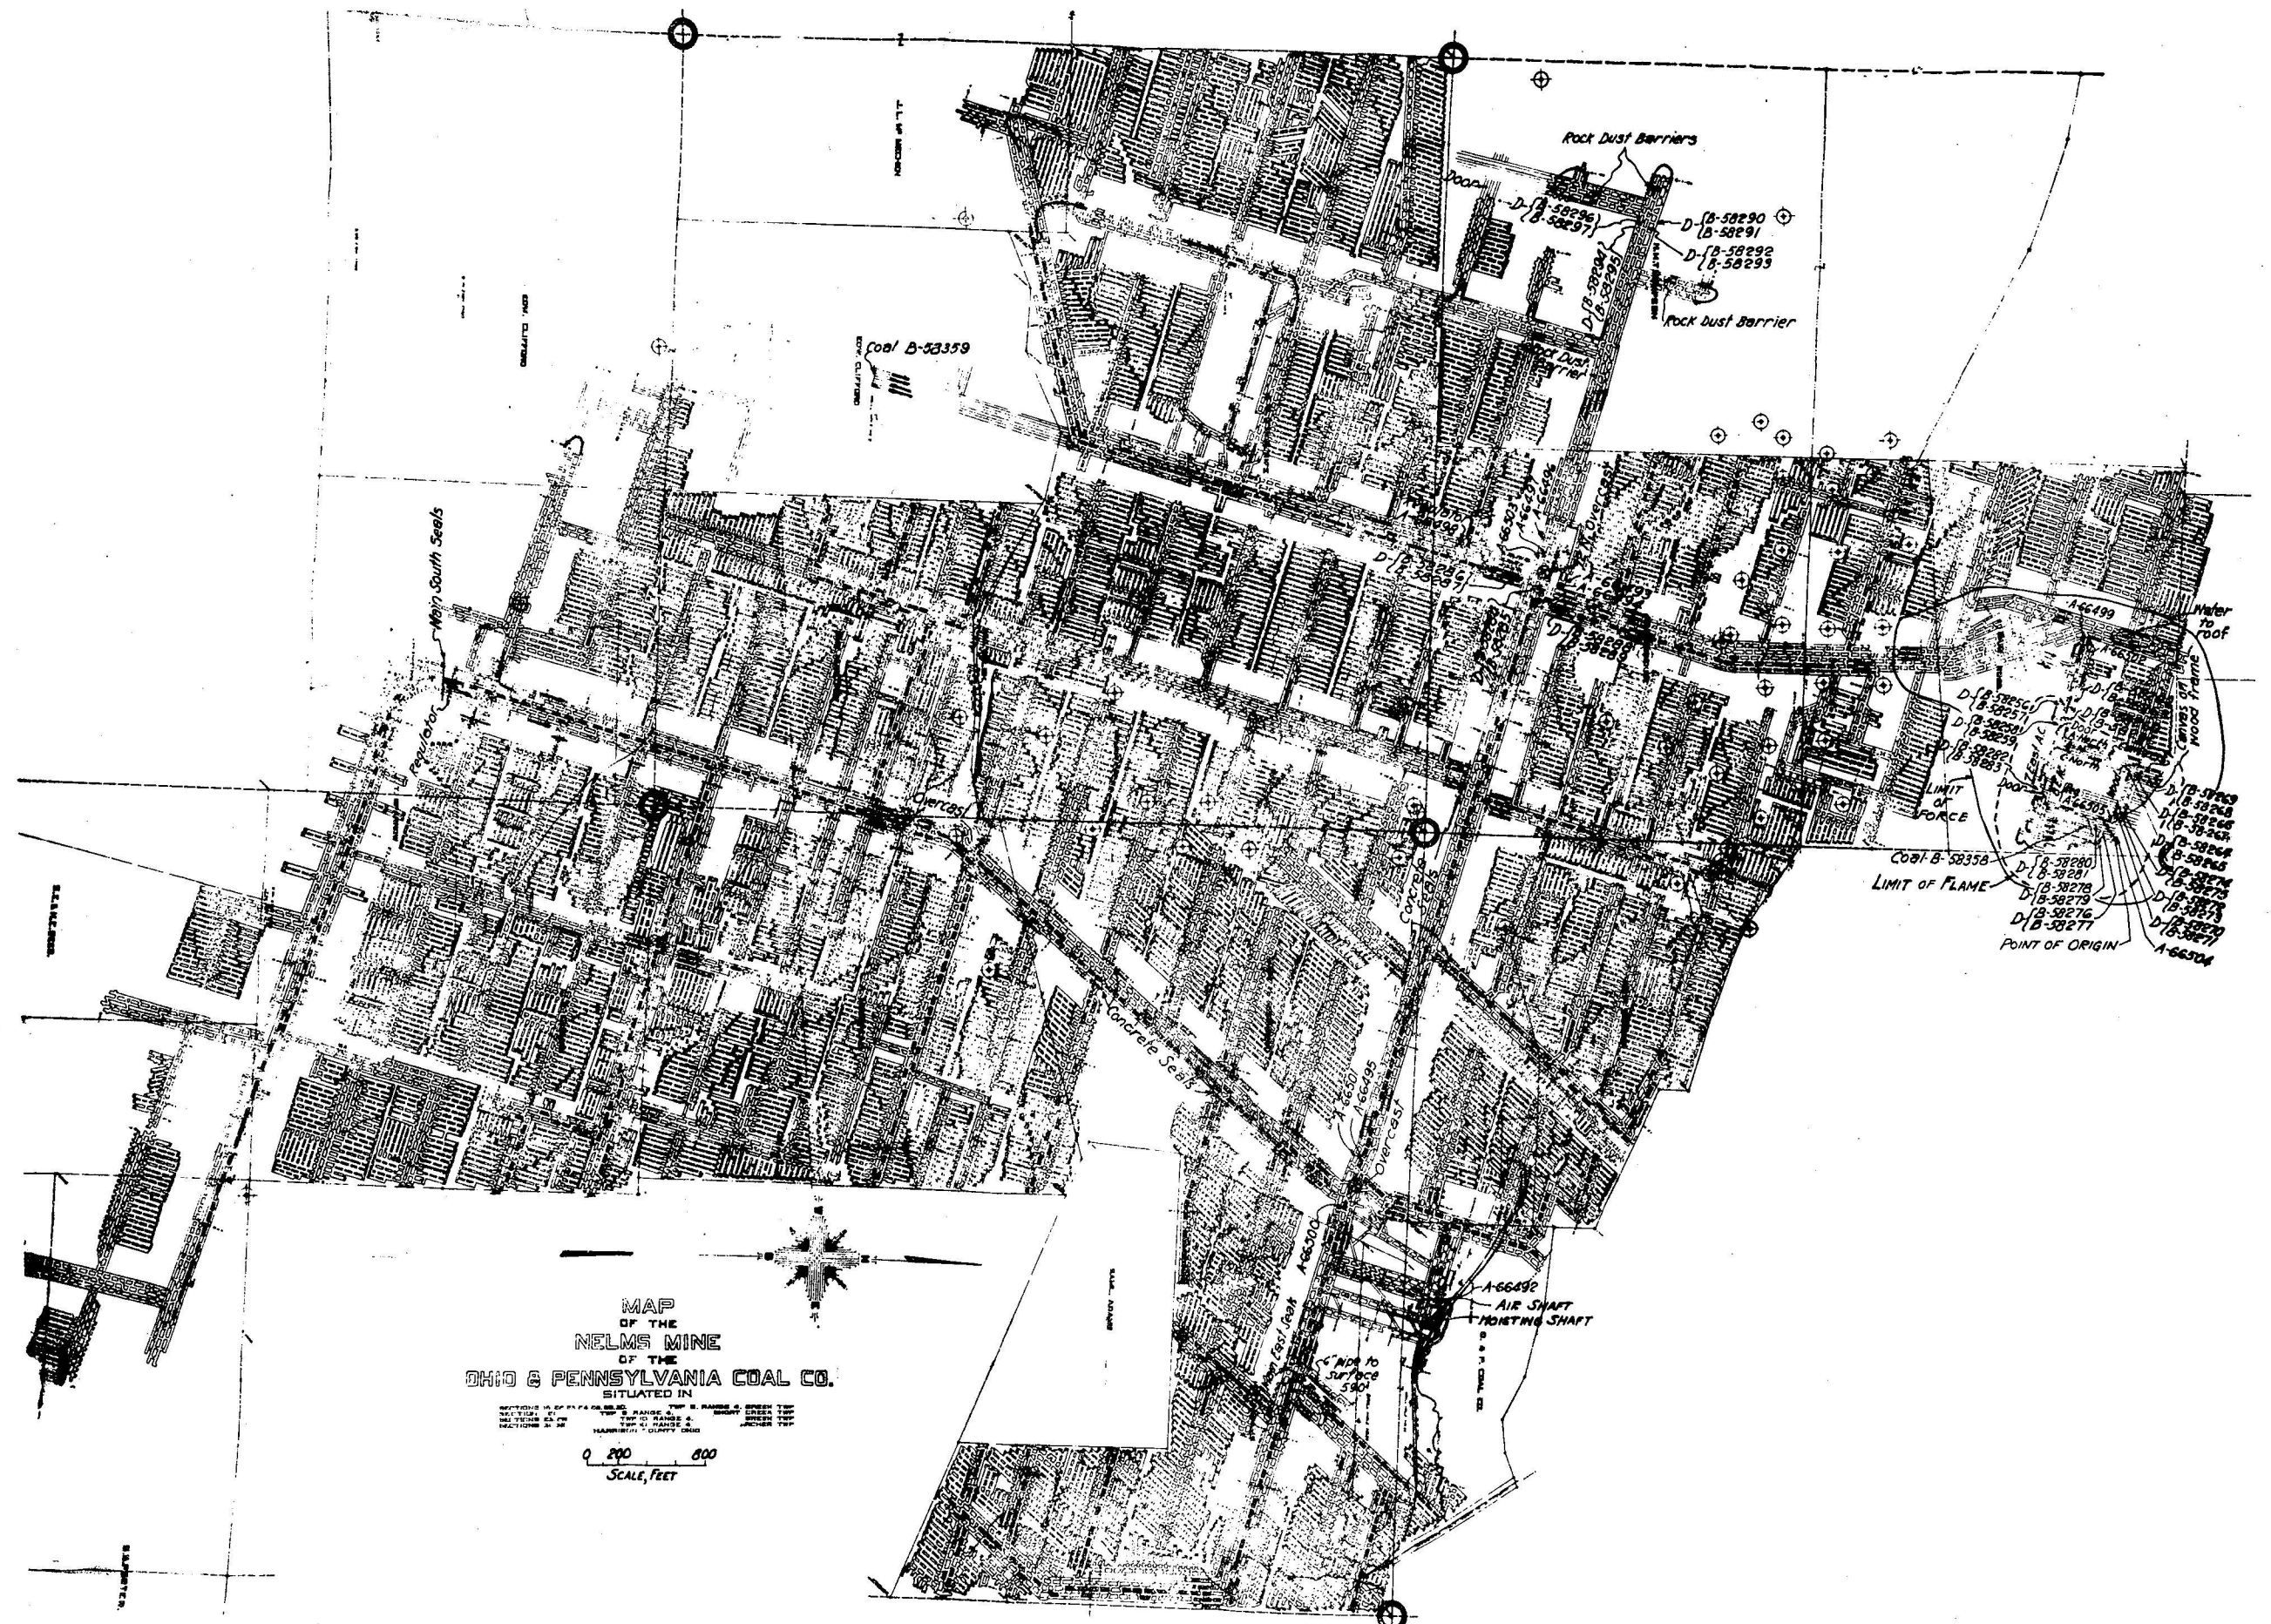
SKETCH SHOWING
 DETAILS OF EXPLOSION
 IN ROOM 13
 OFF T&B ENTRIES

Extensive falls of roof were found in room 12 outby the chute to room 13. Details of conditions at this chute are shown in the sketch of this location. Five loaded cars were in this chute. The timber on these cars indicated forces from the face of room 12 and from room 13. A crossbar just outby this chute had the post on the left rib blown out, and the bar was blown outby being found practically parallel to the right rib.

At the nips of the mining machine near the chute from room 12, pieces of charred dummy paper were found. Between this point and the last crosscut to room 12 crossbars and posts and part of the line brattice indicated forces outby. At the mouth of No. 2 butt room, from room 13, was a pile of rock dust, evidently used for making dummies. At the face of room 13 there was considerable evidence of force and flame, heavy coke being found on the roof. The crosscut to room 12 was 24 feet from the face. On the right rib of room 13 the coal had been undercut for a distance of 22 feet and to within 1 foot of the face of the room. Thirteen feet from the face of the right rib a hole had been drilled in the coal 9 inches from the roof, and directly under this hole, 2 feet 10 inches from the roof, was a second hole, 2 feet 2 inches deep, in which was an auger protruding 1 foot 10 inches. Dust at the mouth of both of these holes was coked and gas was issuing from these holes.

A mounted Chicago Pneumatic Tool Company drill was found on the floor angling toward the left corner of the rib and face of the room. This drill was reported to have been a permissible type, but no permissible plate could be found on it. The disconnecting switch is not found on permissible drills, and the assembly is different from that found on any of the permissible drills manufactured by this company. The cover of the switch on the drill had 8 out of 10 bolts missing, making it nonpermissible. The direction lever was for drilling in and the controller was in the "on" position, indicating that the drill probably had been in operation at the time of the explosion. The shovel for removing the machine cuttings from the kerf on the right rib was found under the kerf near the drill. A Goodman Universal mining machine, which is a permissible type, was found practically parallel to the face of the room with the end of the cutter bar in position to start sumping into

the coal. The controller was in the "on" position. The cover on the bearings of the lever was loose, leaving a clearance estimated to be about 1/64 inch. The top cover of the controller box had 4 out of 8 bolts missing. The jack pipes were in position and the cable was in place, indicating that the machine was probably in the act of sumping into the coal.

The driller was found face down with his head towards the right rib and his feet angling towards the corner of the face and left rib. The driller's helper was found face up, head lying on the cutter bar of the mining machine and feet pointing towards the drill. The machine helper was found lying outby near the rear end of the mining machine, face up, head towards the rib, and feet pointing towards the drill; his legs were over those of the machine-man, whose head was against the left rib and pointing outby. The timberman was also against the left rib with his head outby. In the center of the room, about 12 feet from the face, with head towards the left rib and face towards the right rib, was found the trackman under some timber and a fall.

The leg on the crossbar just inby the drill on the right side of the room was leaning inby at the roof. Two crossbars and their legs were found under the fall outby the drill with the ends of the right rib considerably farther outby than the ends toward the left rib.
