UNITED STATES
DEPARTMENT OF THE INTERIOR
BUREAU OF MINES
DISTRICT C

REPORT OF MULTIPLE FATAL COAL MINE ROOF FALL ACCIDENT
NO. 3 MINE (M.I. 00338)
OAKWOOD RED ASH COAL CORPORATION
OAKWOOD, BUCHANAN COUNTY, VIRGINIA

May 17, 1967

Harold Wiley
Coal Mine Inspection Supervisor

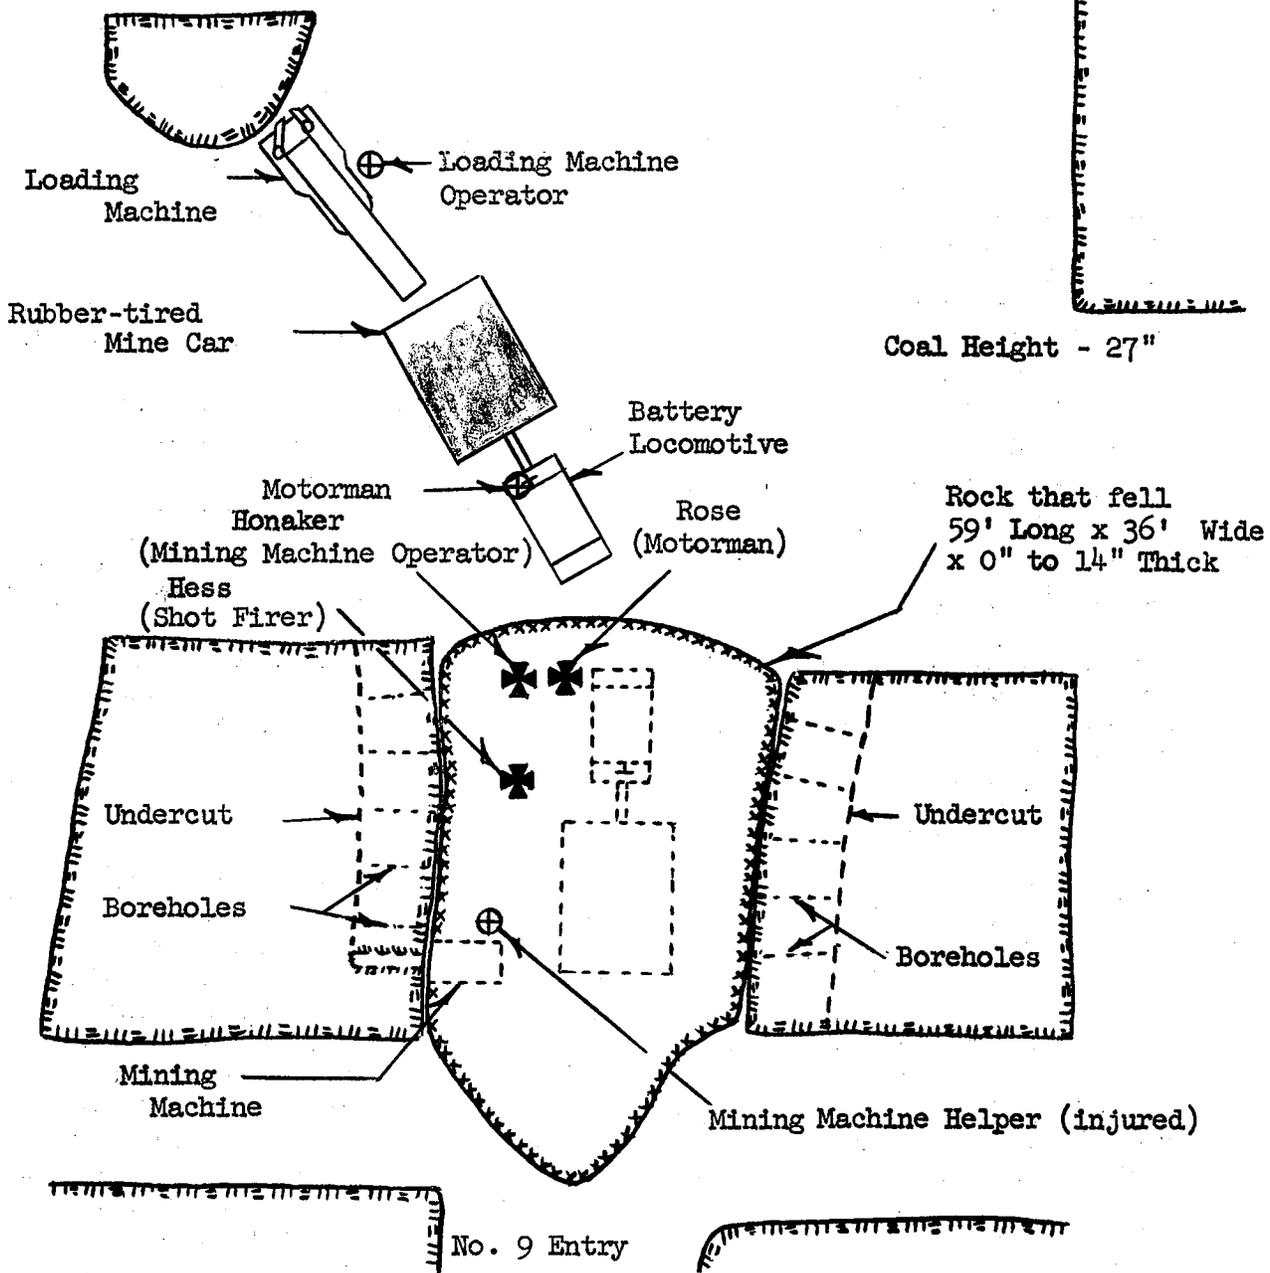
Sketch No. 2

Supports in place prior to fall could not be determined

The fall, which broke into numerous pieces, extended from coal rib to coal rib, was about 59 feet long, 36 feet wide, and ranged in thickness from 0 to 14 inches.

Equipment involved in the accident and caught beneath the fall consisted of a 212-Goodman shortwall mining machine, a hand-drill electric drill, a rubber-tired, battery-powered (Kersey) locomotive, and a rubber-tired mine car which was coupled to the locomotive. The location of this equipment in the accident area is shown in the attached sketch.

Men working under a large expanse of mine roof that was either unsupported or inadequately supported was the direct cause of this accident. The unusual method of pillar extraction, which amounted to "pushing" of entry pillars away from an active roadway, was undoubtedly a contributing factor.

1. The companys adopted systematic method of roof support should be followed by all officials and employees and additional timbering should be done where the need is indicated.
2. A method of pillar extraction that will provide a maximum of protection for all employees should be adopted at this mine. Methods such as the "open end" and the "pocket-and-fender" should be considered.
