**Orient No. 2 Mine**

FINAL REPORT ON MAJOR EXPLOSION DISASTER  
ORIENT NO. 2 MINE  
CHICAGO, WILMINGTON AND FRANKLIN COAL COMPANY  
WEST FRANKFORT, FRANKLIN COUNTY, ILLINOIS

December 21, 1951

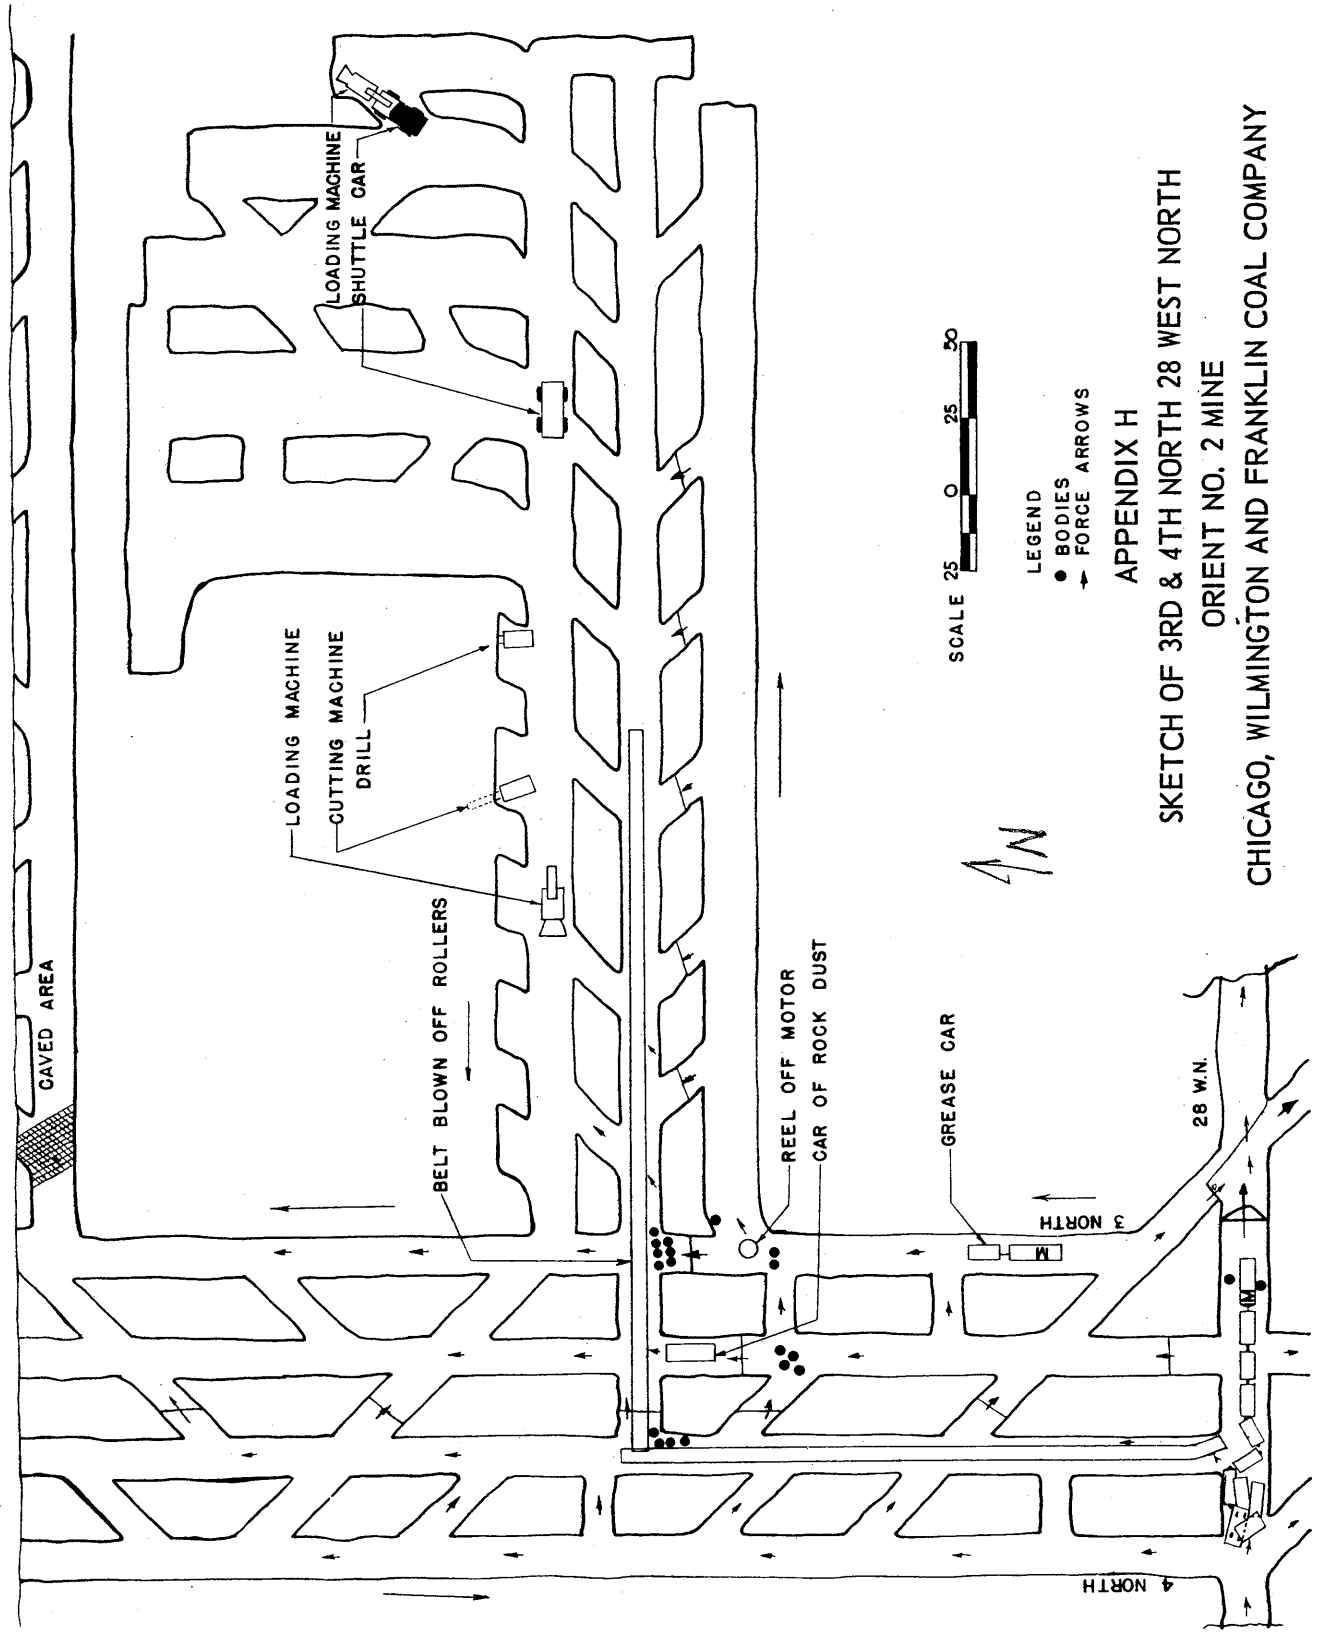
APPENDIX H

In panel 3 and 4 north, 28 west north (Appendix H) direction of major forces was north in all four panel entries. The cable reel of a locomotive was blown 100 feet northward, and stoppings and the stub-entry belt which were placed east-west, or broadside to the direction of force, were blown northward. Forces through the crosscuts in the panel entries removed or damaged all stoppings from west to east. The forces veered eastward into the No. 1 stub entry and blew out some of the stoppings in a northerly direction. No violence was observed in the face regions. All men had come out of the face area bringing their dinner buckets and were found huddled in a small area in the panel entries at the mouth of the stub, where they had died.

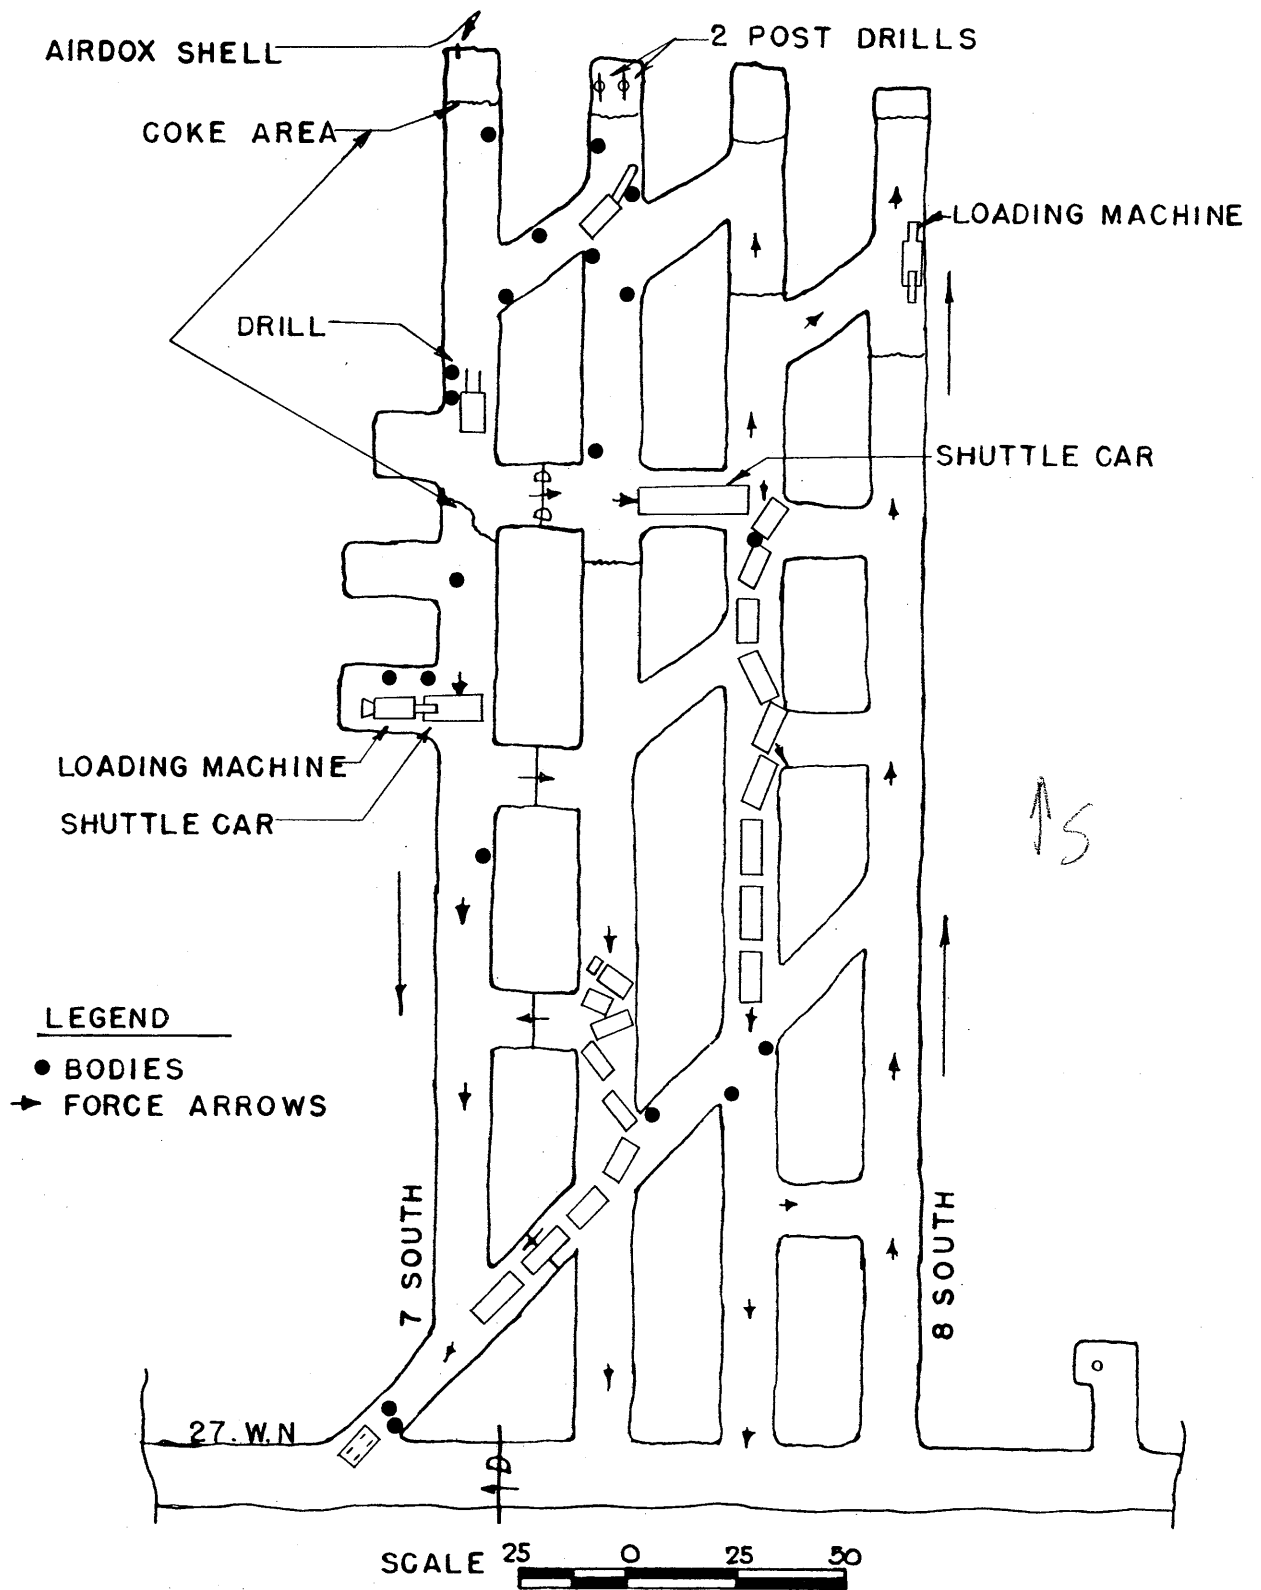
APPENDIX G  
 SKETCH OF 7TH & 8TH SOUTH 27 WEST NORTH  
 ORIENT NO. 2 MINE  
 CHICAGO, WILMINGTON AND FRANKLIN COAL COMPANY

In panel 7 and 8 south, 27 west north (Appendix G) violence was great. The south entries in this panel are designated A, B, C, and D from east to west. Indications of forces moving southward into the panel were noted in D entry, but in the other three entries all major forces traveled to the north and westward through the crosscuts. The trip at the loading point in C entry lacked only a half car of being fully loaded, and an empty trip was moving into B entry. Both trips were blown partially off the track with considerable violence, the forces driving the cars northward and westward. One man was blown forcibly westward under the loaded trip at the loading-point crosscut. The air compressor for shuttle-car tires was blown northward against the empty trip. All doors and stoppings were demolished by the forces traveling westward through the crosscuts, except in the 45-degree haulageway, where the northward moving forces were deflected eastward. Signs of violence were absent in the face regions of the panel entries and the east stub entries. Few, if any, of the men had moved any appreciable distance from the locations where they were working when the explosion occurred.

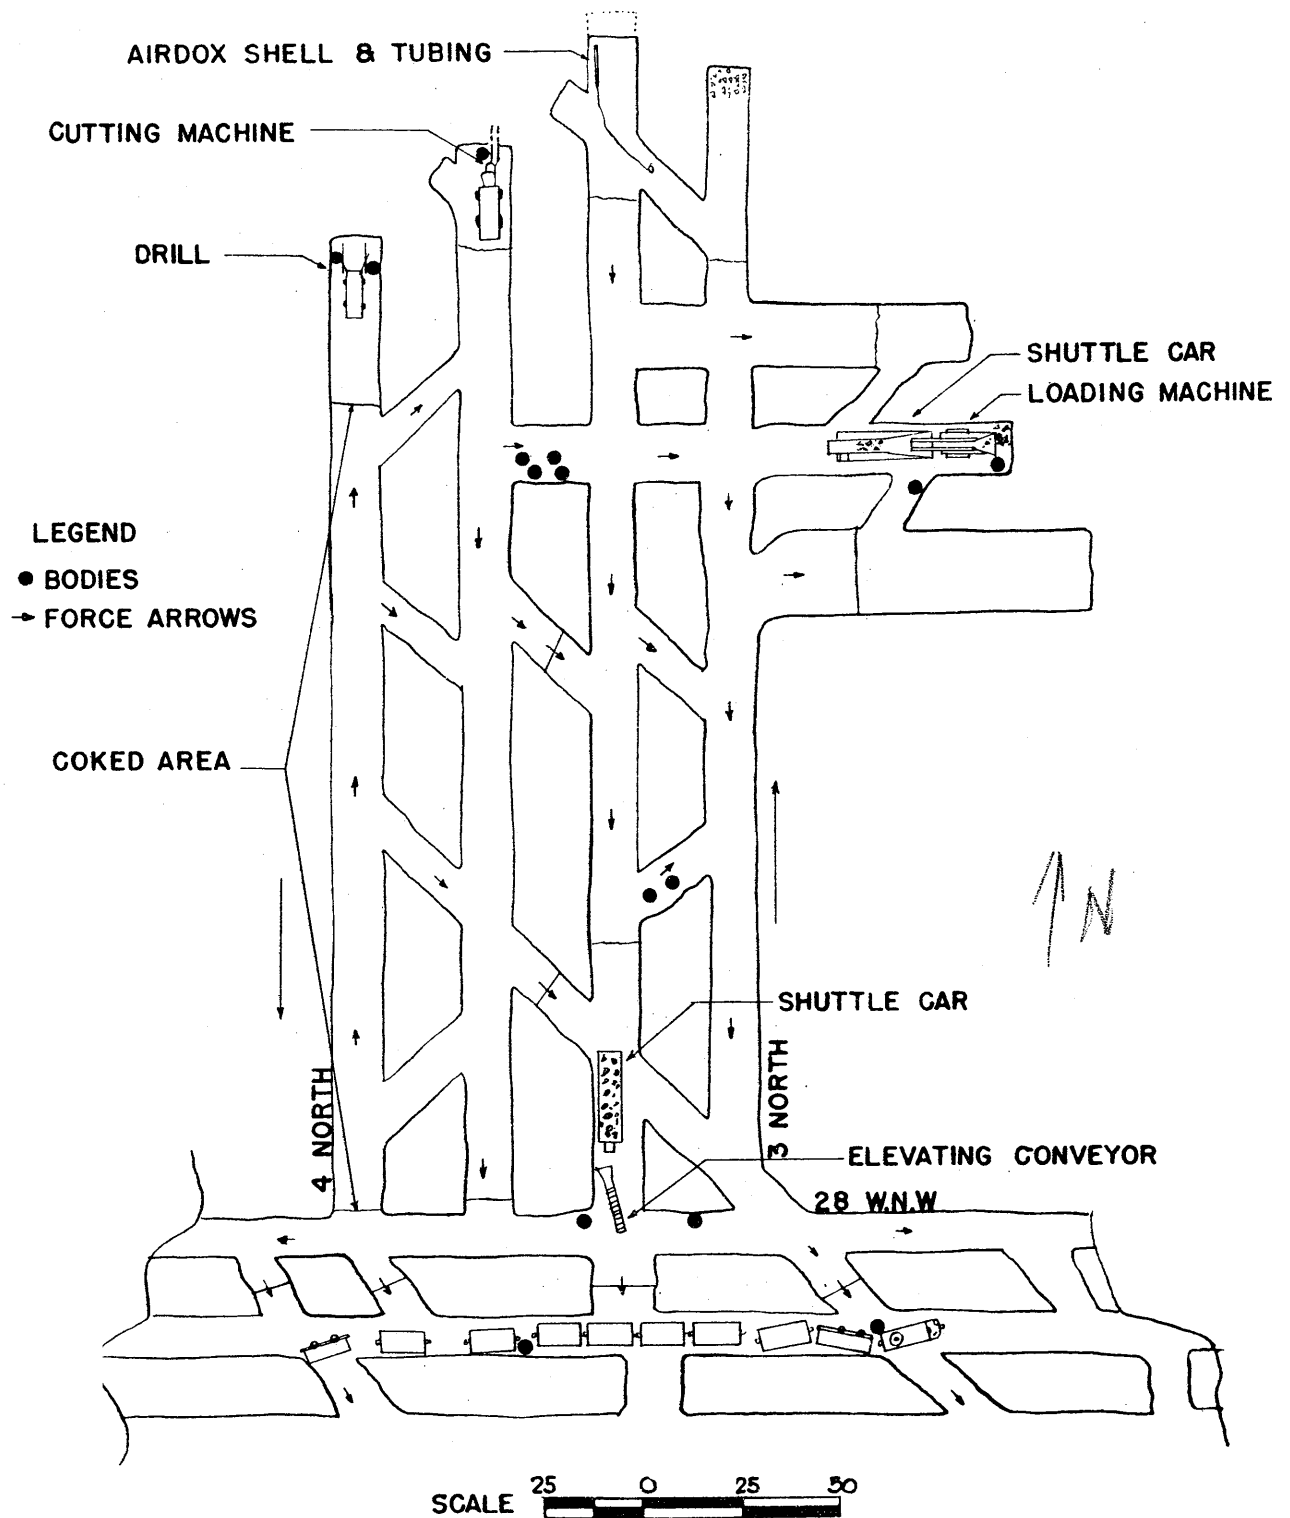
APPENDIX E  
 SKETCH OF 3RD & 4TH NORTH 28 WEST NORTH WEST  
 ORIENT NO. 2 MINE  
 CHICAGO, WILMINGTON AND FRANKLIN COAL COMPANY

In panel 3 and 4 north, 28 west north west (Appendix E) forces within the panel were not violent. Force in the 4 north D entry appeared to have been in by from the mouth of the panel toward the face of the entry. In the rest of the panel the forces moved eastward and southward toward the main cross entries. The force did not extend to the face regions. Loose objects on machines and rock dust on ribs and roof appeared undisturbed. At the mouth of the panel evidence of force was more pronounced toward the south.

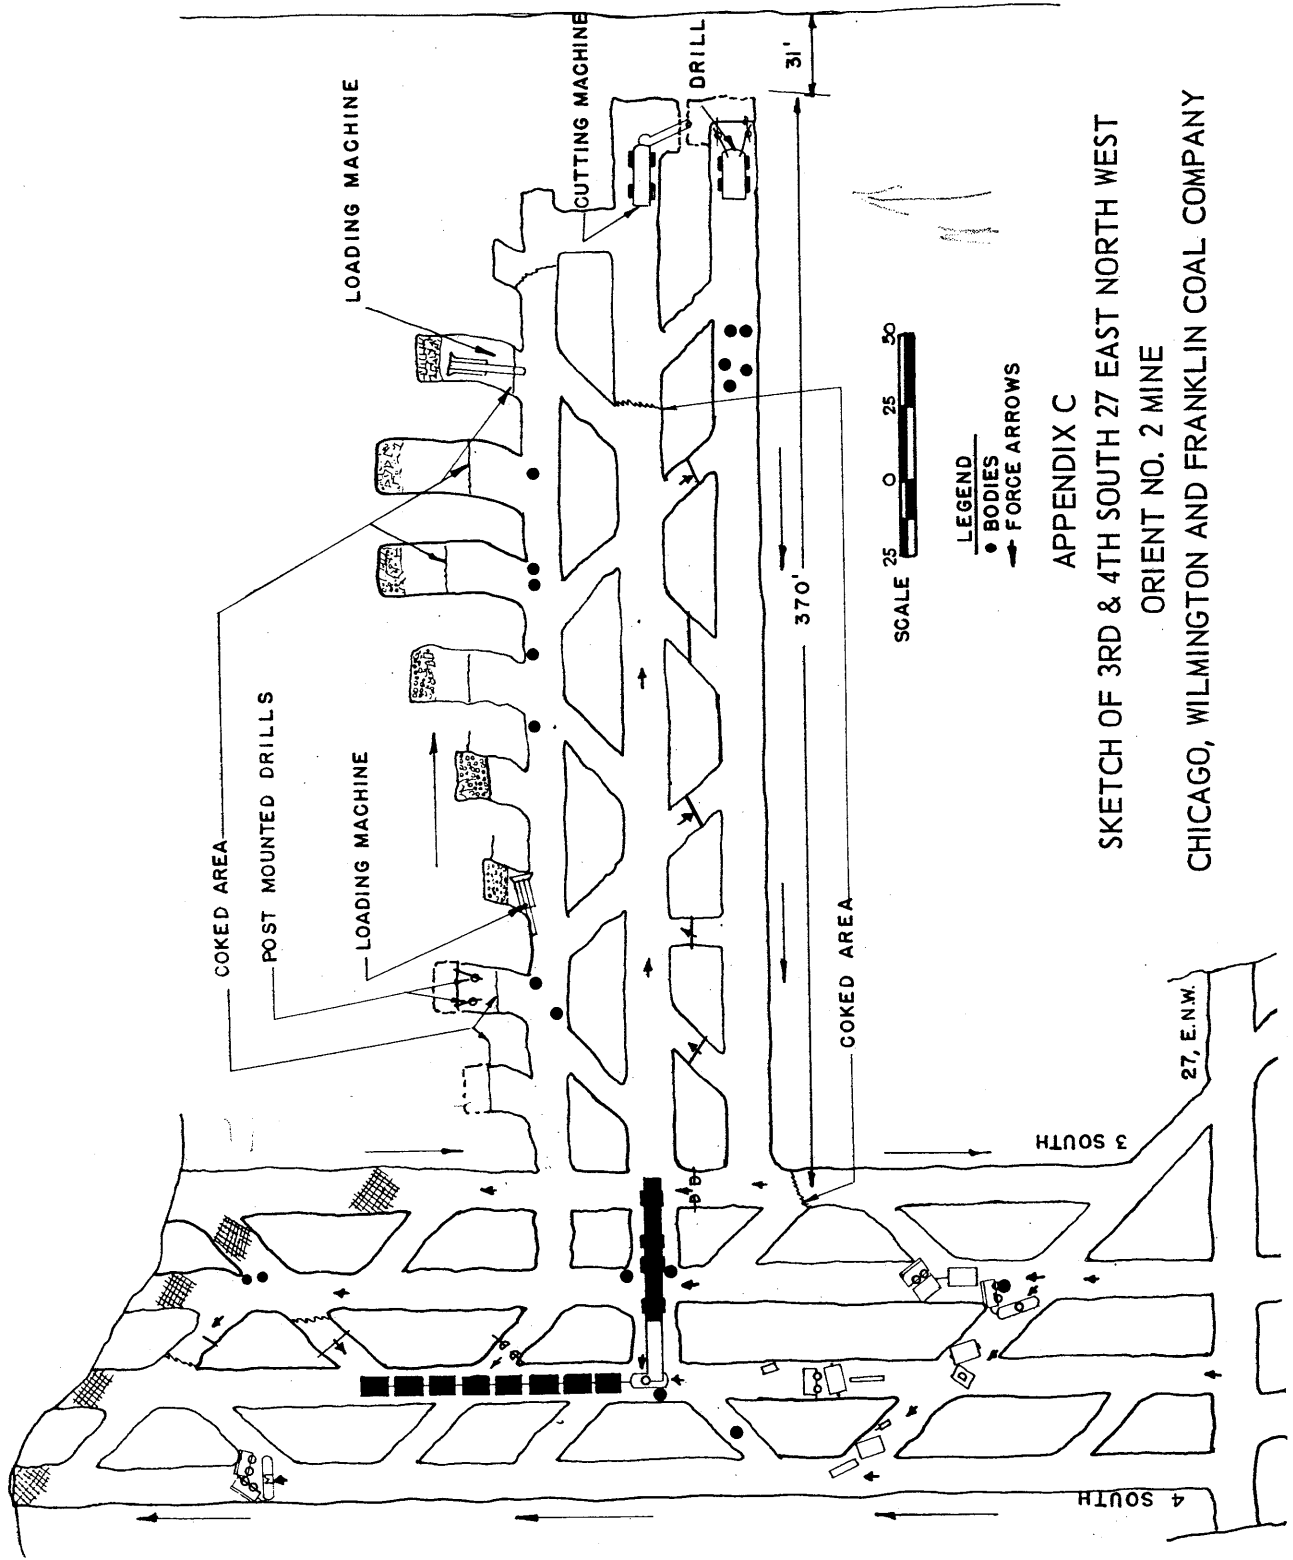
# APPENDIX C

The two shuttle cars were found loaded at the elevating conveyor at the car-loading station at 3 and 4 south. The shuttle cars were completely loaded and were bumpered together. There was no empty car under the elevating conveyor, see Appendix C.

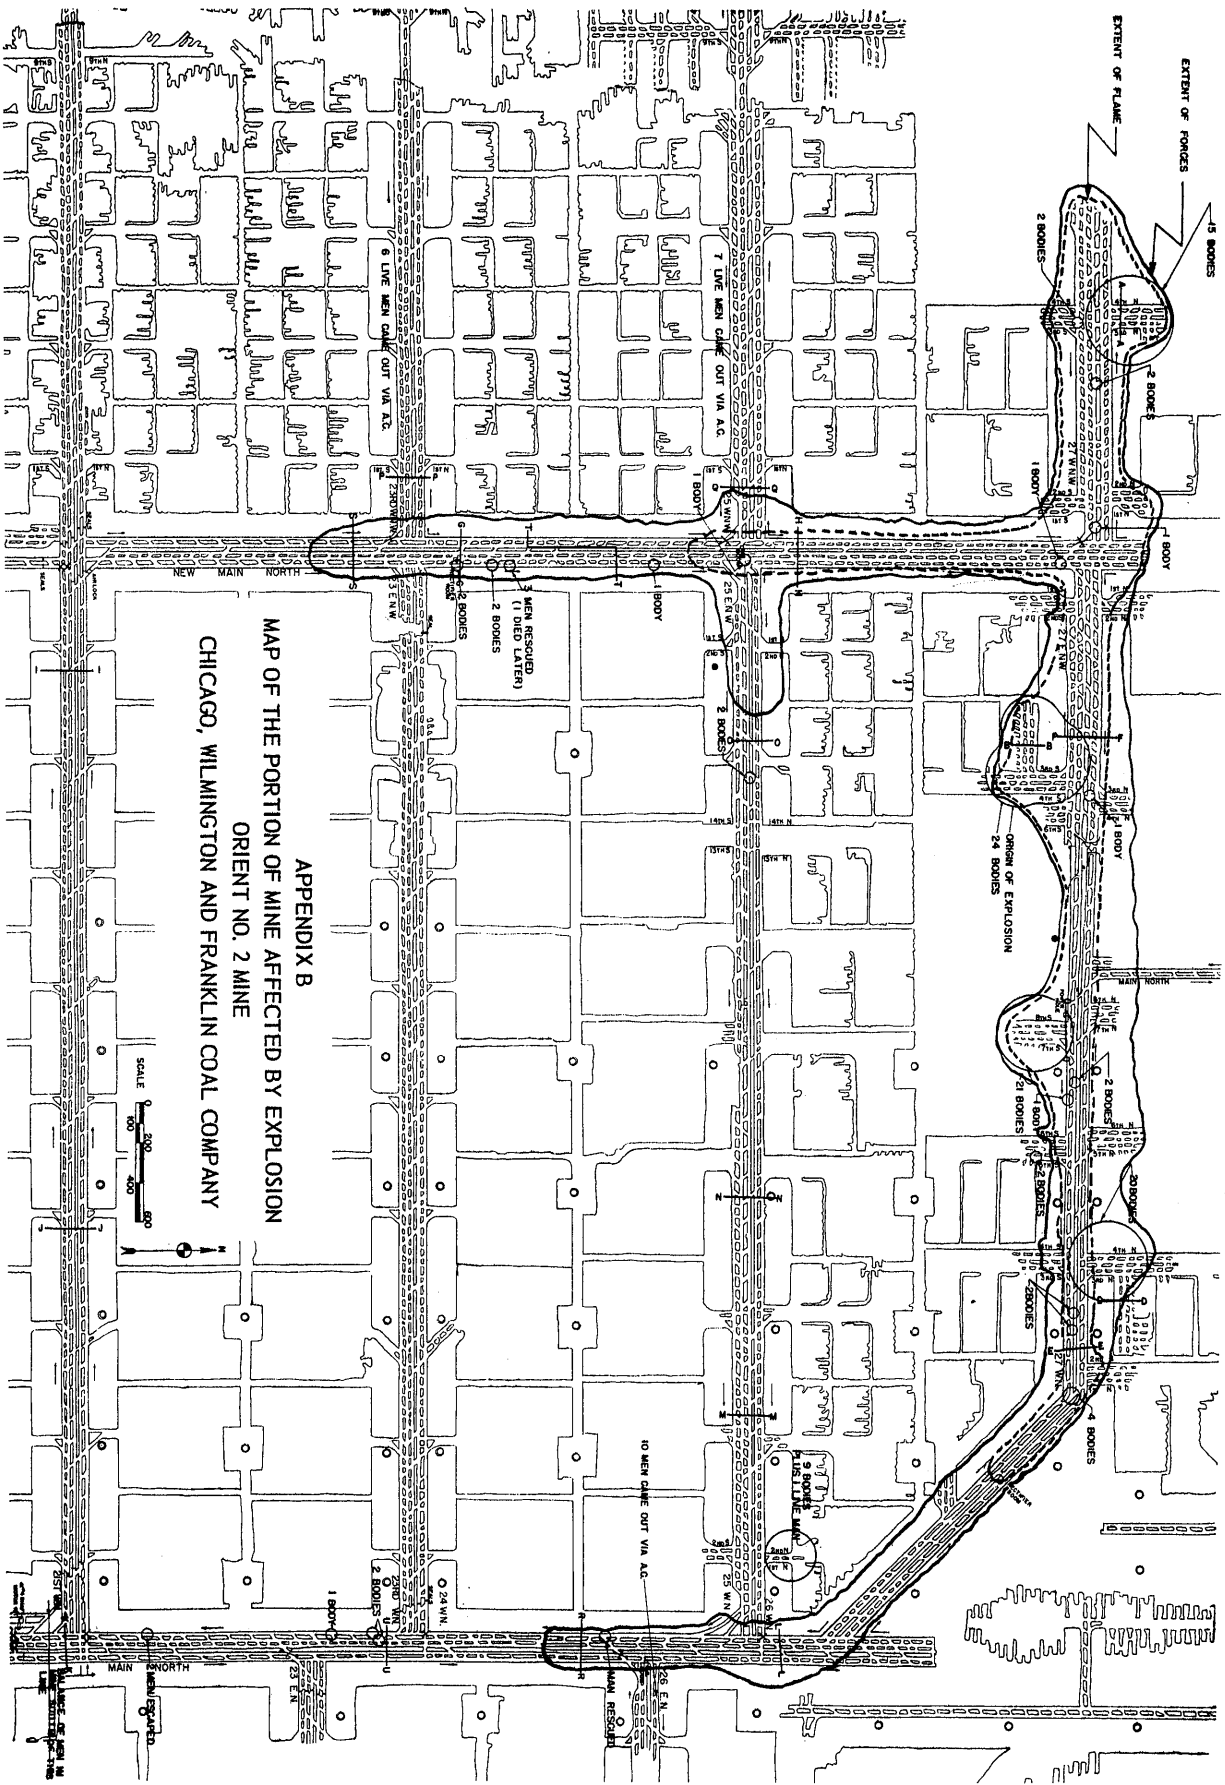
APPENDIX B  
MAP OF THE PORTION OF MINE AFFECTED BY EXPLOSION  
ORIENT NO. 2 MINE  
CHICAGO, WILMINGTON AND FRANKLIN COAL COMPANY

Analyses of dust samples taken in the Nos. 2 and 3 stubs showed particles of coke while samples taken in No. 1 stub showed no signs of coke. Location of samples are shown on Section BB in Appendix B. All of the bodies found in the 3 and 4 south showed signs of burns. The bodies found along No. 3 stub showed signs of extreme burns. The five bodies found in No. 1 stub showed signs of burns but apparently were burned by the hot gases given off from the explosion.

Very little flame entered the 3 and 4 north off the 27 west north. The bodies of the men found in this working section showed very little signs of burning. The analyses of the dust samples taken across the 1, 2, and 3 stubs off of the 3 and 4 north did not show the presence of coke. The location of these samples are shown as Section DD on the map, Appendix B.
