UNITED STATES
DEPARTMENT OF LABOR
MINE SAFETY AND HEALTH ADMINISTRATION
OFFICE OF THE ADMINISTRATOR
COAL MINE SAFETY AND HEALTH

REPORT OF INVESTIGATION
UNDERGROUND COAL MINE EXPLOSION

No. 2 Mine (I. D. 44-02274)
P and P Coal Company, Incorporated
St. Charles, Lee County, Virginia

July 7, 1977

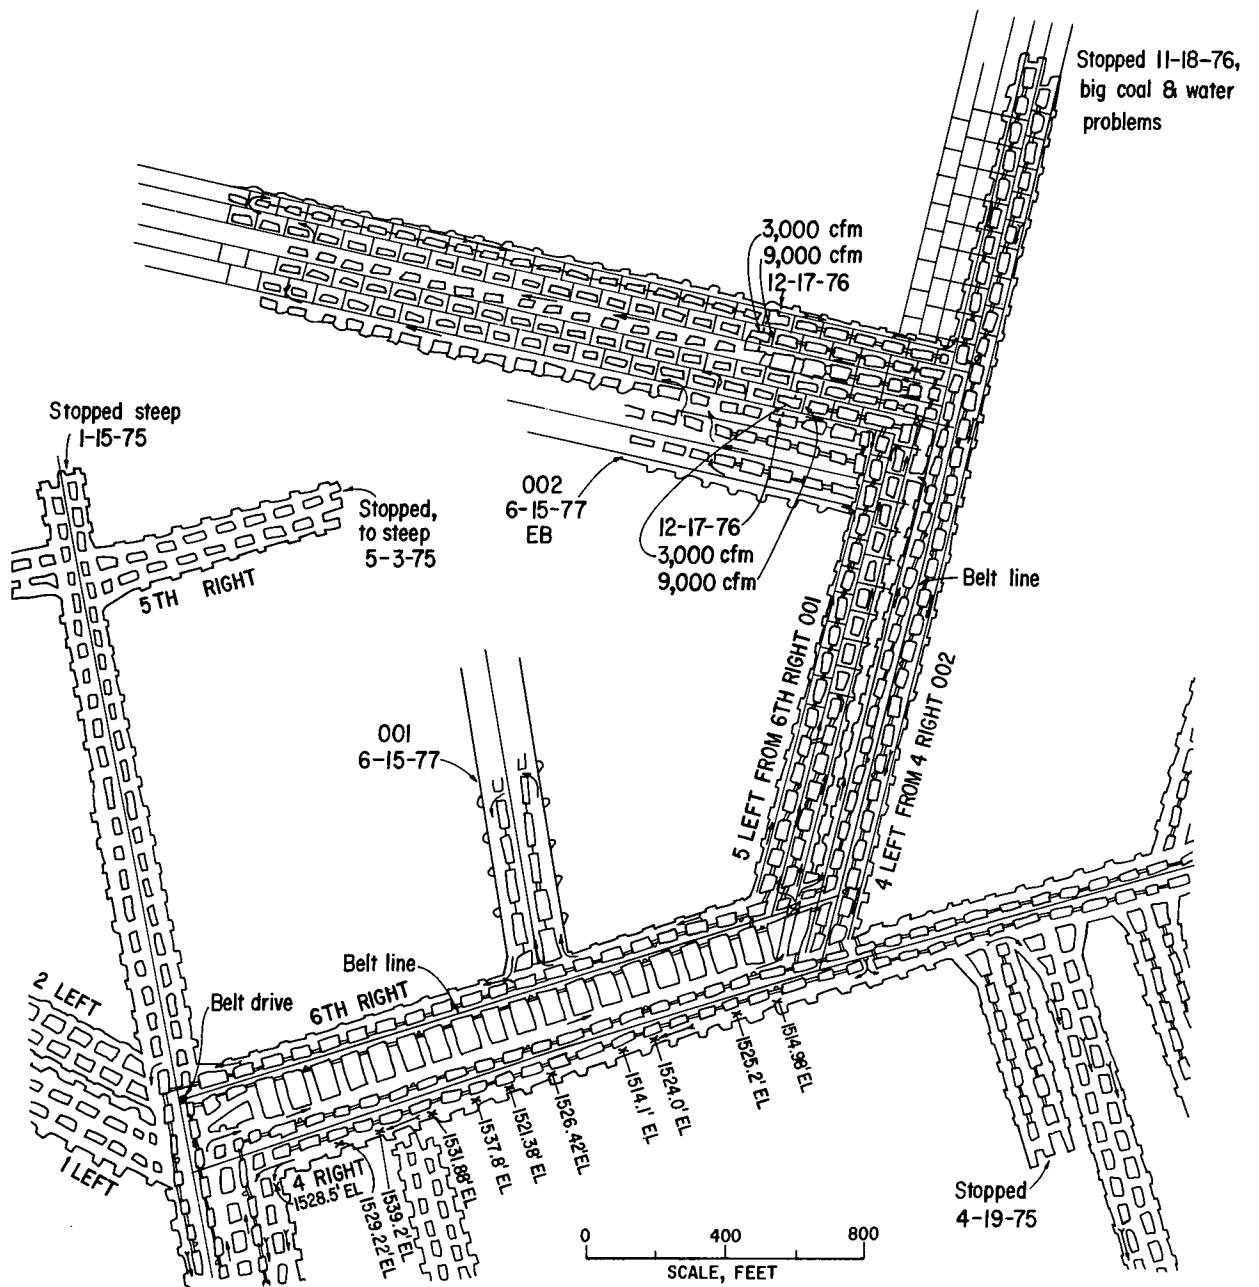
APPENDIX H
 NO. 2 MINE ID 44 02274
 P & P COAL COMPANY
 ST. CHARLES, LEE COUNTY, VIRGINIA
 COPY OF MAP FOUND IN SECTION 002
 AND USED DURING UNDERGROUND RESCUE
 EFFORT TO RECOVER VICTIMS

The wall map in the mine office and the map on the 3 Left (002) working section, used as references during recovery operations, were inaccurate. The map obtained by MSHA personnel on the 3 Left (002) working section had been provided as an escape map for the mine and it was used as a reference map during recovery operations. This escape map was found to be inaccurate in that:
