REPORT OF INVESTIGATION
UNDERGROUND COAL MINE

FATAL POWERED HAULAGE ACCIDENT

Camp No. 11 Mine (ID No. 15-08357)
Peabody Coal Company
Morganfield, Union County, Kentucky

June 4, 1980

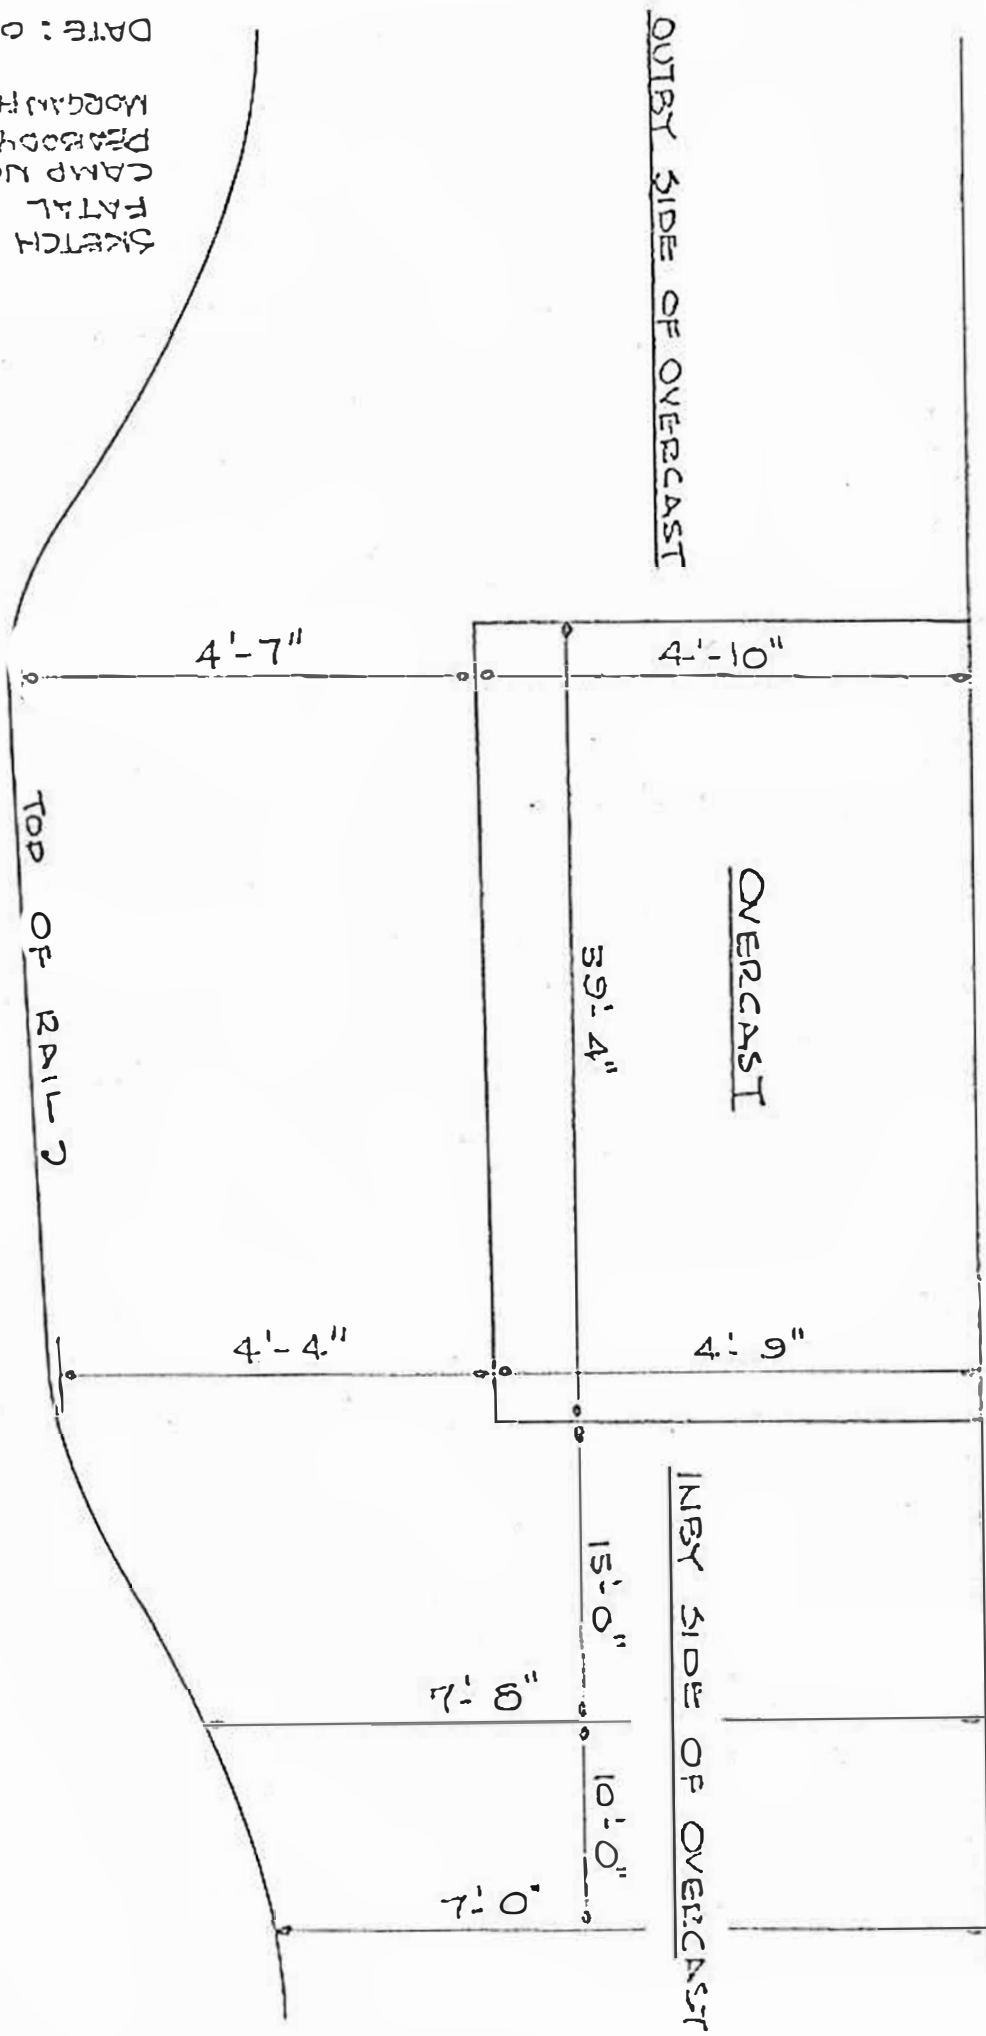
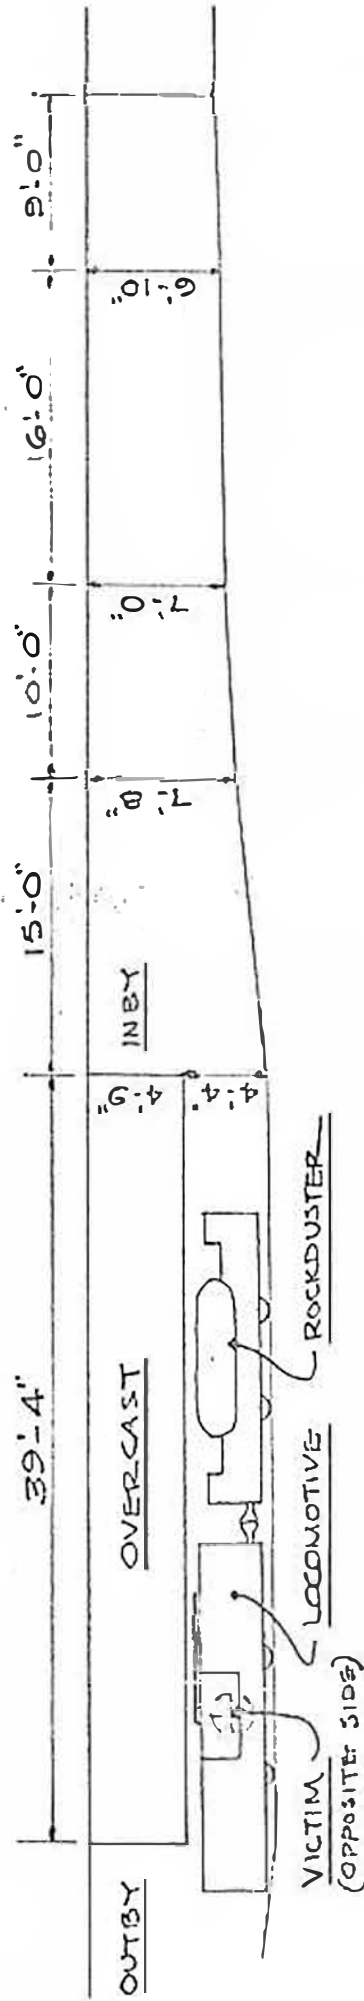
SKETCH SHOWING LOCATION OF
 FATAL HAULAGE ACCIDENT
 CAMP NO. 11 MINE 10 KM. 15-03357
 PEABODY COAL COMPANY
 MORGANFIELD, UNION COUNTY, KENTUCKY
 JUNE 4, 1980
 DATE: 06/26/80 SCALE: HOR. 1" = 10'
 VER. 1" = 4'

1. The victim was considered by management and coworkers to be competent and well qualified to operate the rock-dusting machine and the utility locomotive.
2. The utility locomotive was examined by an MSHA electrical inspector after the accident and defects were not detected.
3. The trolley wire in the area of the accident was apparently in good repair.
4. The vertical height under the overcast (52.2 inches) was approximately the height of the coal seam (53 inches).

5. The bottom along the track entry was graded inby and outby the overcast to provide a gradual descent.
6. The change in clearance, at the overcast, was adequately marked with reflectors.
7. The rock-dusting machine weighed approximately 16,000 lbs. fully loaded.
8. Engineering specifications set out by the manufacturer showed that the utility locomotive was mechanically capable of pulling the rock-dusting machine and also had the braking capacity to stop the fully loaded locomotive and rock-duster.

It was the consensus of the investigating committee that the cause of the accident was failure to stop the locomotive and set the brakes before attempting to put the trolley pole back on the wire. Not facing the direction of travel while the locomotive was in motion was a contributing factor.
