Report of Investigation Underground Coal Mine Explosion

U.S. Department of Labor
Mine Safety and Health Administration
1990

**Pyro No. 9 Slope
William Station Mine
I.D. No. 15-13881
Pyro Mining Company
Sullivan,
Union County,
Kentucky**

September 13, 1989

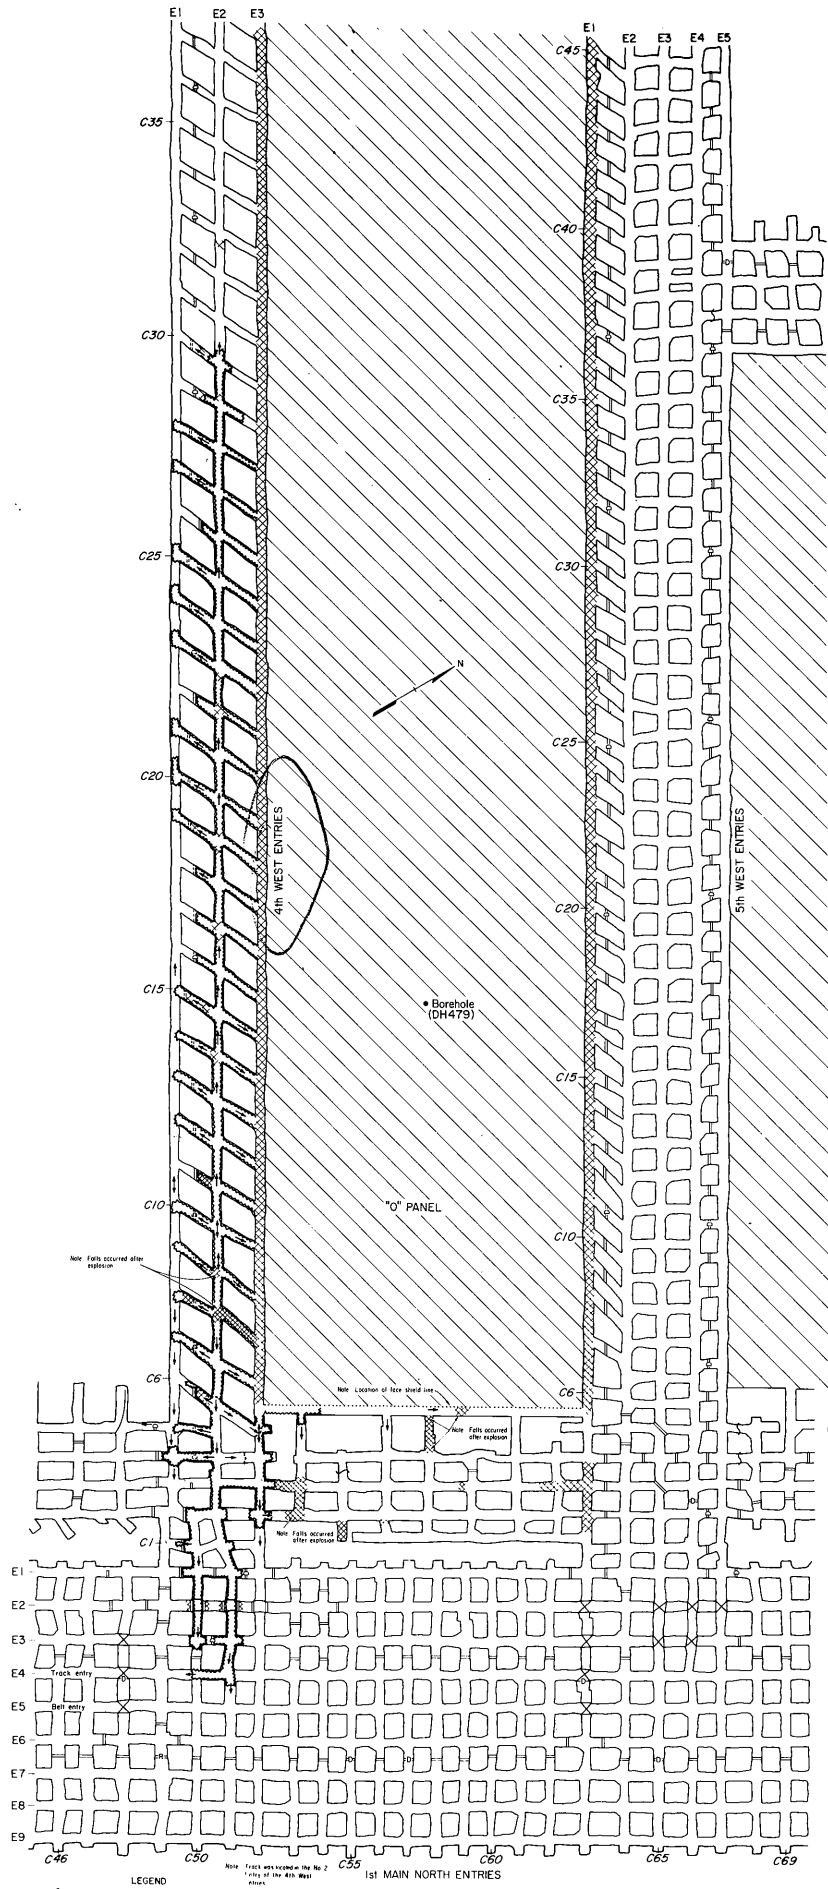
APPENDIX Z - MINE MAP (Affected Area)

Direction and extent of forces, extent of flame, and information gathered during the investigation.
