Report of Investigation Underground Coal Mine Explosion

U.S. Department of Labor
Mine Safety and Health Administration
1990

**Pyro No. 9 Slope
William Station Mine
I.D. No. 15-13881
Pyro Mining Company
Sullivan,
Union County,
Kentucky**

September 13, 1989

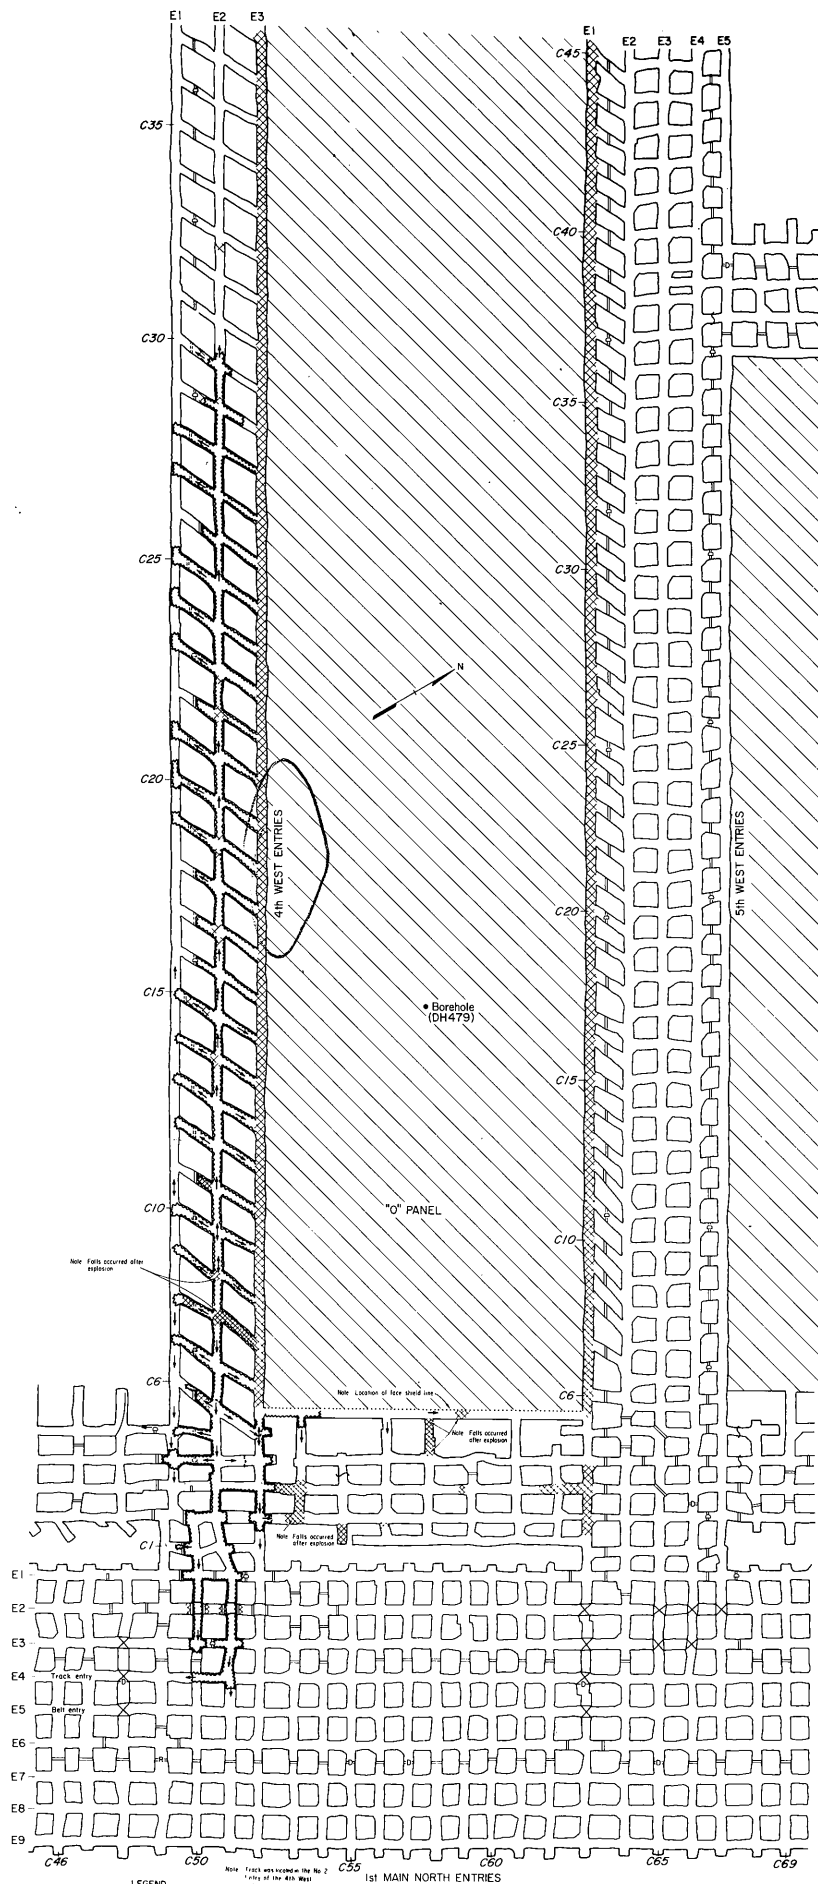
APPENDIX Z - MINE MAP (Affected Area)

Direction and extent of forces, extent of flame, and information gathered during the investigation.

The teams found soot in the 1st Main North Entries, the 4th West Entries, and in the face area. The forces of the explosion became more evident the further the teams traveled up the 4th West Entries. The teams observed heavier soot, damaged equipment, evidence of heat, and blown-out stoppings. The teams found soot and debris in the No. 6 Crosscut and the No. 3 Entry leading to the longwall face area. They observed soot and evidence of heat on the face, but the explosion evidence diminished on the face the farther away from the headgate the teams traveled. The evidence of flame was non-existent beyond the No. 1 Recovery Chute. The forces were not evident beyond the No. 3 Recovery Chute, which is located approximately 400 feet down the longwall face toward the No. 1 Entry of the 5th West Entries. The teams found little evidence of the explosion in the recovery rooms (Appendix Z).
