.FINAL REPORT OF MAJOR MINE-EXPLOSION DISASTER ROBENA NO. 3 MINE

UNITED STATES STEEL CORPORATION

COAL DIVISION, FRICK DISTRICT CARMICHAELS, GREENE COUNTY, PENNSYLVANIA

December 6, 1962

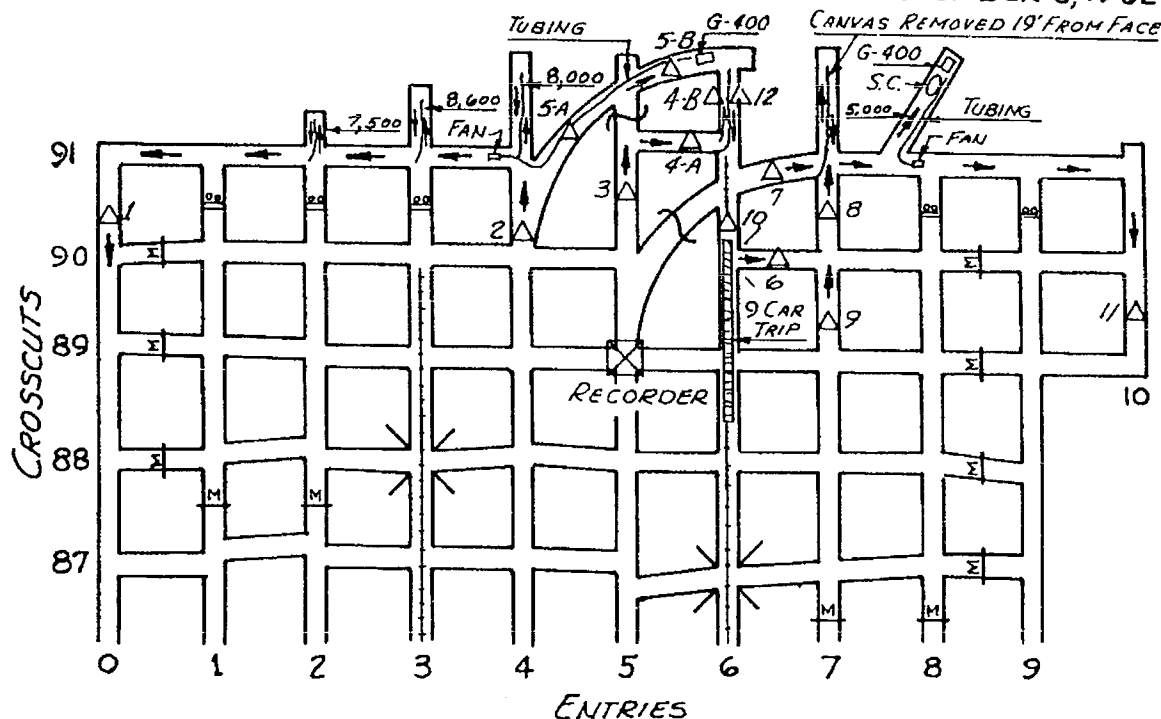
TEST A-3 DATA SHOWING AIR QUANTITIES CU. FT./MIN.  
TESTS TAKEN JAN. 15, 1963

1. 5,000 cfm returning down No. 6 entry from face of upper radius.
2. 7,600 cfm toward the nip station from 91 crosscut.
3. A flow through the upper radius of 4,500 cfm from ventilation pressure without the auxiliary fan.

VENTILATION STUDY  
FACE AREA - 4 MAIN BUTTS - 8 FLATS LT. SECTION  
ROBENA NO. 3 MINE  
CONDITIONS ASSUMED PRIOR TO EXPLOSION ON DECEMBER 6, 1962

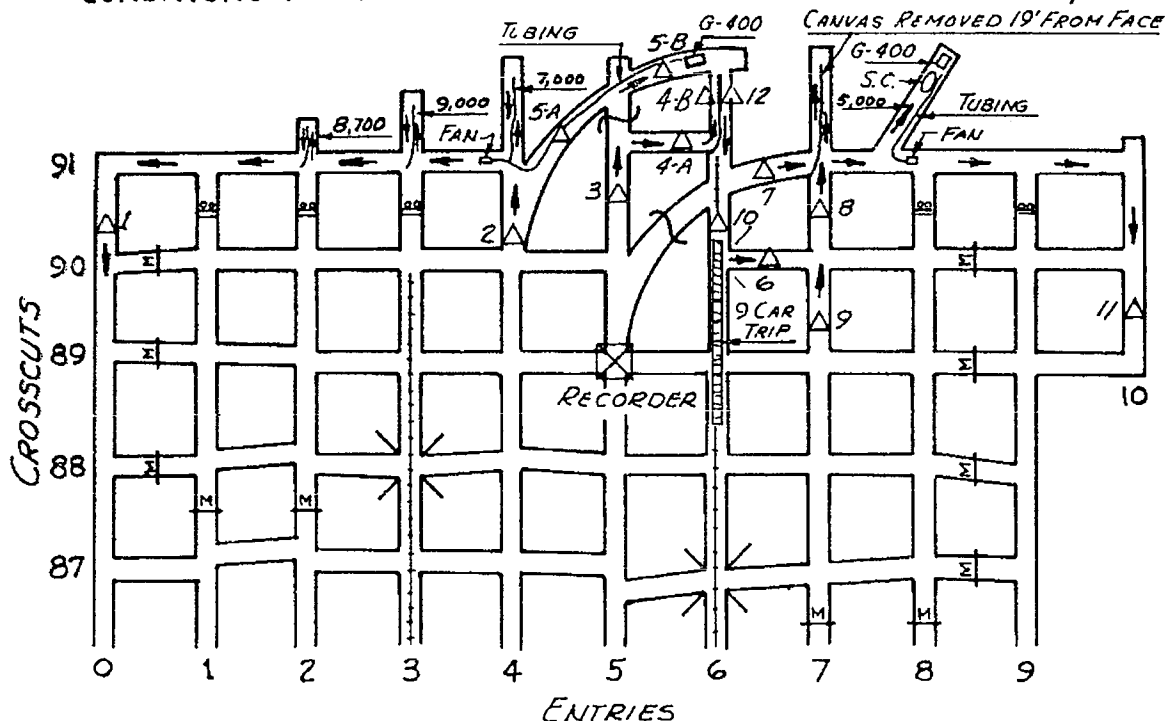
TEST A-2 DATA SHOWING AIR QUANTITIES CU. FT./MIN.  
TESTS TAKEN JAN. 15, 1963

VENTILATION STUDY  
FACE AREA - 4 MAIN BUTTS - 8 FLATS LT. SECTION  
ROBENA NO 3 MINE  
CONDITIONS ASSUMED PRIOR TO EXPLOSION ON DECEMBER 6, 1962

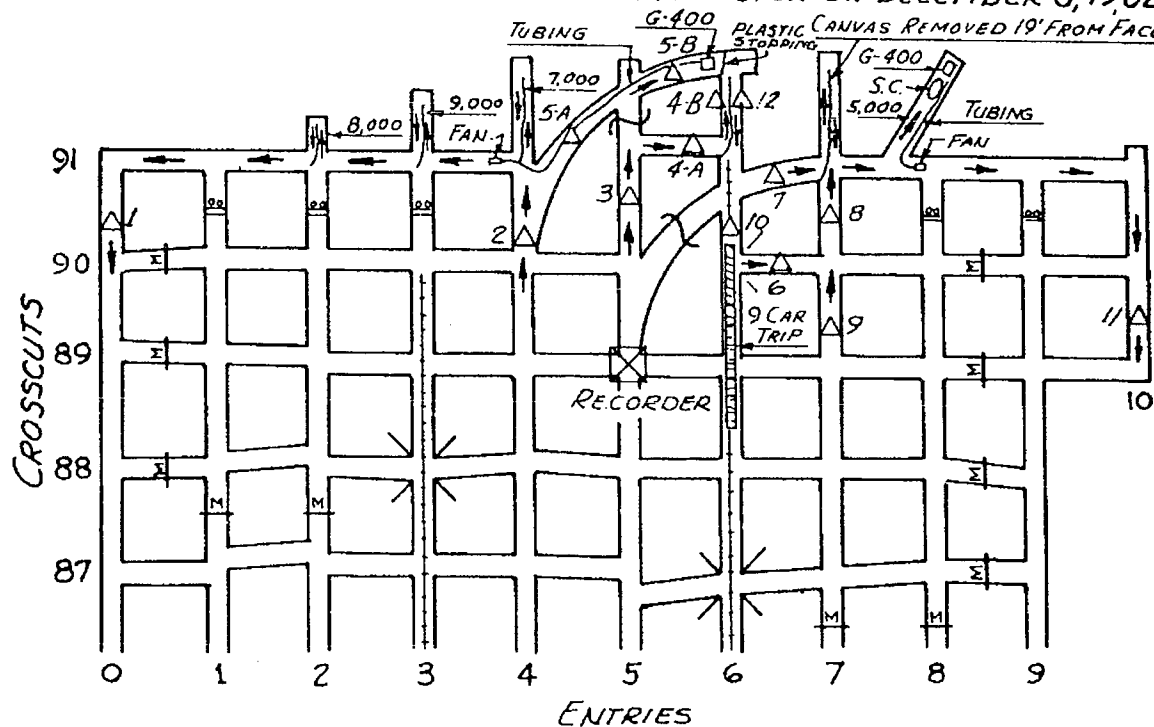
TEST A-1 DATA SHOWING AIR QUANTITIES CU. FT./MIN.  
TESTS TAKEN JAN. 15, 1963

VENTILATION STUDY  
 FACE AREA - 4 MAIN BUTTS - 8 FLATS LT. SECTION  
ROBENA NO. 3 MINE  
 CONDITIONS ASSUMED PRIOR TO EXPLOSION ON DECEMBER 6, 1962

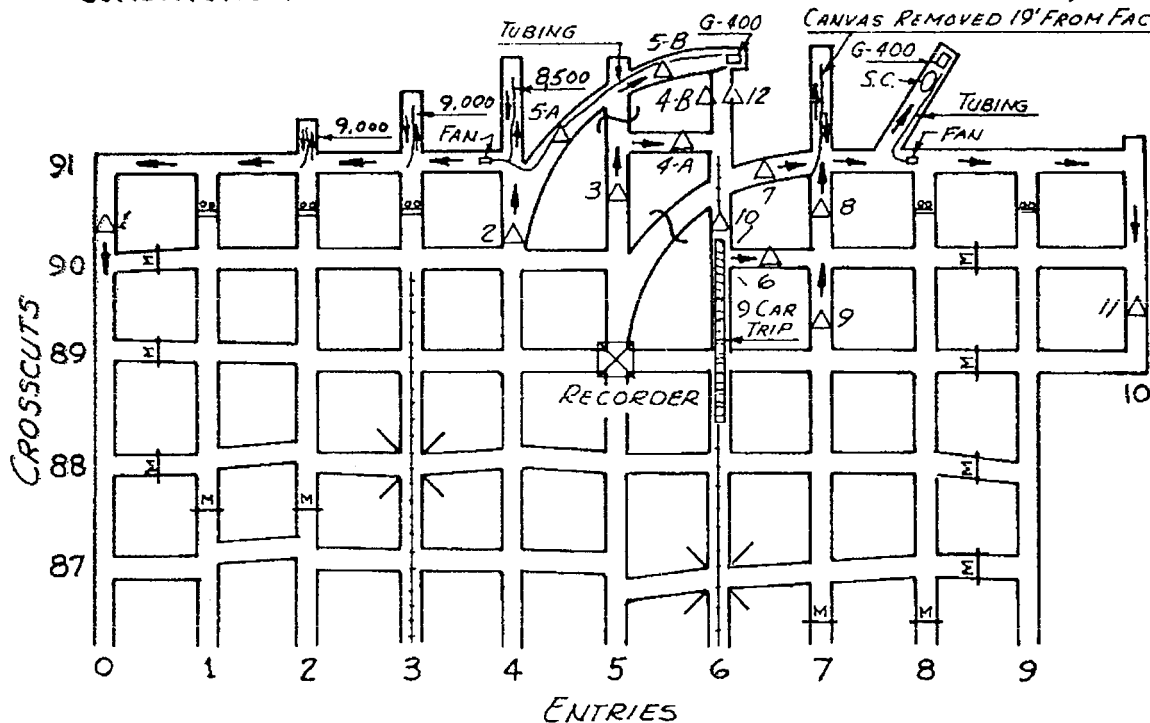
TEST A-4 DATA SHOWING AIR QUANTITIES CU. FT./MIN.  
TESTS TAKEN JAN. 15, 1963

VENTILATION STUDY  
 FACE AREA - 4 MAIN BUTTS - 8 FLATS LT. SECTION  
ROBENA NO. 3 MINE  
 CONDITIONS ASSUMED PRIOR TO EXPLOSION ON DECEMBER 6, 1962

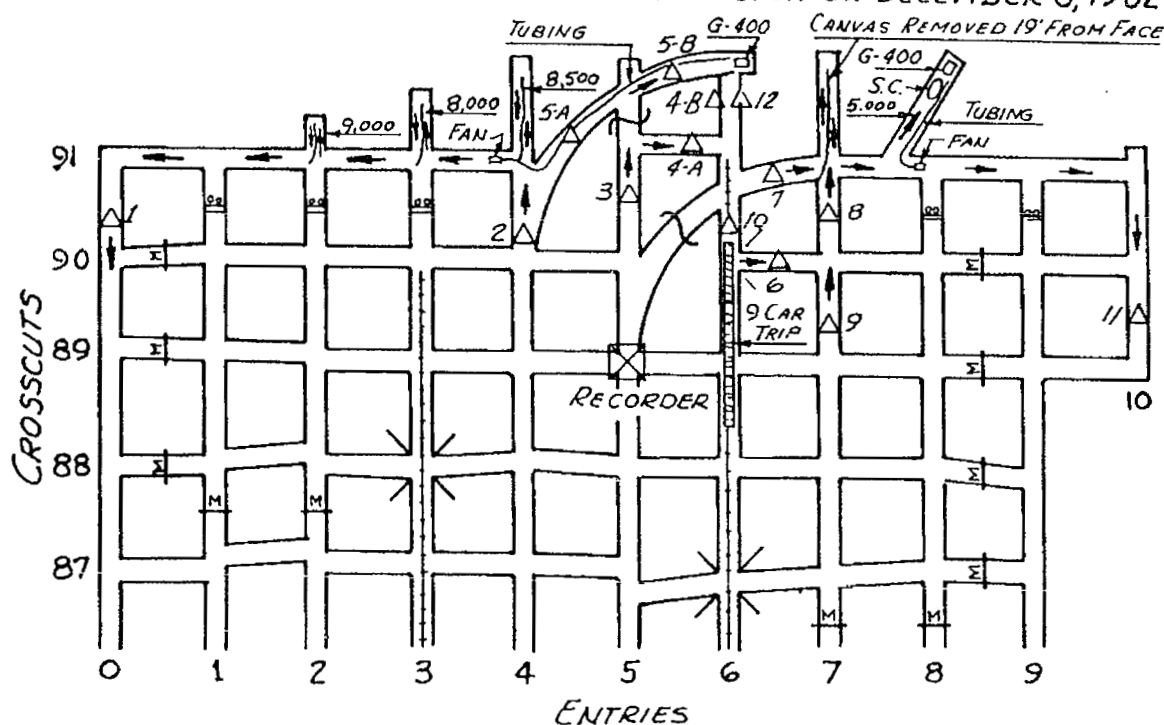
TEST A-5 DATA SHOWING AIR QUANTITIES CU. FT./MIN.  
TESTS TAKEN JAN. 15, 1963

VENTILATION STUDY  
FACE AREA - 4 MAIN BUTTS - 8 FLATS LT. SECTION  
ROBENA NO. 3 MINE  
CONDITIONS ASSUMED PRIOR TO EXPLOSION ON DECEMBER 6, 1962

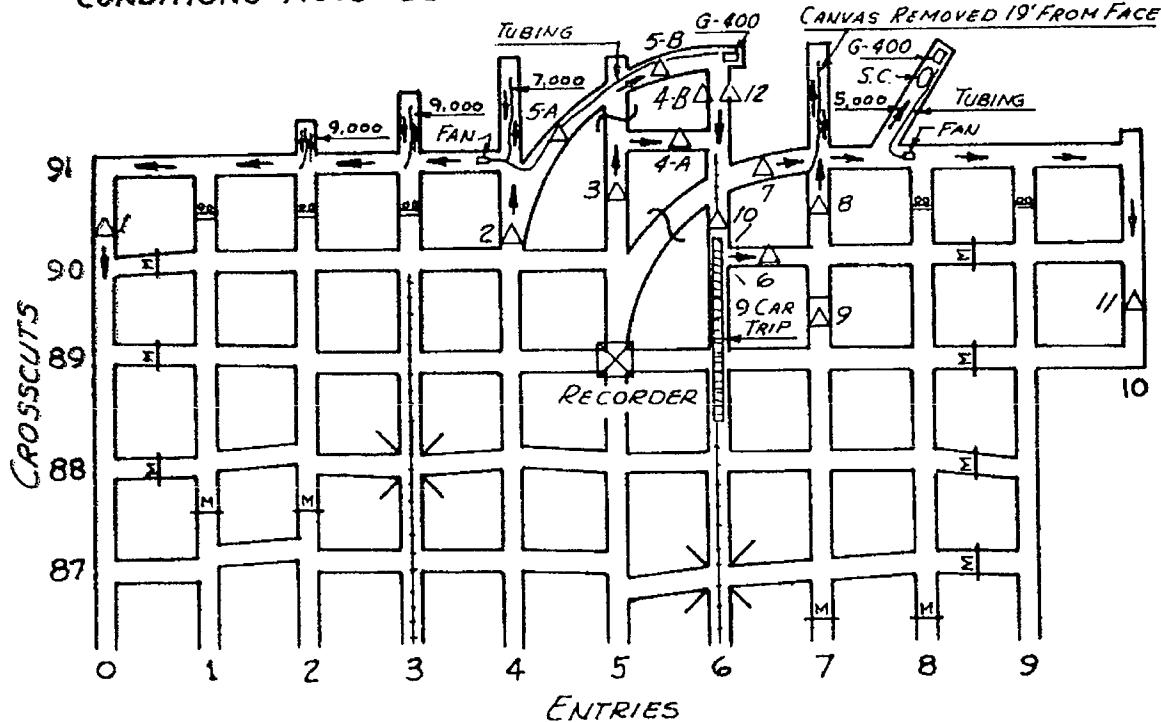
TEST A-B DATA SHOWING AIR QUANTITIES CU. FT./MIN.  
TESTS TAKEN JAN. 15, 1963

CONDITIONS ASSUMED PRIOR TO EXPLOSION ON DECEMBER 6, 1962
