REPORT OF INVESTIGATION
(UNDERGROUND COAL MINE)

FATAL ROOF-FALL ACCIDENT

Rushton Mine (ID No. 36 00856)
Rushton Mining Company
Rush Township, Centre County, Pennsylvania

October 2, 1979

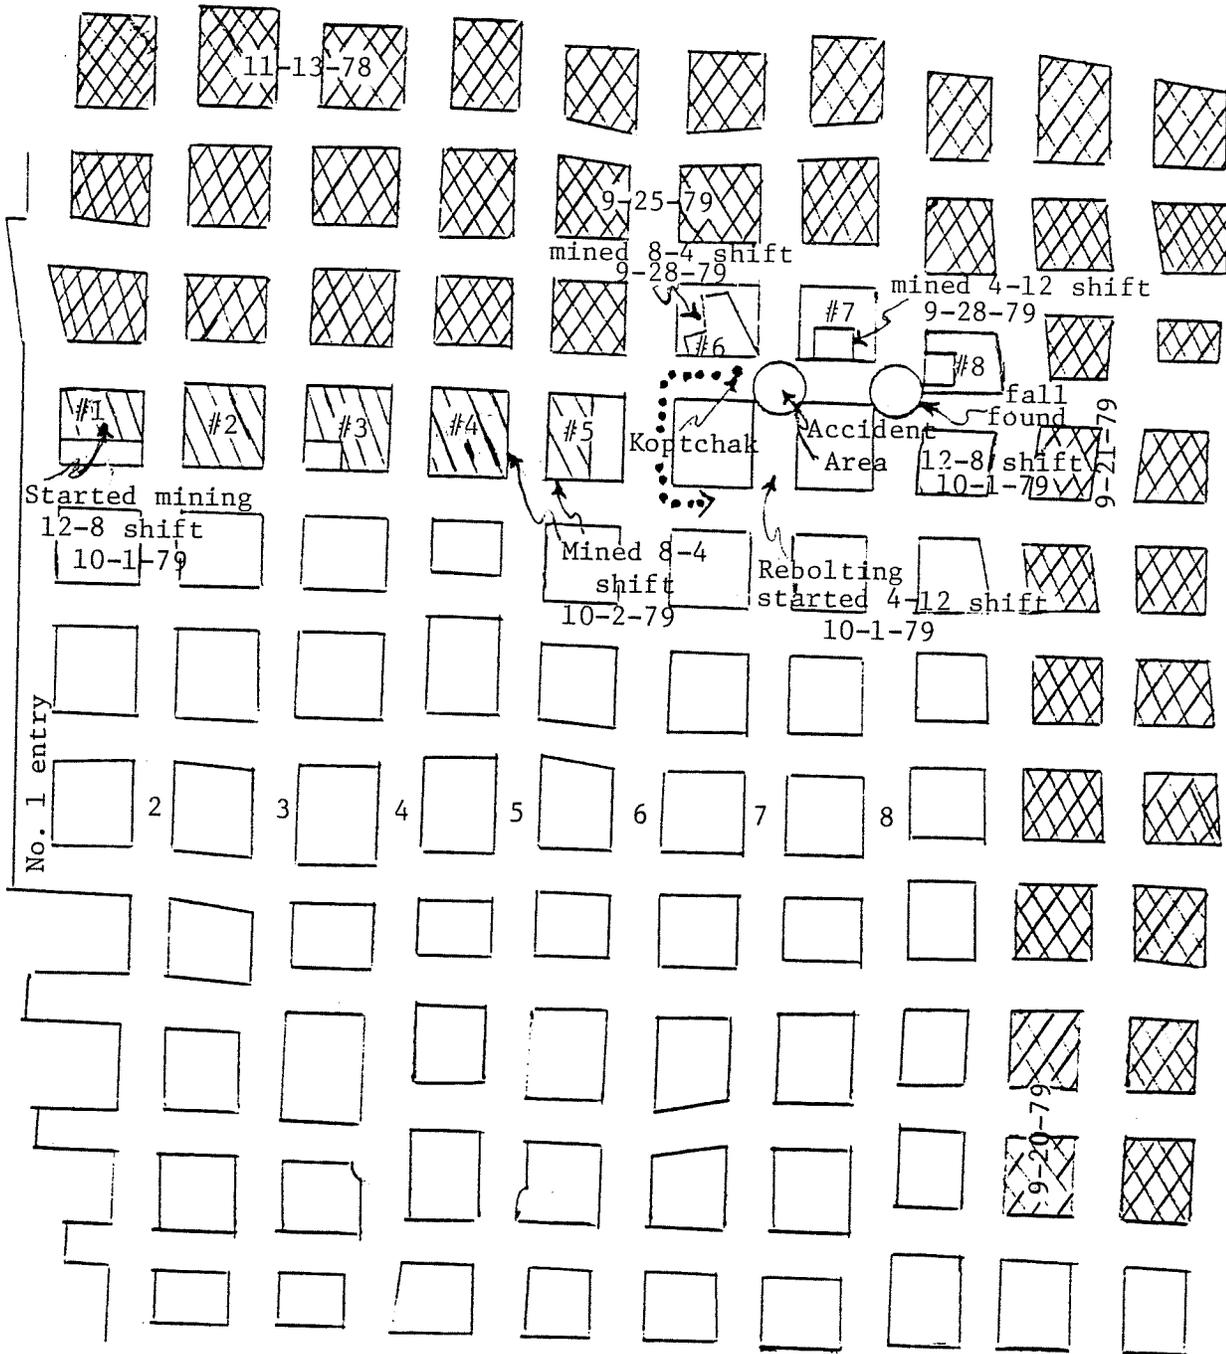
Sketch No. 1 (Not to Scale)

Sketch of Fatal Roof-Fall Accident
 Rushton Mine (ID No. 36 00856)
 Rushton Mining Company
 Rush Township, Centre County, Pennsylvania

On Tuesday, October 2, 1979, at about 3:15 p.m., a roof-fall accident occurred at the intersection of the No. 7 entry near survey station No. 2120 of the 1 east mains 7 butt (009) working section of the Rushton mine resulting in the death of Marilyn McCusker, general laborer, who was filling in as a roof-bolter helper. McCusker, age 35, had about two years mining experience, approximately three months of which was as a roof-bolter helper at intermittent intervals. The accident occurred when McCusker (victim) was retreating from the intersection after she had noticed the roof starting to dribble. She was caught under the edge of a fall approximately 20 feet by 25 feet and up to 2½ feet in thickness. Management's failure to adequately support a known bad roof area with temporary roof supports until additional permanent roof supports could be installed was the cause of the accident. Failure to carry out a method of pillar recovery that would eliminate pillar points and pillars that project in by the breakline, and to effectively train all personnel required to install roof supports were contributing factors.

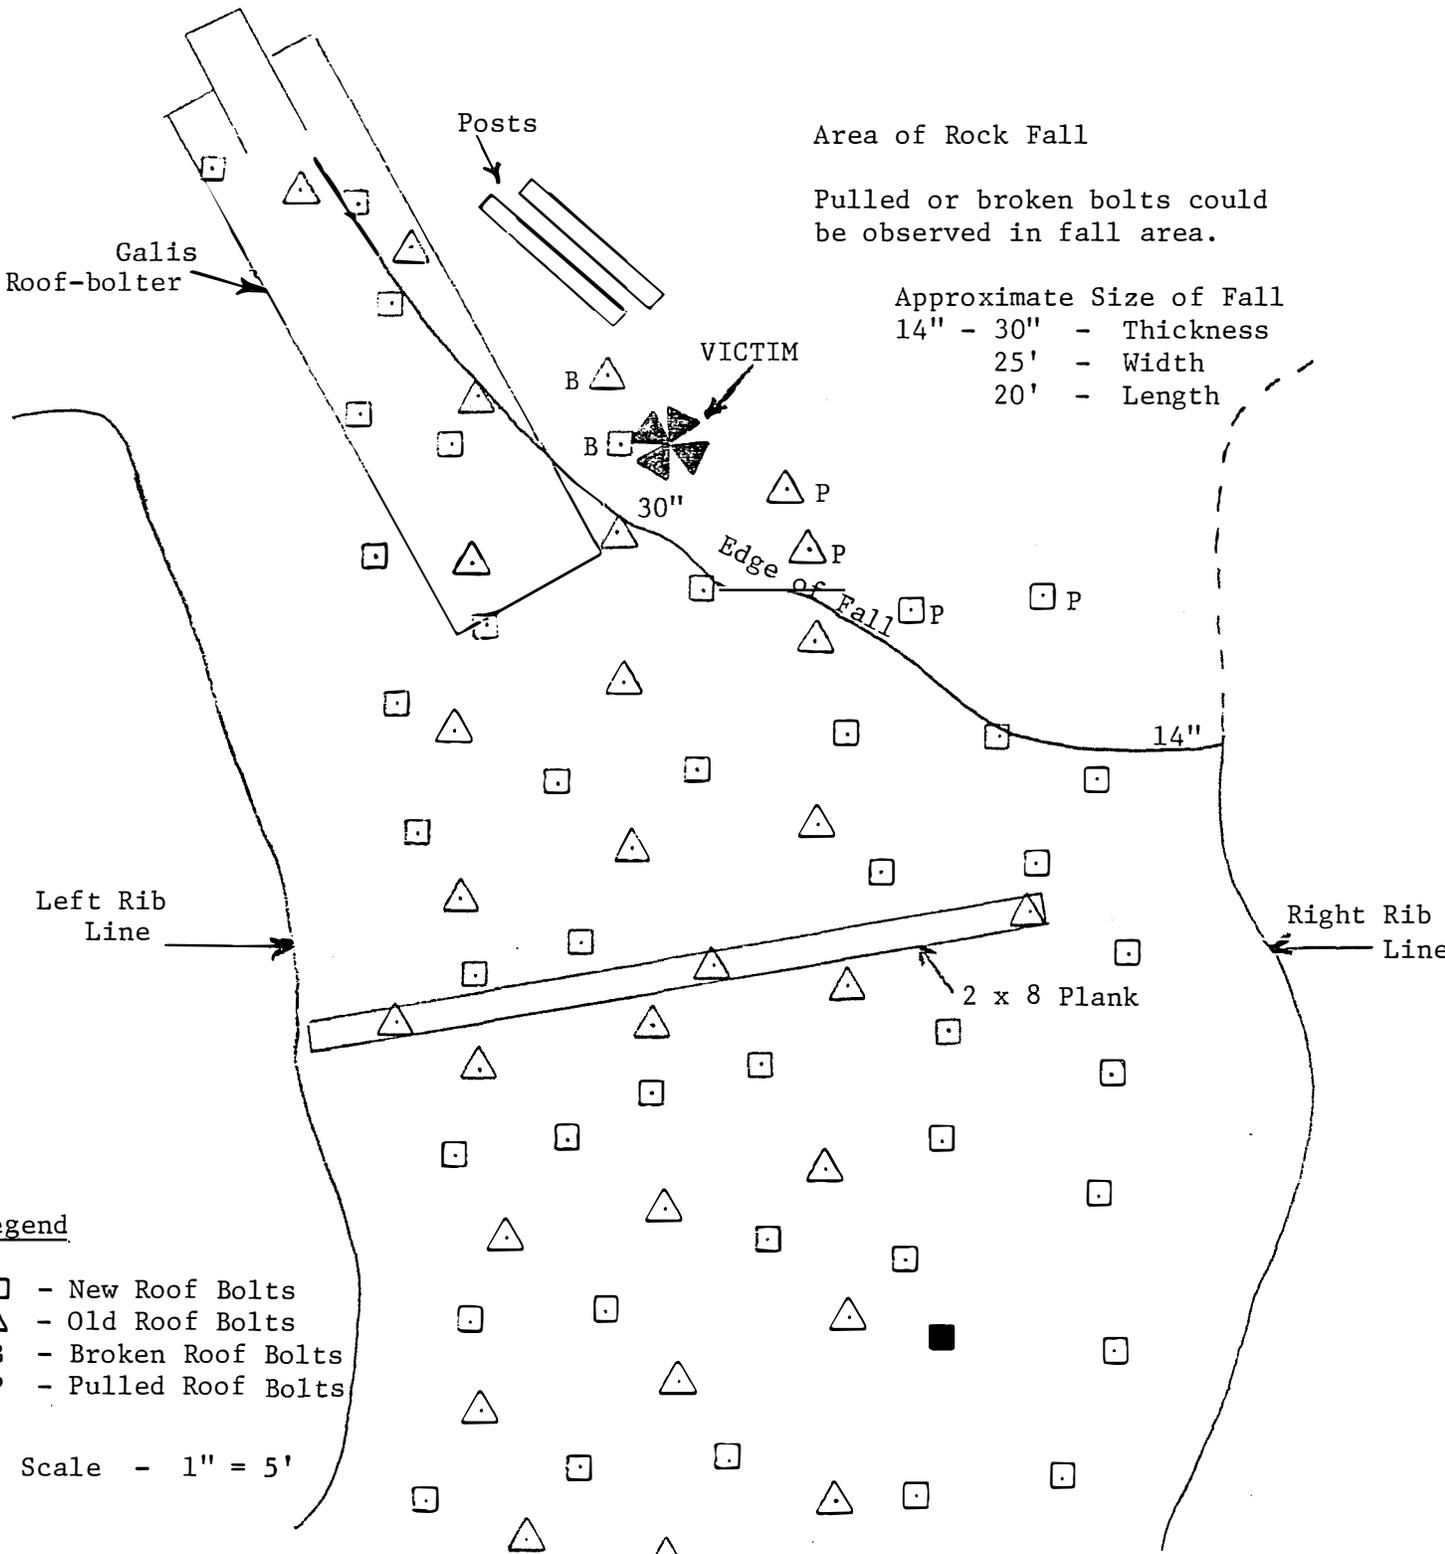
Sketch No. 2

Area of Rock Fall

Pulled or broken bolts could be observed in fall area.

Approximate Size of Fall
 14" - 30" - Thickness
 25' - Width
 20' - Length

No. 7 Entry of 1 East Mains
