Report of Investigation Underground Coal Mine Explosions

**Scotia Mine
I.D. No. 15-02055
Scotia Coal Company
Ovenfork,
Letcher County,
Kentucky**

March 9 and 11, 1976

Release Date: August 11, 1993

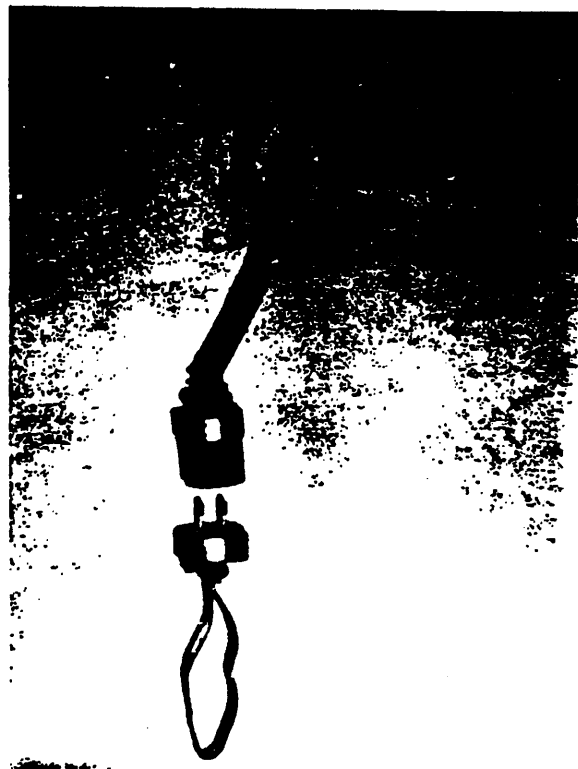
FIG. 13 SHORT CIRCUITING PLUG IN
BELT CONVEYOR CONTROL CIRCUIT

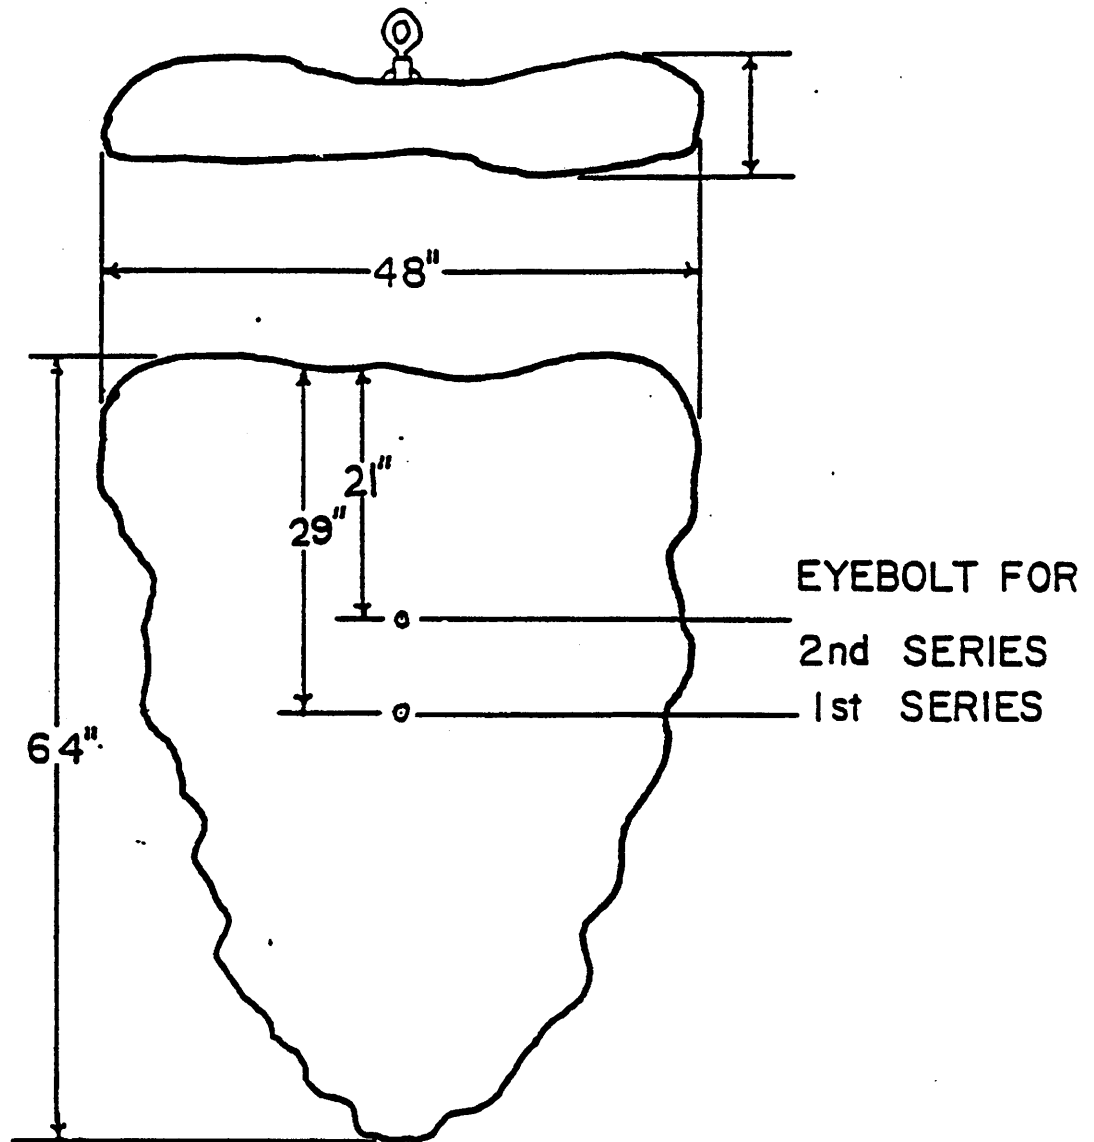
FIGURE 1

AVG. THICKNESS $\approx 6''$
DENSITY $\approx 168 \text{ lb/ft}^3$
WT. $\approx 800 - 900 \text{ lbs}$
