FINAL REPORT OF MAJOR MINE-EXPLOSION DISASTER

SILTIX MINE
THE NEW RIVER COMPANY
MOUNT HOPE, FAYETTE COUNTY, WEST VIRGINIA

July 23, 1966

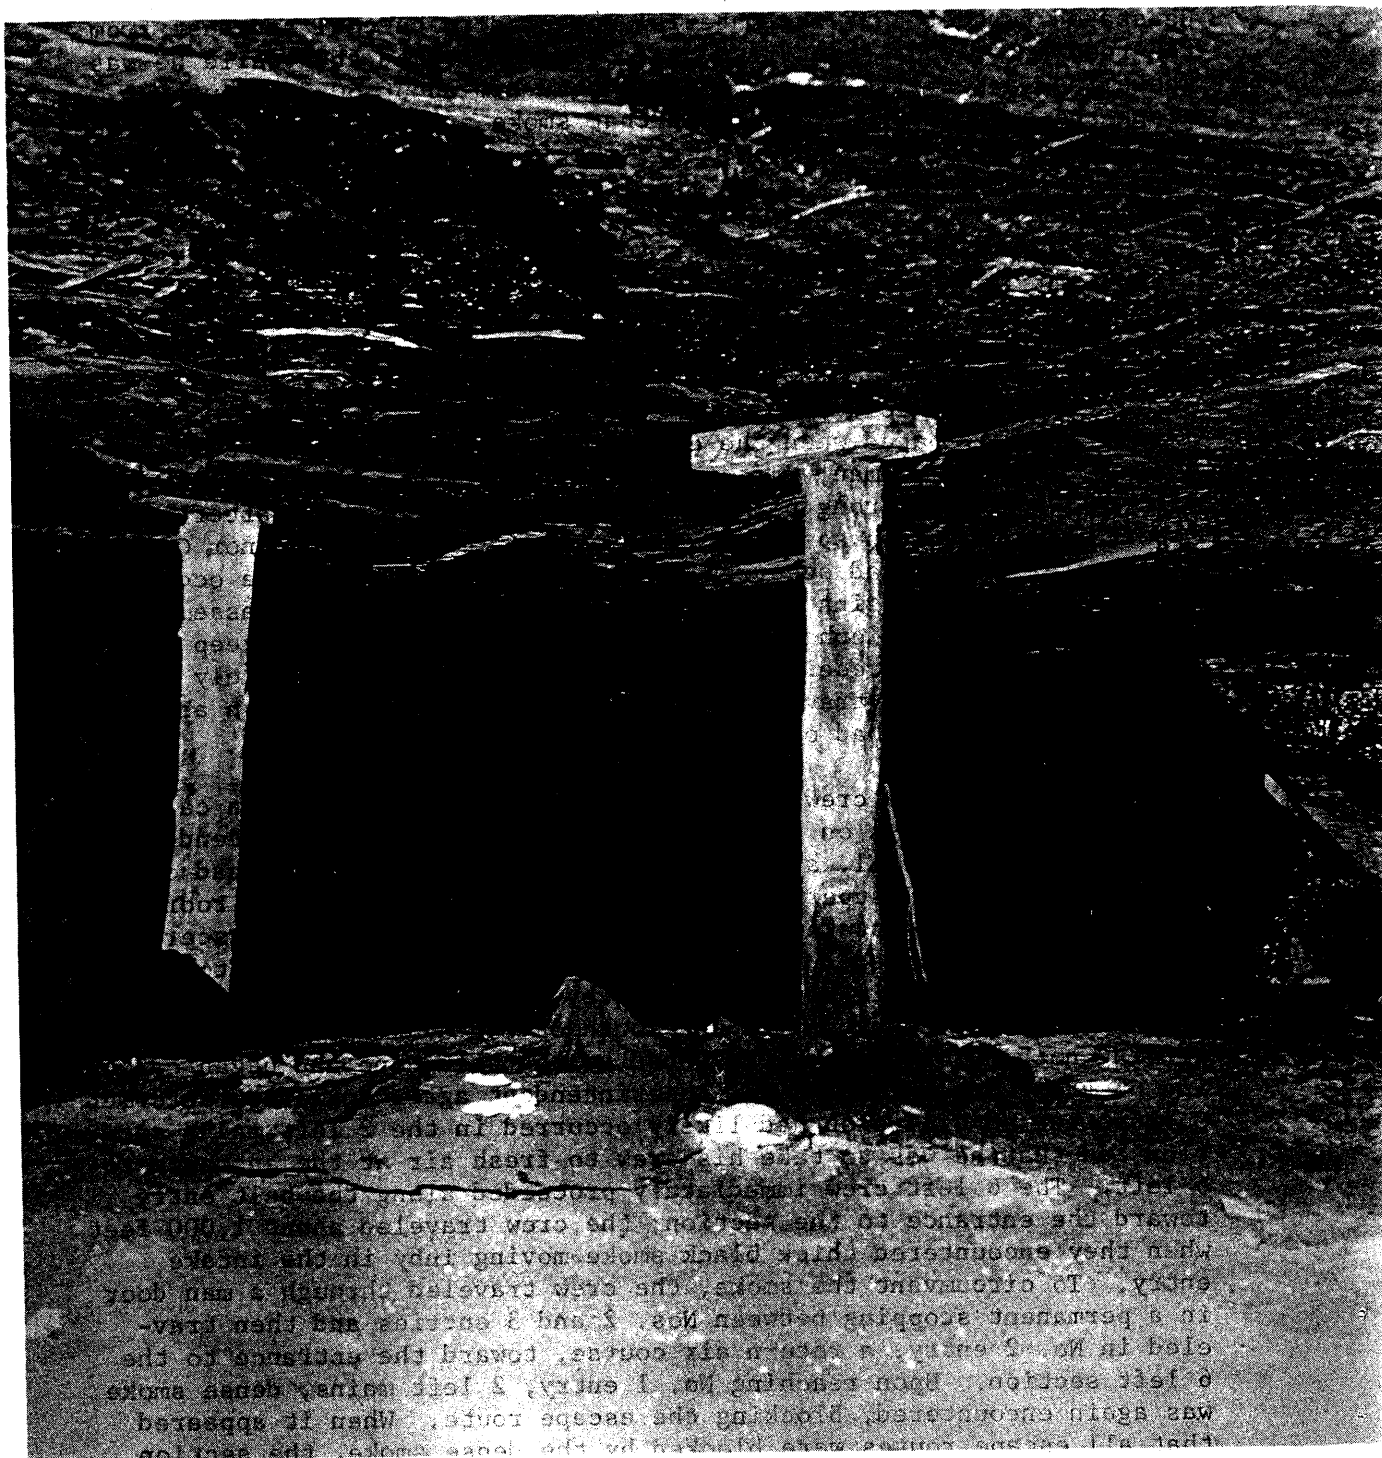
INSIDE OF BARRICADE.

searching for barricading materials in the return air courses. The barricade was constructed at a crosscut between Nos. 2 and 3 entries, 6 left, three crosscuts inby the mouth of 6 left; it consisted of three plies of brattice cloth supported by wooden timbers and nails and was shaped in a semi-circle (See Appendix B). One end of the barricade was attached to the inby corner of the crosscut and the other end was attached to the outby corner of the crosscut. The rear wall of the barricade was formed by a permanent stopping between Nos. 2 and 3 entries. From measurements taken during the investigation, the cross-sectional area within the barricade was about 580 square feet. The 11 men entered the barricade and remained therein for approximately 45 minutes; they were rescued about 10:30 a.m. The men remained calm while confined and all decisions made were agreed upon by all members of the crew. None of the men showed ill effects from their confinement, and all were in good physical condition when rescued.

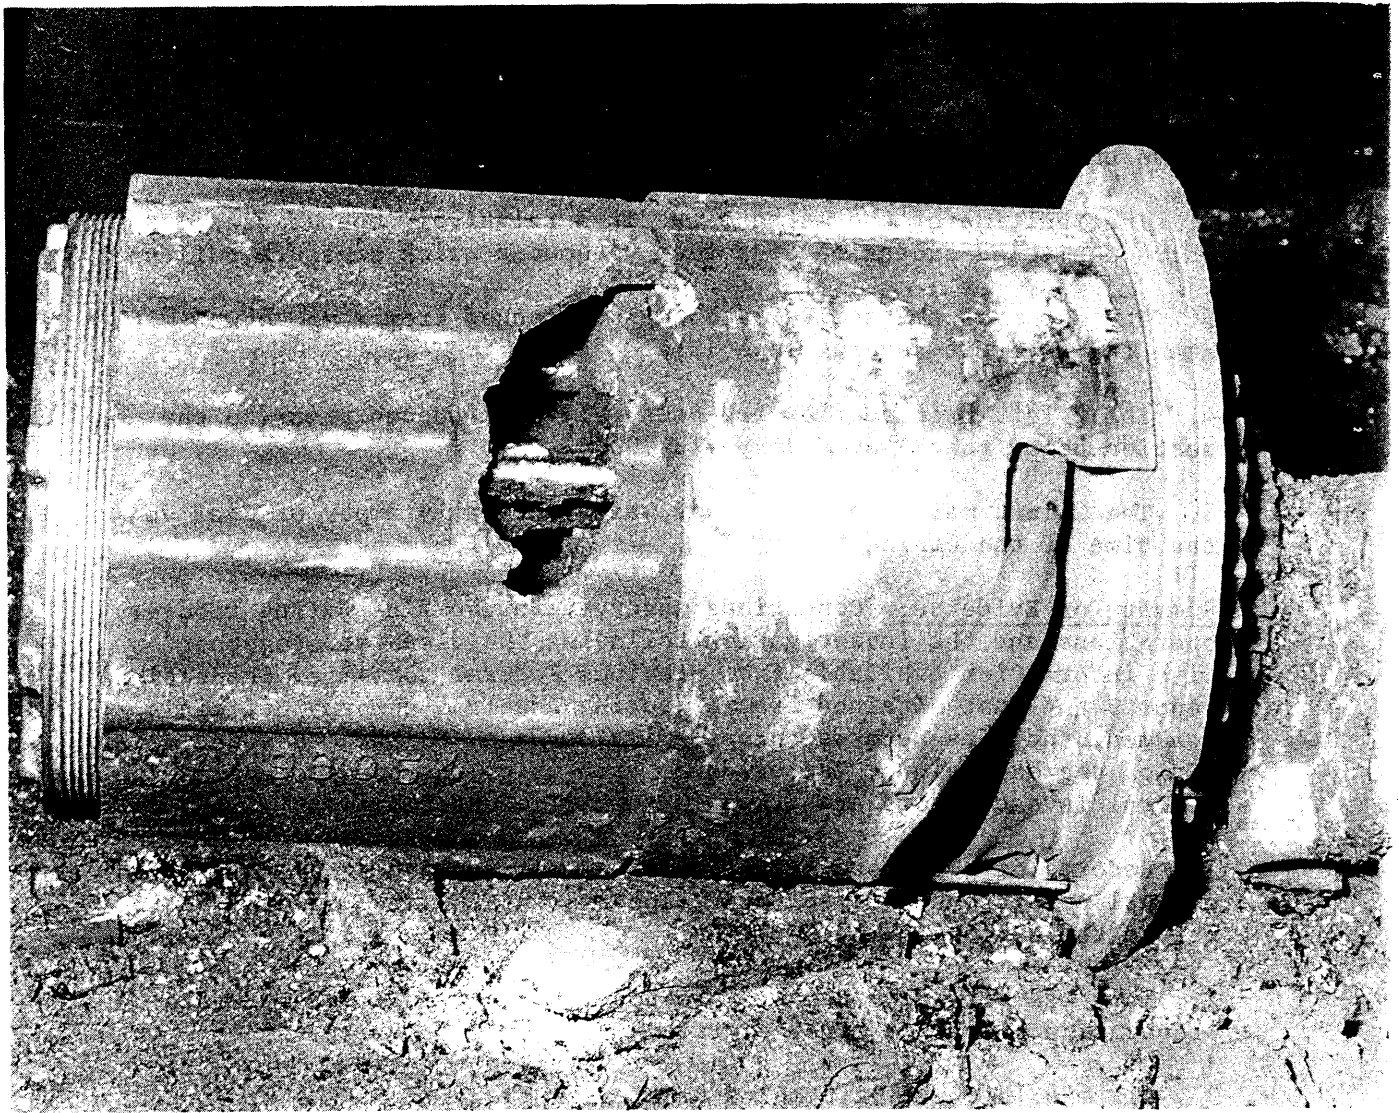
The No. 1 standard drive MT66 Jeffrey shuttle car located immediately outby the continuous miner had openings in excess of .004-inch in the forward and reverse tram switches; a splice in the rear headlight cable and a broken headlight globe; a hole burnt through the trailing cable reel into the collector ring assembly; and six temporary splices in the trailing cable, exposed conductors were present in two splices.

Point of Origin: Bureau of Mines investigators believe that the explosion originated about 100 feet outby the face of No. 4 room off No. 1 entry, 2 left mains, at the location where the No. 1 standard-drive shuttle car was found.

DAMAGED CABLE REEL OF NO. 1 STANDARD DRIVE SHUTTLE CAR.

15. Permissible equipment shall be maintained in permissible condition.

16. A suitable maintenance program that will keep permissible equipment in permissible condition shall be developed, adopted, and followed.
