UNITED STATES DEPARTMENT OF THE INTERIOR
BUREAU OF MINES

MINE EXPLOSION

NO. 1 MINE EXPLOSION, DAWSON, NEW MEXICO.

February 8, 1923.

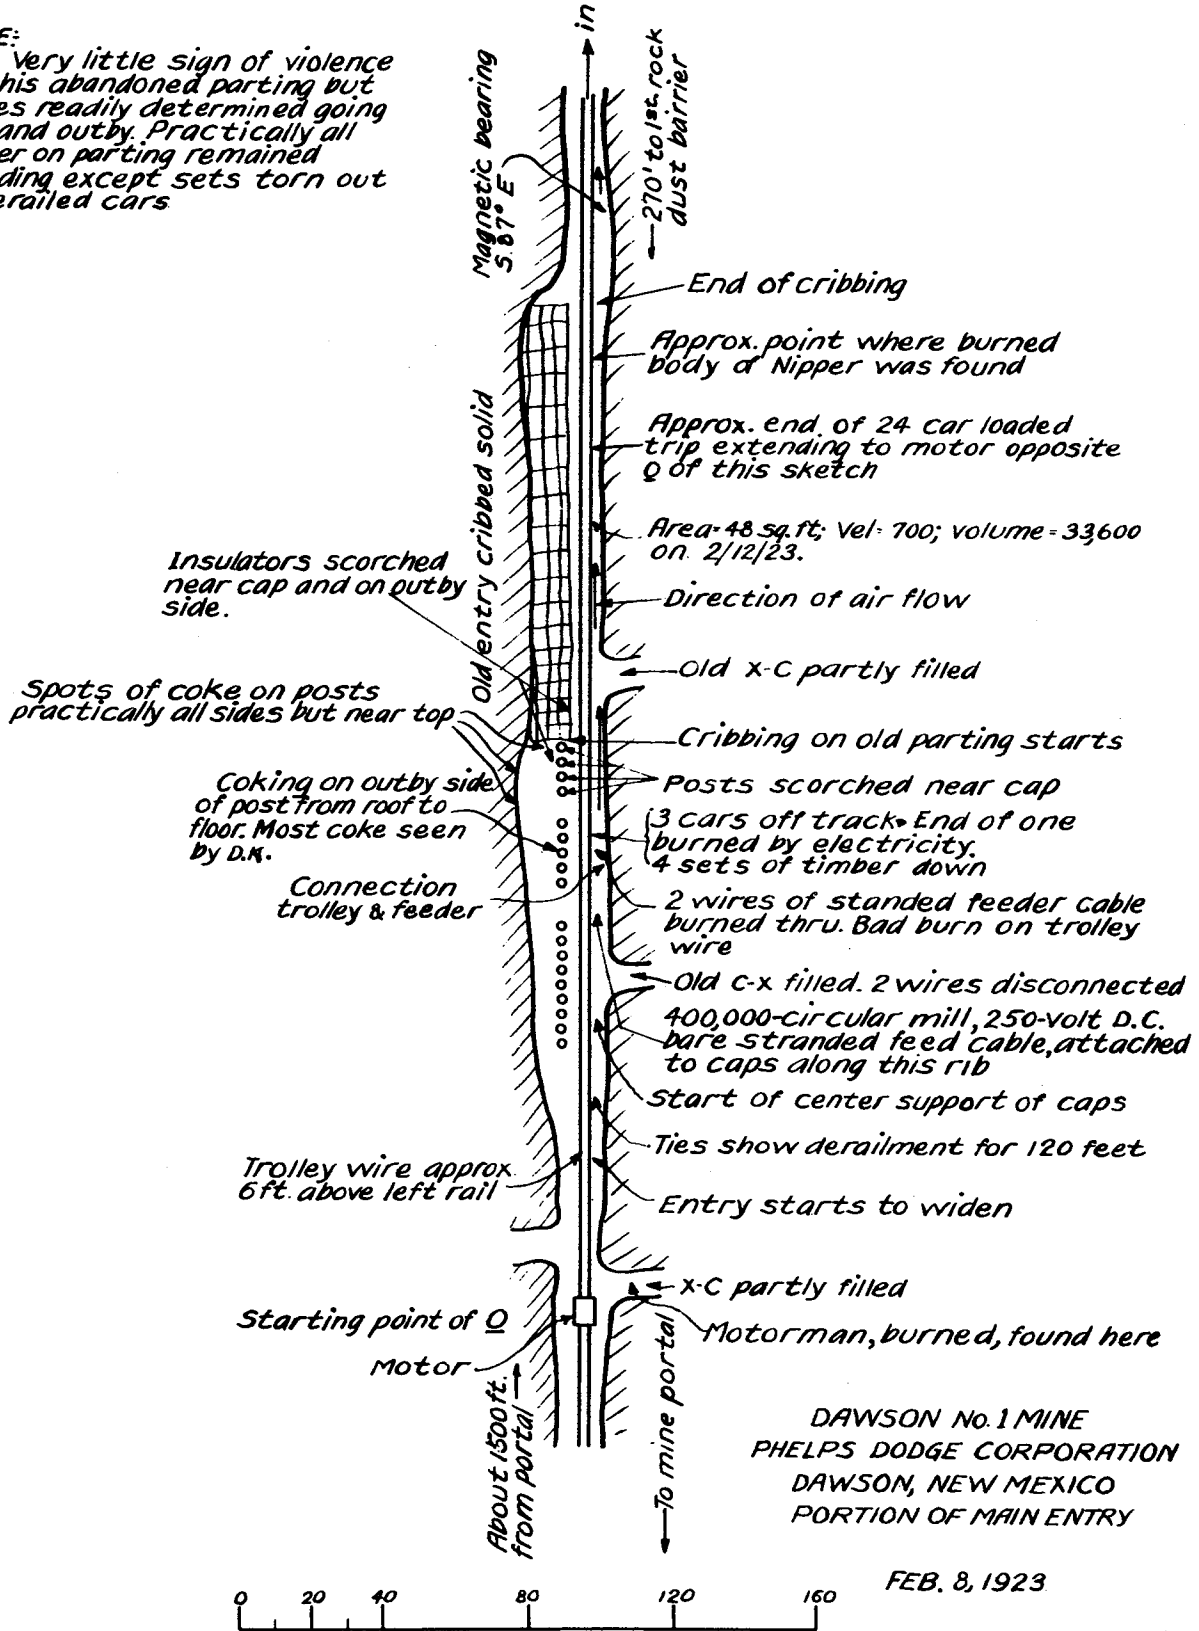
The attached sketch of a "Portion of the Main Entry" shows, in general, the conditions found at the abandoned parting at which the loaded trip with bodies of motorman and nipper were found. The trolley locomotive at head or outer end of trip had proceeded a few feet out of the old parting and was on the track, and while somewhat dust-covered, was in good condition mechanically and electrically. There was evidence that at least one, probably two, loaded cars (one with machine cuttings) adjacent to the locomotive had been off the track for at least 100 feet within the old parting and were placed, at least partly, on the track by a re-railer in the track a short distance back of the place where the locomotive was found. The motorman, burned to some extent, was found dead at the mouth of a South crosscut near the locomotive. The old parting had cross bars from rib to rib practically throughout, there being center posts a few feet away from the north rail; however, the east end of the parting for a distance of about 100 feet was filled on the north side with timber cribs, leaving but 7 or 8 feet to the south rib. Practically none of this timber on the abandoned parting was disturbed by the explosion, though a few sets had been pulled out by some derailed cars about 125 feet back of the locomotive, these timbers letting the trolley wire and 400,000 circular mill bare stranded trolley feed cable down on the end of the steel cars.

NOTE:
 Very little sign of violence on this abandoned parting but forces readily determined going inby and outby. Practically all timber on parting remained standing except sets torn out by derailed cars

Undoubtedly there were two decided arcs as the trolley wire showed a decided burn, and opposite it the stranded feed cable had two or three wires severed by burns. There was much very fine dry settled dust on the timber caps in this region, as well as in the adjacent cribs and on the floor, and the dislodged timbers undoubtedly released considerable of this dry fine dust, and this dust together with that brought back from bumping over ties of the derailed car of machine cuttings gave the fuel for ignition in contact with the intense heat from the two arcs.

Posts, as well as longitudinal lagging in the vicinity of the burned places on the trolley wire and trolley feed cable, showed decided evidence of being scorched especially near the roof, this being true for a distance of about 25 to 40 feet inside the point of arcing. There was decided coking on a center post about 15 feet outby the point of arcing, the heaviest coking being on outby side and extending almost from roof to floor. There was also spotted coking on nearby timbers and particularly on some posts on the north rib ~~at~~ the point of arcing; porcelain insulators about a foot from the roof showed decided scorching on outby side with little or no signs of scorching or soot on inby side.
