REPORT OF INVESTIGATION
(UNDERGROUND COAL MINE)

MULTIPLE FATAL ROOF FALL ACCIDENT

Stillhouse Run No. 1 Mine (ID No. 46-06306)
Elk River Sewell Coal Company, Incorporated
Bergoo, Webster County, West Virginia

December 3, 1981

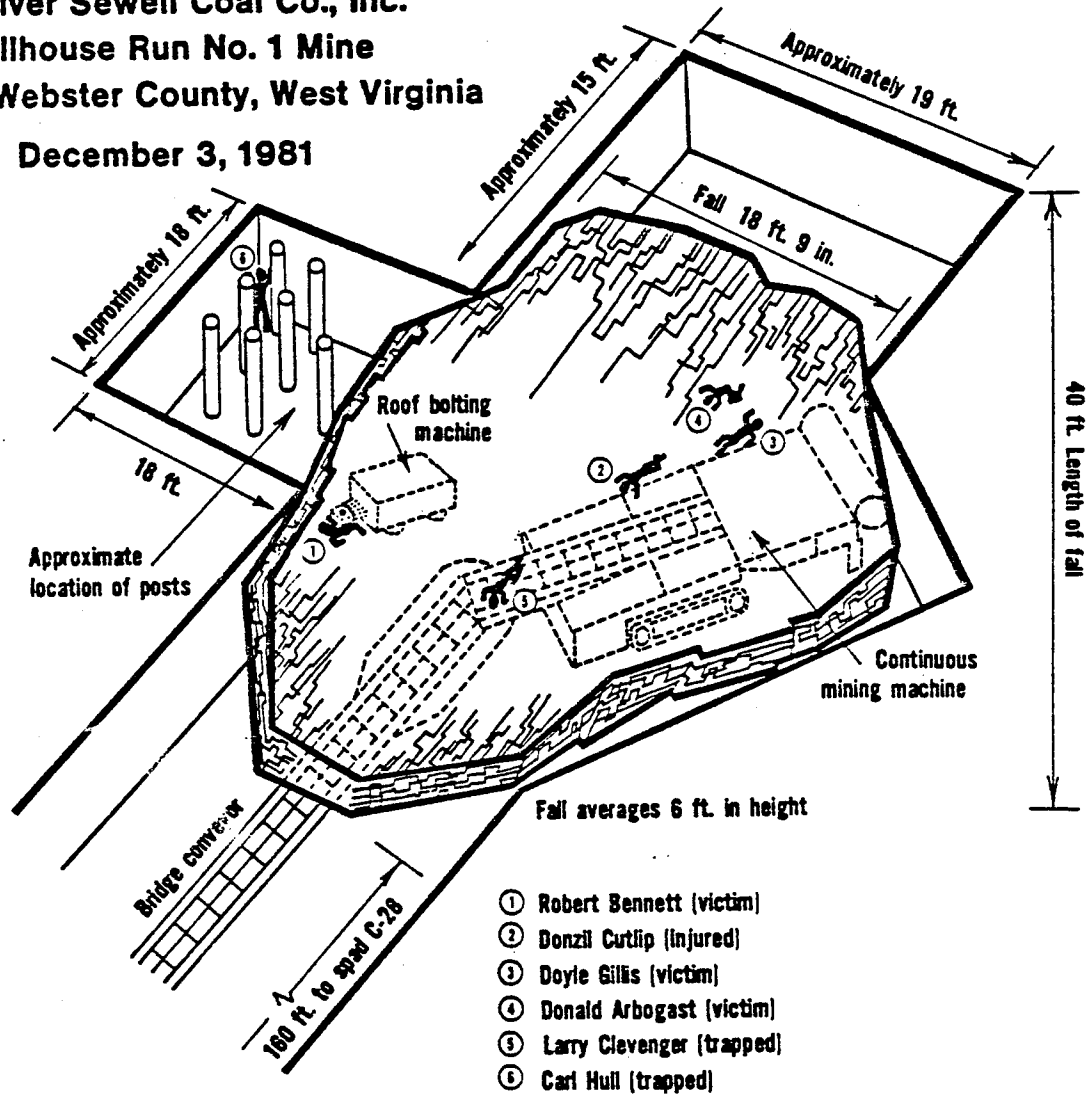
At approximately 9:20 p.m., the mining machine was shut down to reposition previously installed posts and to move the roof-bolting machine into position. Soon after the roof-bolting machine was positioned near the left side of the left crosscut, the roof collapsed on 5 miners and 1 miner was trapped behind the fall. The fall was approximately 40 feet in length, 20 feet in width and 6 feet in height.

3. Due to the increased thickness of the coalbed, all of the roof coal was not removed in the left crosscut and intersection. This prevented an examination of the bone roof. It could not be determined if the uncut coal covered any fractures that may have been in the roof. However, after the roof fall, large fractures were observed in the roof near the right rib where the widening cut of coal was removed.

4. While attempting to cut the coal from the roof, one roof bolt located in the intersection near the right corner of the left crosscut in No. 2 entry was damaged. However, miners stated that this bolt was replaced prior to positioning the roof-bolting machine at the approximate location shown on the sketch.
