Taylor Mine Accident Documents
Taylor Mine
Taylor Coal Company
Beaver Dam, Ohio Co., KY
Accident date: May 6, 1913
Time range of materials: May 6-27, 1913
Number of items: 3

REPORT
ON
SHAFT ACCIDENT
at
TAYLOR MINE
of the
TAYLOR COAL COMPANY,

at
BEAVER DAM, KY.

by
H. D. Mason, Jr.
Foreman Miner.

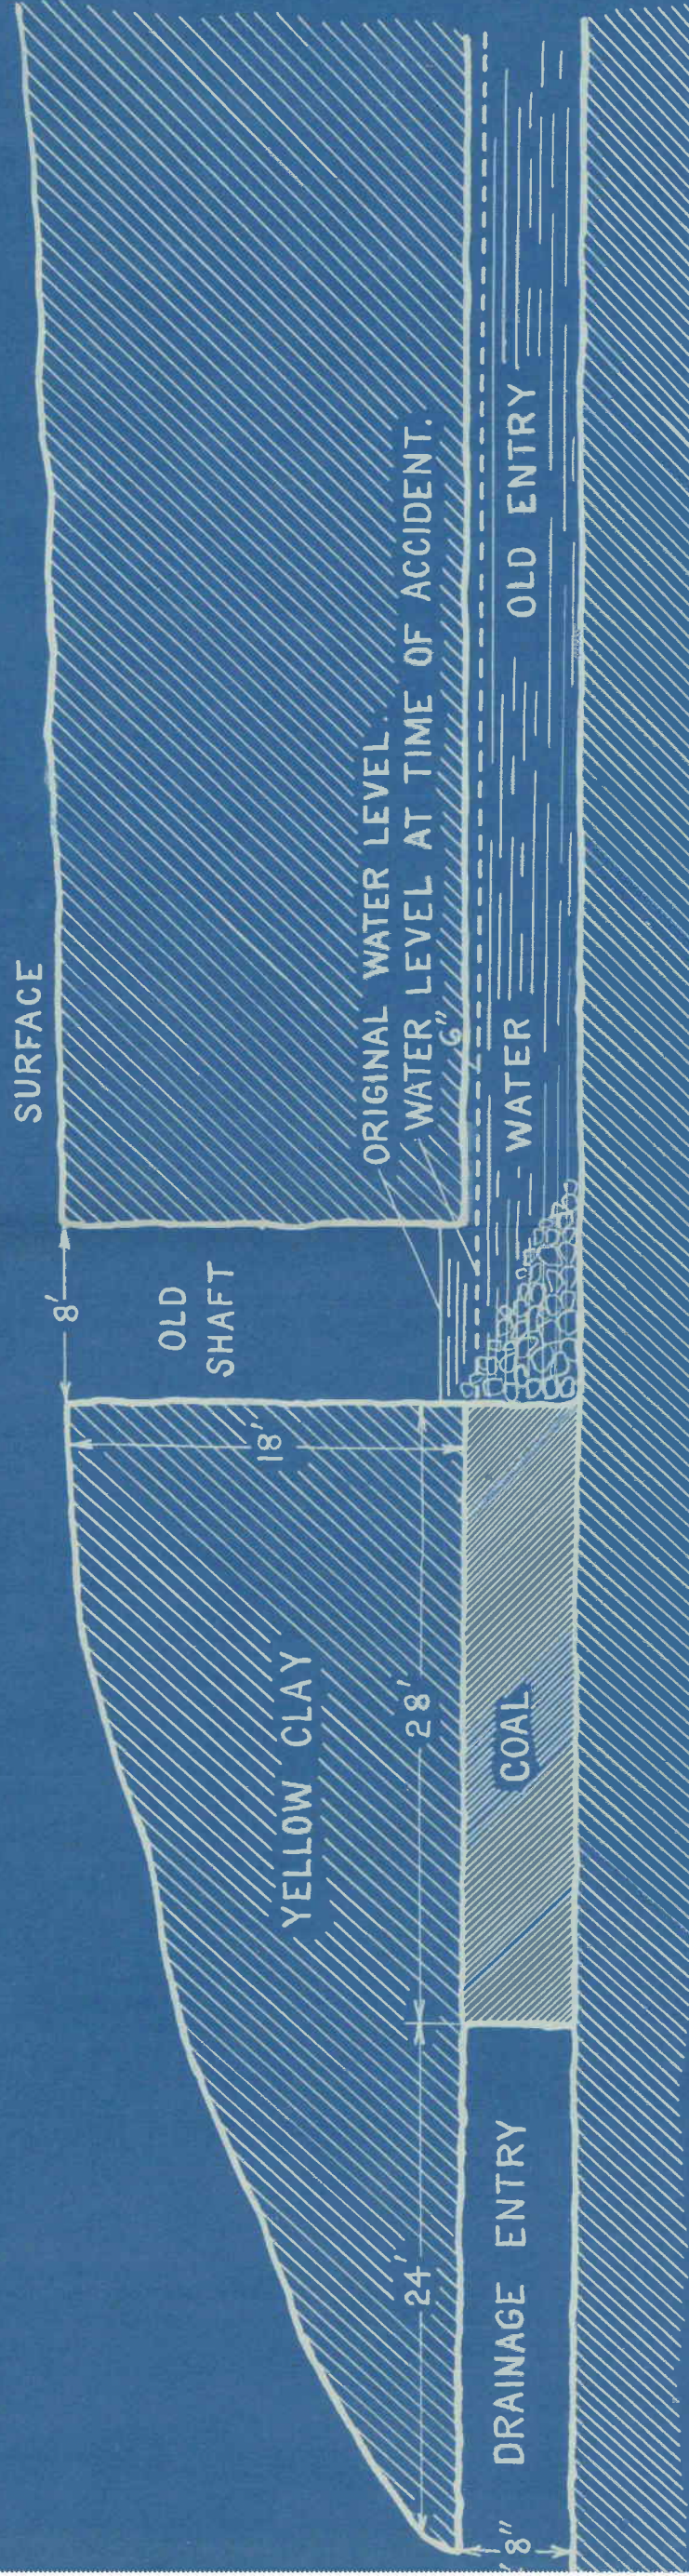
OLD AIR SHAFT NEAR BEAVER DAM, KY.
TAYLOR MINE OF THE TAYLOR COAL CO.
SCENE OF ACCIDENT OF MAY 6, 1913.

The abandoned shaft 22 ft. 8 in. deep, had filled up with water to a depth of 6 feet from the old entry, 4 ft. 8 in. in height, and a drainage drift was being driven in from the hillside for the purpose of drawing off this water from the old workings. (see sketch). This drainage drift had been driven a distance of 24 feet and there remained a thickness of 28 feet of solid coal between the bottom of the old shaft and the face of the drainage entry. A six foot drill hole had also been bored in advance of the coal face.

The seepage of water through this intervening coal stratum gradually lowered the water level in the old entry, until a 6 inch air space separated the top from the level of the standing water. Through this air space was forced the carbon dioxide gas from the accumulation in the old workings, and this gas at least partially filled up the old shaft. Several days previous to the lowering of the water level in the shaft, Mining Engineer Carl D. Fraser, a son of C. F. Fraser, had descended this old shaft as far as the water permitted and had noticed no ill effects, nor indications of carbon dioxide.

Lessons to be Learned: Undoubtedly the atmosphere in the shaft should have been tested with an open light, or preferably a safety lamp, and the extinguishing of the light would have warned Vellar against attempting the descent.
