REPORT OF MULTIPLE FATAL ROOF-FALL ACCIDENT

WHARTON NO. 2 MINE
EASTERN GAS AND FUEL ASSOCIATES, COAL DIVISION
BARRETT, BOONE COUNTY, WEST VIRGINIA

May 28, 1958

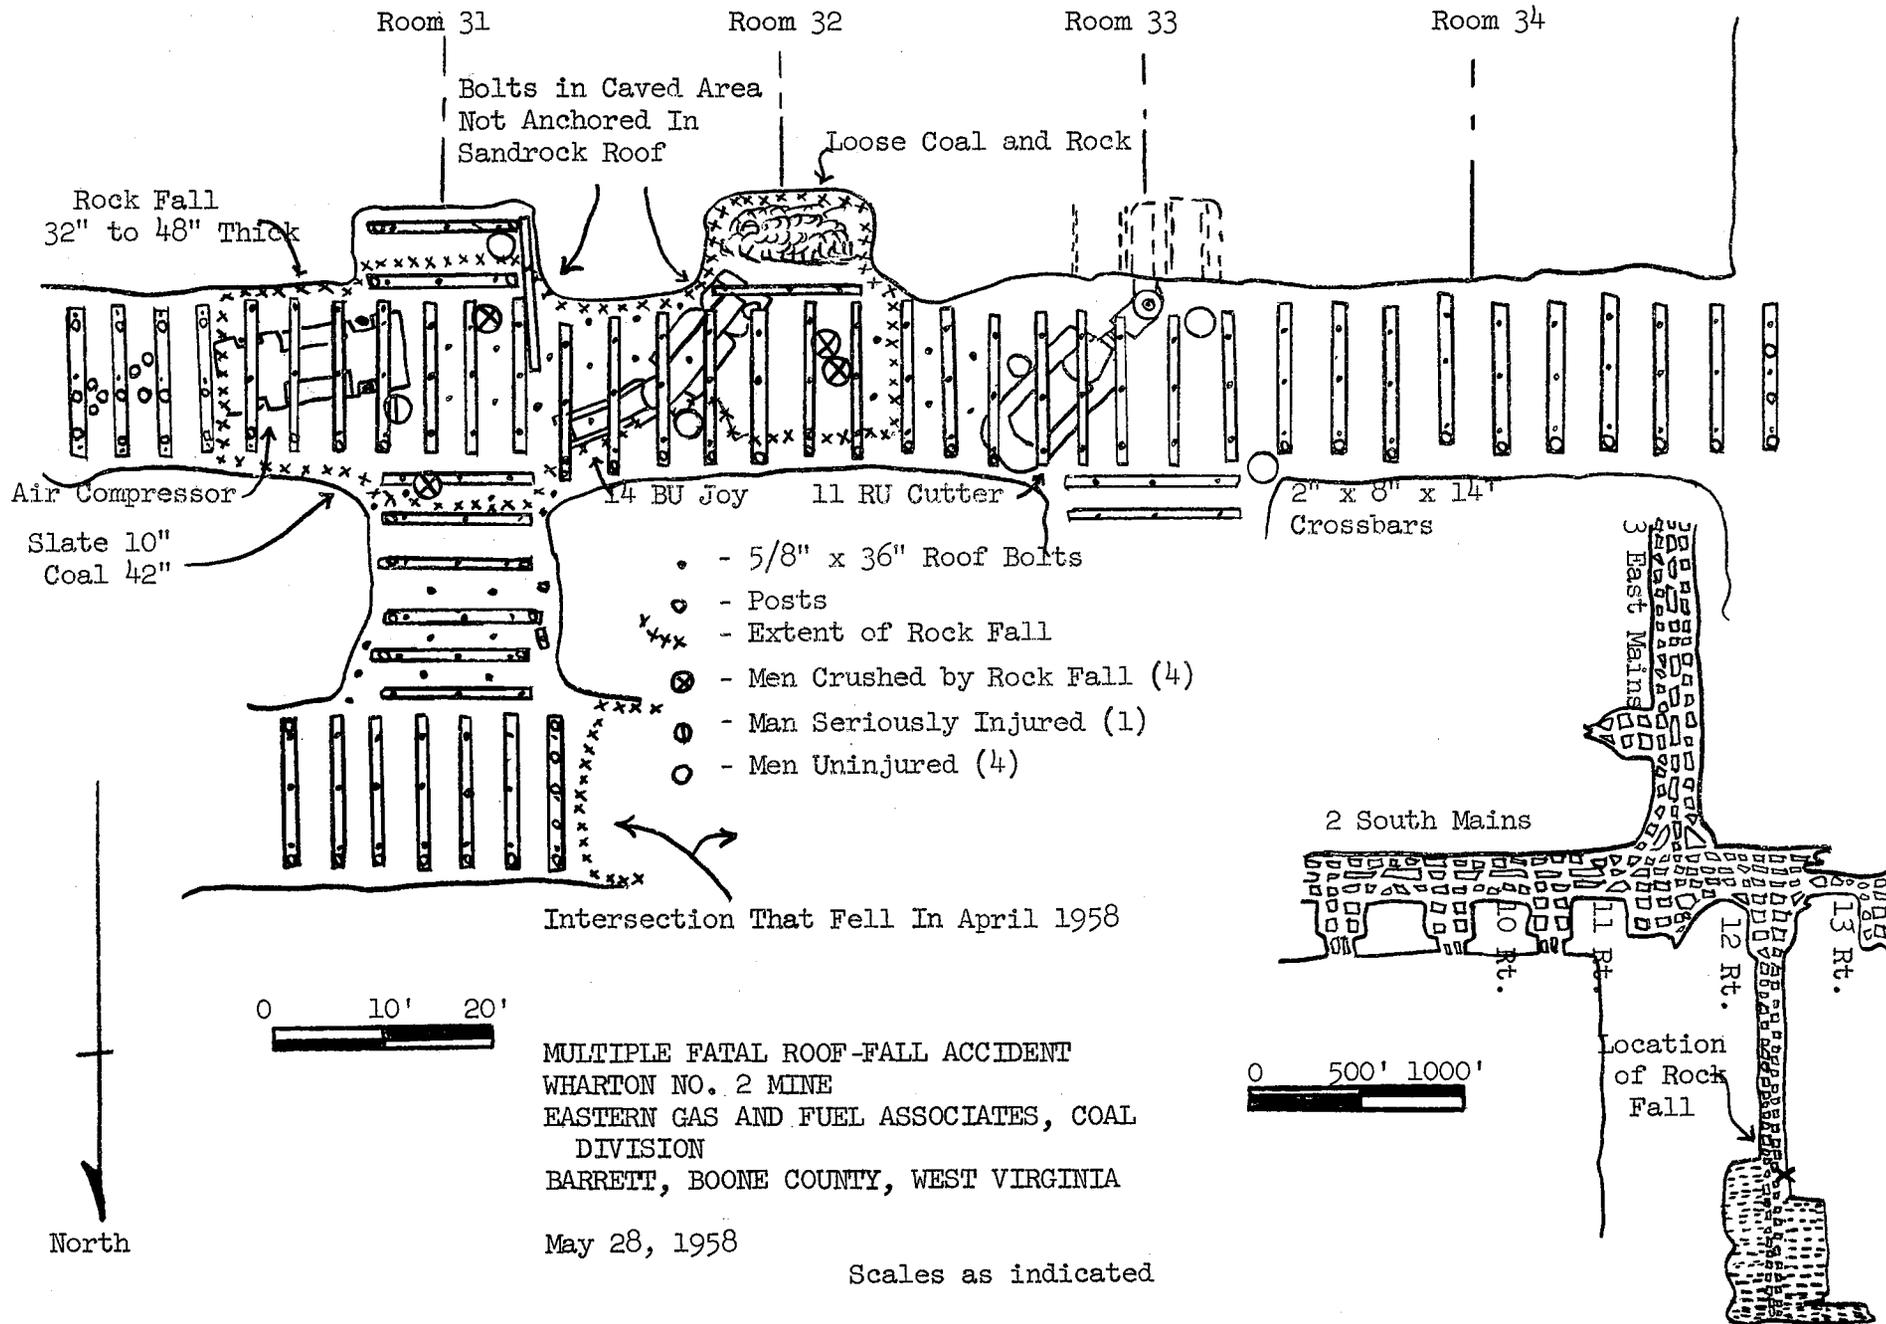
The torque on the roof bolts installed in No. 1 entry and the adjoining places was between zero and 420 foot-pounds; however, 5 bolts tested had a torque reading of zero and 22 bolts tested had a torque reading of less than 150 foot-pounds as indicated in Appendix C. A fall of bolted roof had occurred in an adjacent intersection in No. 2 entry, April 30, 1958, and another in a nearby intersection in No. 3 entry during the first week in May 1958. The rock that fell was from 34~~4~~ to 45 inches in thickness, and the roof failure was generally above the anchorage of the 36-inch length bolts. 30

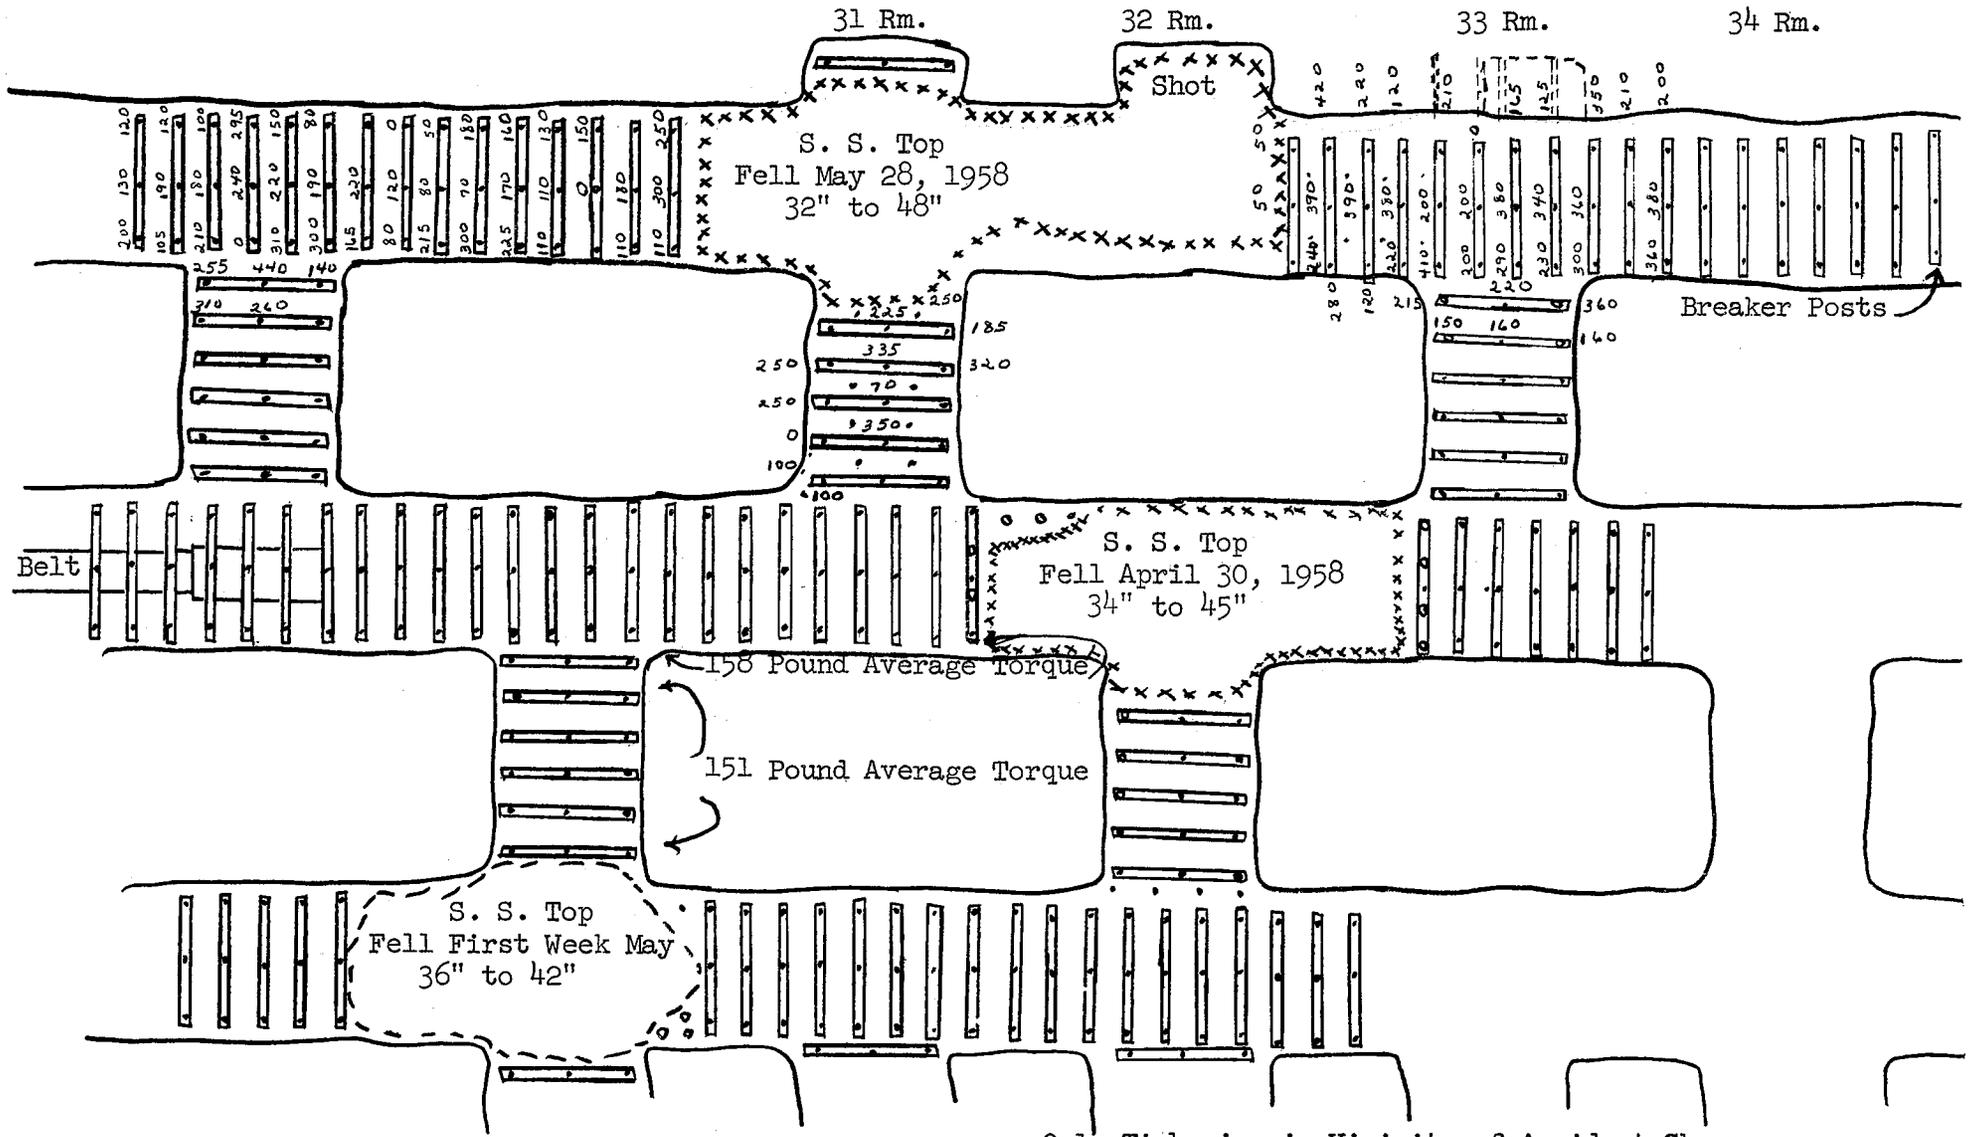
Appendix B

During the working shift previous to the accident, it was evident that the working places (right rooms) were near their projected limits, and the section foreman had several members of the crew moved to No. 1 entry of 12 butt right to prepare the area to turn 4 new rooms off No. 1 entry. Line timbers were removed from under the ends of the crossbars adjacent to the left rib of No. 1 entry for a distance of about 100 feet to permit the left rib to be cleared of loose coal and rock for the turning of the 4 new rooms (left). This area of No. 1 entry was cleaned during the shift previous to the accident, and conventional timbers were not used to replace the line timbers knocked from under the crossbars. The officials and employees mentioned that the afore-mentioned was the usual method of cleaning entry ribs to begin new rooms. However, bolts were installed between and near the ends of some of the crossbars from which line timbers had been removed (see Appendix B).
