**UNITED STATES
DEPARTMENT OF LABOR
MINE SAFETY AND HEALTH ADMINISTRATION
COAL MINE SAFETY AND HEALTH**

CAI-2000-18/19

**REPORT OF INVESTIGATION
UNDERGROUND COAL MINE EXPLOSIONS
JULY 31 - AUGUST 1, 2000**

**WILLOW CREEK MINE - MSHA ID. NO. 42-02113
PLATEAU MINING CORPORATION
HELPER, CARBON COUNTY, UTAH**

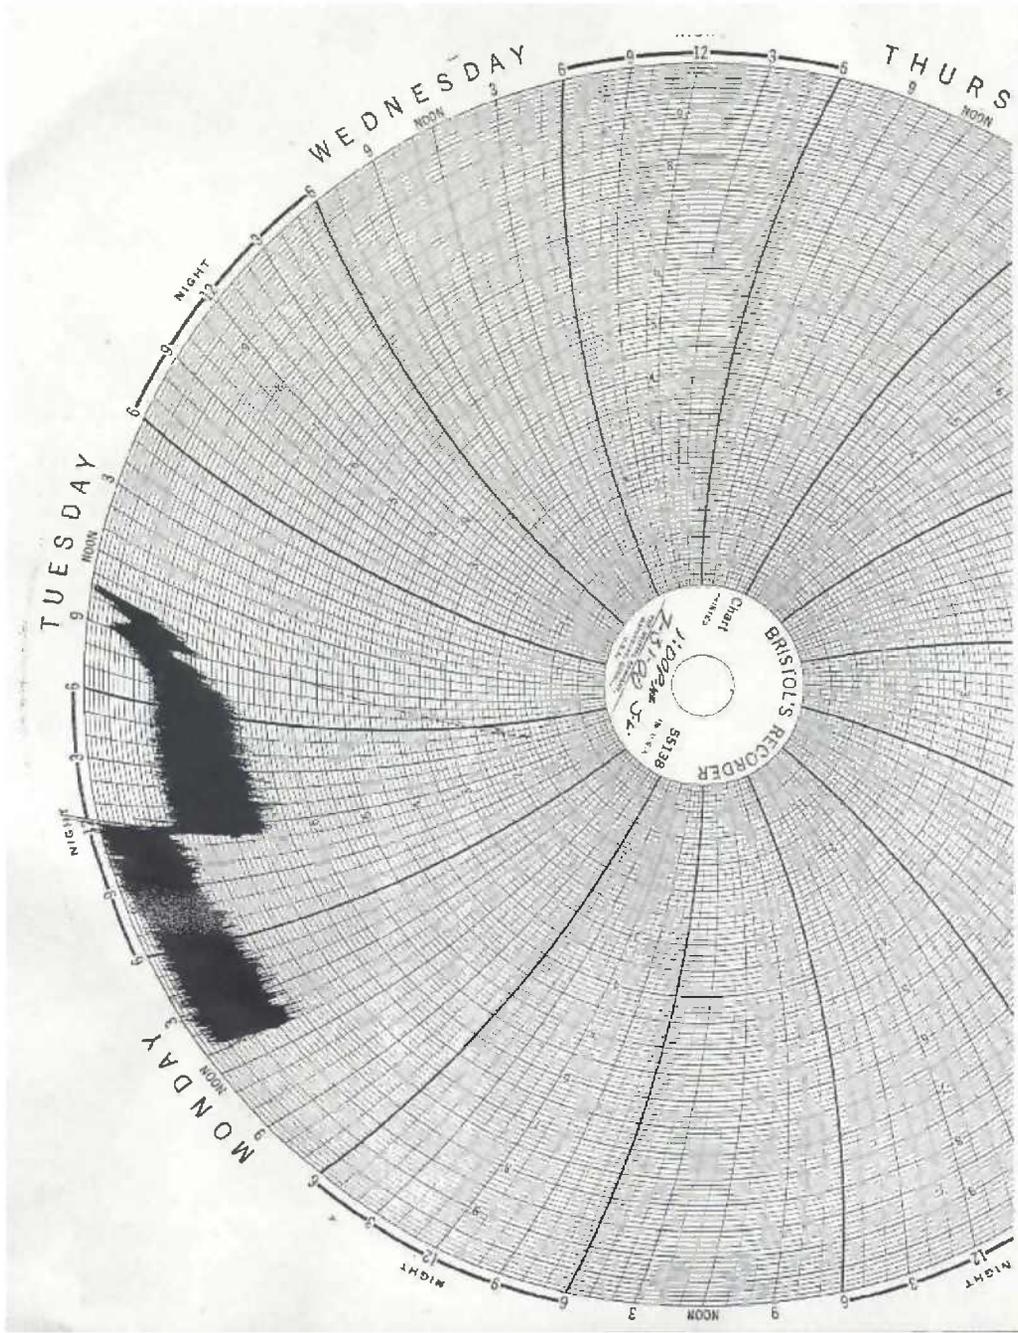
Figure 1 - Bristol Fan Pressure Recorder Chart

Due to the sampling and recording intervals, the Allen-Bradley monitoring system did not record the first explosion pressure spike. The magnitude of the fan pressures recorded by the Allen-Bradley monitoring system differed from those recorded by the Bristol recorder. Figure 2 (see Appendix F) shows the Allen-Bradley monitoring system fan pressure data during the time of the accident. These pressure spikes were consistent with explosion forces. Decreases following the pressure spikes were likely the result of damage to underground ventilation controls.

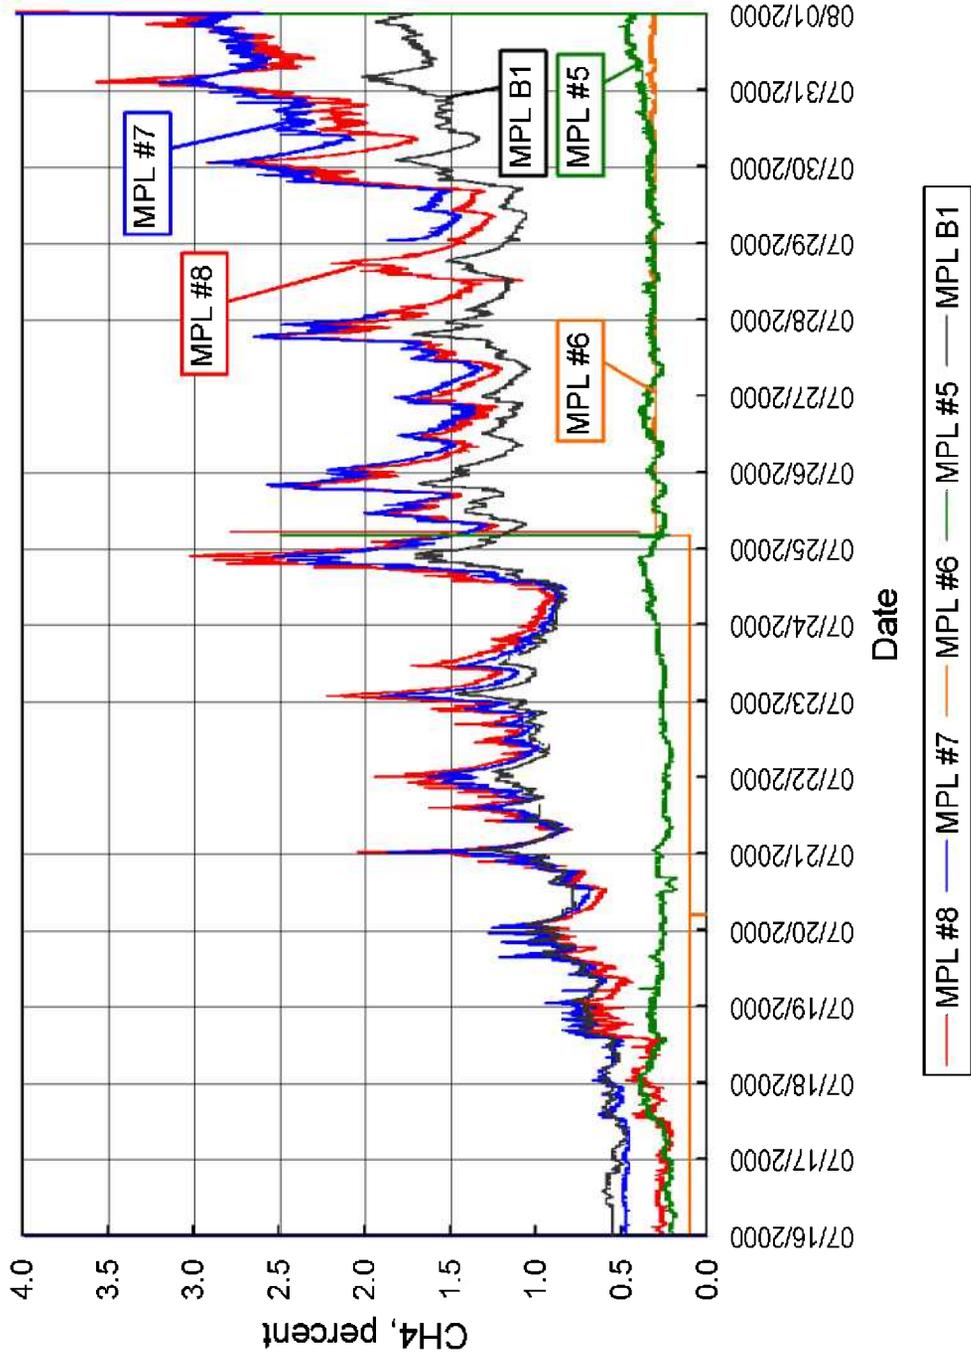
Figure 3 - Methane Concentration at Bleeder MPLs

Airflow from the bleeder split ventilating the pillared portion of the worked-out area consistently contained methane in excess of 2.0 percent after July 29, 2000. Airflow from the regulator at the pump room and from MPL #5 and MPL#6 diluted the methane downwind of MPL #8. However, methane concentrations in the bleeder airflow continued to increase. These changes in conditions should have prompted an investigation to ensure that ventilation was adequate. Improved distribution and/or additional airflow through the pillared worked-out area was needed to dilute and remove the methane being liberated. However, as a result of the system's configuration and because the regulators near MPL #7 and MPL #8 were fully open, no additional capacity was readily available.

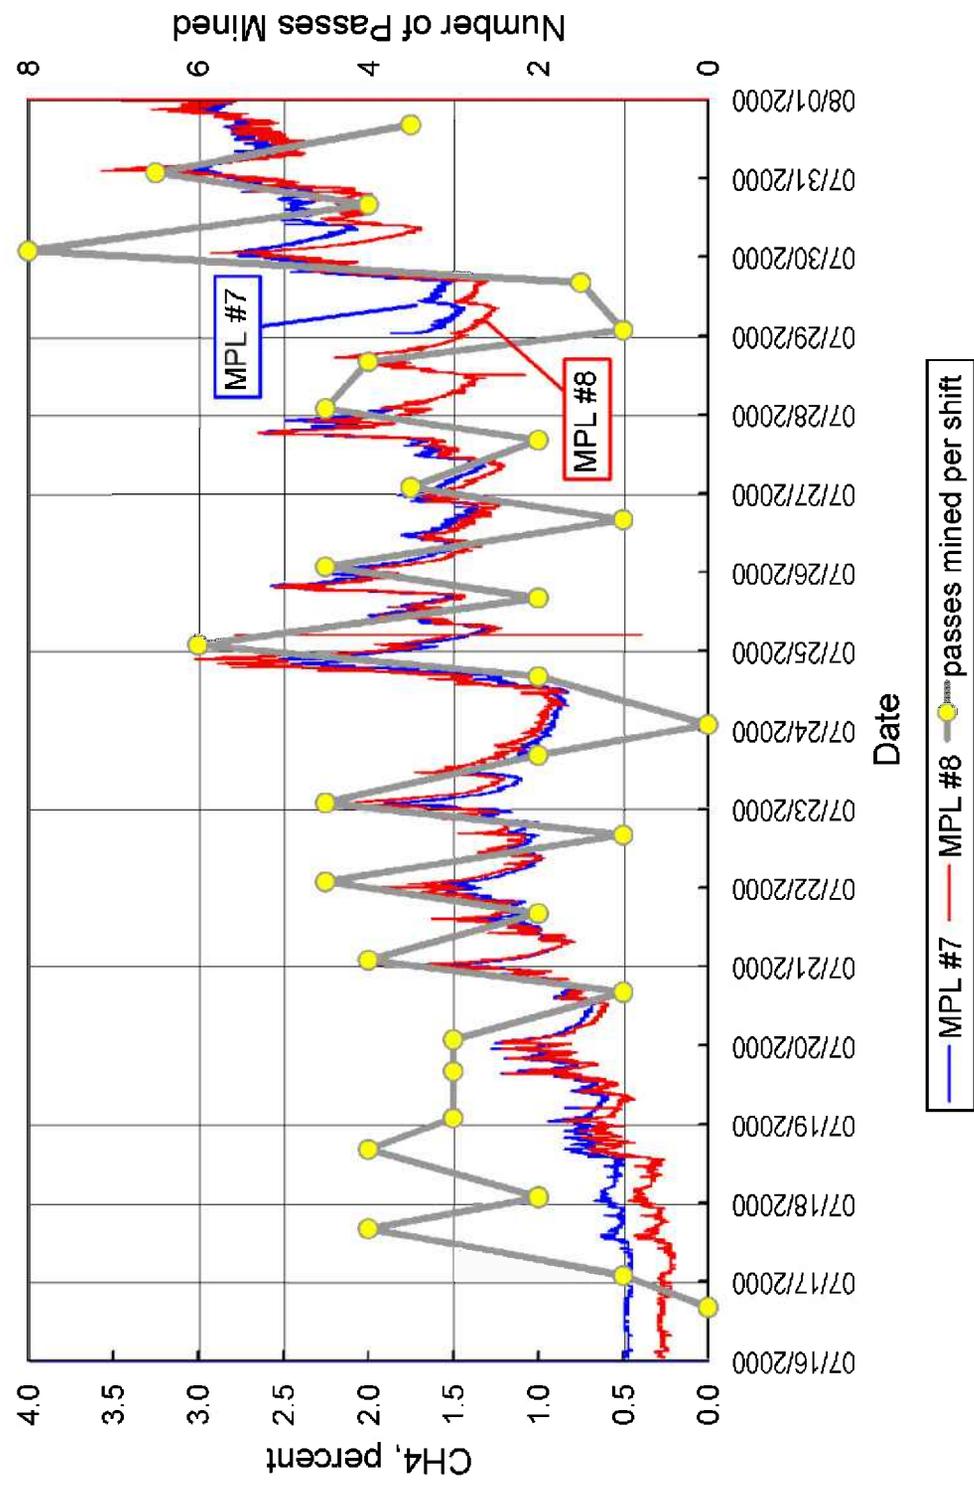
Figure 4 - Methane Concentration at Tailgate Bleeder Connector MPLs and Longwall Production

Cut-outs on the tailgate and headgate routinely caused relief of stresses in the strata. The conditions on the tailgate resulted in sudden significant quantities of methane being released. The methane releases regularly caused production to cease because of resulting elevated methane concentrations on the face. Additionally, methane feeders were encountered at other locations on the face that resulted in production delays. Production resumed as the methane release decreased.

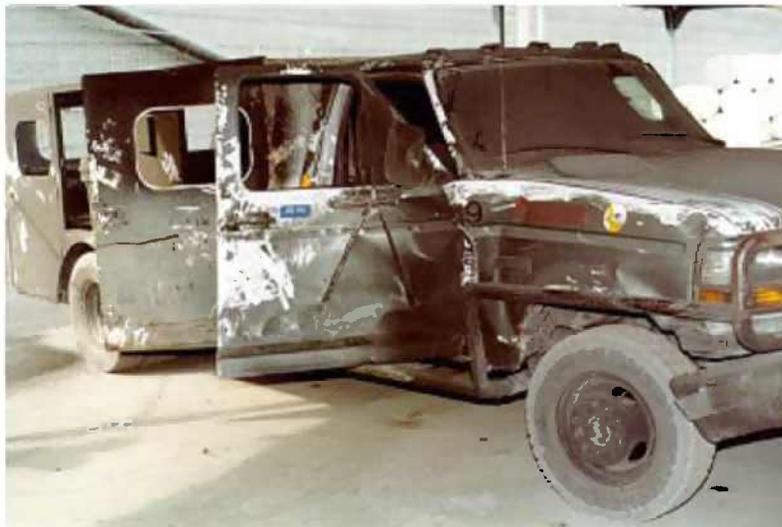
D-3 Section Longwall Mantrip showing extensive dust and soot deposits on white vehicle.
