REPORT OF INVESTIGATION
(UNDERGROUND COAL MINE)

MULTIPLE FATAL ROOF FALL ACCIDENT

Spartan Mine (ID No. 11-00612)
Zeigler Coal Company
Sparta, Randolph County, Illinois

September 15, 1980

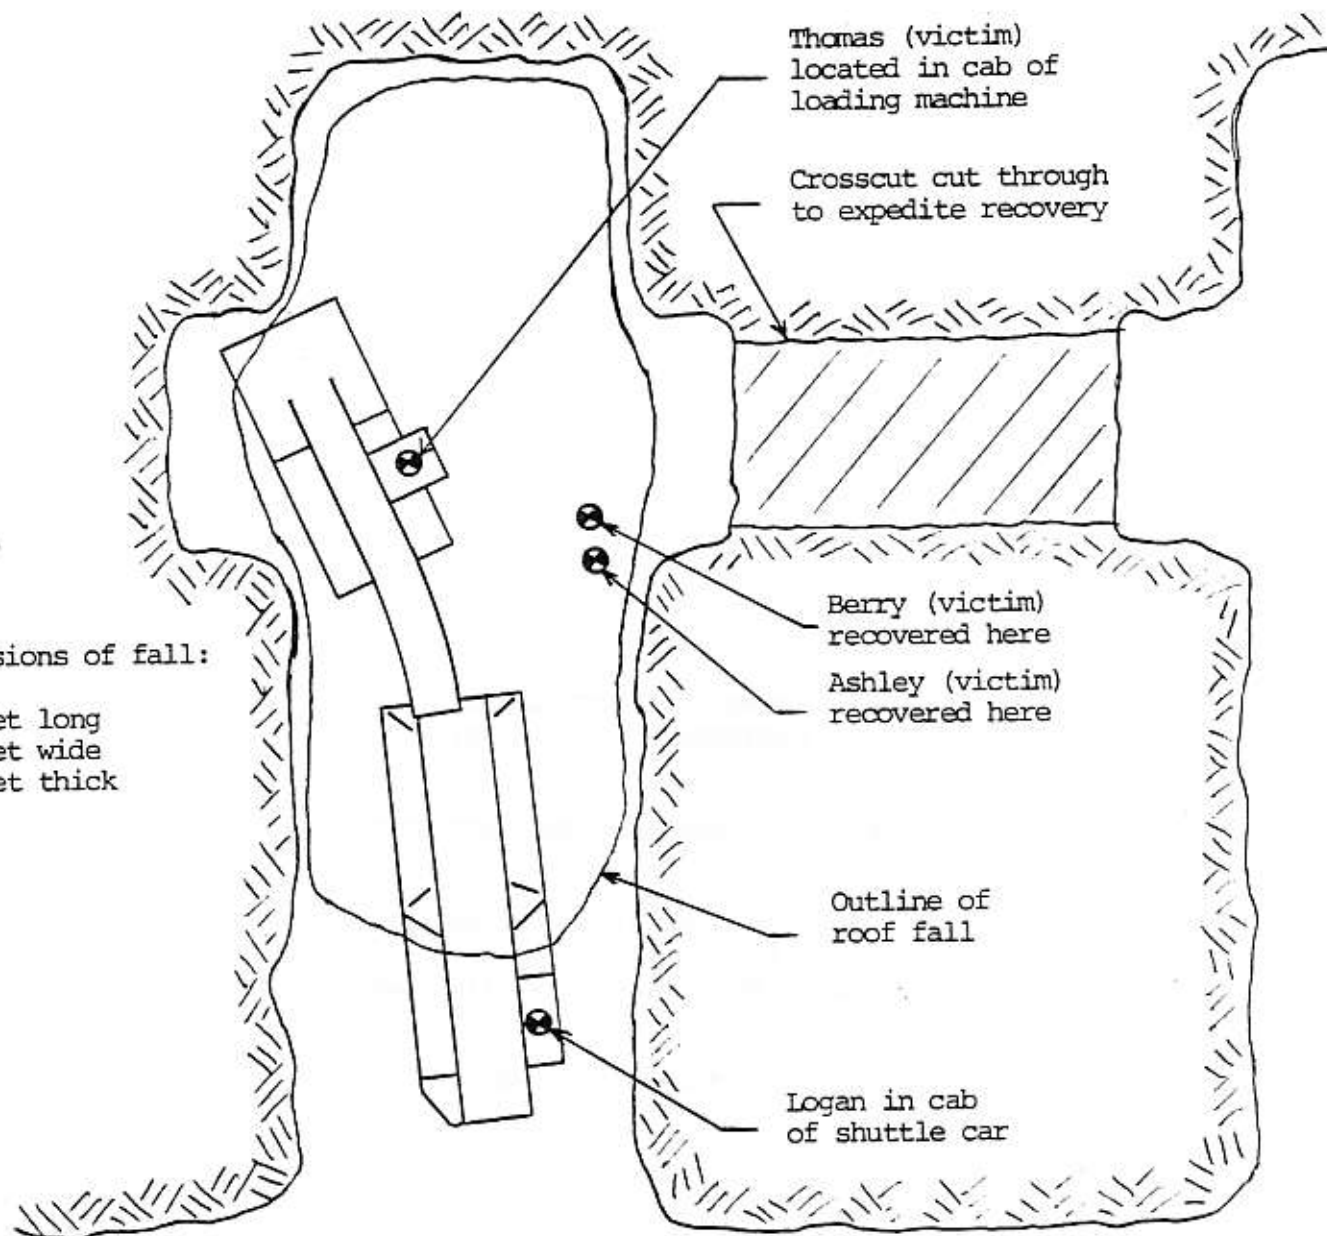
SKETCH OF
MULTIPLE FATAL ROOF FALL ACCIDENT

Dimensions of fall:

57 feet long
22 feet wide
5½ feet thick

3. The immediate roof overlying the coalbed was laminated dark shale and limestone.
4. The roof that fell pulled the expander nuts out of the roof bolt shells leaving the shells in the hole, except for those holes where the thickness of the fall was at or above the anchorage zone.

5. A fracture in the roof was present in the No. 3 entry from the outby end of the fall to and including the second open crosscut from the face. This condition had evidently existed for some time because there was rock dust present in the opening created by the fracture. The rock dust had to be either thrown by hand or blown by a rock dusting machine into the opening.
