REPORT OF COAL MINE FIRE (3 FATAL)

NO. 8-B MINE BUFFALO MINING COMPANY SAUNDERS, LOGAN COUNTY, WEST VIRGINIA

December 12, 1968

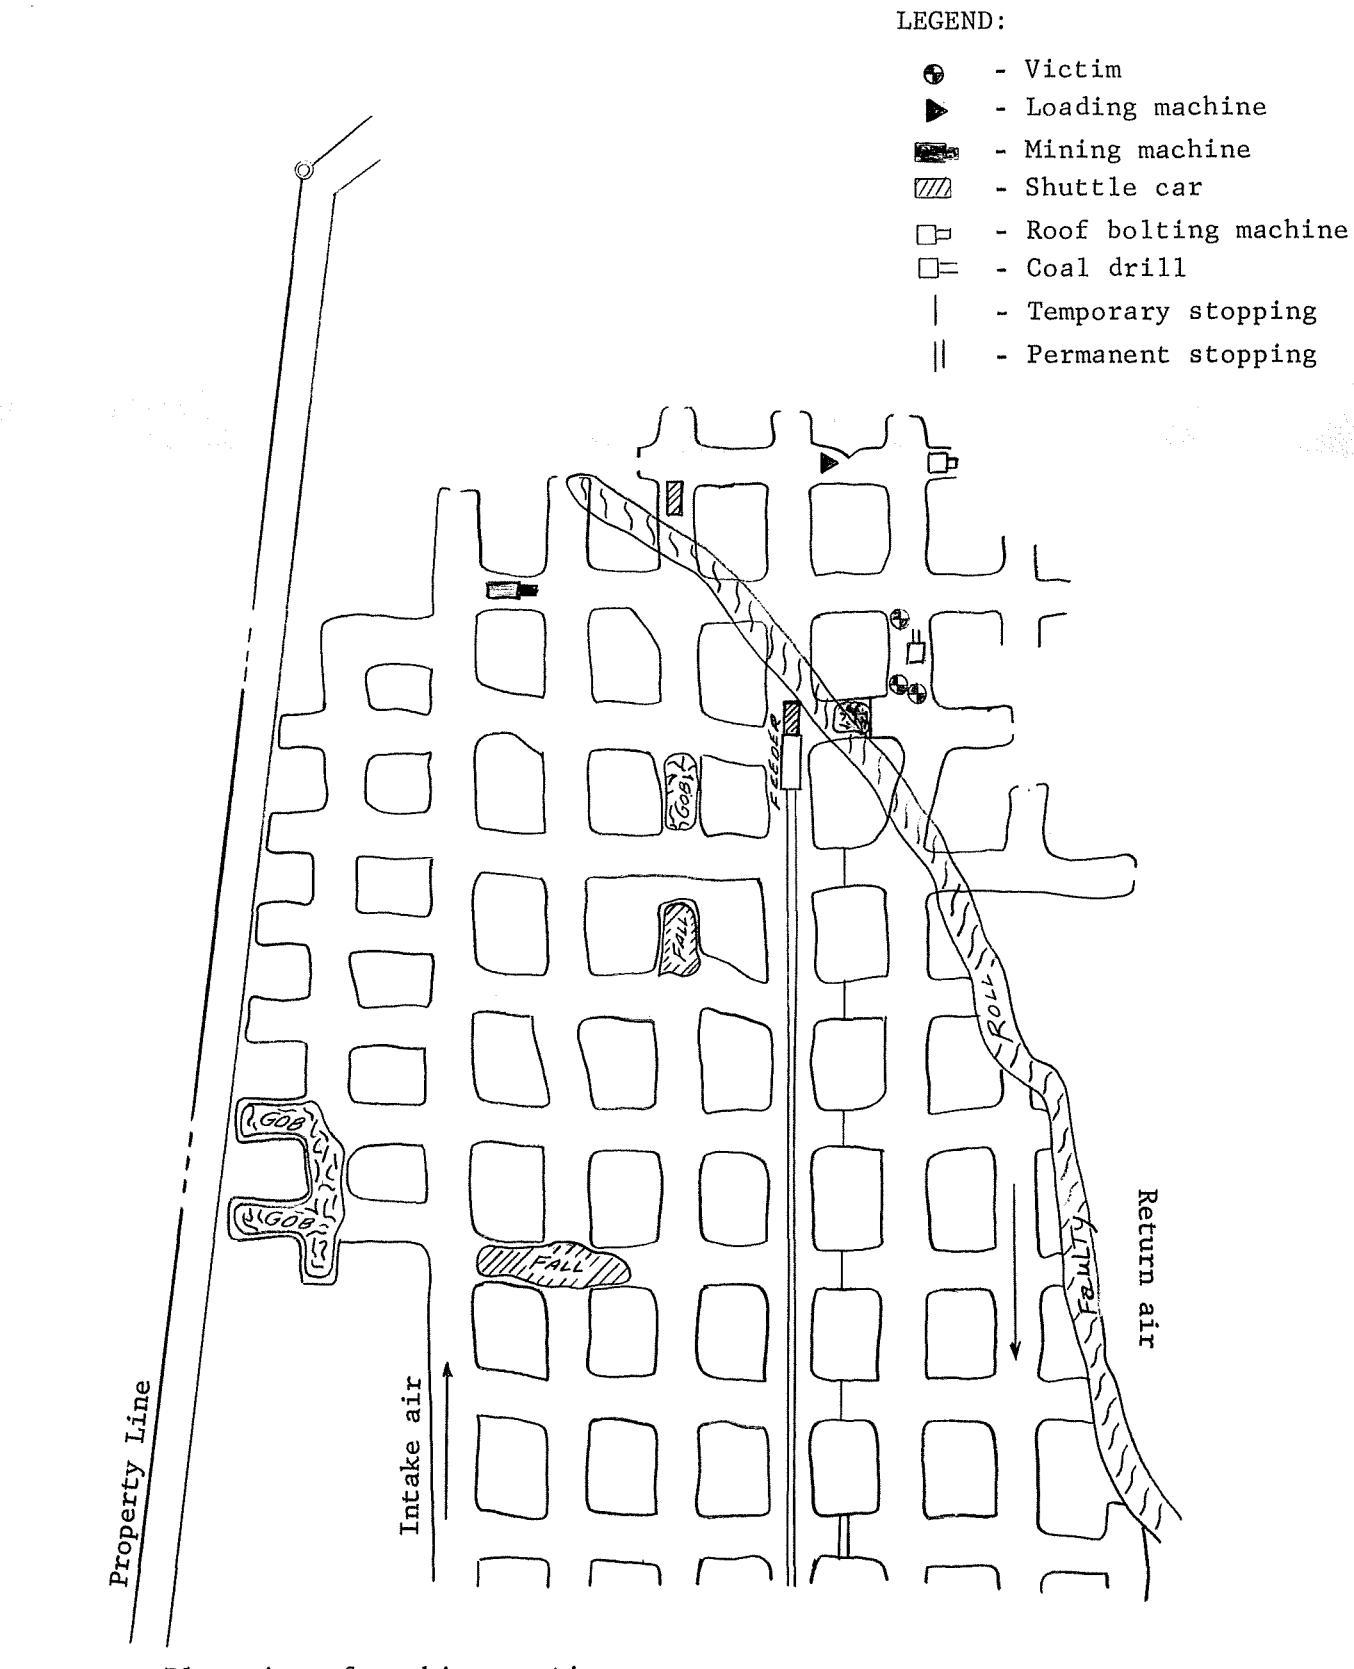
Plan view of working section

REPORT OF COAL MINE FIRE NO. 8-B MINE BUFFALO MINING COMPANY SAUNDERS, LOGAN COUNTY, WEST VIRGINIA APPENDIX B Scale 1" = 100'

<u>Point of Origin</u>: The fire originated at the belt conveyor feeder in No. 4 entry No. 1 section of the 8-B JR portal at a point about 80 feet outby survey station spad No. 323.

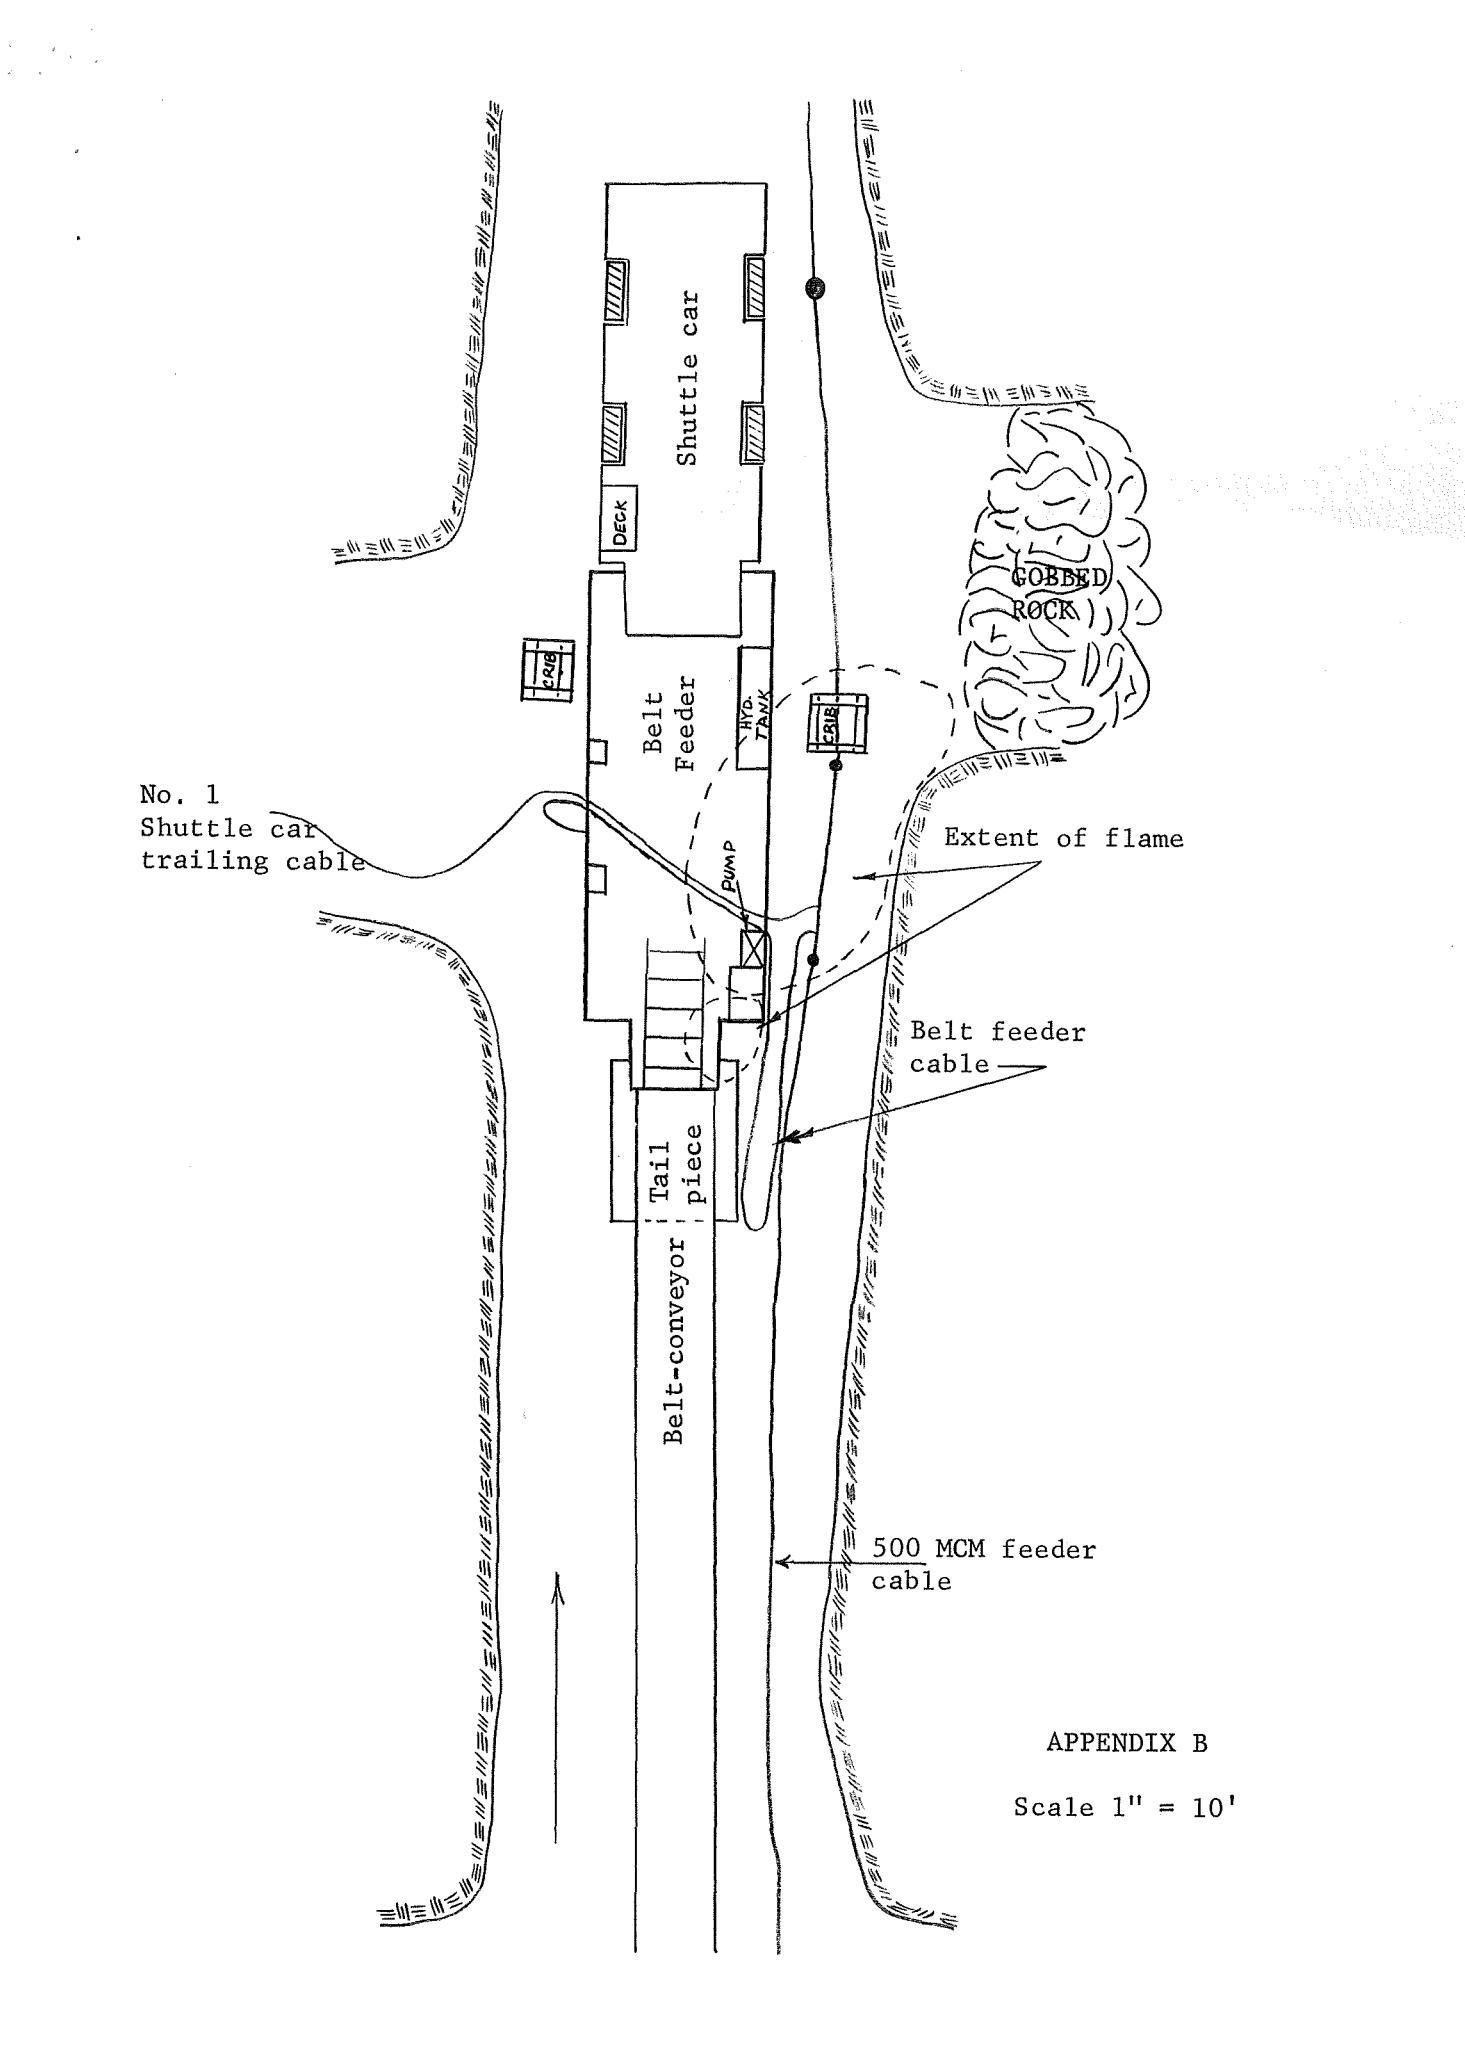
Evidence revealed during the investigation indicated that a well made but poorly insulated ring-type splice in the belt feeder power conductor was resting against a hydraulic valve and was in close proximity to several hydraulic hoses containing hydraulic oil under pressure. Also, there was evidence of a ruptured hydraulic hose and it was apparent that the pump motor had continued to run until the oil supply in the hydraulic tank was practically exhausted. There is no doubt that spraying, flaming oil intensified the fire and caused the ignition of coal and coal dust, a nearby wooden crib, rubber covering of numerous hydraulic hoses, the conveyor belt at the tailpiece, and part of the insulation from the power cables of the belt feeder and shuttle car.

<u>Cause of Fire</u>: It was the consensus of the investigating committee that the belt-feeder power cable short circuited at a poorly insulated temporary splice near a hydraulic valve, and the resultant electric arcing ruptured a hydraulic hose or hoses releasing and igniting hydraulic oil, preheated and under pressure, and surrounding combustible materials. It was agreed however that a hydraulic hose might have burst and the escaping oil, striking the power cable, caused a poorly insulated temporary splice in the power cable to contact a hydraulic valve.
