Identification No.: 02-00152 Report Issued: August 12, 1982

Joseph N. Cassaro, underground mine supervisor, age 46, Social Security Number 0947; George M. Martinez, stope miner, age 39, Social Security Number 9060; and Joseph Granillo, stope miner, age 26, Social Security Number 2689; were fatally injured between 5:30 and 6 p.m., May 10, 1982 in three separate incidents that involved a cave-in and fall-of-ground in the farm area of the 3440-2C stope.

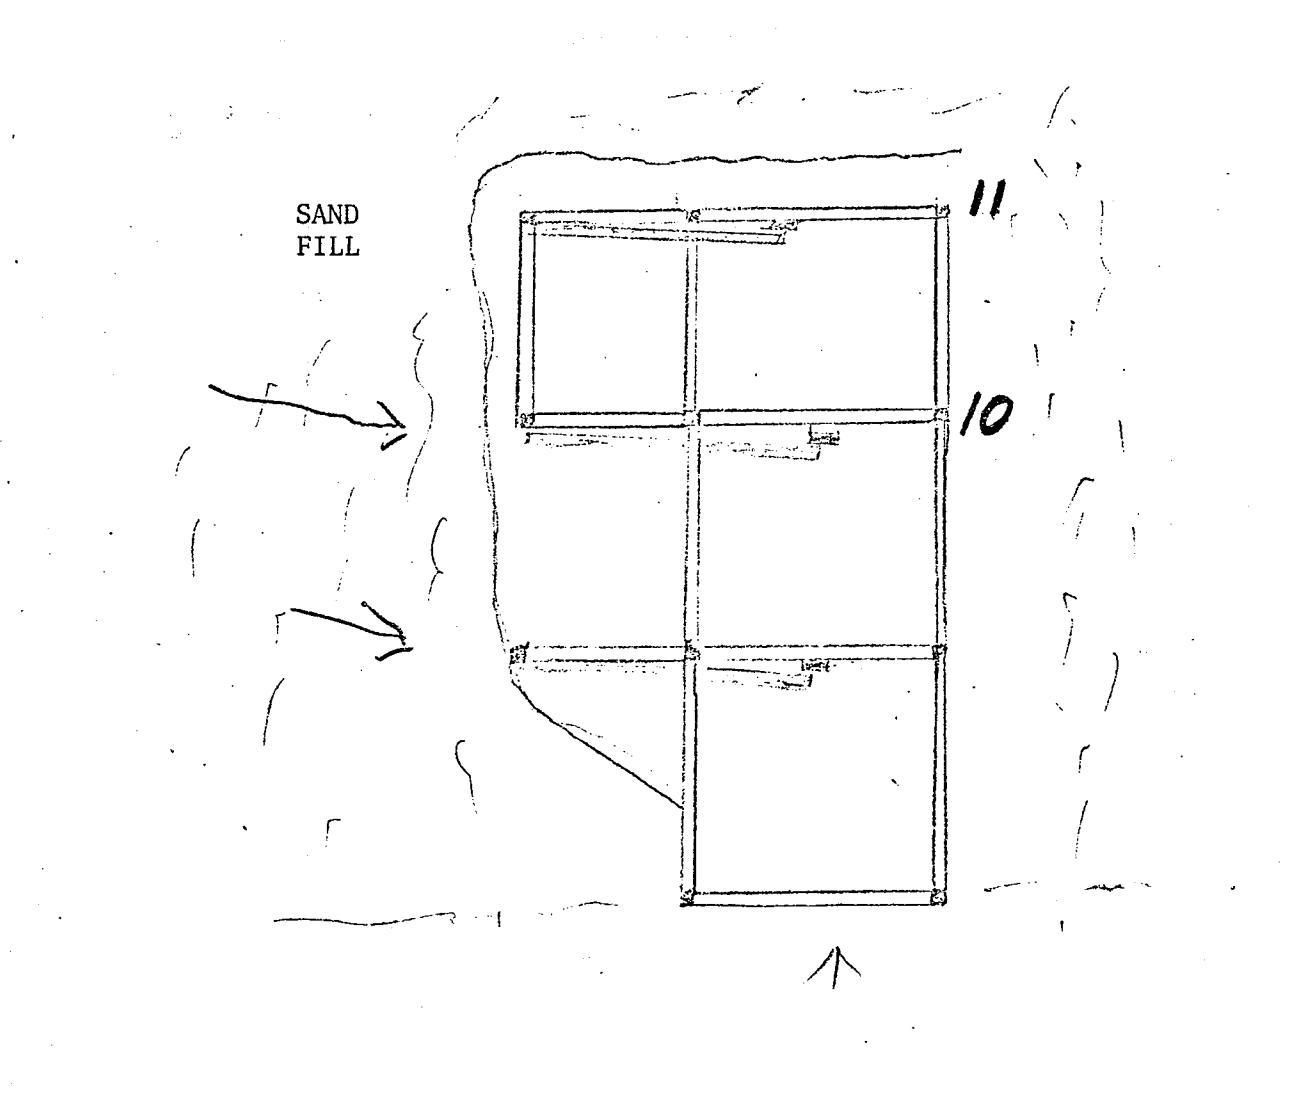
After the meeting George A. Gomez and Granillo (victim) proceeded to their working place, 3440-2C stope. They instructed the timber rustlers to stay near the stope's timber slide at the level, while Granillo and Gomez checked on what timbers they were going to need. After returning with their timber order, Gomez and Granillo sat down near the stope's entrance, drank a soft drink, smoked a cigarette and discussed the timbering process. They were to finish timbering by standing two posts under the middle set and blocking and lagging the west and face sides. (See Sketch #1)

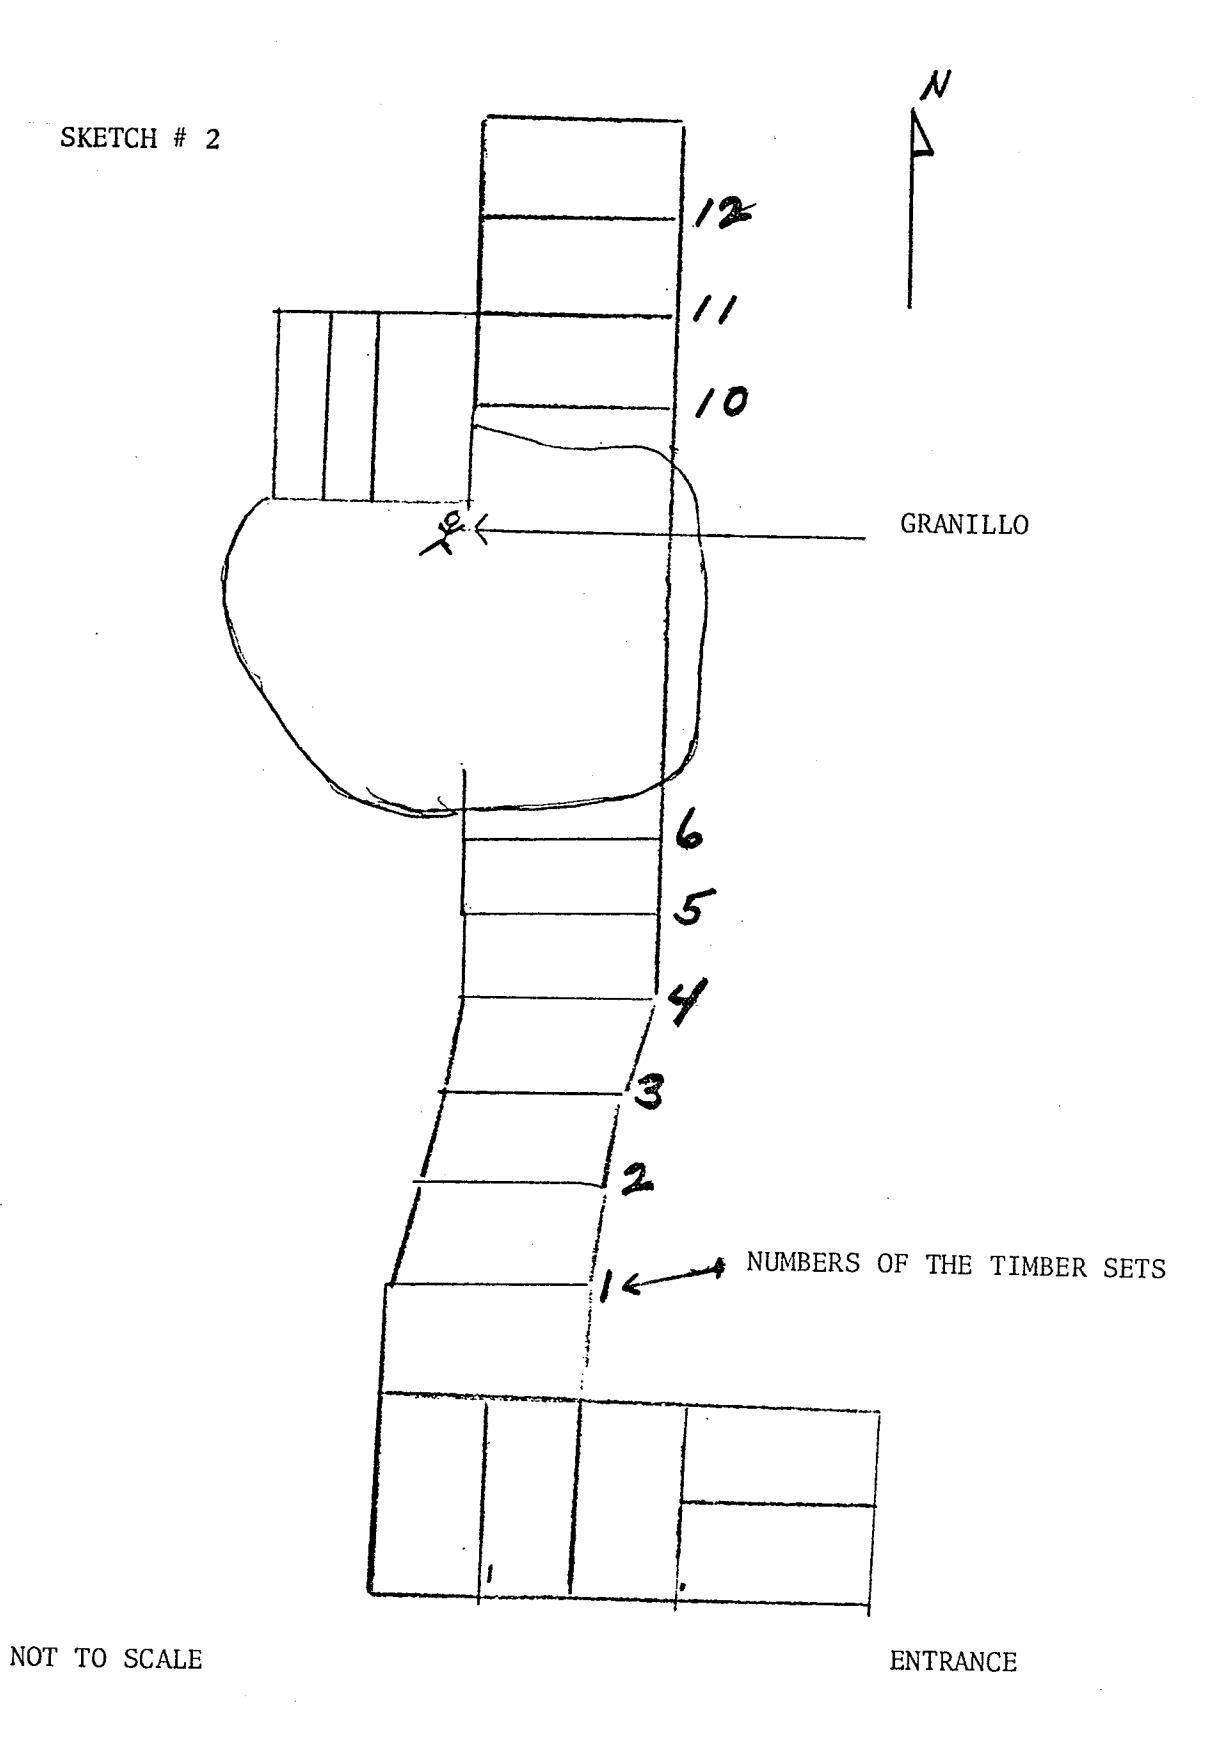
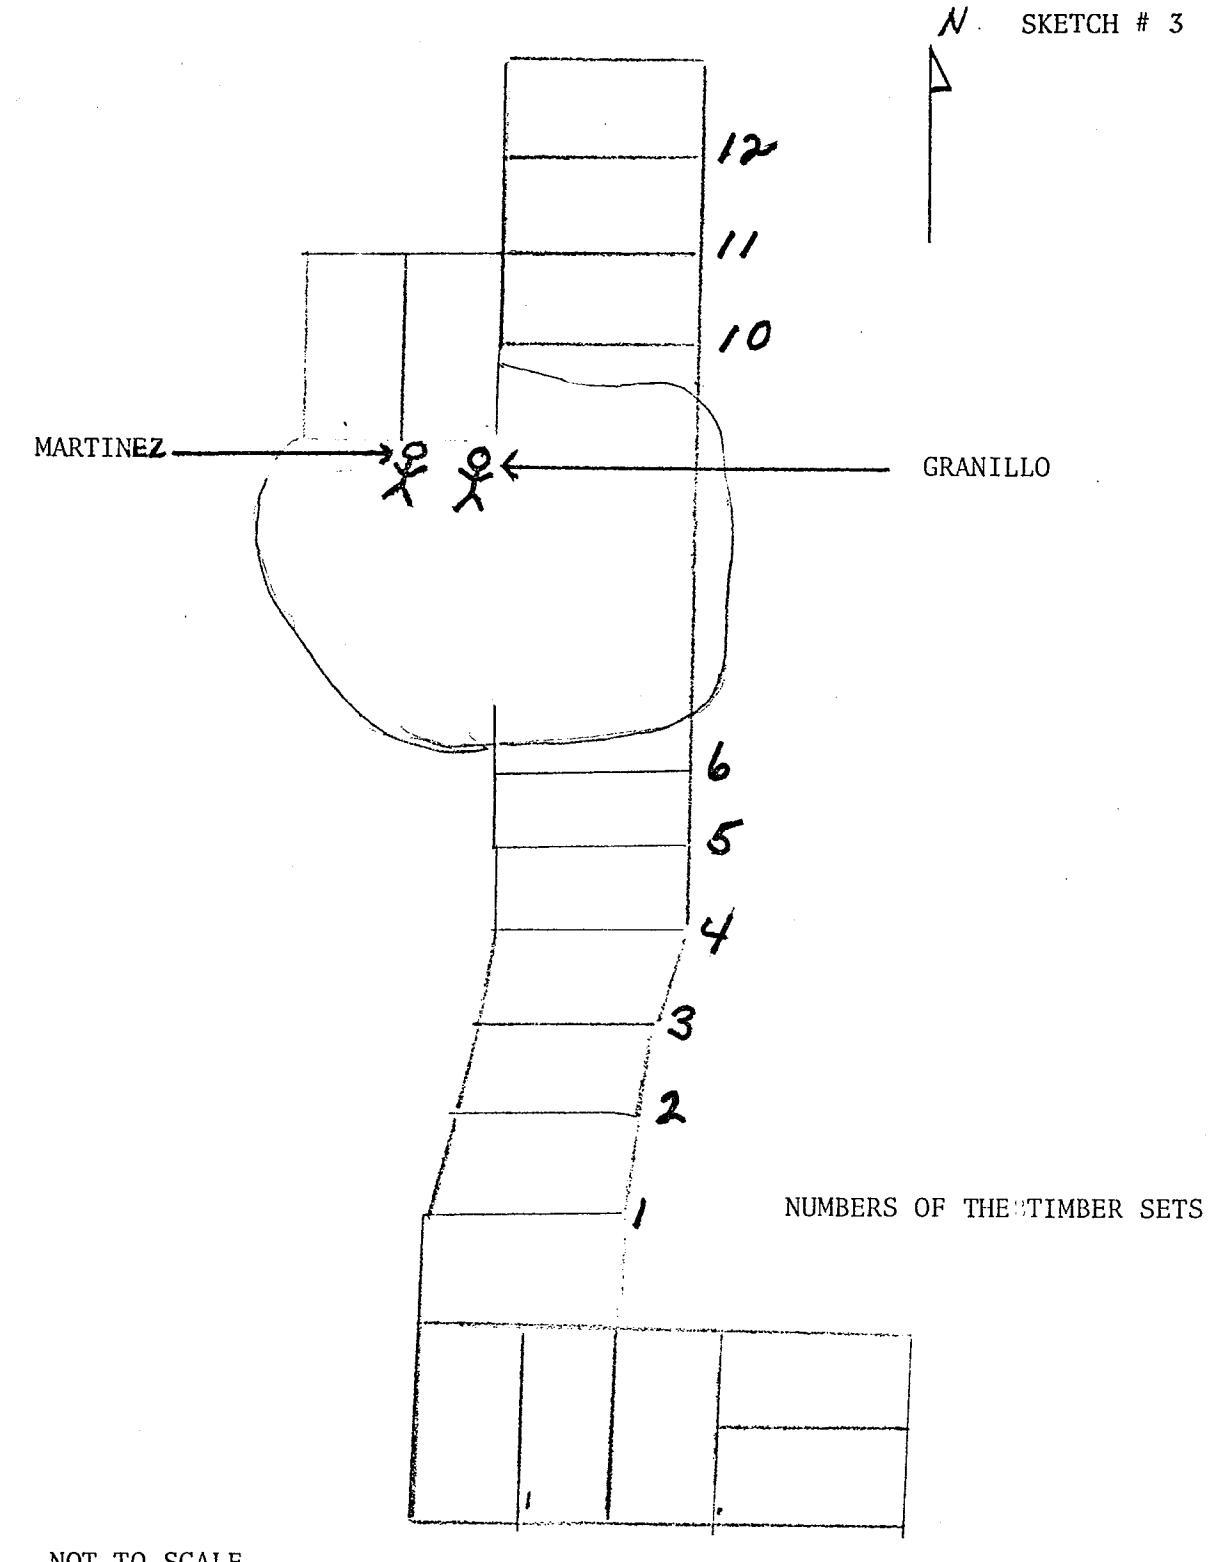
The cave-in washed out the sets 7, 8 & 9 and the roof peeled to a width of about 30 feet and was cone shaped approximately 12 to 15 feet from the top of the existing 17 N panel and the farm area. The 10, 11, and 12 sets were still in place after the accident.

Gomez stated the ground or timber gave no warning whatsoever. When the dust had cleared, Gomez saw that the farm pony set, the 7th, 8th and 9th sets of the 17 N panel (see sketch #2) were washed out. He saw Granillo trapped up to his waist and was not able to pull him out. He immediately ran for help to the adjacent 3440-5C stope, some 200 feet away. Andy Arroyos (witness) miner; Paul Gonzales (witness) miner; Martinez and Cassaro (victims) responded to Gomez's call.
