REPORT OF INVESTIGATION UNDERGROUND COAL MINE DUST EXPLOSION

No. 1 Mine (ID No. 15-12624) RFH Coal Company Craynor, Floyd County, Kentucky

January 20, 1982

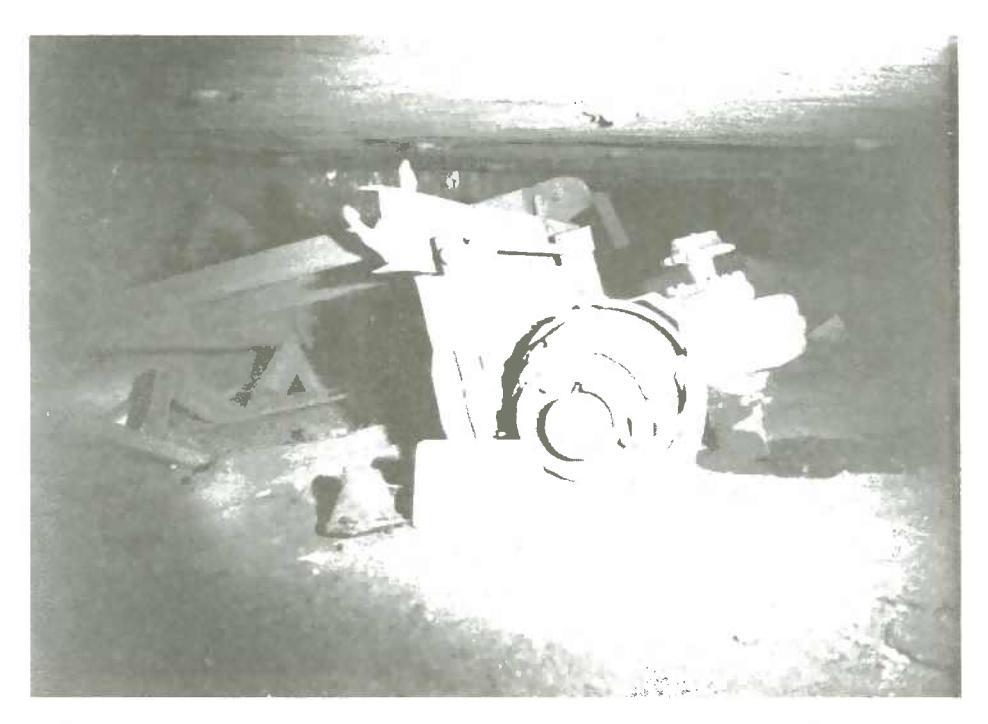
FIGURE 1. - Pony belt conveyor drive in the No. 5 entry between the Nos. 11 and 12 crosscuts.

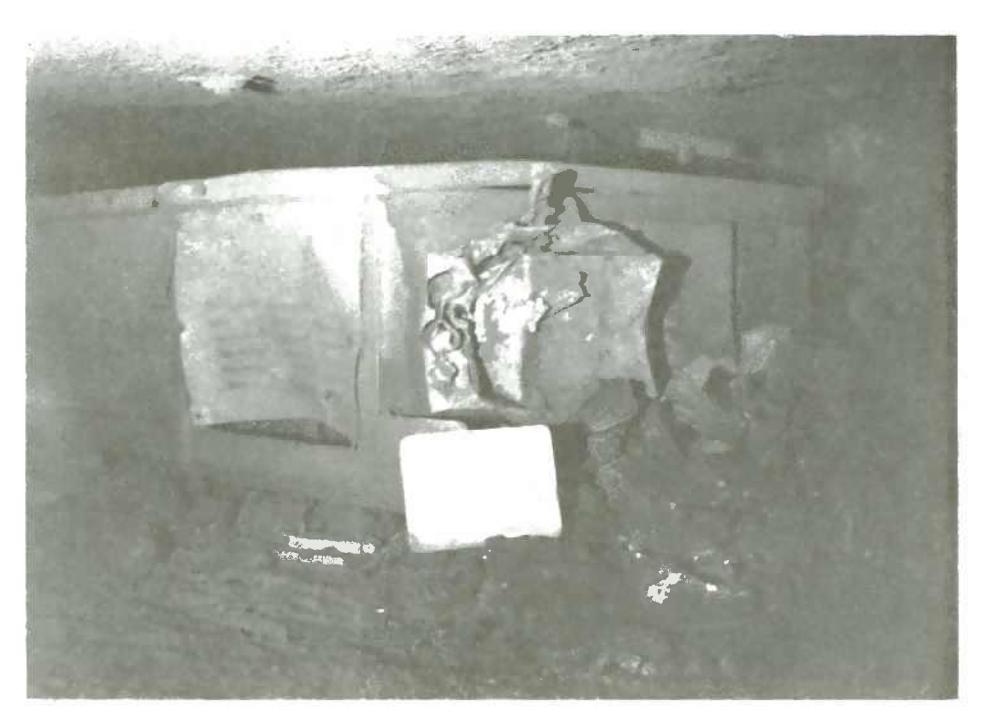
belt conveyors were extensively damaged by the explosion. Explosion forces moved the power center, estimated to weigh 2 tons, a distance of about 70 feet.

FIGURE 2. - Section power center in the No. 6 entry between the Nos. 11 and 12 crosscuts.

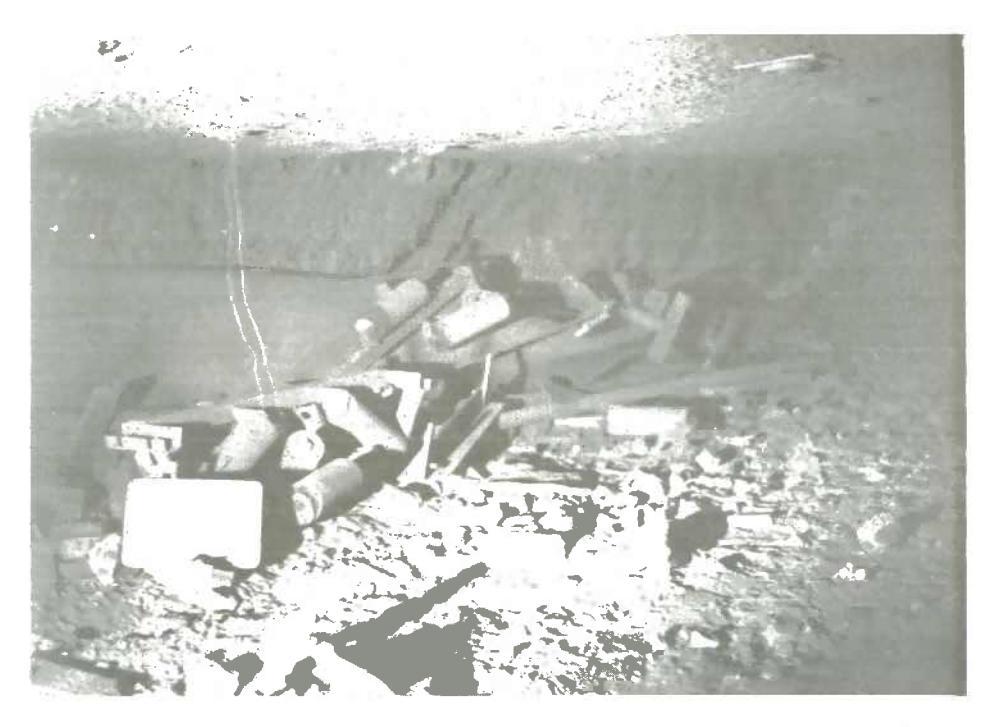
FIGURE 3. - Part of the pony belt conveyor in the No. 12 crosscut between the Nos. 5 and 6 entries.

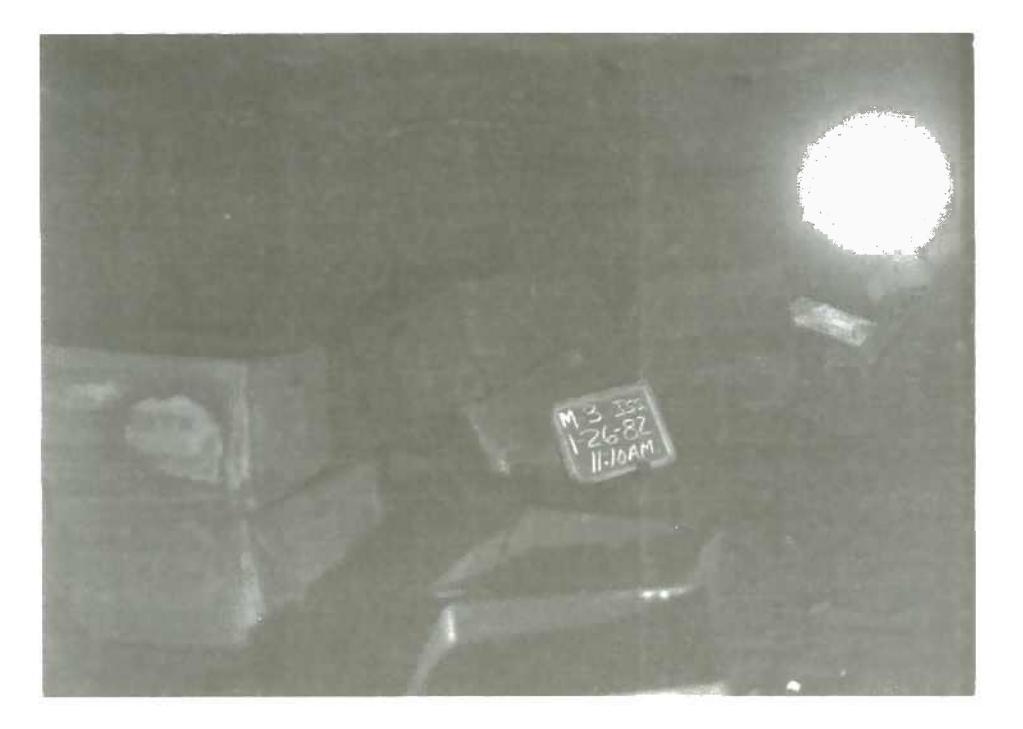
FIGURE 4. - Cases of Tovex 320 water gel explosives being stored along the active roadway in the No. 7 entry between the Nos. 2 and 3 rooms.

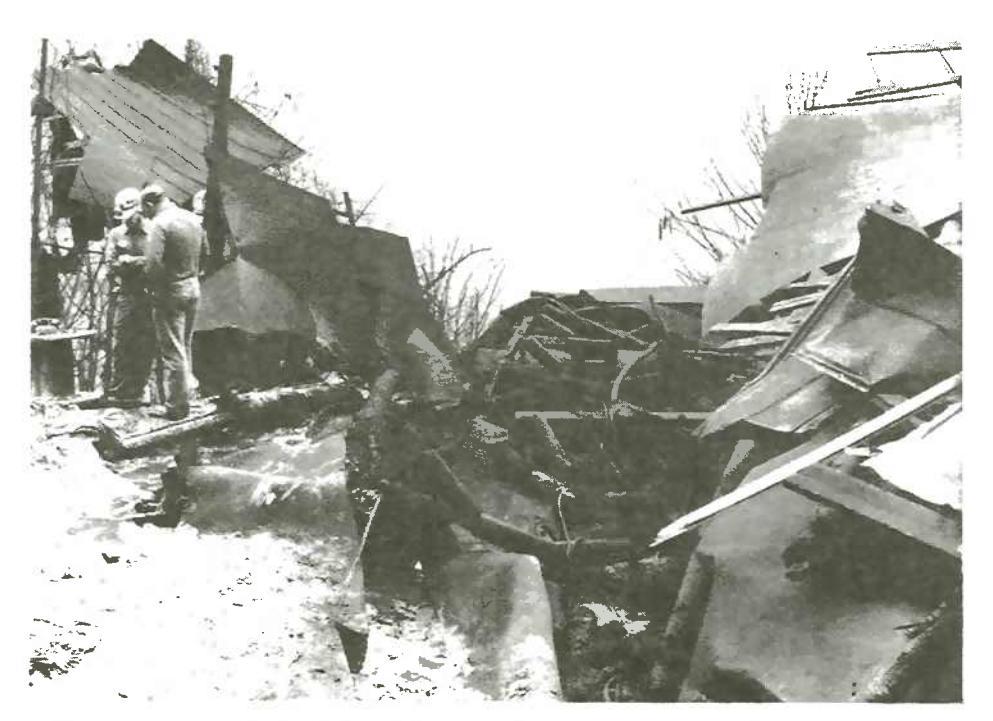
Surface facilities that were in direct line with the mine openings were destroyed. The fan housing, which was constructed of concrete blocks and sheet metal, was extensively damaged. All electrical power lines, including the power circuit for the mine fan, were severed and torn down. A 1,000-gallon water tank was blown about 50 feet over the hill. Trees that were in direct line with the forces were coated with dust and debris and had several broken limbs. Some of the mine supplies and debris on the surface were blown to the hillside opposite the mine openings, a distance estimated at 800 to 1000 feet. The direction and extent of forces are shown in Appendix K. Photographs showing damage caused by the explosion are in Appendix E.

FIGURE 5. - Surface areas directly in line with the No. 4 entry.

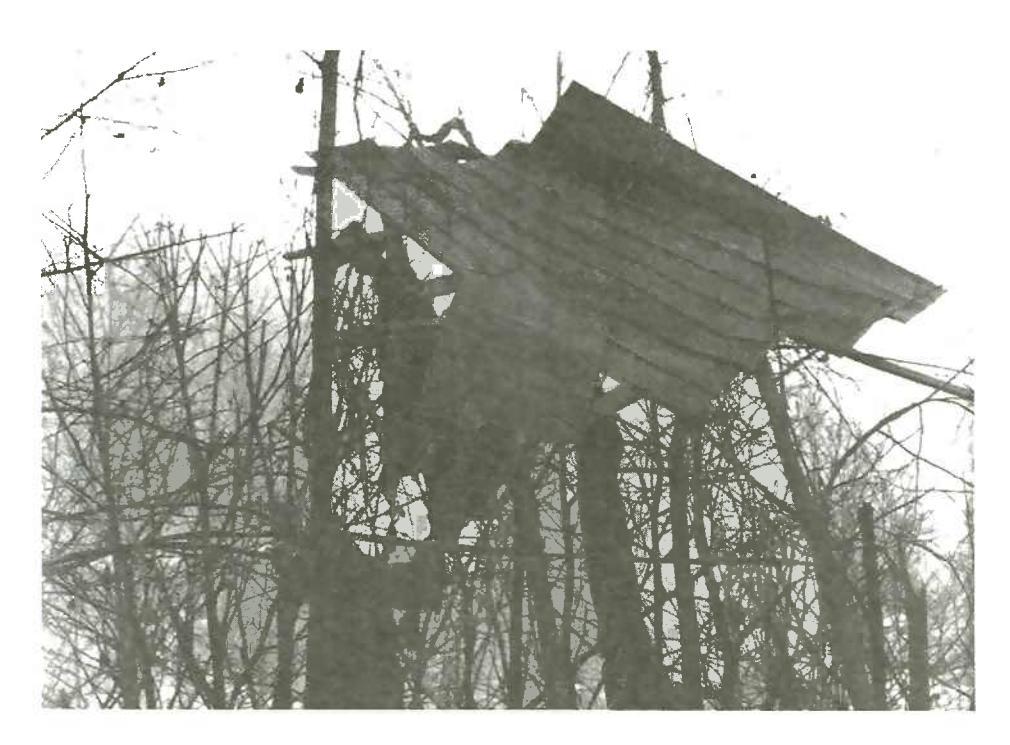
FIGURE 6. - Portion of structure that had been installed over the main belt conveyor
