United States Department of Labor Mine Safety and Health Administration Office of the Administrator Coal Mine Safety and Health

REPORT OF INVESTIGATION DECEMBER 7, 1992 UNDERGROUND COAL MINE EXPLOSION #3 MINE - ID. NO. 44-06594 SOUTHMOUNTAIN COAL CO., INC. NORTON, WISE COUNTY, VIRGINIA

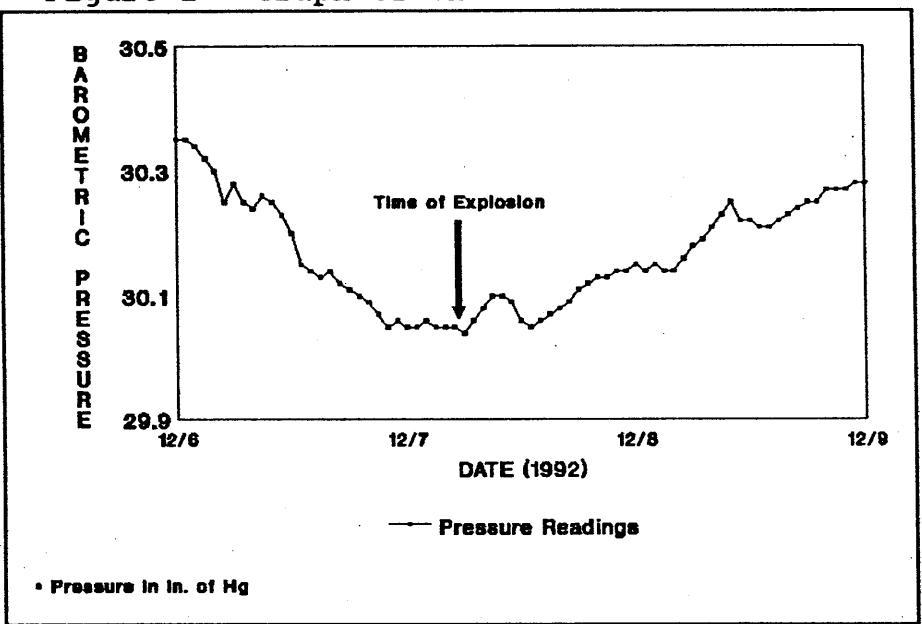
Figure 1 - Graph of the Barometric Pressure

Figure 1 indicates that a significant drop in the barometric pressure occurred in the hours prior to the explosion. This increases the likelihood of methane migrating from the 1 Left pillared areas.
