January 14, 1926; Jamison No. 8 Mine, Farmington, W. Va.; 19 Killed

(From Bureau of Mines report, by G. S. Rice and J. W. Paul)

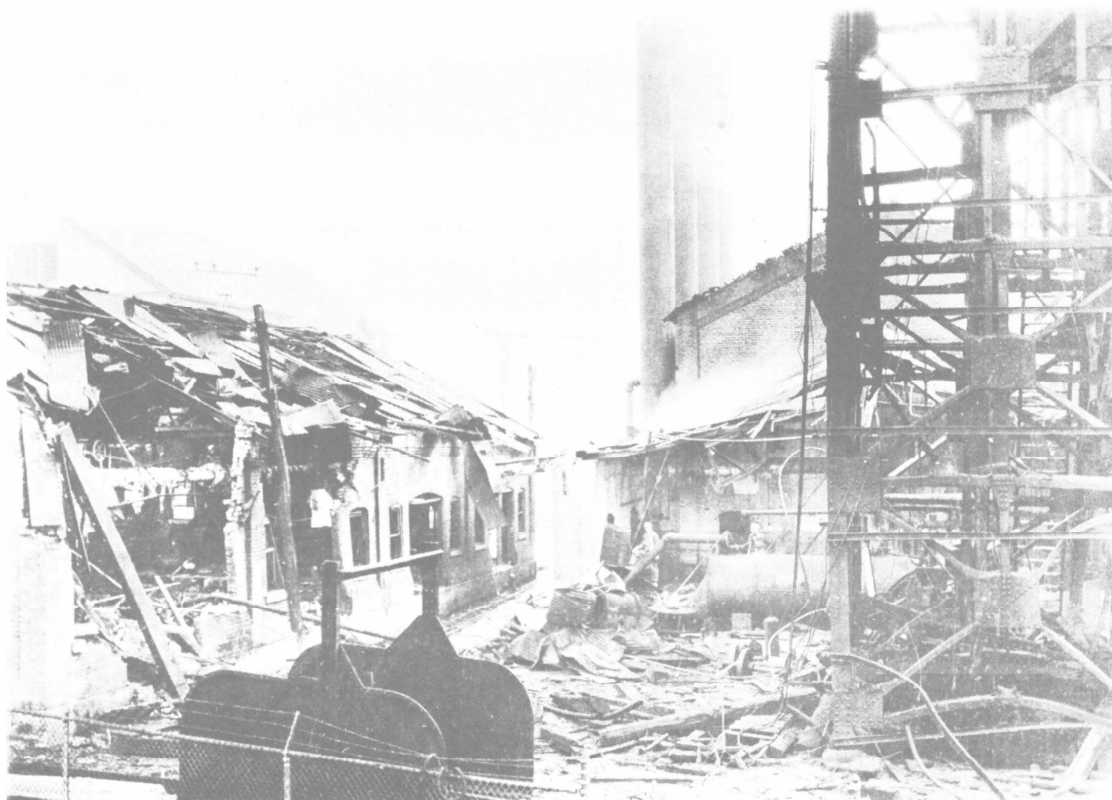
FIGURE 69.—Surface destruction by explosion, Barrackville, W. Va., March 17, 1925.

All recovery work except fire fighting was in fresh air. The explosion was not violent, and the destruction of the shaft timbering was due to its badly decayed condition. The origin was a room face where gas was lit by an open light. Gas had been coming in large quantities from roof cracks in this section. Dry coal dust entered into the explosion, but the low violence and the mixture of fine shale dust from the roof prevented a more widespread explosion. Had the men stayed in their places, many would have been saved.

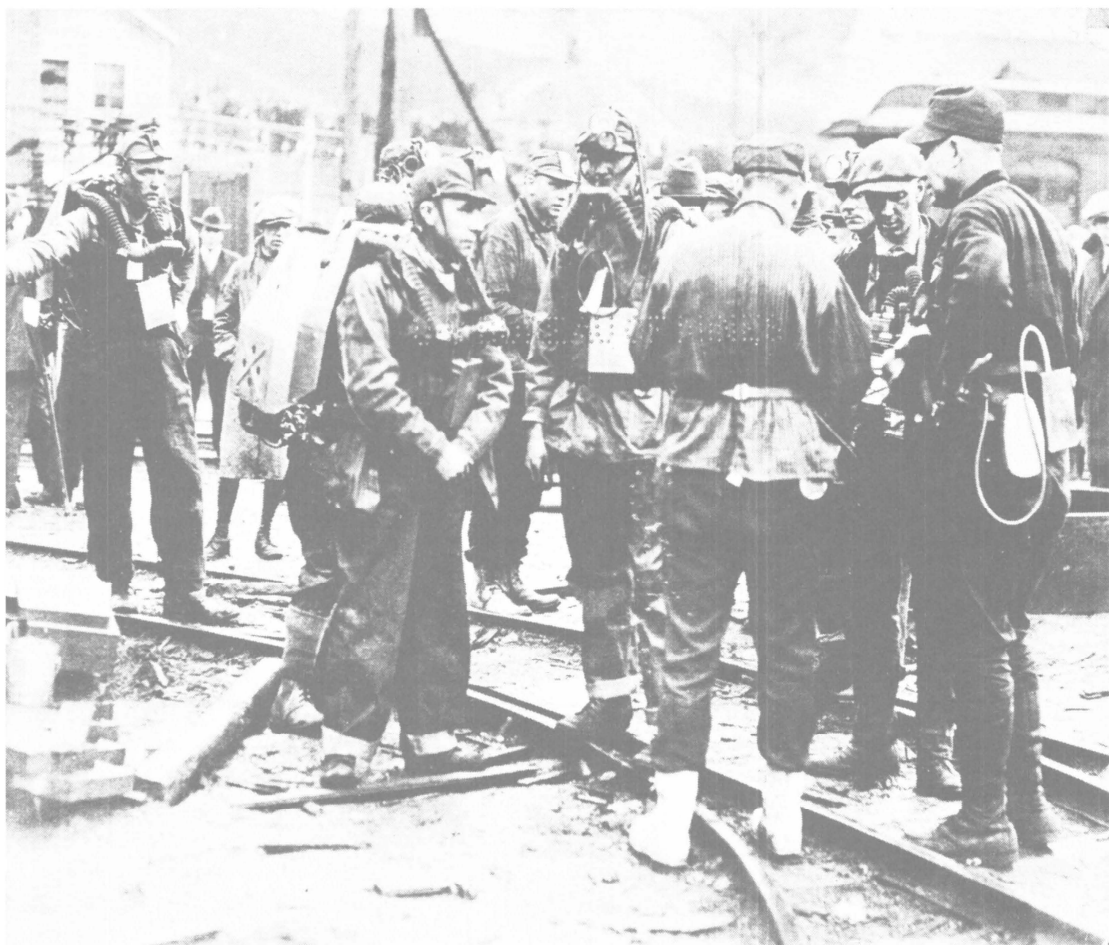
FIGURE 70.—Apparatus crew and advance workers being checked in at Barrackville mine, March 1925.
