UNITED STATES
DEPARTMENT OF THE INTERIOR
BUREAU OF MINES

REPORT OF MAJOR MINE INUNDATION DISASTER
RIVER SLOPE MINE
MAY SHAFT SECTION, SCHOOLEY COLLIERY
KNOX COAL COMPANY, INCORPORATED
PORT GRIFFITH, LUZERNE COUNTY, PENNSYLVANIA
(Post Office - Pittston, Luzerne County, Pennsylvania)

January 22, 1959

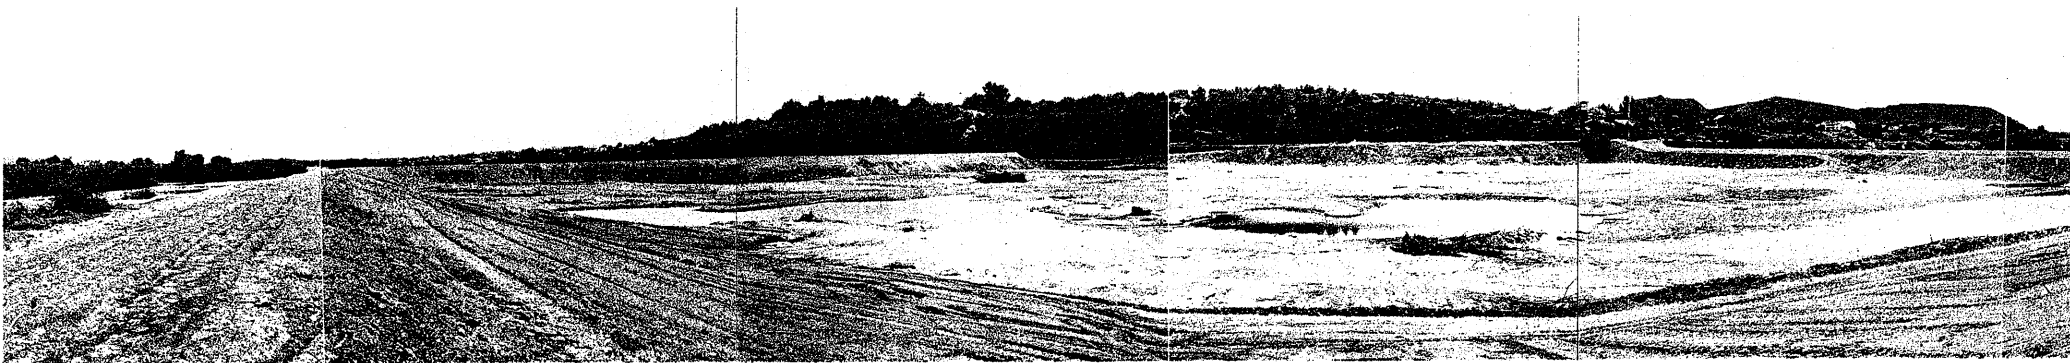
FIGURE 13. - Upstream, Downstream, and Southeast Sides of Cofferdam, and River Slope Tipple.

The No. 1 Contracting Company of Pagnotti Interests erected a cofferdam, installed bulkheads underground, and drilled boreholes from the surface into areas within the bulkheads; the Santarelli Vibrated Block Company poured the concrete. This work provided the seal under and adjacent to the river in the involved break-in area.

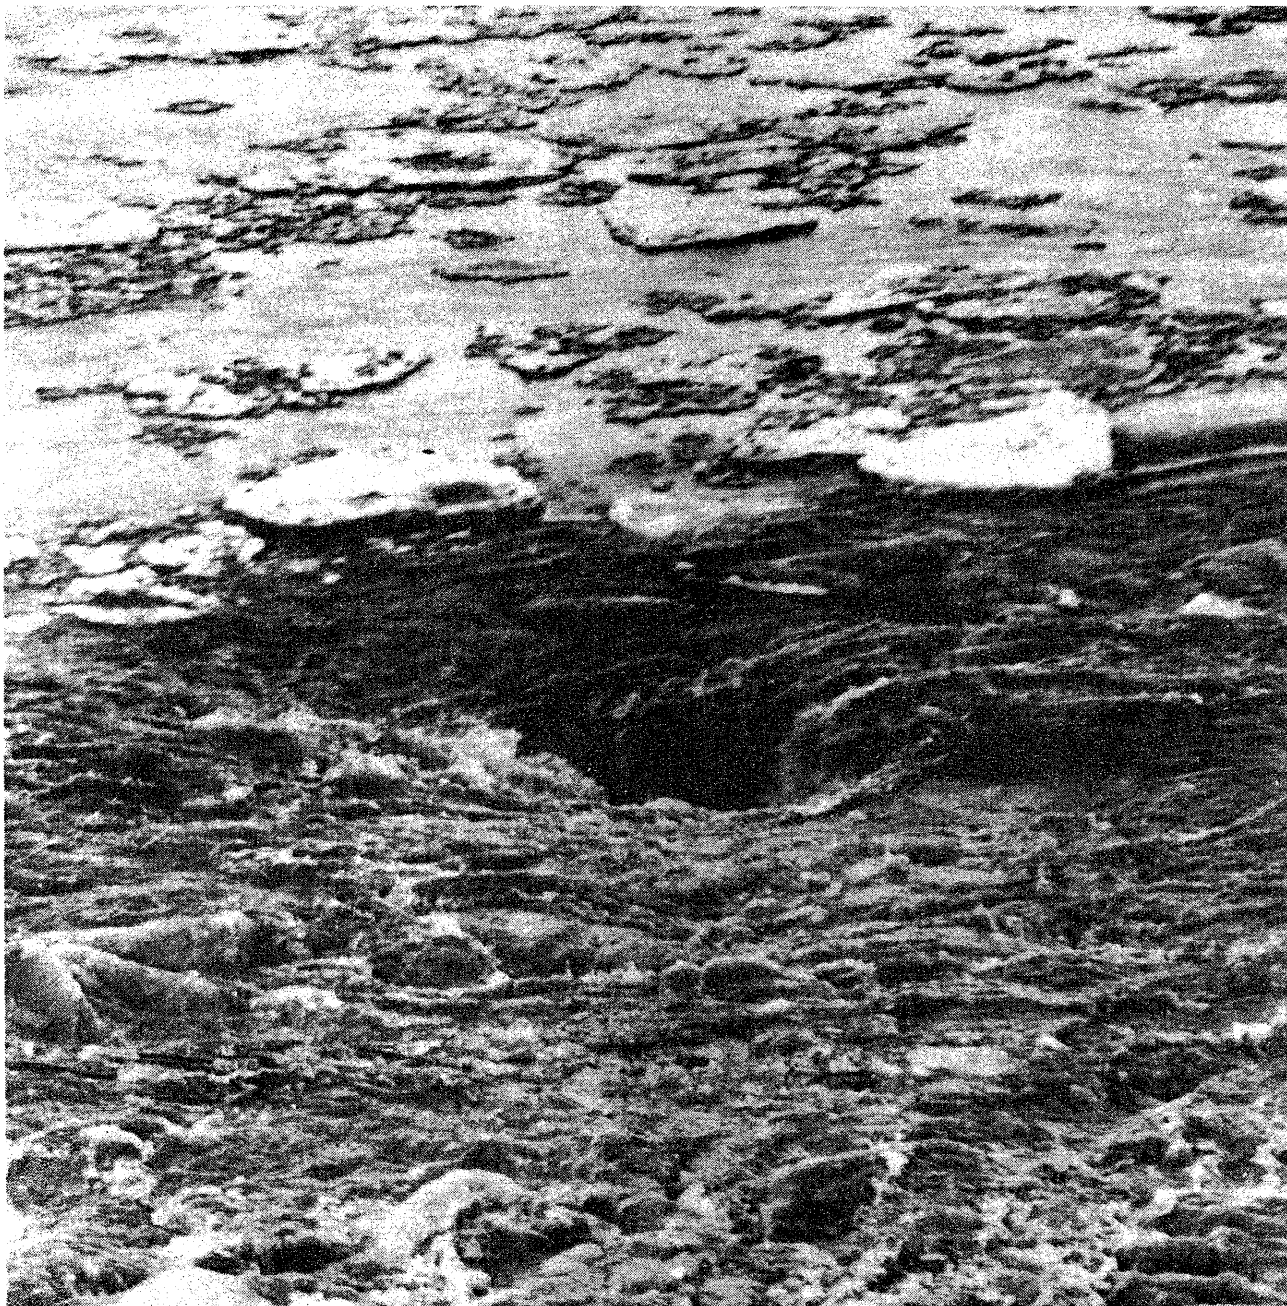
FIGURE 1. - Swirling Water and Ice Entering Break-In to Mine Workings.

Participating Organizations: The main opening of the break-in was plugged with railroad gondolas, mine cars, and other various materials through the combined efforts of the officials and workmen of numerous coal companies and contracting firms, both large and small, from Lackawanna and Luzerne Counties, and officials and workmen of the Lehigh Valley Railroad and numerous interested persons on January 25, 1959.

Recovery Operations: Work of blocking the breach was begun soon after it occurred. The westbound track of the Lehigh Valley Railroad was broken and diverted toward the area of the break-in. Railroad gondolas, small mine cars, bales of excelsior, and other available materials were dumped into the opening. Heavy equipment, such as autotrucks, bulldozers, and cranes were placed in operation on January 23, 1959, the morning following the break-in, and large boulders were dumped and pushed into the opening along with the other materials. This work continued around-the-clock, and on January 25 the opening was blocked sufficiently to stem the fast inflow of water to a much lesser degree. Following this lessening of inflow, the break-in area was surrounded with a semi-circle of large rocks and earth materials having a radius extending into the river about 185 feet and on a level with the railroad bed. This work lessened the inflow of water further, but an estimated 20,000 g.p.m. of water was still inflowing, as indicated in appendix F, figure 5, which was photographed where water was flowing from the Pittston vein to the underlying Marcy vein on March 23, 1959.

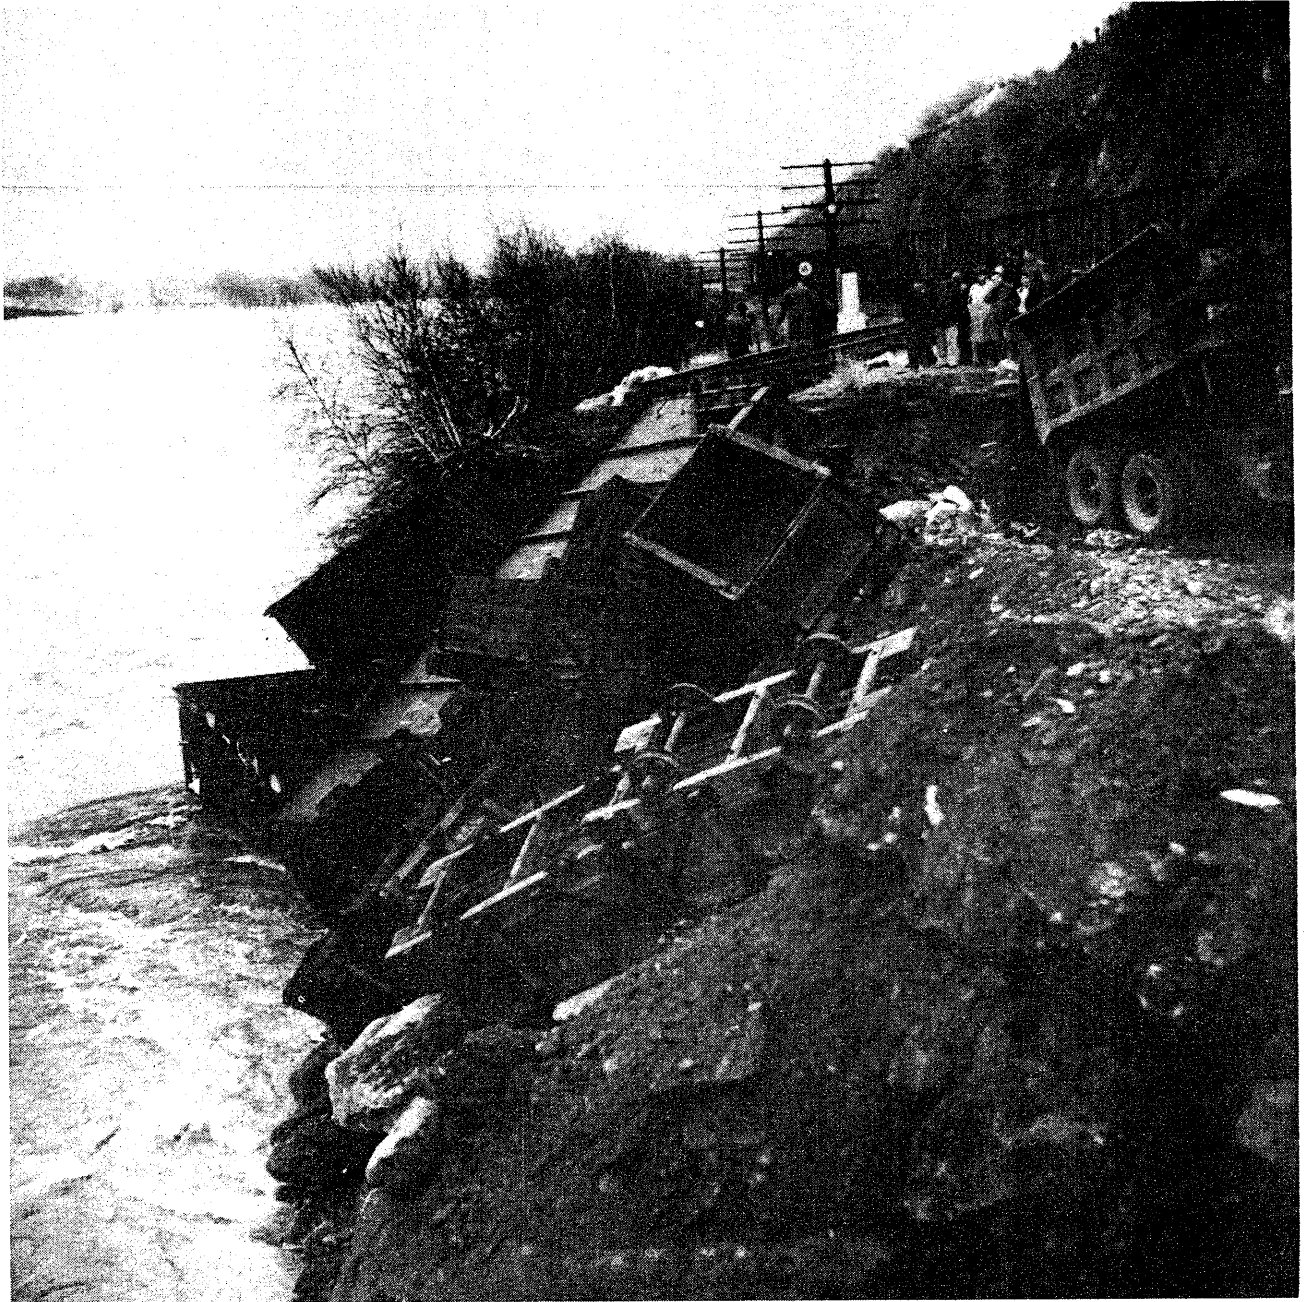
FIGURE 2. - Materials Being Dumped Into River Break-In Area.

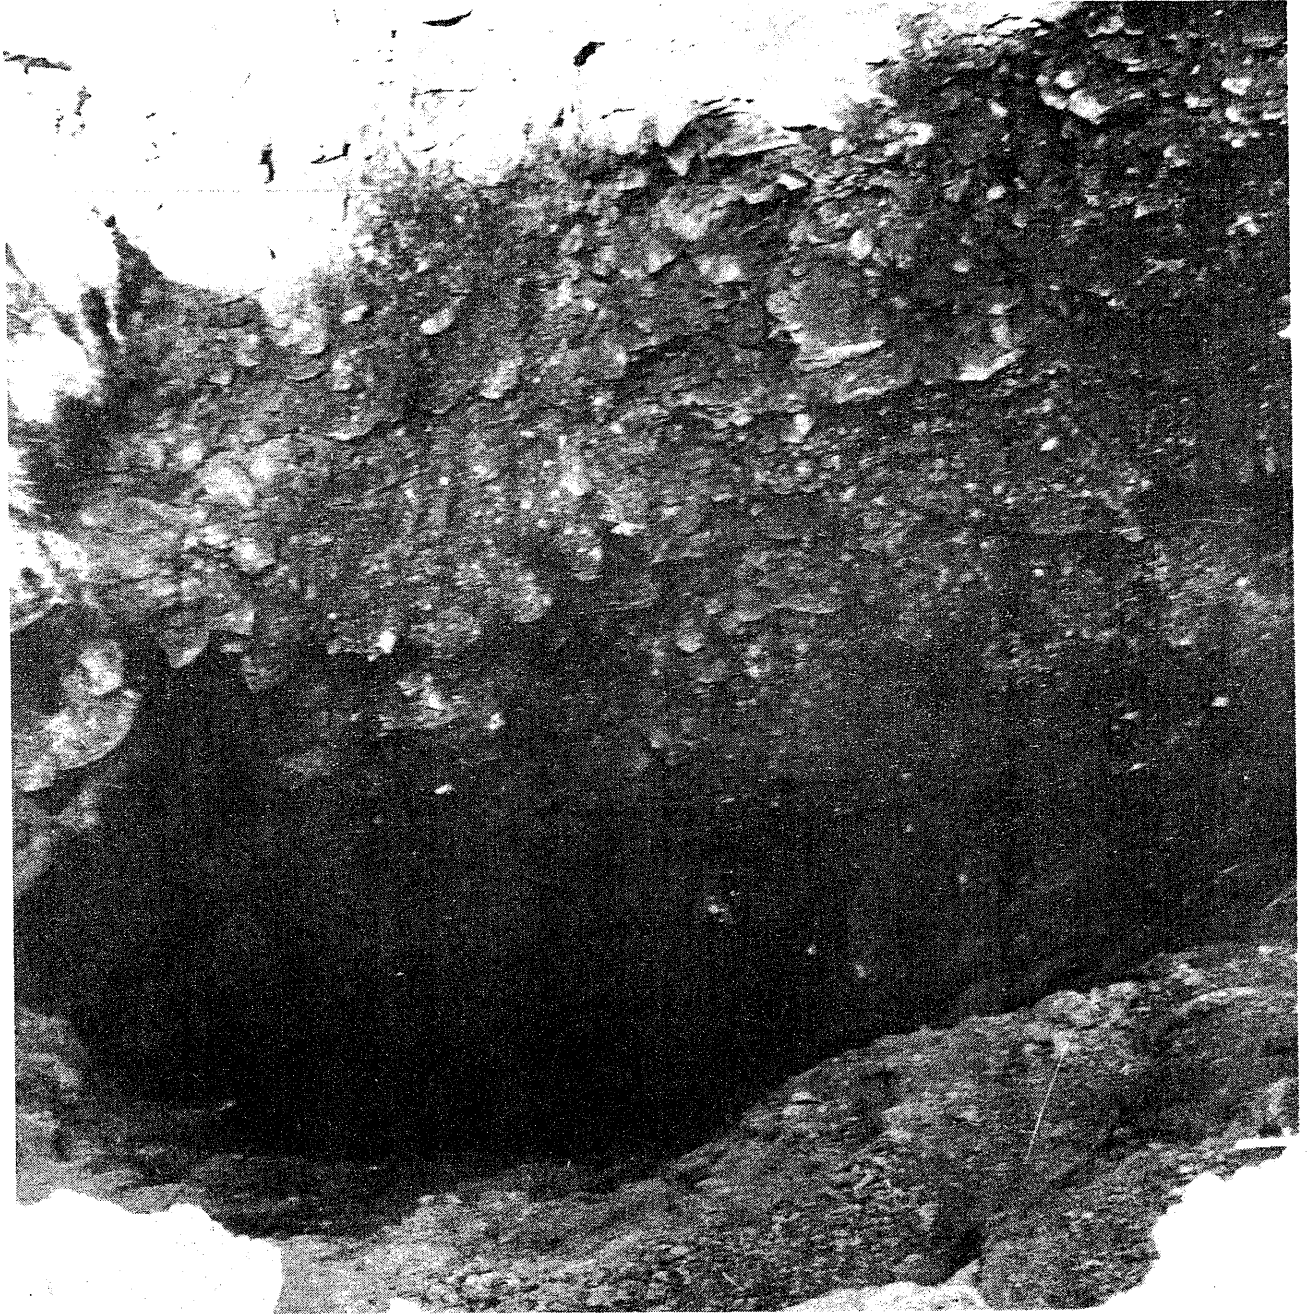
FIGURE 4. - Inside of Pothole That Occurred January 31, 1959, Revealing Thin Rock Strata.

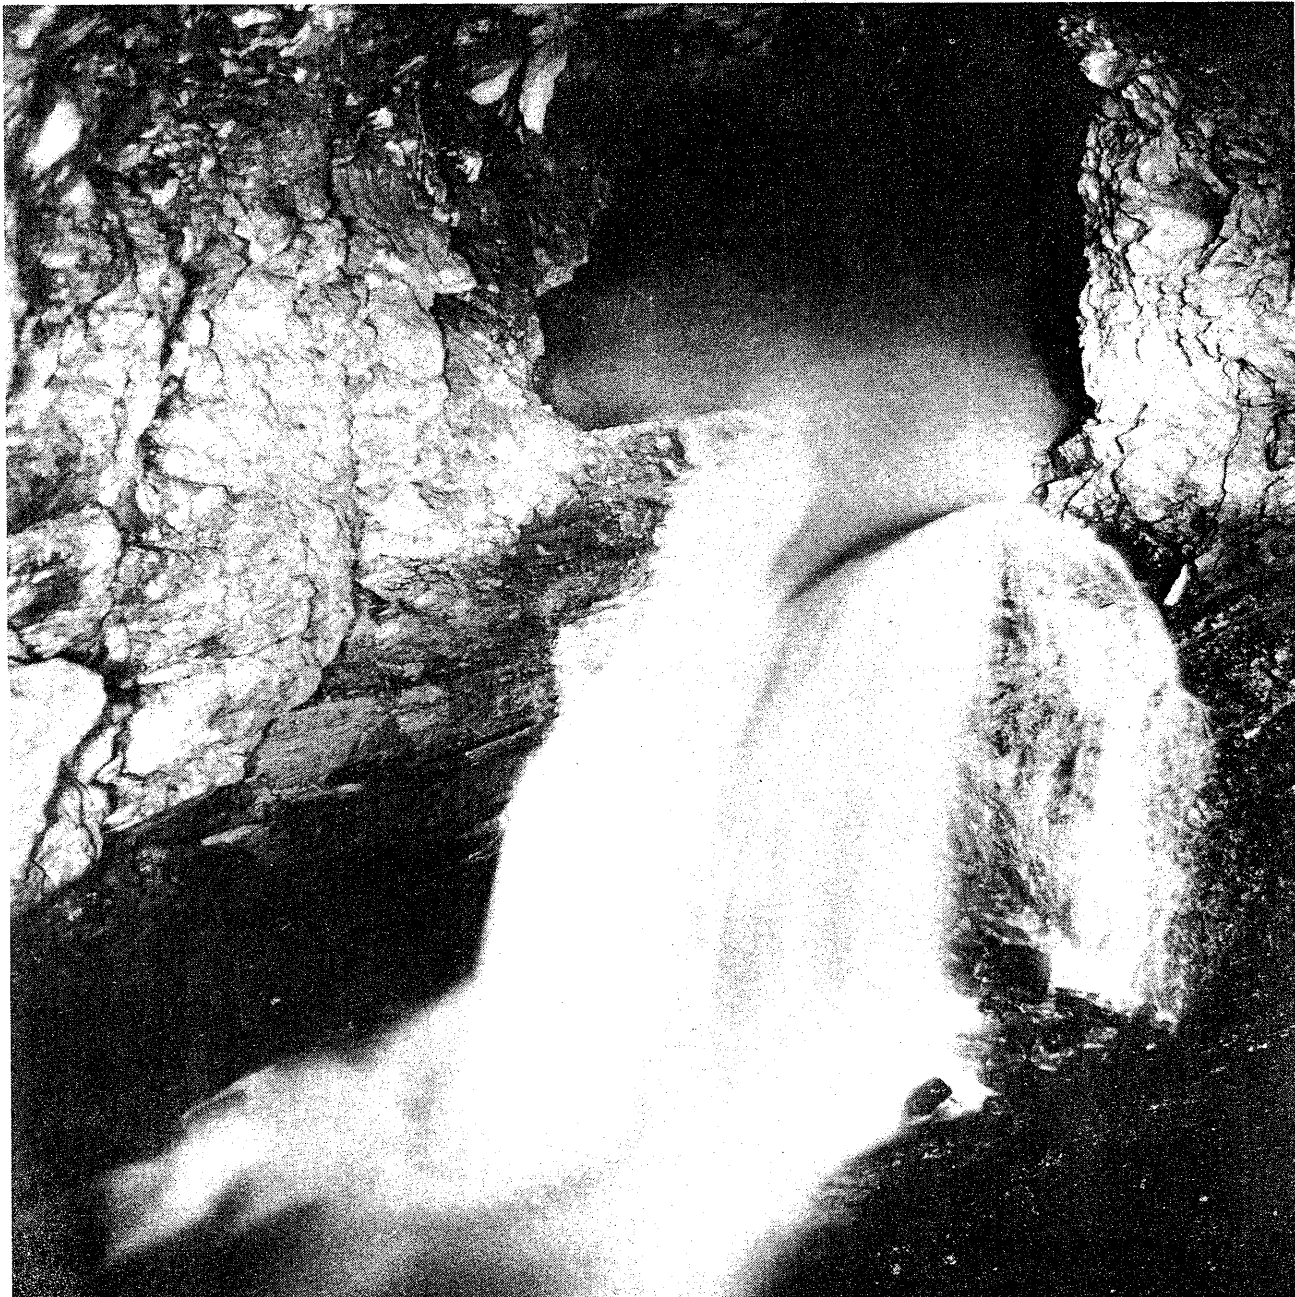
FIGURE 5. - Water Flowing From Pittston Vein to Marcy Vein Along River Slope, on March 23, 1959.

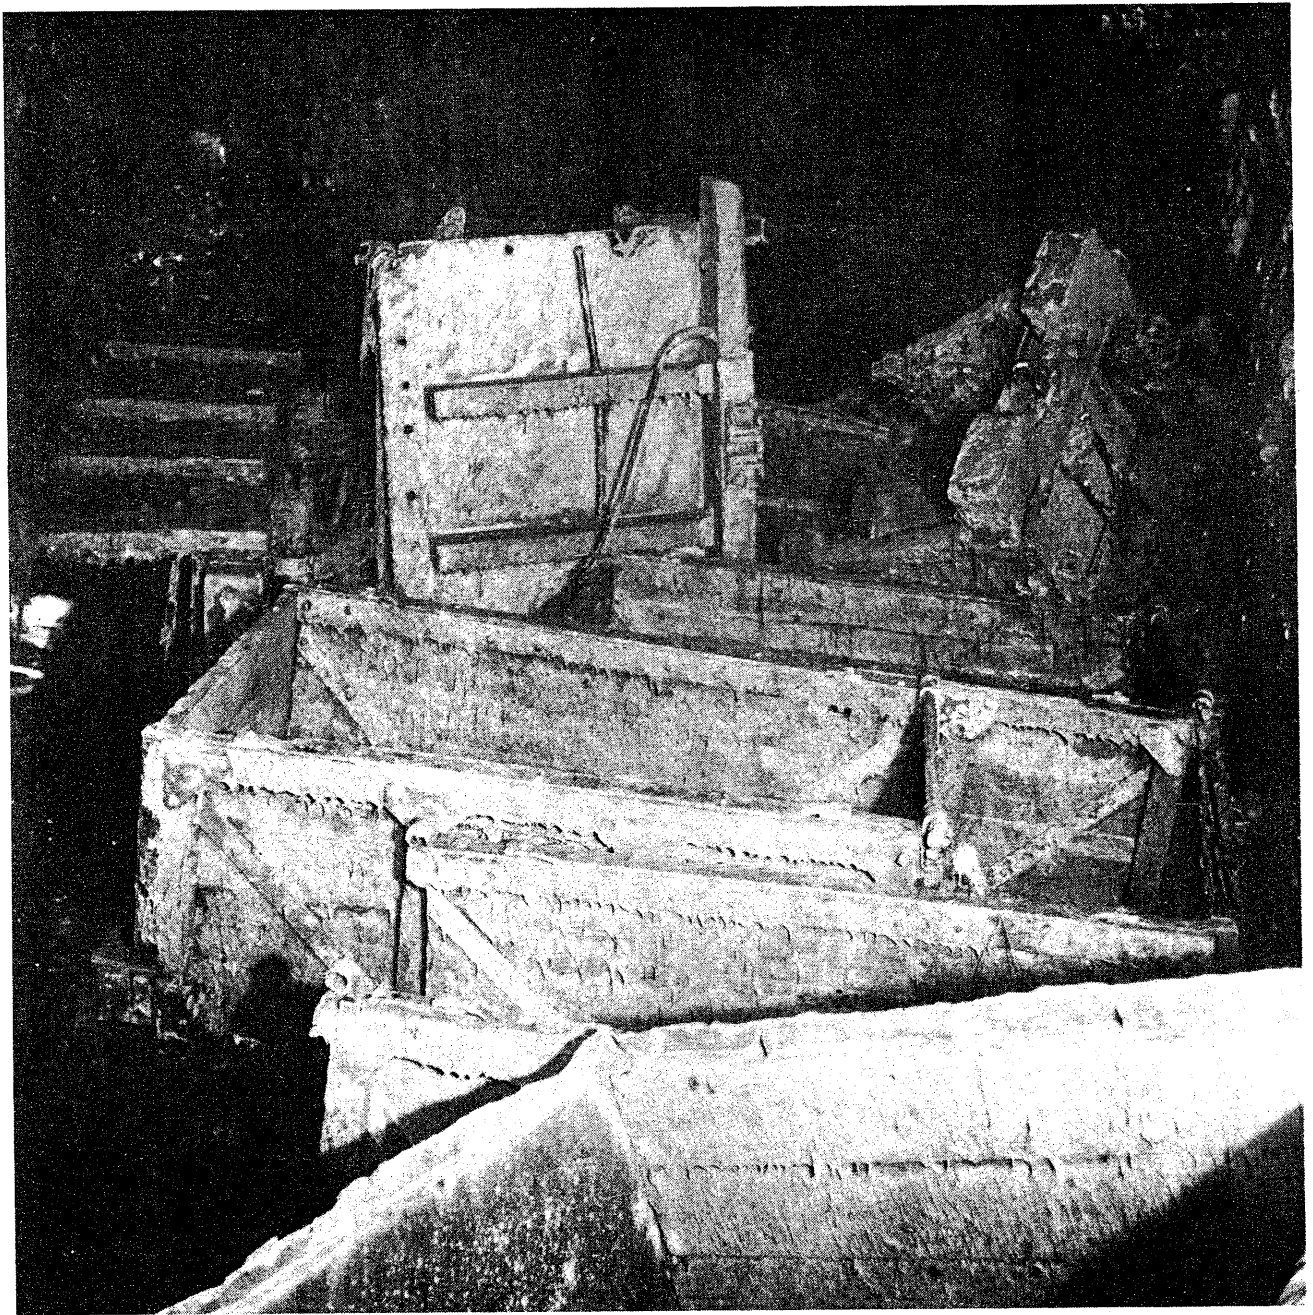
FIGURE 10. - Mine Cars Lodged Along No. 1 Offcourse Chamber About 120 Feet From River Break-In Area.
