UNITED STATES
DEPARTMENT OF THE INTERIOR
BUREAU OF MINES

FINAL REPORT OF MAJOR MINE EXPLOSION DISASTER
MARIANNA NO. 58 MINE
BETHLEHEM MINES CORPORATION
MARIANNA, WASHINGTON COUNTY, PENNSYLVANIA

September 23, 1957

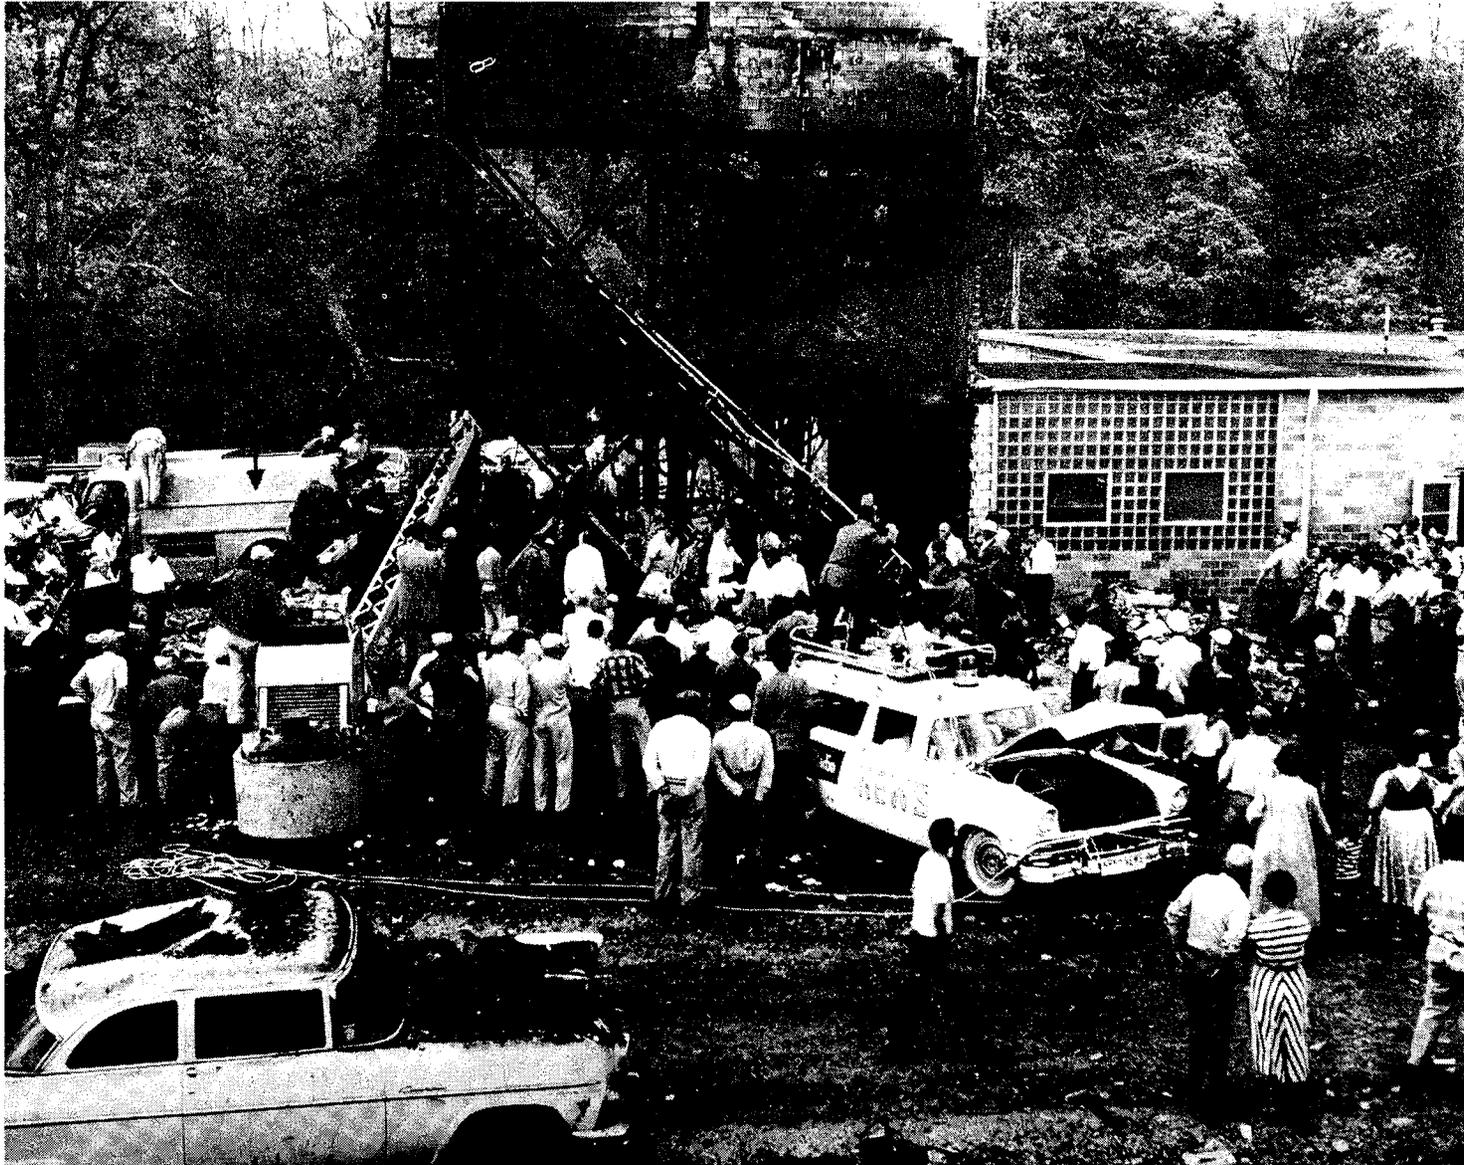
Figure 1. - Photo shows some of the damage done to the headframe at the Moore shaft portal by the explosion forces. The arrow designates the truck equipped with winch and A-frame boom that was used in the emergency rescue hoisting and lowering operations.

A map showing the probable point of origin, the direction and area of forces, and the extent of flame is shown in this report as Appendix D. Some surface structure damage at the Moore shaft of this mine is shown in figure 1.

The shaft had been completed and a modern automatic elevator had been installed about 4 months prior to the explosion. The elevator was destroyed, as was a portion of the structure above the shaft. See figure 1. The elevator was so controlled that it automatically returned to the surface when not in use to prevent moisture from damaging the controls. When the explosion occurred, the elevator was at the top of the shaft, and forces developed by the explosion projected it into the headframe above the shaft collar.

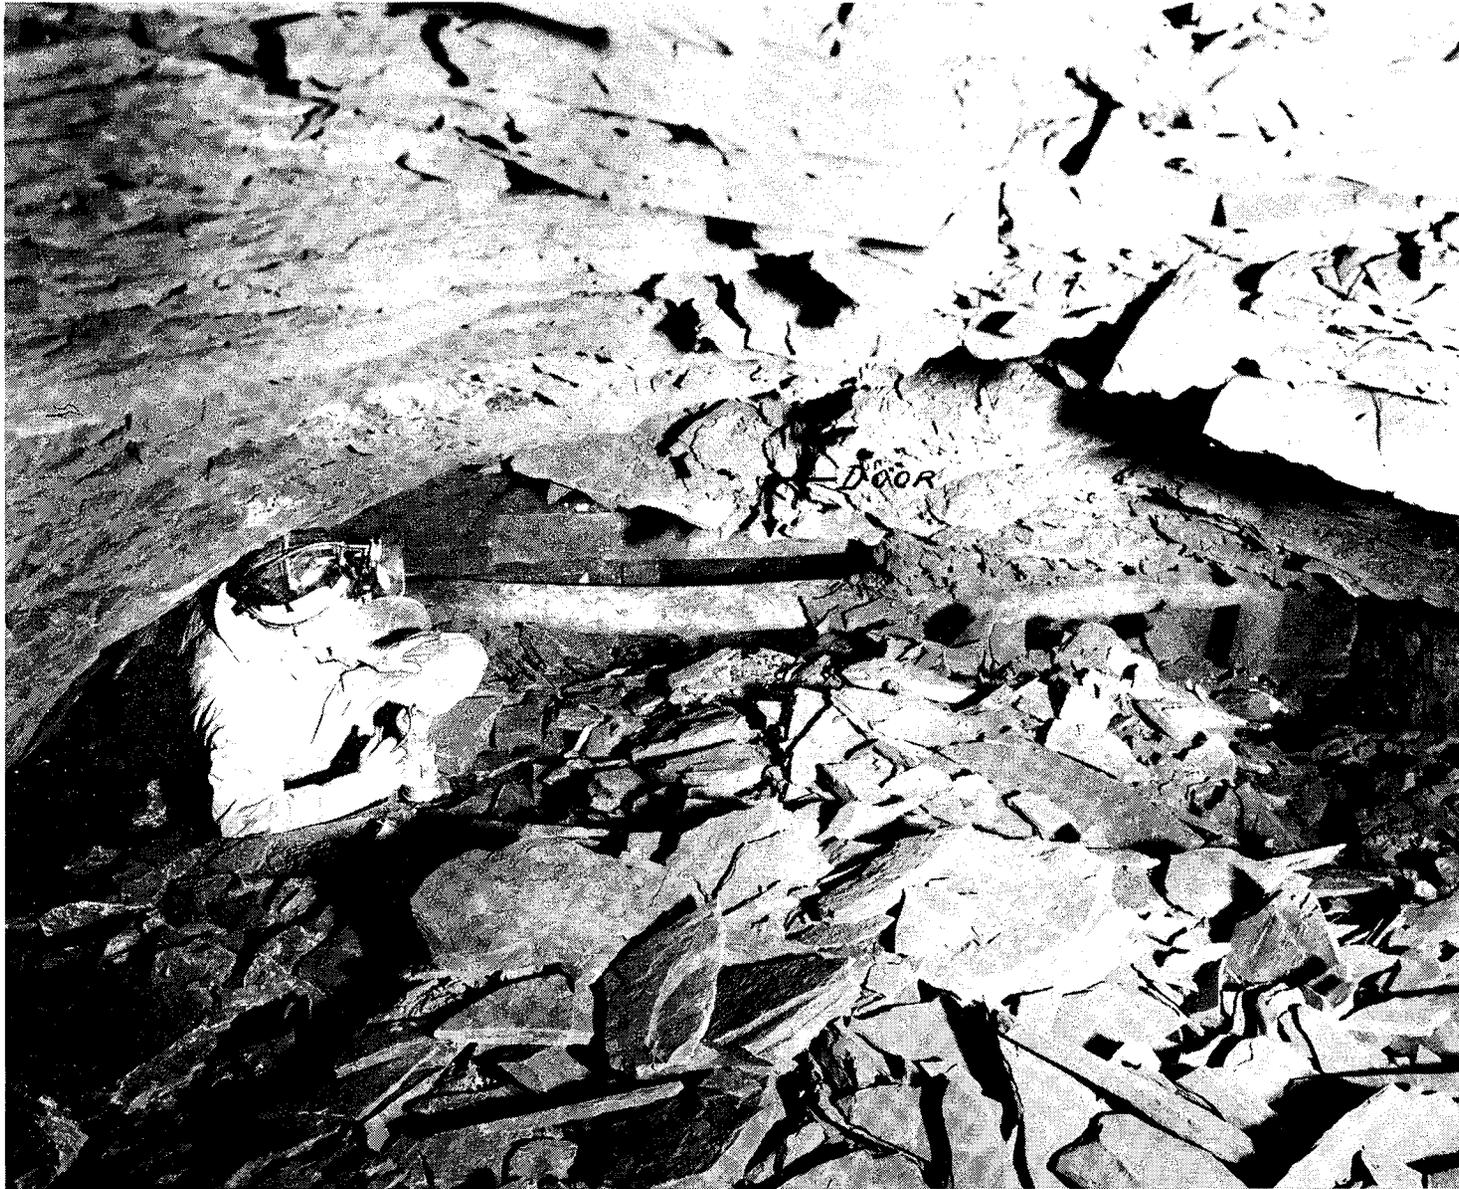
Figure 3. - Hinged inspection door in stopping between No. 6 and 7 entries showing heavy roof fall near the door.

The investigation also revealed two possible sources for this gas to reach the 30 mains haulageway near C face west. First, a top-hinged inspection door in a stopping between Nos. 6 and 7 entries may have been partly open as a result of a heavy roof fall near the door, pushing the door partly open (figure 3); or with the airflow being reversed as it was prior to the explosion, the door may have been opened by the ventilating pressure differential. Secondly, a block or blocks had been removed from the next outby stopping to ventilate a former compressor station, and testimony indicated that these had not been replaced, thus affording an escapeway for the gas from the return airways onto 30 mains haulage road between the two angle chutes connecting it with C face west.
