Reports

Delagua Mine

An Account of the Conditions Existing at the Mine before and after the Explosion

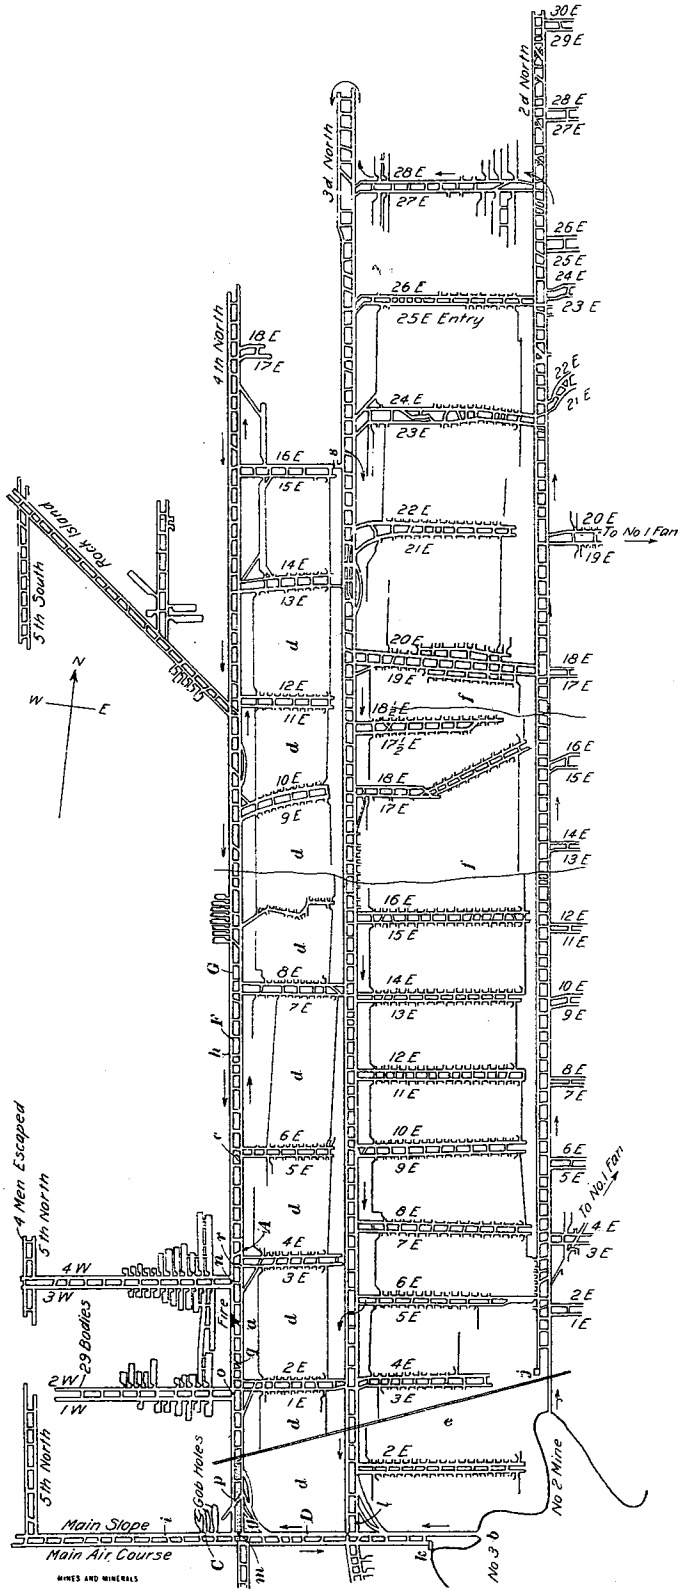
FIG. 1

A = slate forced into inby side of cap.
n = door blown outby.
C = slate forced into outby side of cap.
D = slate forced into inby side of cap.
l = door blown inby.
F = slate forced into outby side of cap.
G = slate forced into outby side of cap.

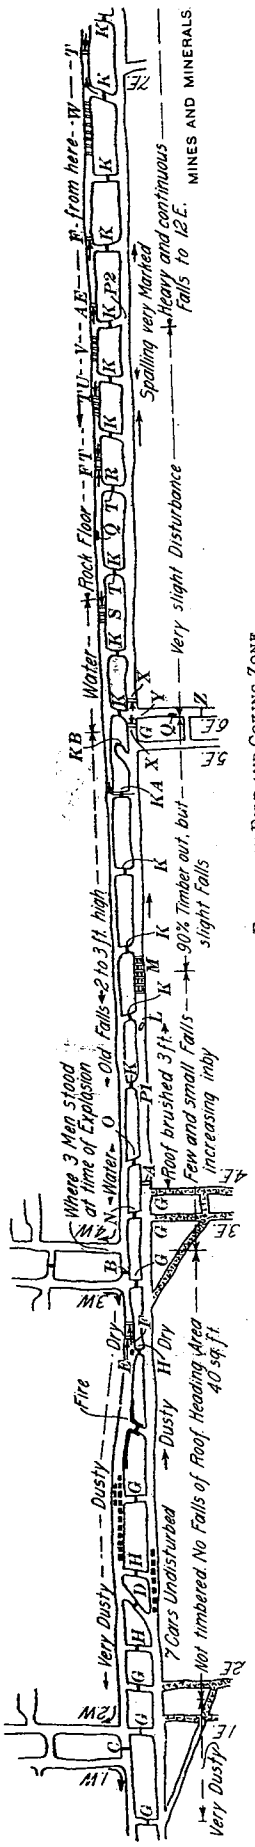
FIG. 2. ENLARGED SECTION OF ENTRIES AT FIRE AND COKING ZONE

A, slate forced into cap; *B*, door blown outby; *C*, curtain, unharmed; *D*, first west haulage door, slightly bulged into back heading; *E*, heavy coke on outby side; *F*, light coke on outby side; *G*, gobbed snut, not damaged; *H*, Bulged in toward back heading but not broken; *K*, entirely destroyed, blown into back heading; *L*, timber fallen outby; *M*, undisturbed timbering; *N*, brattice through which men escaped; *O*, upper ½ apparently out before fire; *P1*, electric pump not harmed but rheostat blown into back heading; *Q*, coke on rib 40 feet inby; *R*, the only stopping blown into haulage road; *P2*, electric pump blown 3 feet and rheostat 20 feet, very violent action here; *S*, three caps with center posts. Heavy coke on inby side of all members; *T*, coke on inby side; *U*, four sets caps, very heavy coke inby, some little outby; *V*, six caps unharmed; *W*, nine sets timber unharmed; *KA*, used as tool house by men working in 5th west; *KB*, fifth west started since November 1st on night turn; *X*, very heavy dust; *Y*, gob thrown into entry; fall, heavy spalling opposite mouth; curved arrows show direction of throw of heavy materials; small arrows show place of deposit of coke, slate or other materials; *Z*, Brattice blown inby; ‖ caps in place.

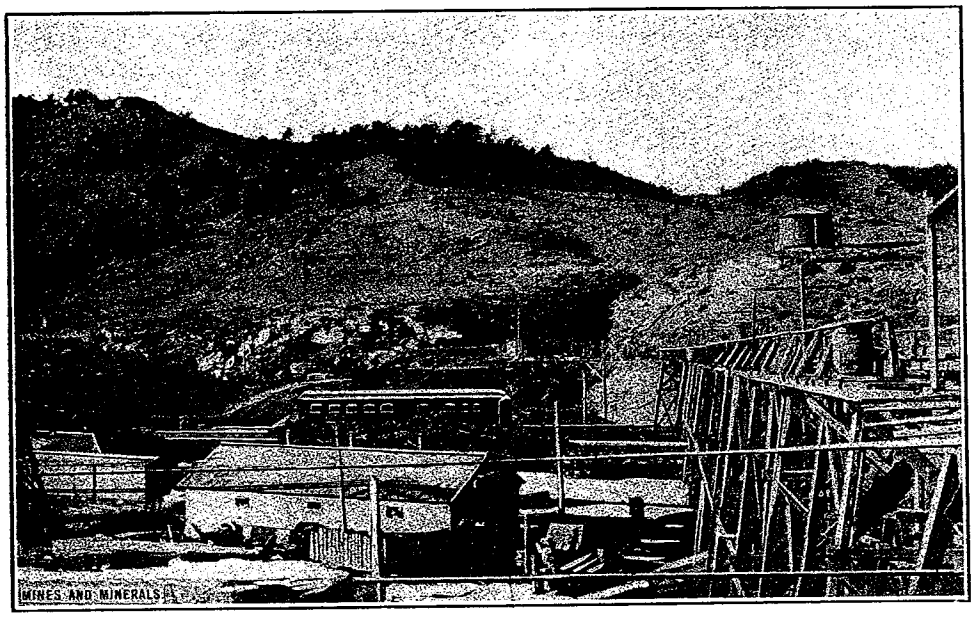
FIG. 3. DELAGUA NO. 3 MINE, SHOWING U. S. RESCUE MINE CAR, TEMPORARY TIPPLE, AND WATER TANK TO RIGHT OF DRIFT MOUTH
