FINAL REPORT OF MAJOR MINE-EXPLOSION DISASTER  
CANE CREEK MINE, POTASH DIVISION  
TEXAS GULF SULPHUR COMPANY  
GRAND COUNTY, UTAH  
(Mine development under contract with  
HARRISON INTERNATIONAL, INCORPORATED)

August 27, 1963

#### INTRODUCTION

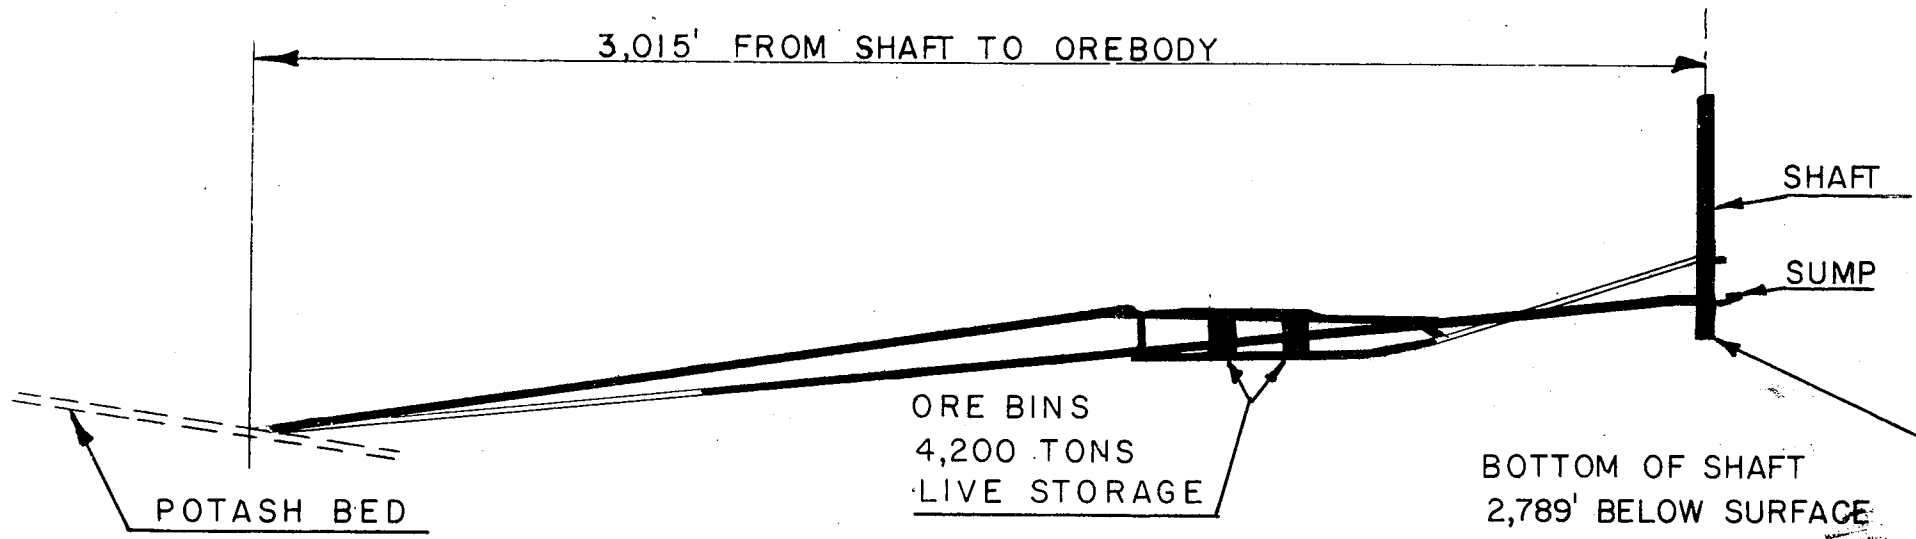
Appendix J  
CANE CREEK MINE  
TEXAS GULF SULPHUR COMPANY

VERTICAL SECTION

- 40 HP fan, moved about 100'
- Cap lamp, broken
- Cigarette butt
- Load center
- Switch house
- 15 HP fan
- 15 HP fan and vent tube

- Explosives and detonators scattered
- Vent line badly damaged and stacked up here
- Detonator storage, detonators scattered
- Extraneous materials, roof bolts etc. here

Loose detonators

Vent line damaged extensively

Vent line bowed but not broken

2 cases deteriorated explosives  
 2 bags AN/FO  
 5 cases of explosives  
 Empty matchbook

2 loose detonators, 2 cans of cutter bits  
 Third barricade (tight)  
 Second barricade (gap on right rib)

- Water line broken by men in barricaded area
- Water manifold with hoses hooked into air line
- Vent line intentionally broken and sealed
