United States
Department of Labor
Mine Safety and Health Administration
Office of the Administrator
Coal Mine Safety and Health

Report of Investigation
Underground Coal Mine Explosion
McClure No. 1 Mine - I.D. No. 44-04251
Clinchfield Coal Company
McClure, Dickenson County, Virginia
June 21, 1983

Originating Office
Mine Safety and Health Administration
4015 Wilson Boulevard
Arlington, Virginia 22203
Joseph A. Lamonica - Administrator

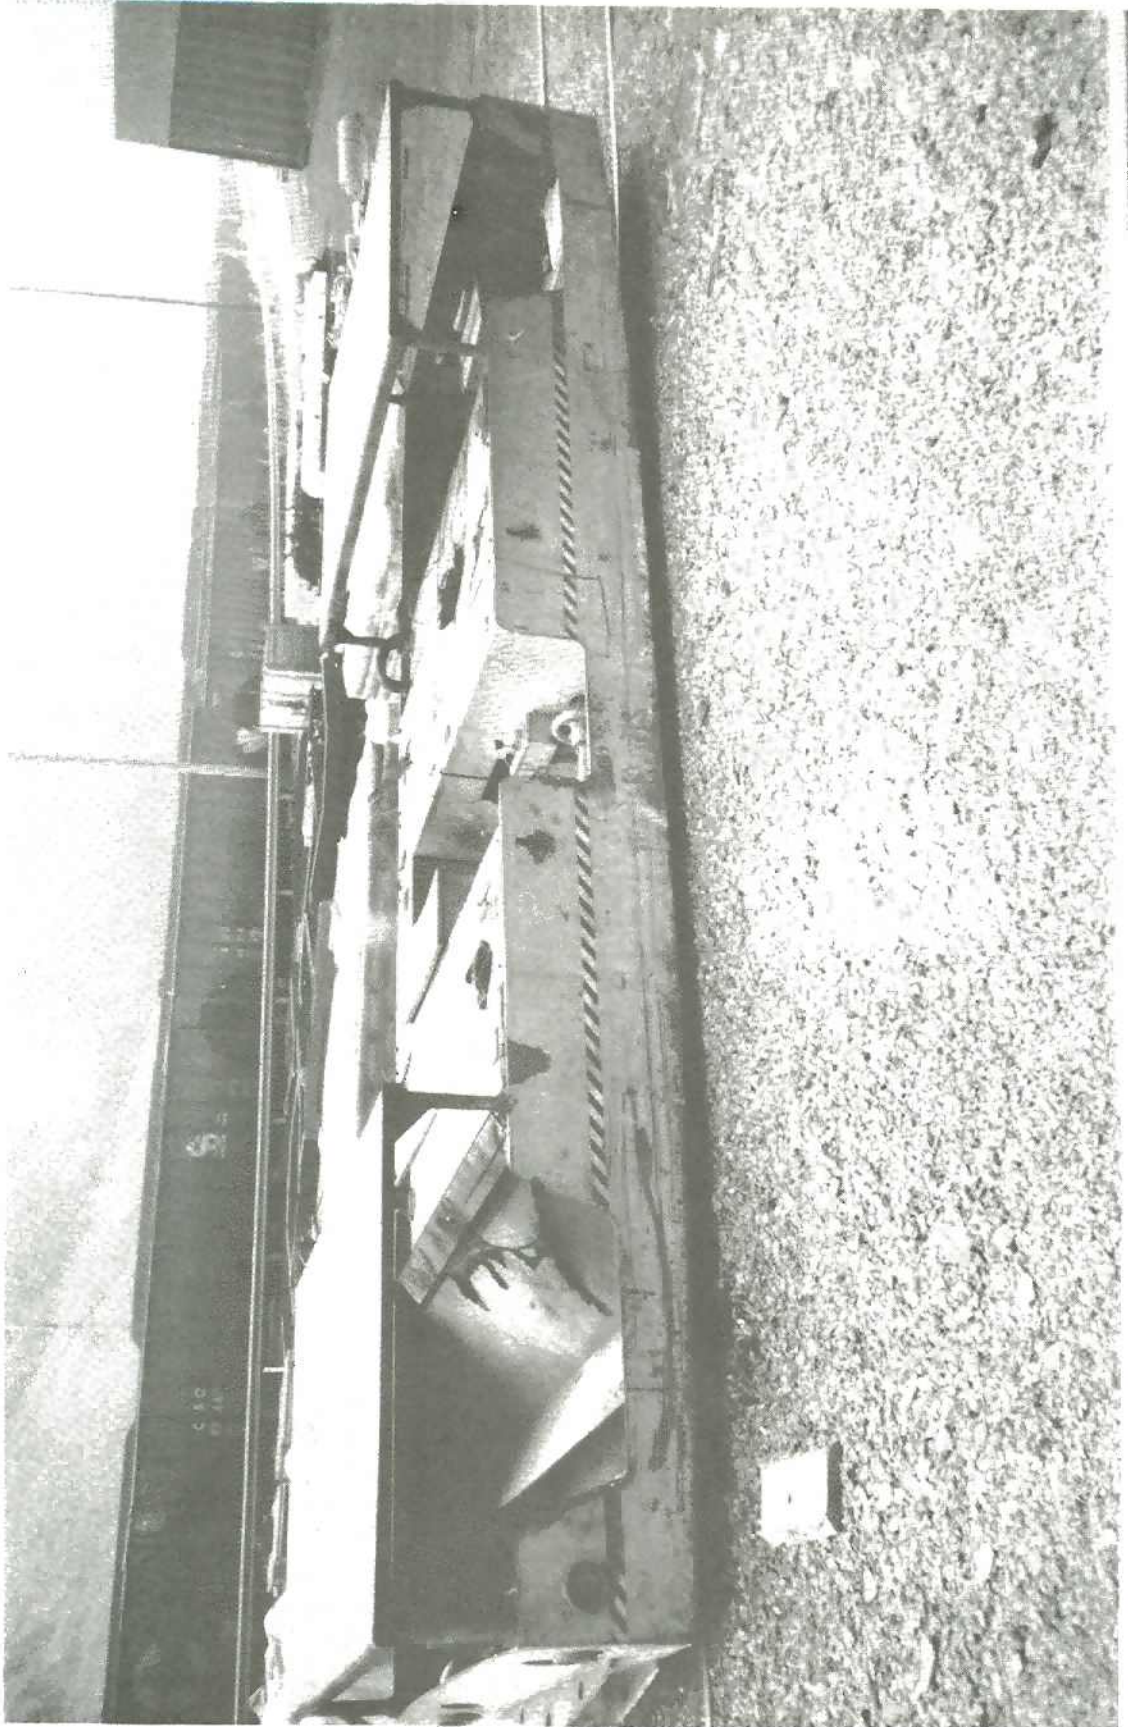
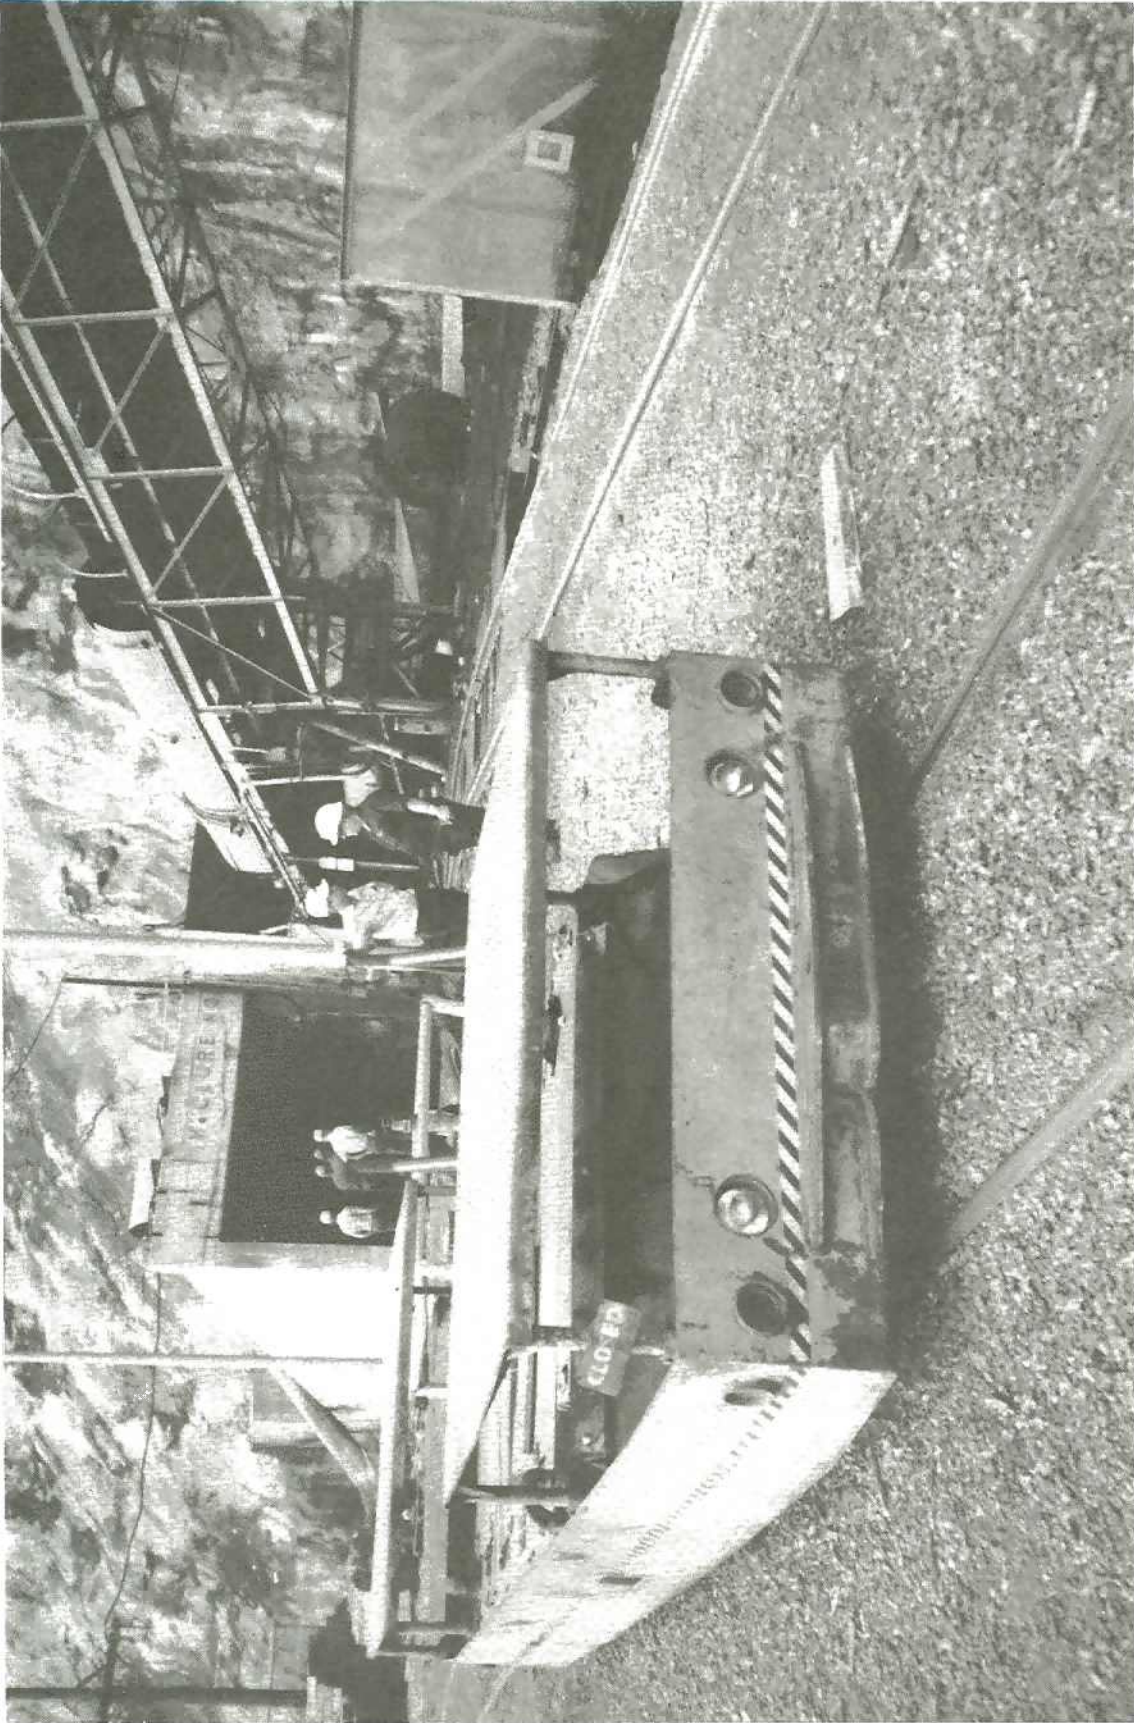
Figure 1: Personnel Carrier, West Virginia Armature Co.
Rail Runner II, Serial Number 200-0668

(shown in Figures 1 and 2). Two victims of the McClure No. 1 Mine explosion (Luther McCoy and Forest Riner) were allegedly riding the personnel carrier in the 2 Left section at the time of the mine explosion on June 21, 1983. Tests were conducted on August 11, 1983 to determine the initial velocity necessary to generate sufficient momentum for the personnel carrier to coast from the location where the bodies of McCoy and Riner were found (near crosscut No. 16) to its final stopping location (near crosscut No. 2).

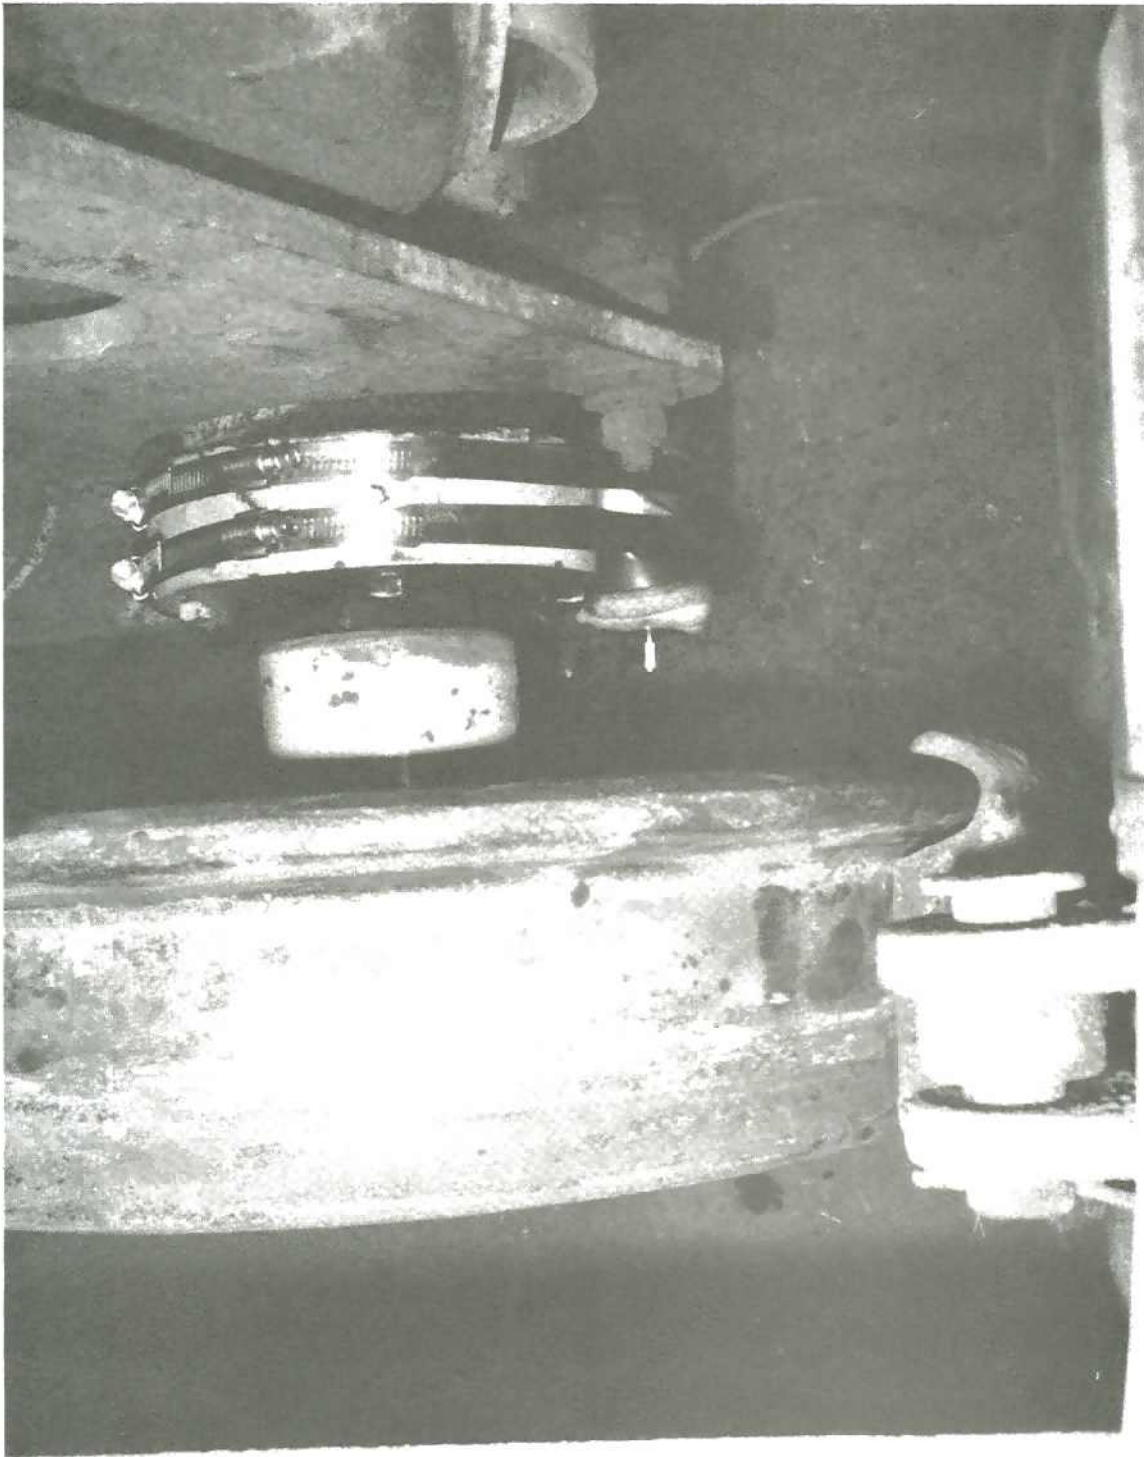
Figure 3: Mounting Position of the Tachometer

A precision tachometer was used to measure the instantaneous velocity of the personnel carrier. The tachometer was strapped to the stationary axle bearing case by adjustable band clamps (Figure 3). Polyurethane foam was inserted between the band clamps and the tachometer to permit mechanical play. The tachometer was mounted in a position that allowed the drive wheel on the tachometer shaft to ride on the rotating personnel carrier axle (Figure 4). The tachometer output voltage was recorded on channel No. 1 of an onboard Brush strip chart recorder.

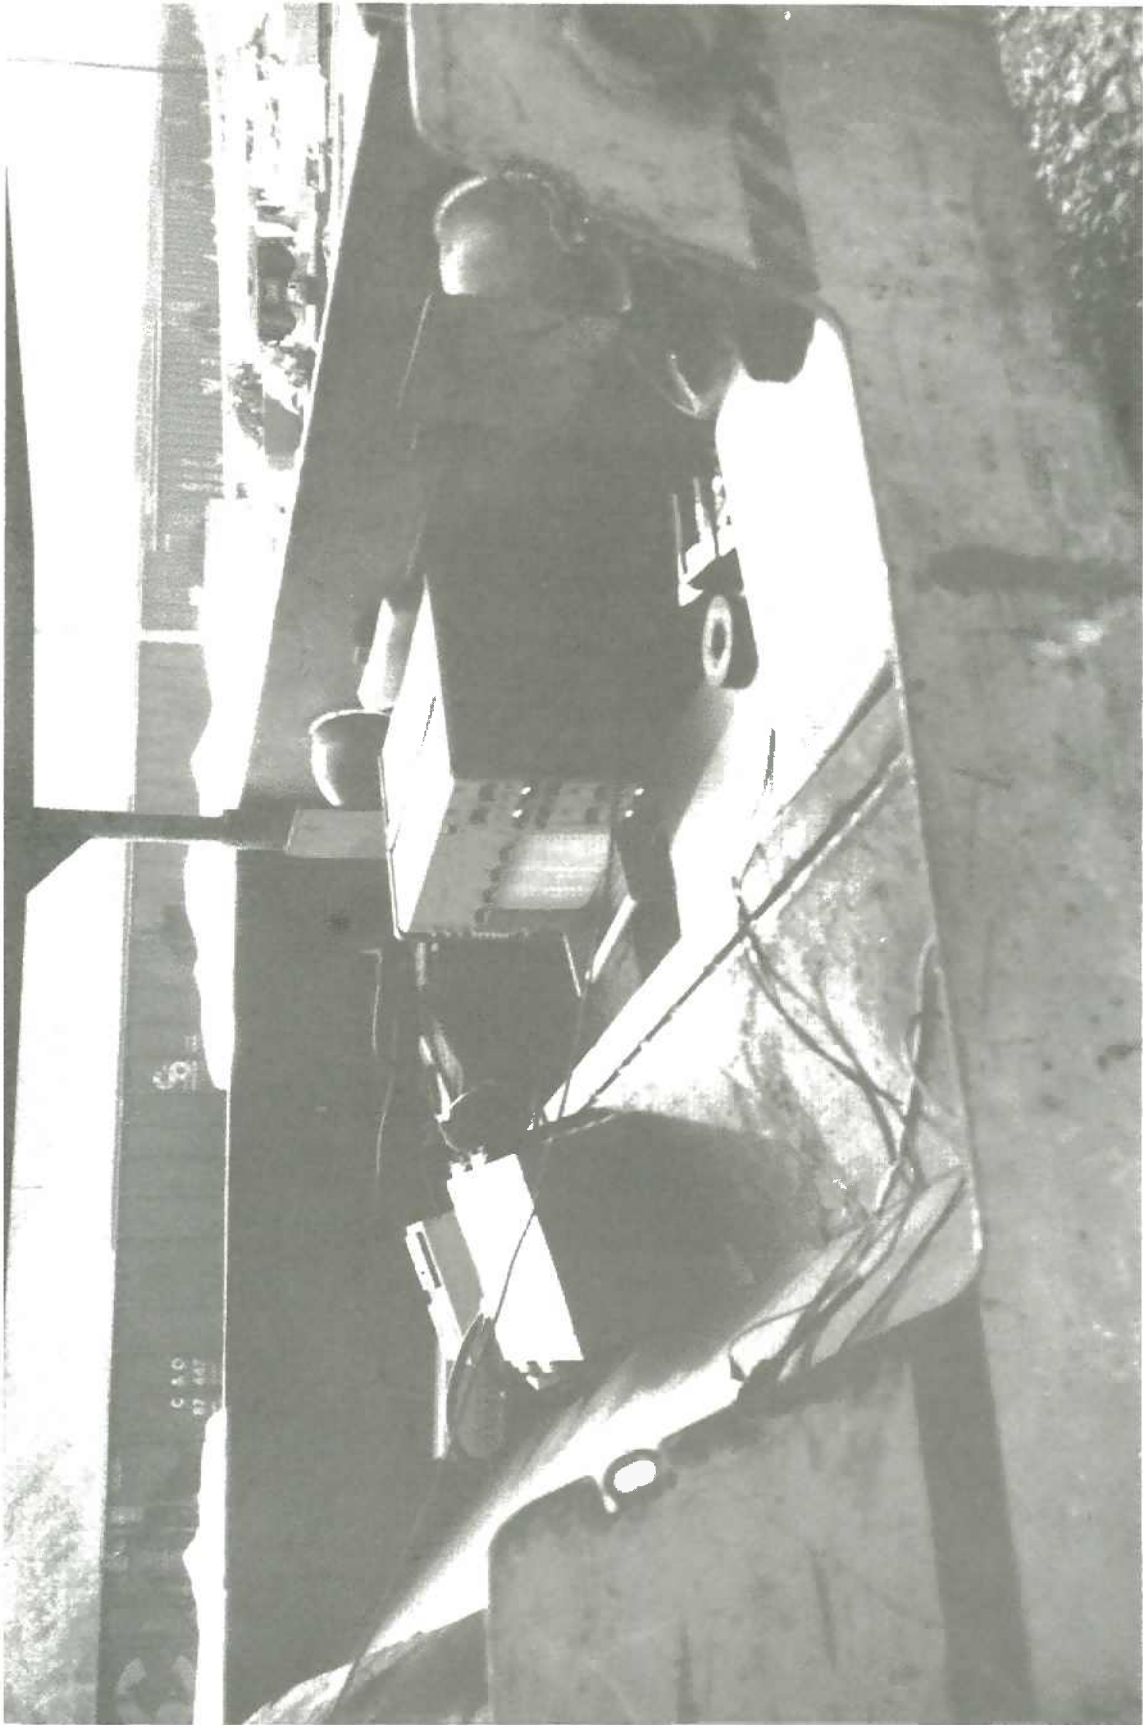
Figure 5: Test Instrumentation

Thus the run and neutral positions of the control handle are indicated on the chart recorder by zero and 120 Vdc respectively. The onboard four channel Brush recorder was energized by a battery powered 12 Vdc/120 Vac inverter (Figure 5).

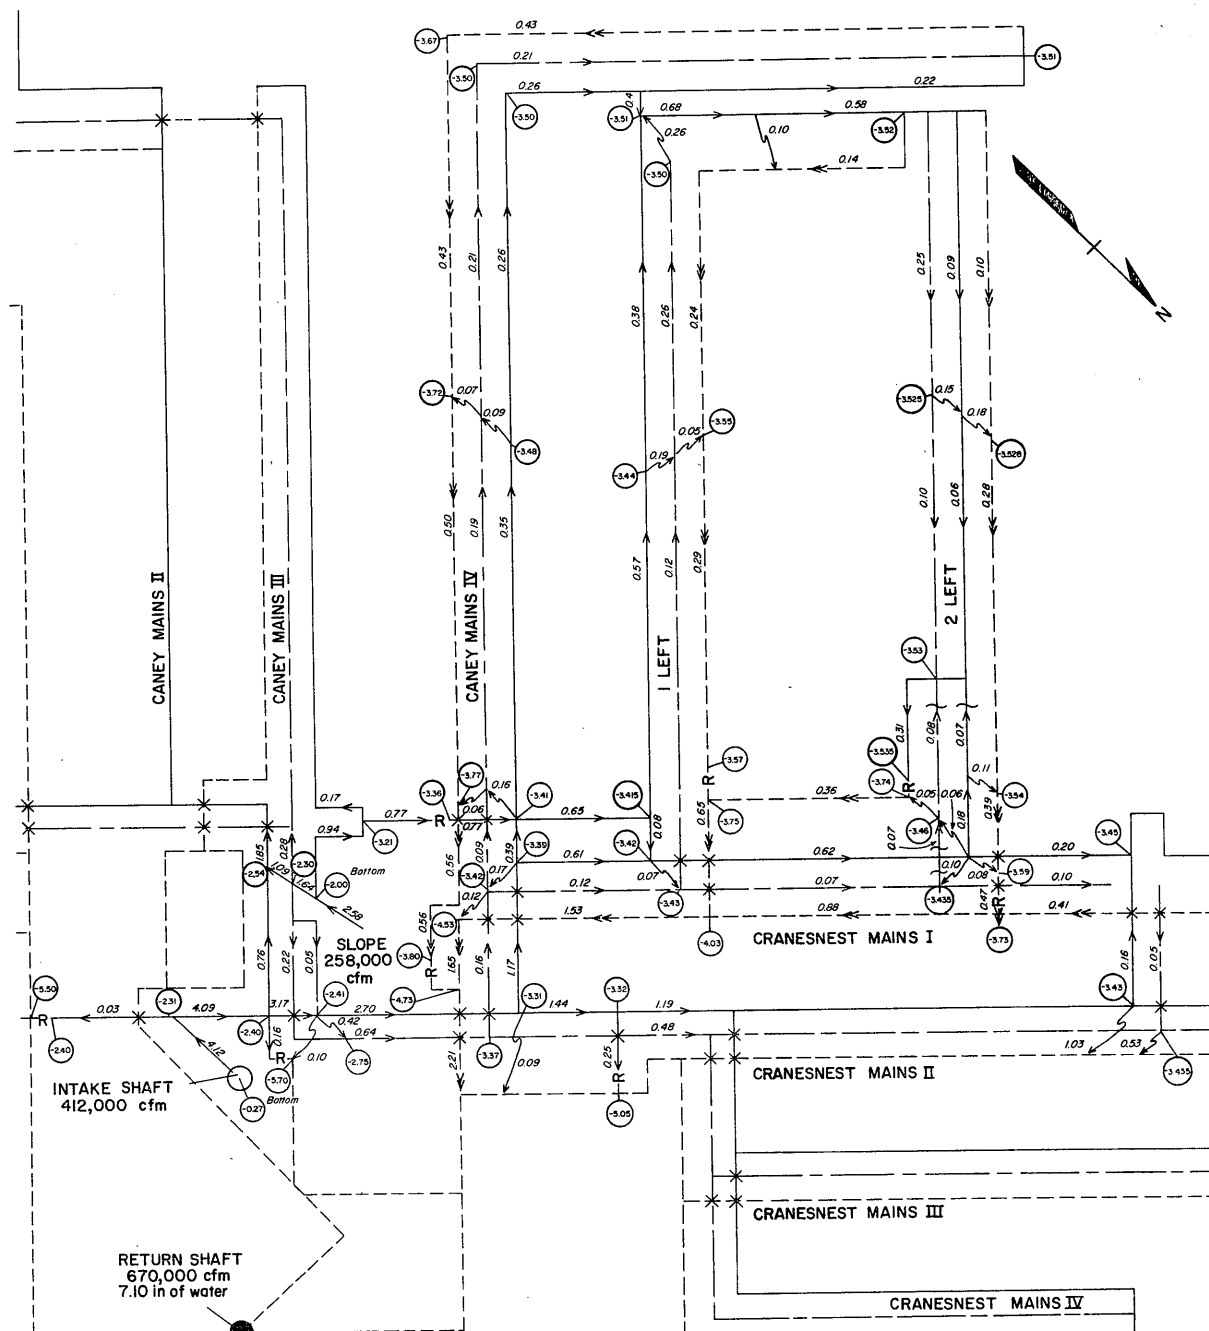
FIGURE 2
 McClure No. 1 Mine
 Mine ID 44-04251
 Clinchfield Coal Company
 McClure, Dickenson County, Virginia
 Jawbone coalbed
 DOL - MSHA - PHTC - VENT. DIV.
 4800 Forbes Ave., Pittsburgh, PA
 Date - July 11-16, 1983
 Not to scale

Figure 2 is a ventilation schematic illustrating mine airflow direction and quantity for the portion of the mine surveyed. Also shown are the ventilation pressures (inches of water) at various locations throughout the mine. The indicated air quantities have been divided by 100,000 (100,000 cfm is shown as 1.00) and are balanced and suitable for computer simulation of the ventilation system.

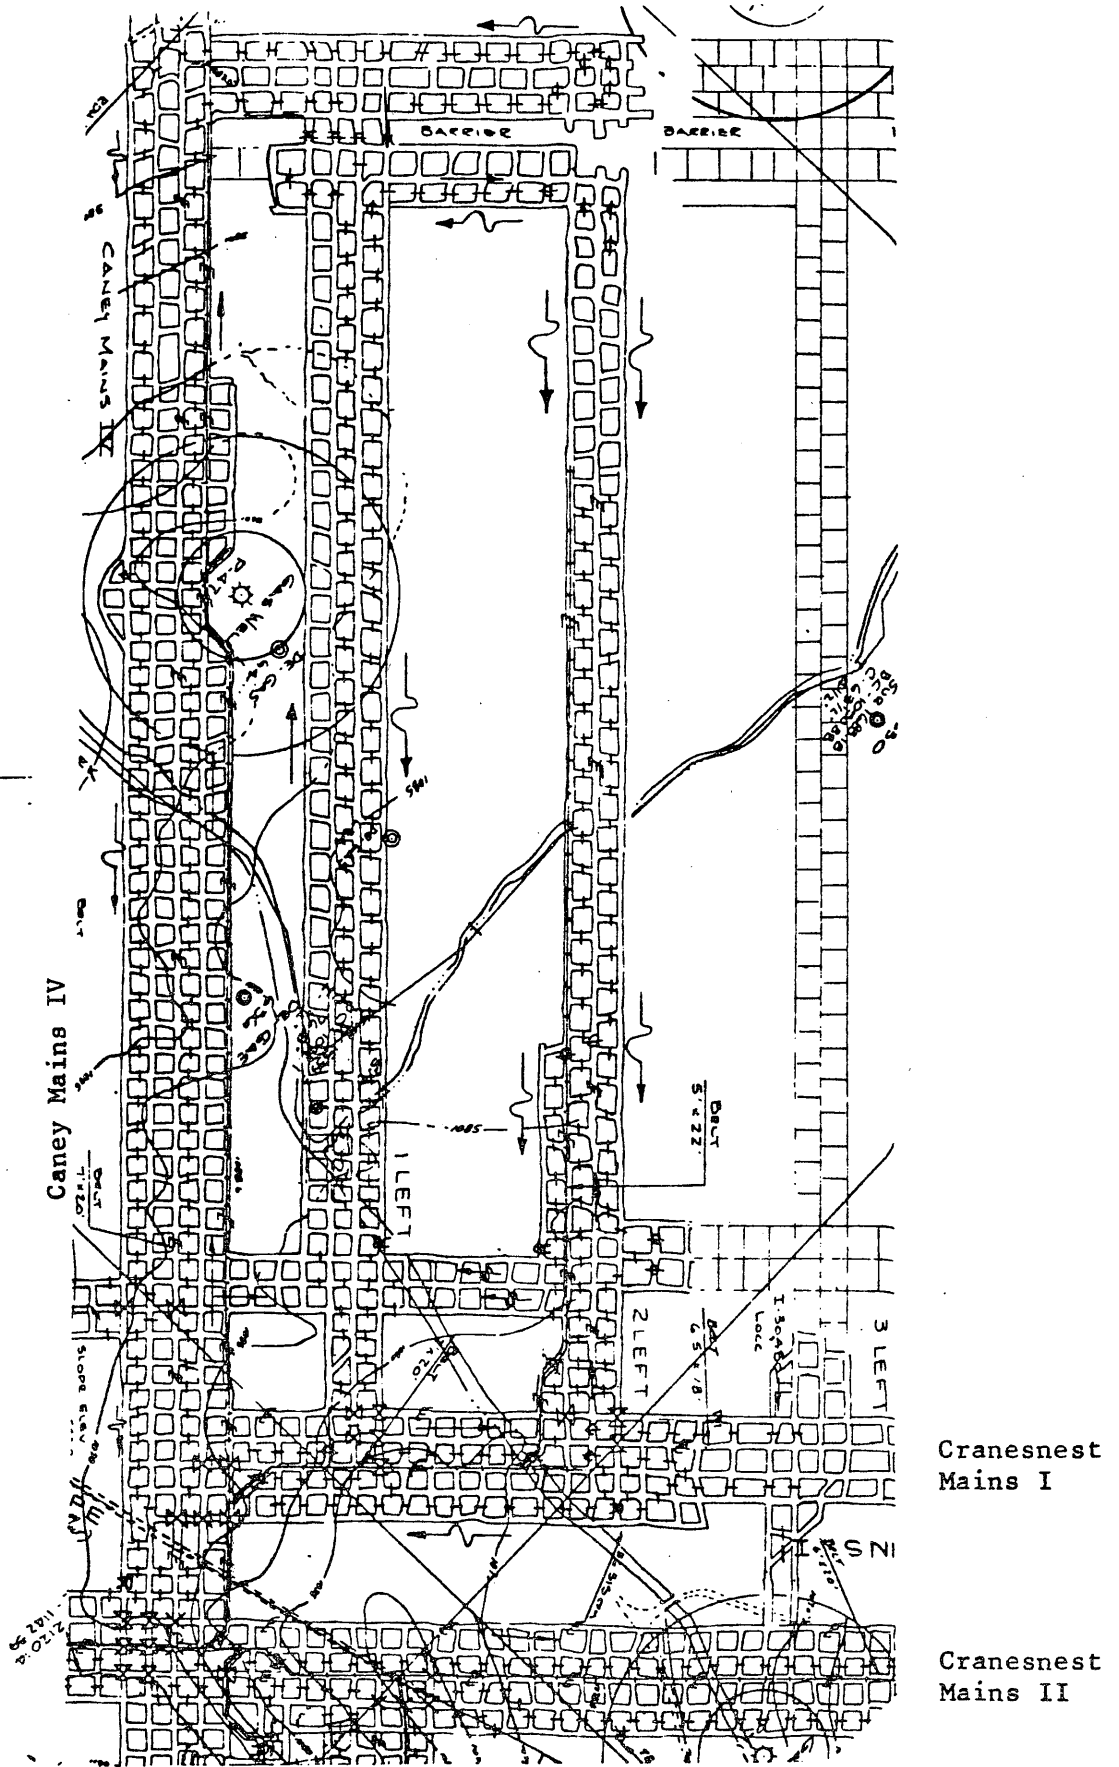
Figure 3 - Survey Area, McClure No. 1 Mine

The portion of the mine surveyed was in the west bordered by Cranesnest Mains II and Caney Mains IV headings. Figure 3 is a mine map of this area showing the development, ventilation controls and airflow direction at the time of the survey. Air quantity and pressure measurements were made at selected locations in the remaining portion of the mine to permit a computer simulation of the ventilation system in the study area.

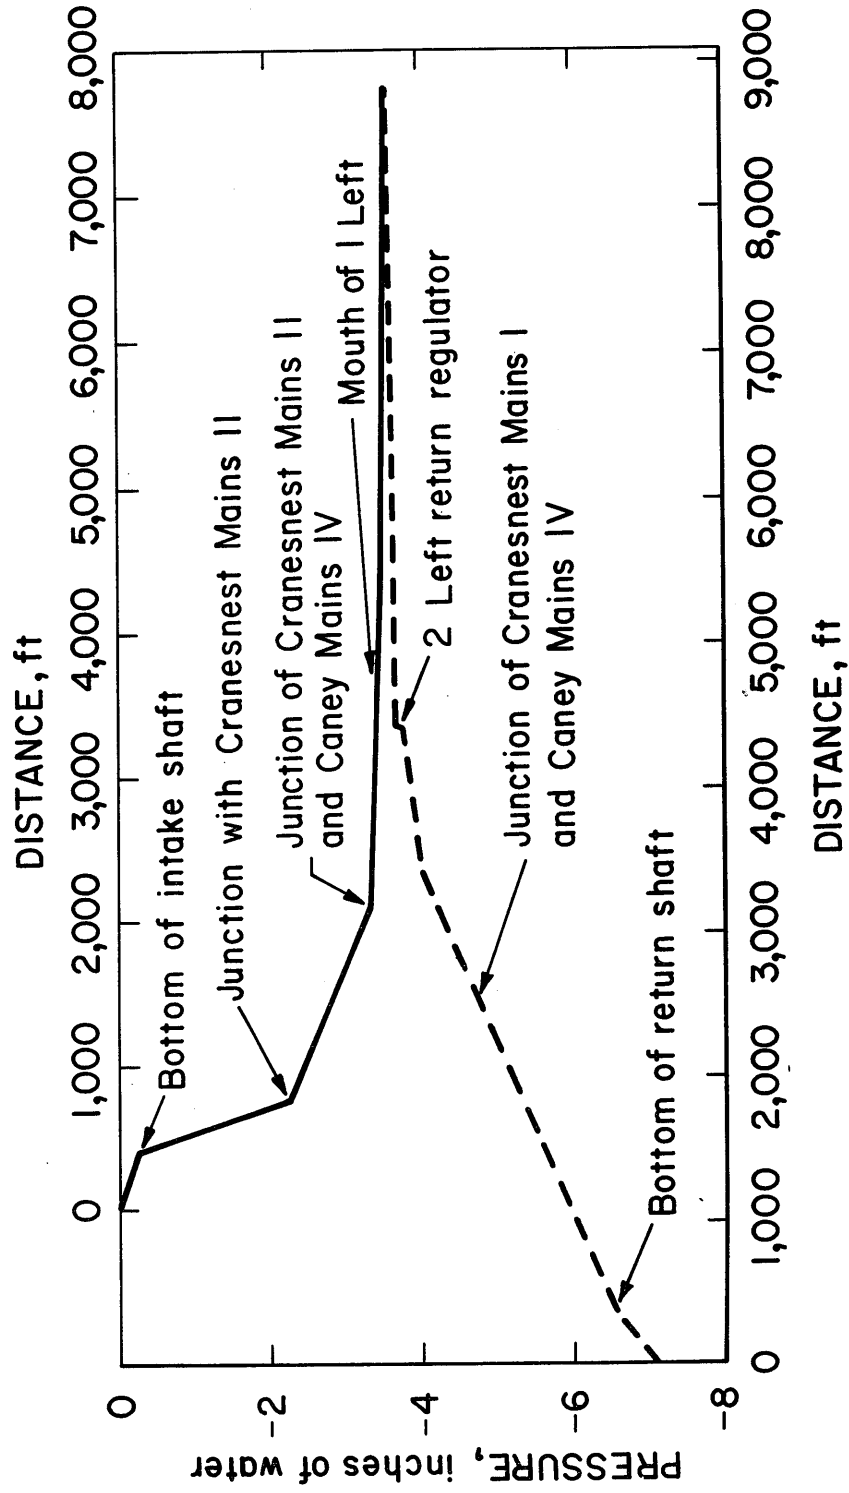
FIGURE 4 - Pressure Gradient of 2 Left Section;
 McClure No. 1 Mine, July 1983

Figure 4 shows the ventilation pressure losses incurred by the ventilating air as it travels to and from the 2 Left Section. The gradient was constructed by plotting the total ventilation pressure measured at key locations against the distance of the location from the intake or return shaft opening. The slope of the line on the gradient indicates the pressure loss to length of airway; therefore a steep slope will indicate an area in the mine with either high resistance to airflow or a high airflow quantity. Steep pressure gradient areas are of primary concern when determining regions of the mine where improvements in terms of reduce mine resistance, would be most beneficial.

The pressure gradient illustrated in Figure 4 shows that the greatest restriction to airflow occurred in the intake aircourse from the bottom of the intake airshaft to the Cranesnest Mains II entries, a distance of approximately 350 ft. The ventilation pressure loss in this aircourse was 2.04 inches of water which was 29 percent of the total ventilation pressure (7.1 inches of water) developed by the mine fan.

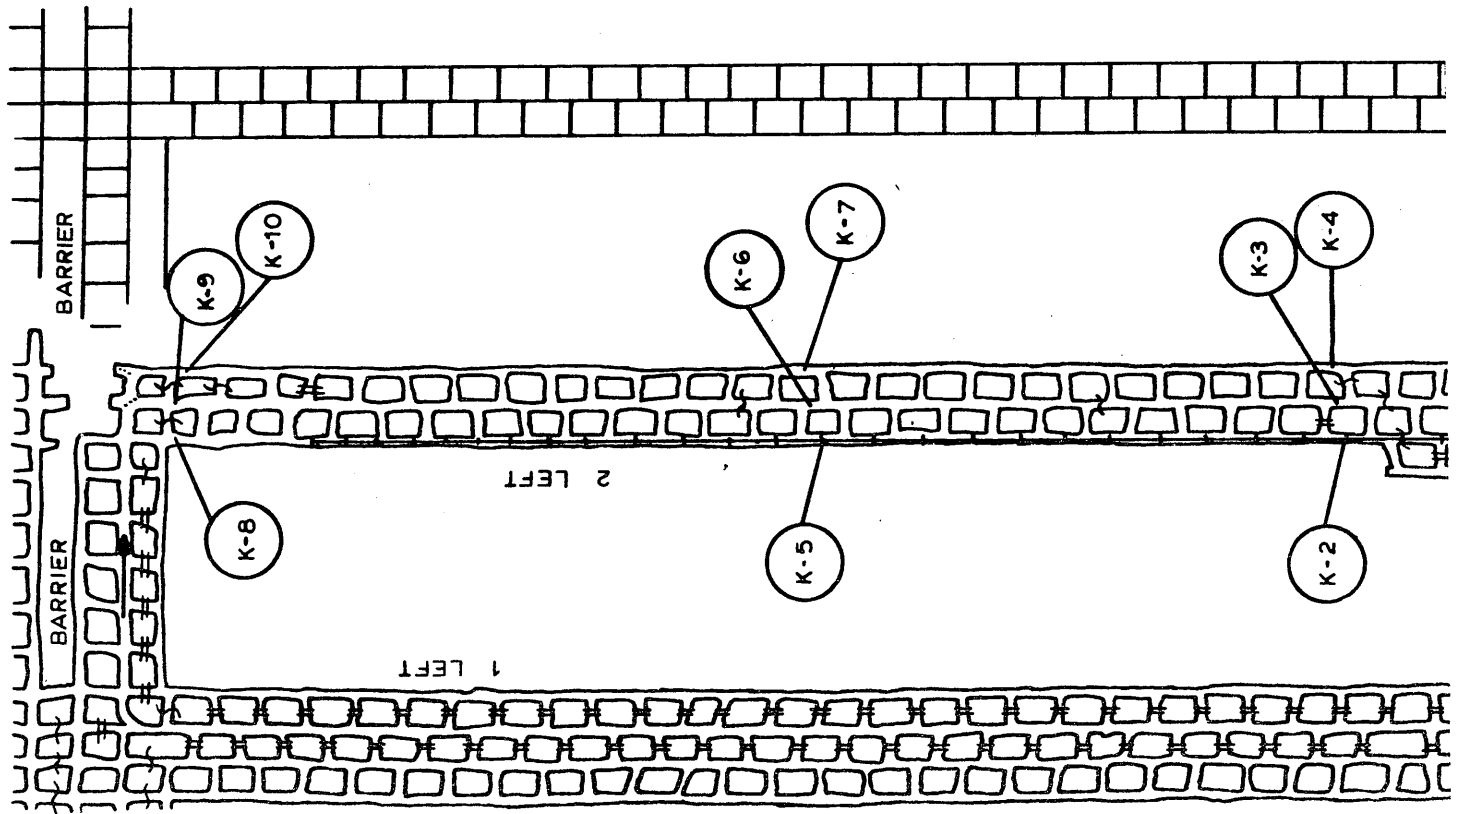
Figure 5.- Location of Monitoring Stations, Average Methane Concentrations, Balanced Air Quantities, Average, Methane Quantities

monitored daily at three locations selected at the beginning, mid-point, and end of the 2 Left Section. Three stations were established at each location and each day during a 3-day period a vacuum bottle air sample was collected and an air velocity measurement made at the nine stations. In addition, a continuous recording methane detector was installed at each station to determine if the methane concentration at each location varied from the concentration determined by analysis of vacuum bottle air samples. An examination of the methane recorder strip charts indicated that no significant variation occurred in the daily measured methane concentration at each location. The nine monitoring stations (K-2 thru K-10) are shown in Figure 5 along with the average methane concentration (determined by laboratory analysis of air samples), balanced air quantity and average methane quantity at each station.

Location	Average methane conc. %	Balanced air quantity (cfm)	Average methane quantity (cfm)
K-2	0.61	10,000	61
K-3	0.24	6,000	14
K-4	0.47	28,000	132
K-5	0.48	18,000	86
K-6	0.27	6,000	16
K-7	0.40	20,000	80
K-8	0.08	25,000	20
K-9	0.13	9,000	12
K-10	0.22	10,000	22

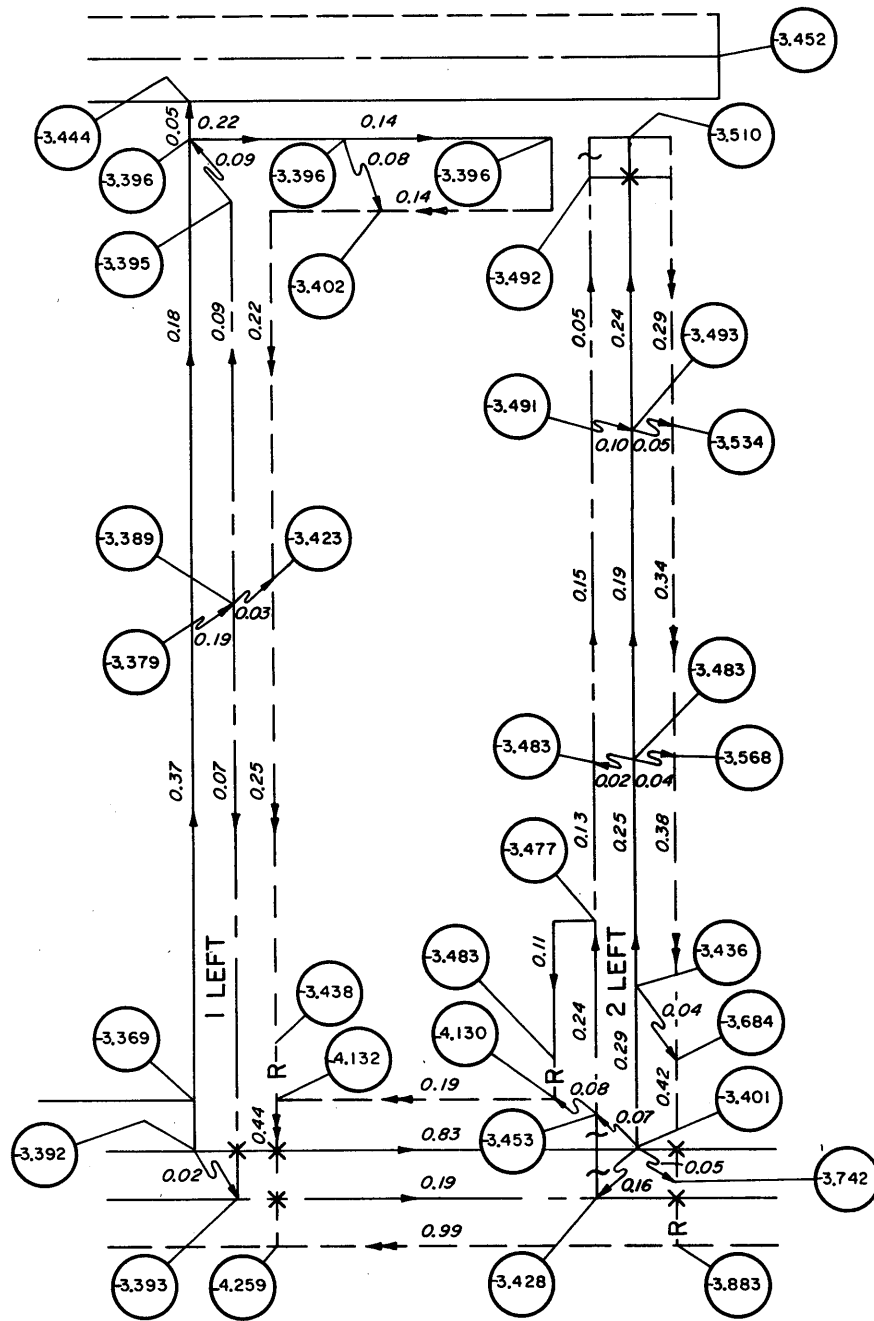
FIGURE 6- Ventilation Schematic of 2 Left Area Before Cut-through

Figure 6 is a schematic of a simulation of the ventilation system for the 2 Left area before the cut through into the longwall set-up entries. The resistances used for the aircourses were based on values calculated from the data collected during this survey. The air quantities correspond to the reported air quantities that existed in the entries under normal operating conditions.
