UNITED STATES
DEPARTMENT OF THE INTERIOR
BUREAU OF MINES

FINAL REPORT OF MAJOR MINE
INRUSH OF HOT GASES AND STEAM
DISASTER

SHERWOOD MINE
INLAND STEEL COMPANY
IRON RIVER, IRON COUNTY, MICHIGAN

June 1, 1959

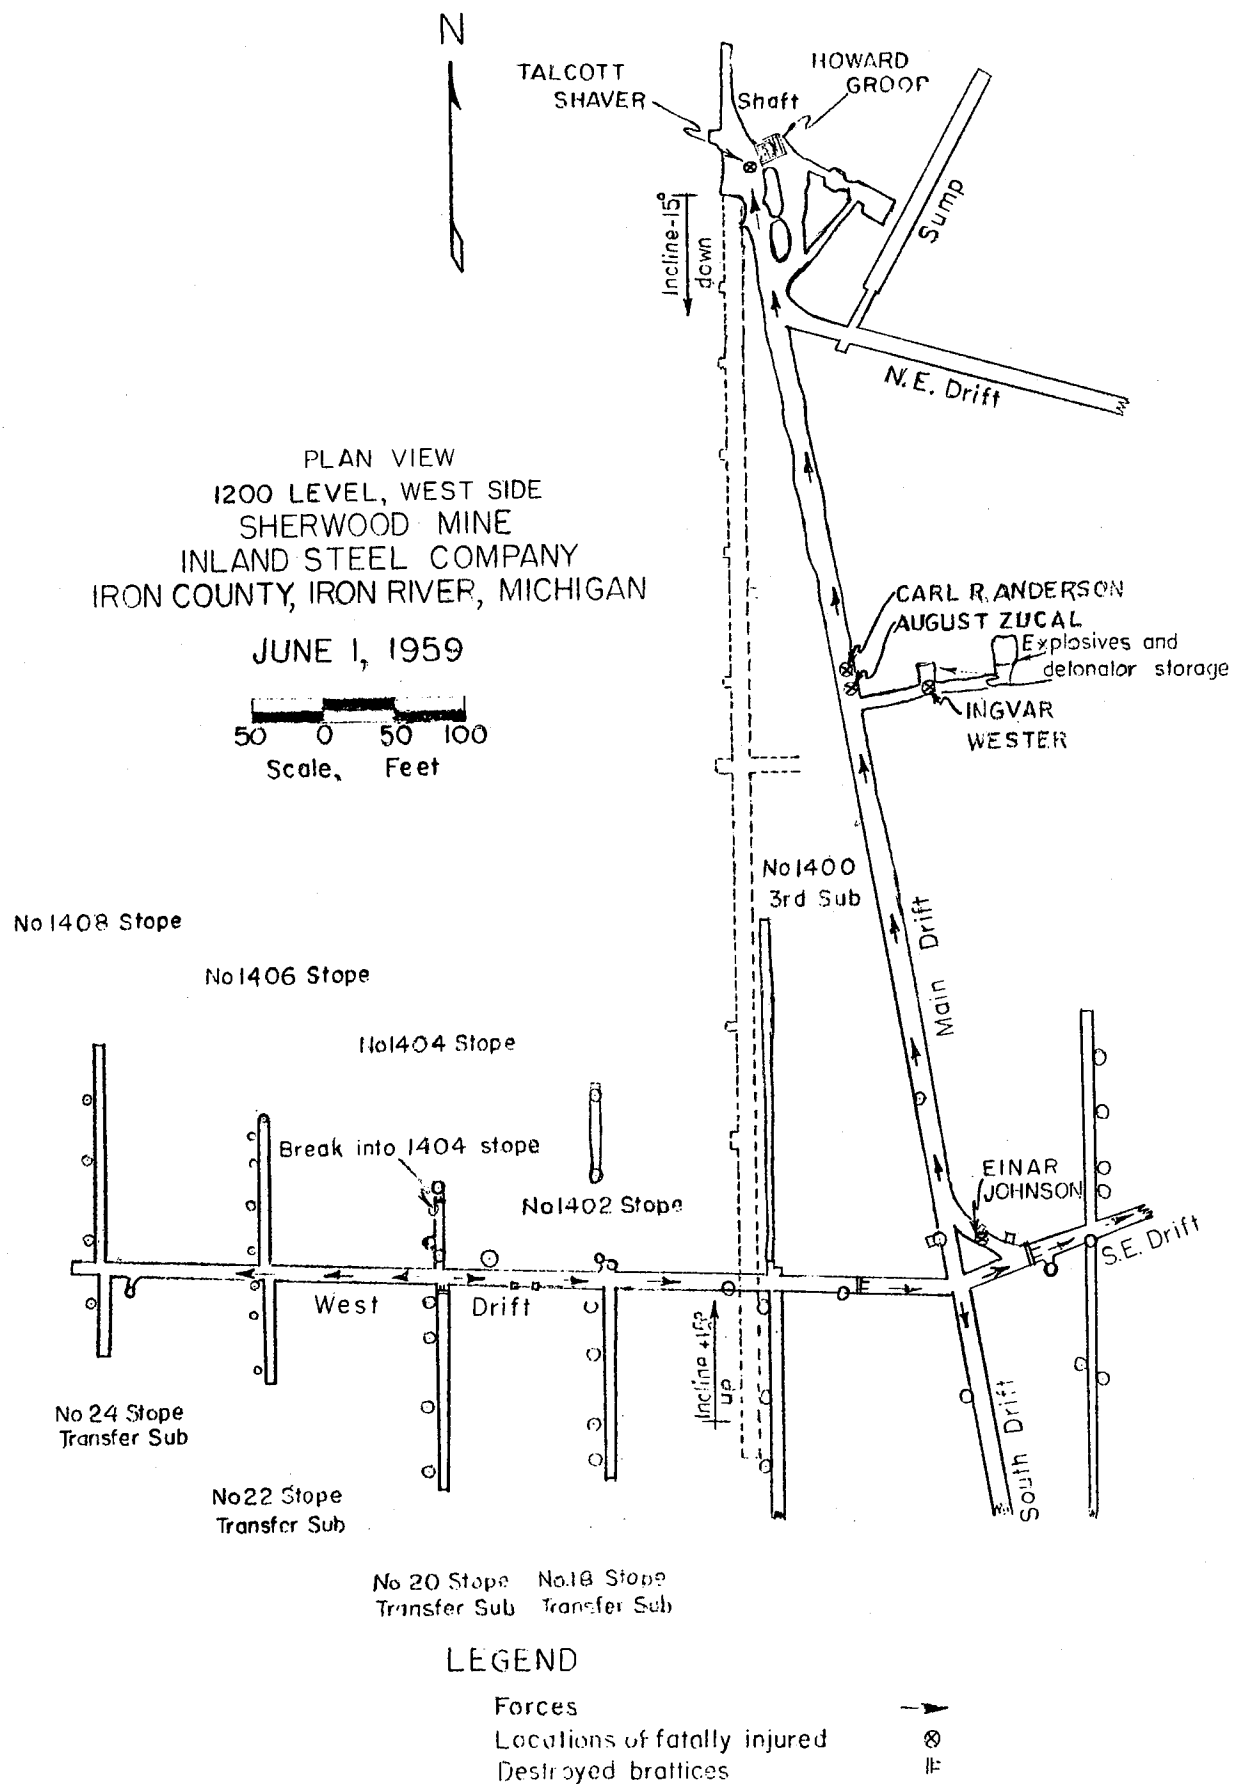
Figure 1

The greatest forces appeared to travel from a point in the 1200 level west drift near the top of No. 1404 stope. Evidence was conflicting at this point regarding the direction of travel in No. 20 stope transfer sublevel and in the dog drift above No. 1404 stope on the opposite side of the west drift (see figure 1). There was some evidence that forces travelled west from this point in the west drift, but the greatest forces travelled east towards the main drift.
