REPORT OF INVESTIGATION  
(SURFACE AREA OF UNDERGROUND COAL MINE)

MULTIPLE FATAL FALL OF MATERIAL ACCIDENT

Virginia Pocahontas No. 1 Mine (ID No. 44-00246)  
Island Creek Coal Company  
Oakwood, Buchanan County, Virginia

August 24, 1982

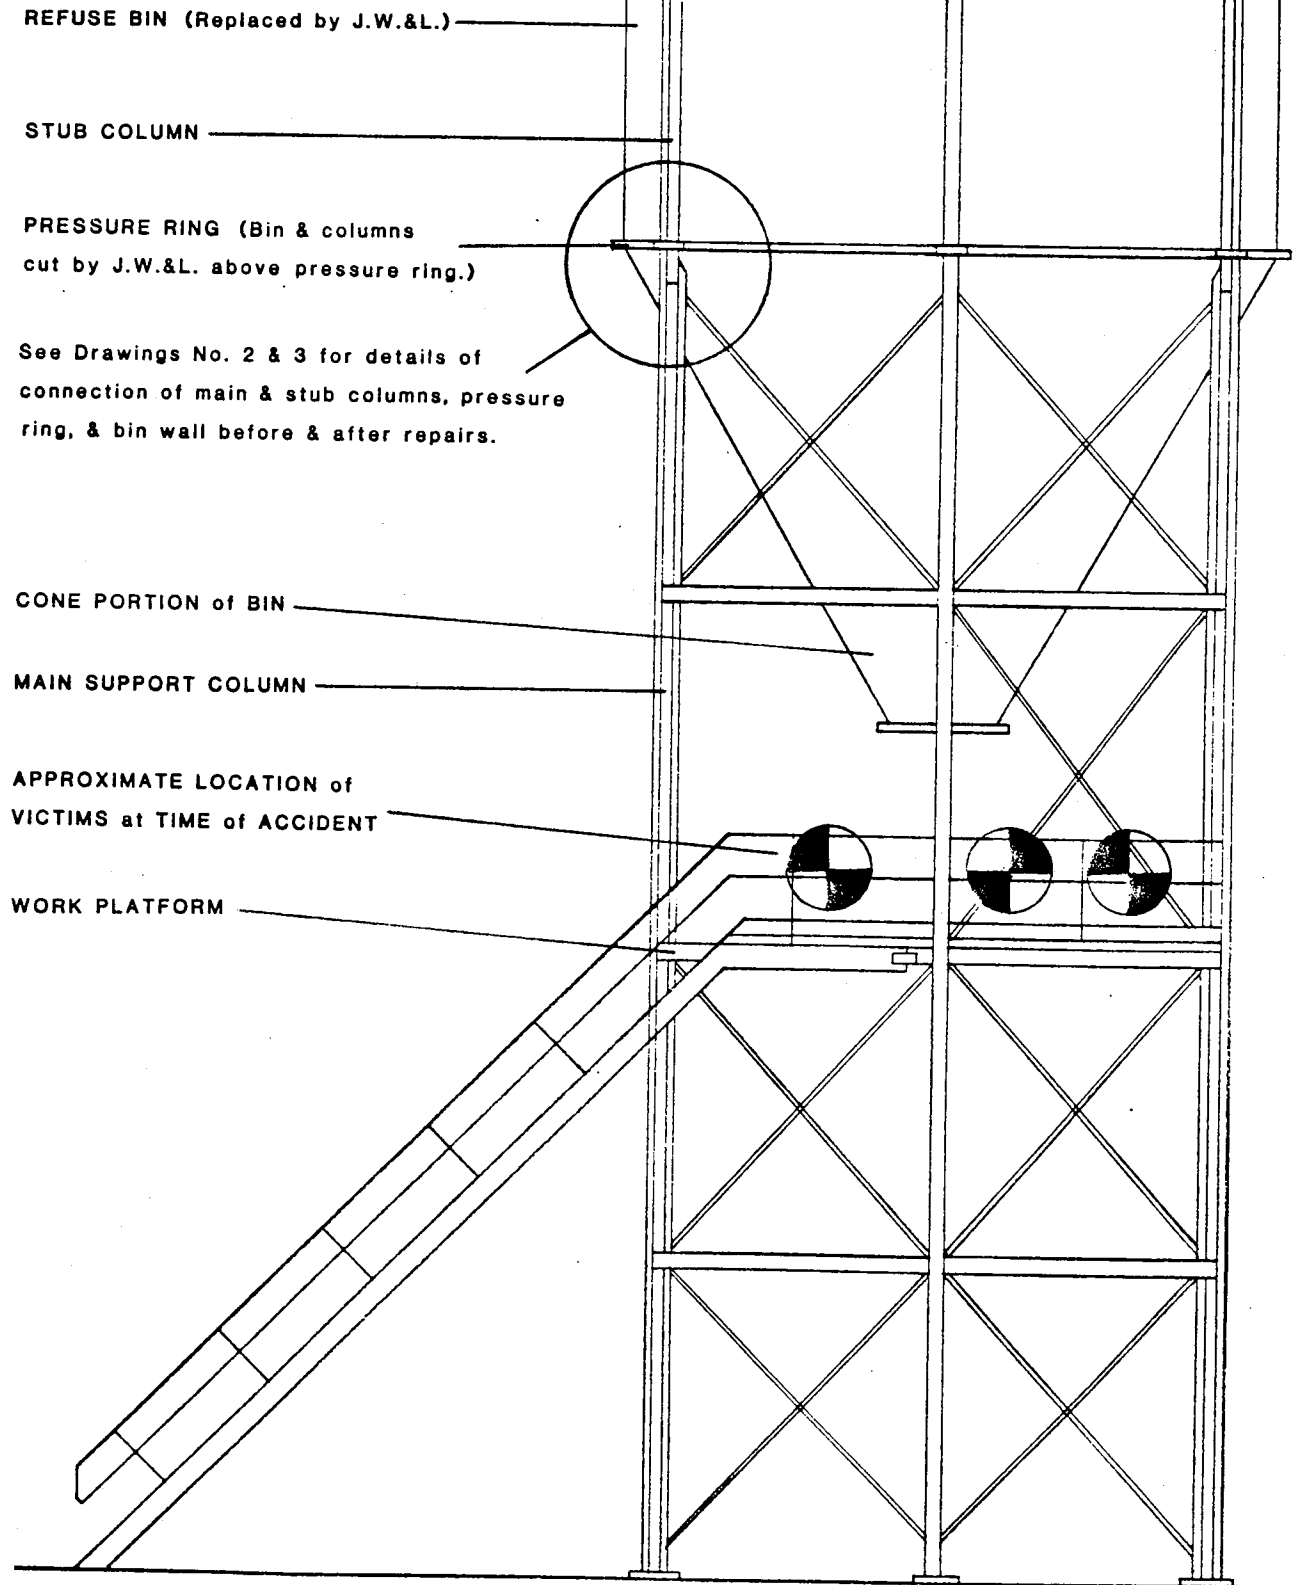
### DRAWING NO. 2

The accident occurred because repair work performed by the independent contractor on the refuse bin resulted in the facility being structurally unsound. Two of the six bin upper support columns (stub columns) were not aligned with the main support columns, significantly reducing the load supporting capability of the structure.

Connection of Main & Stub Columns, Pressure Ring, & Bin Wall Before Repairs

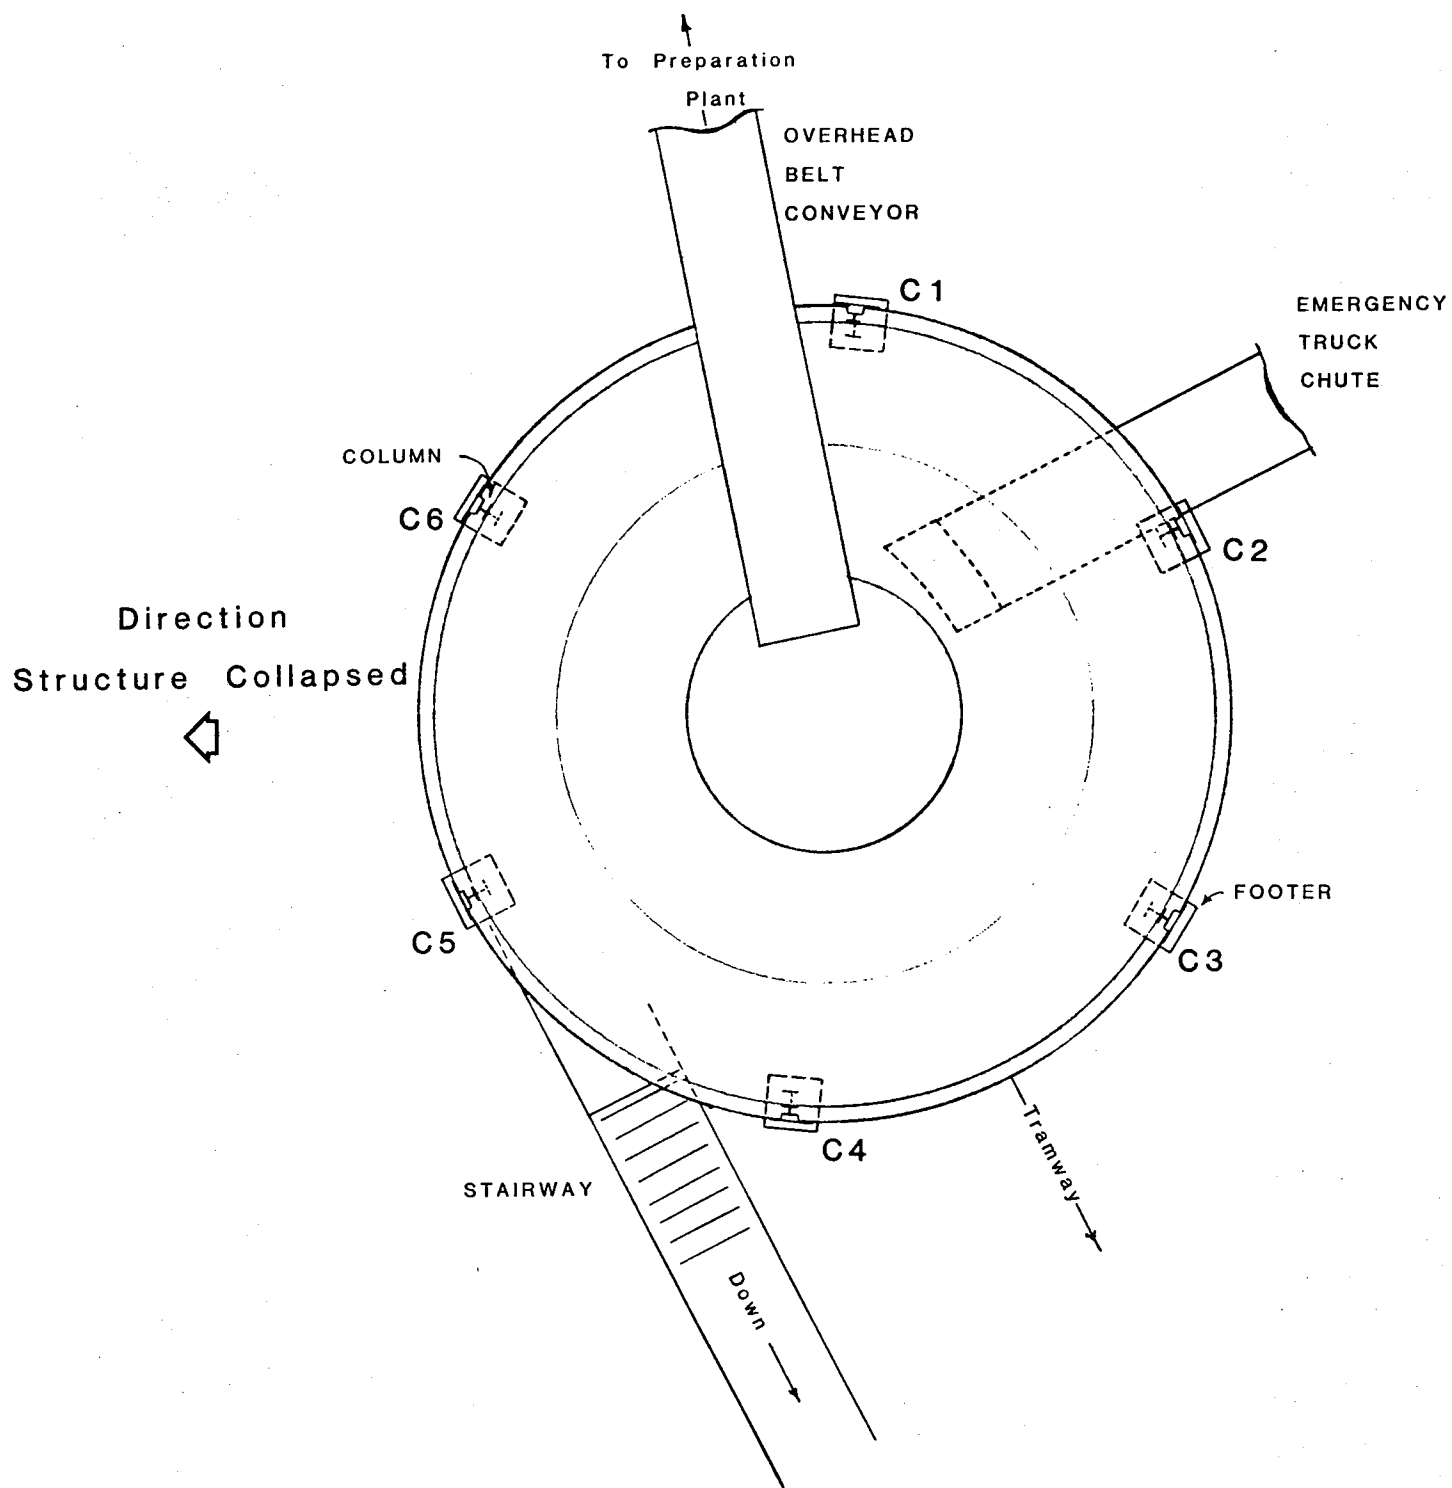
## DRAWING NO. 4

Overhead Diagram
