THE UNITED MINE WORKERS OF AMERICA, AFL-CIO/CLC

Sago Mine Disaster

OF JANUARY 2, 2006

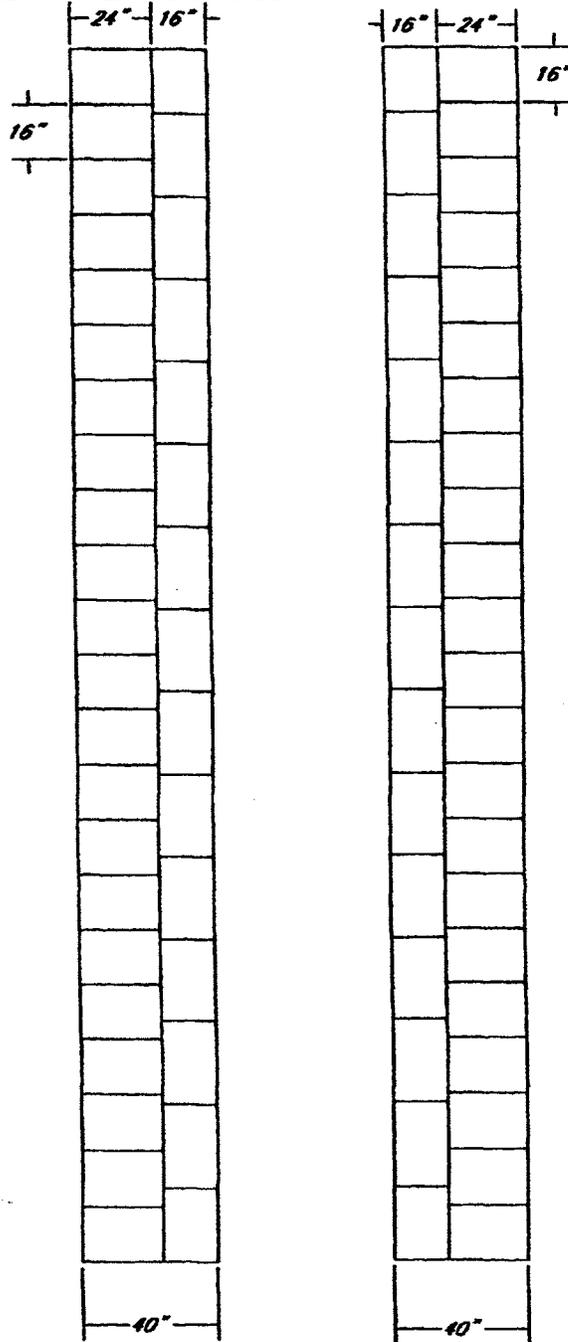
40" THICK OMEGA BLOCK SEAL

1. Total thickness 40 inches
2. No hitching required
3. Joints must be staggered
4. All joints shall be a minimum $\frac{1}{4}$ inch thick and be motared using an approved mortar/sealant
5. Three rows of wood planks running the entire length of the seal shall be installed across the top of the seal
6. Wedges will be placed on 1' centers or less with an approved sealant used to fill the gaps
7. An approved sealant shall be used as full face coating on both sides of the seal.

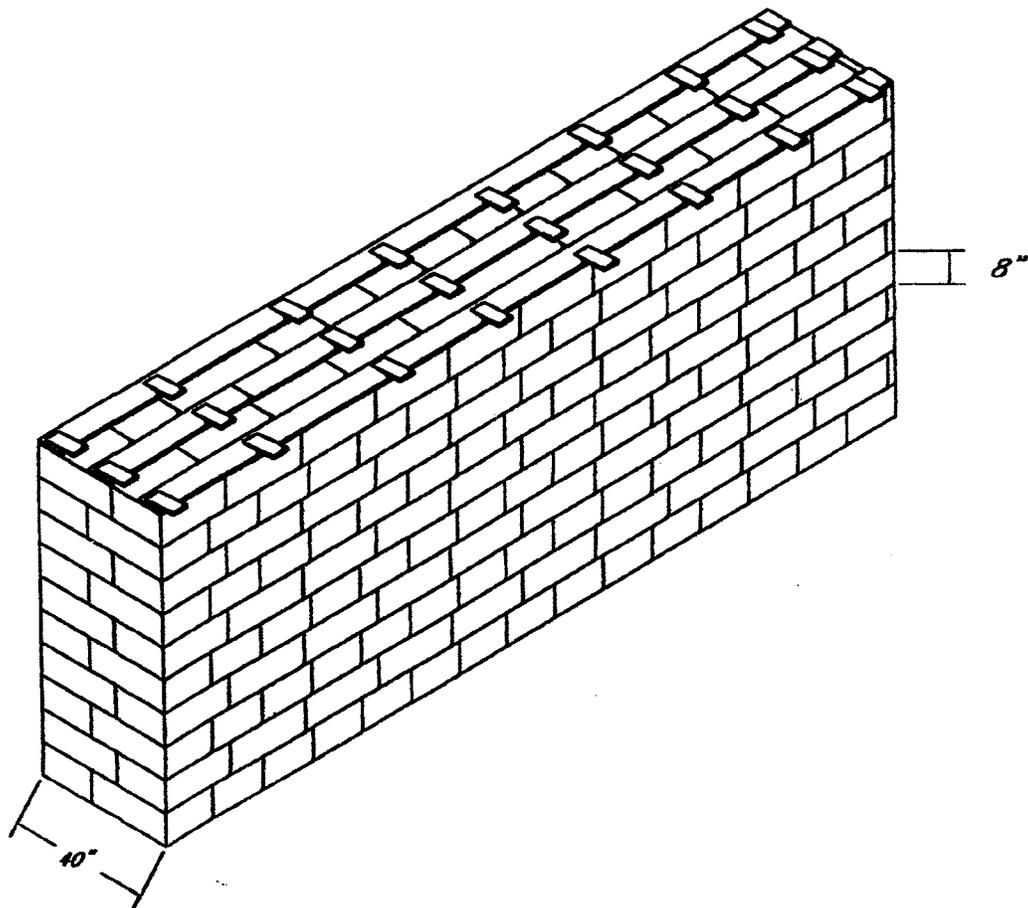
*40" THICK OMEGA BLOCK SEAL
FOR USF WITH SEALS UP TO 8 FT HIGH BY 20 FT WIDE
NO HITCHING REQUIRED*

1. Total thickness of completed seal shall be 40 inches
2. No hitching required
3. Joints must be staggered
4. All joints shall be a minimum $\frac{1}{4}$ inch thick and be mortared using "BlocBond"
5. Three rows of wood planks running the entire length of the seal shall be installed across the top of the seal
6. Wedges will be placed on 1' centers or less with "BlocBond" used to fill the gaps
7. "BlocBond" shall be used as full face coating on both sides of the seal.

- seals shall be at least 10 feet from the corner of the pillar
- Sampling pipes shall be installed as per 75.335

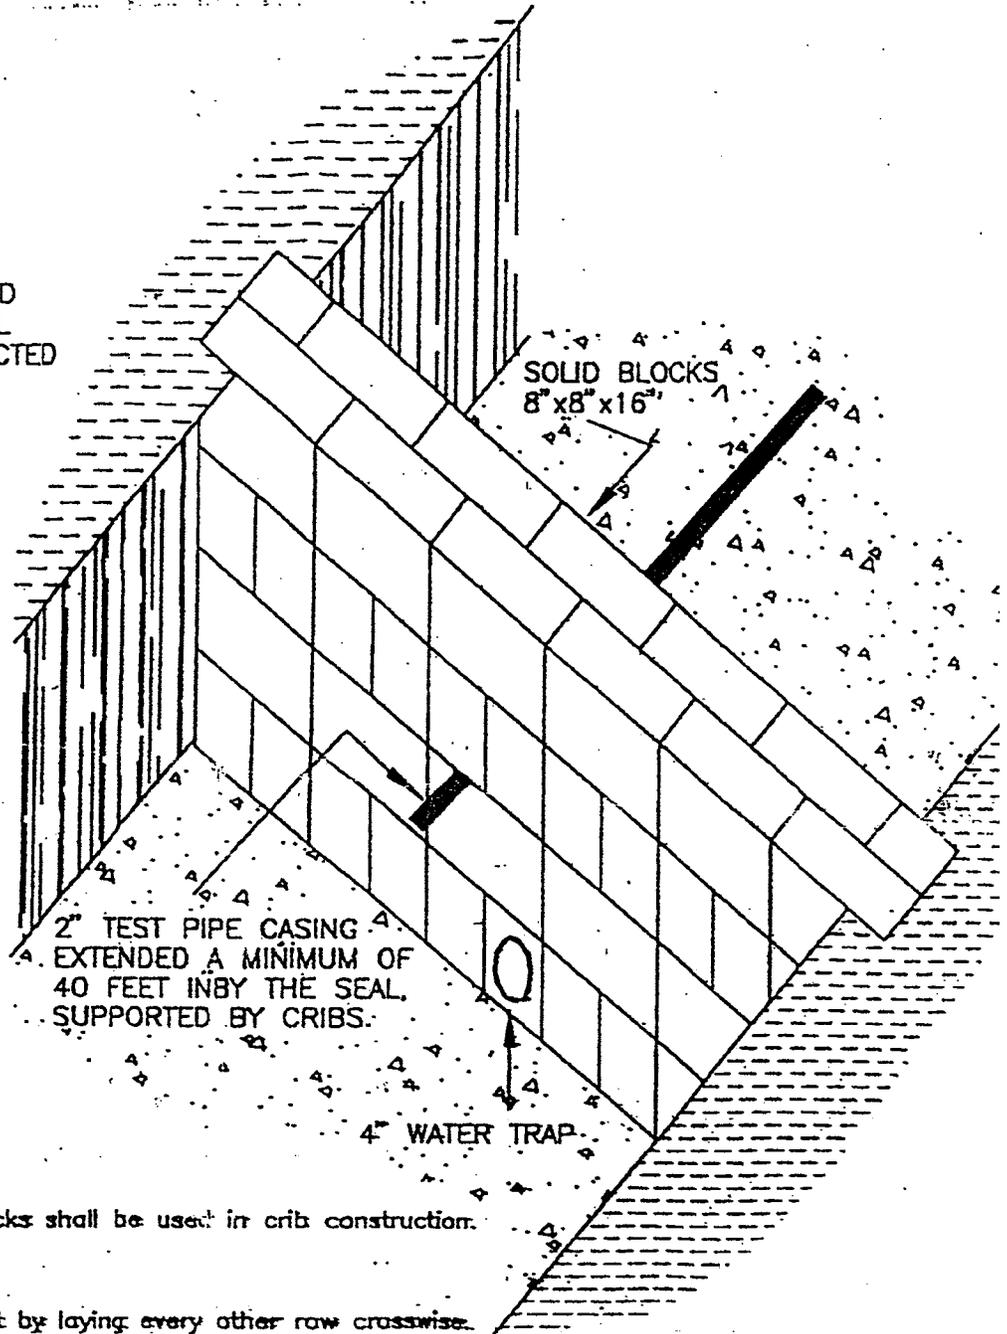
METHOD FOR SEALING ABANDONED OR WORKED OUT AREAS

BLOCKS TO BE ANCHORED ONE FOOT IN SOLID COAL AND SHALL BE CONSTRUCTED ON SOLID BOTTOM.

TWO ROWS OF BLOCKS WITH CONCRETE MOTAR LINES AND 1/2" PLASTER ON THE OUT-BY-SIDE AND WHERE POSSIBLE ON THE IN-BY-SIDE.

2" TEST PIPE CASING EXTENDED A MINIMUM OF 40 FEET INBY THE SEAL, SUPPORTED BY CRIBS.

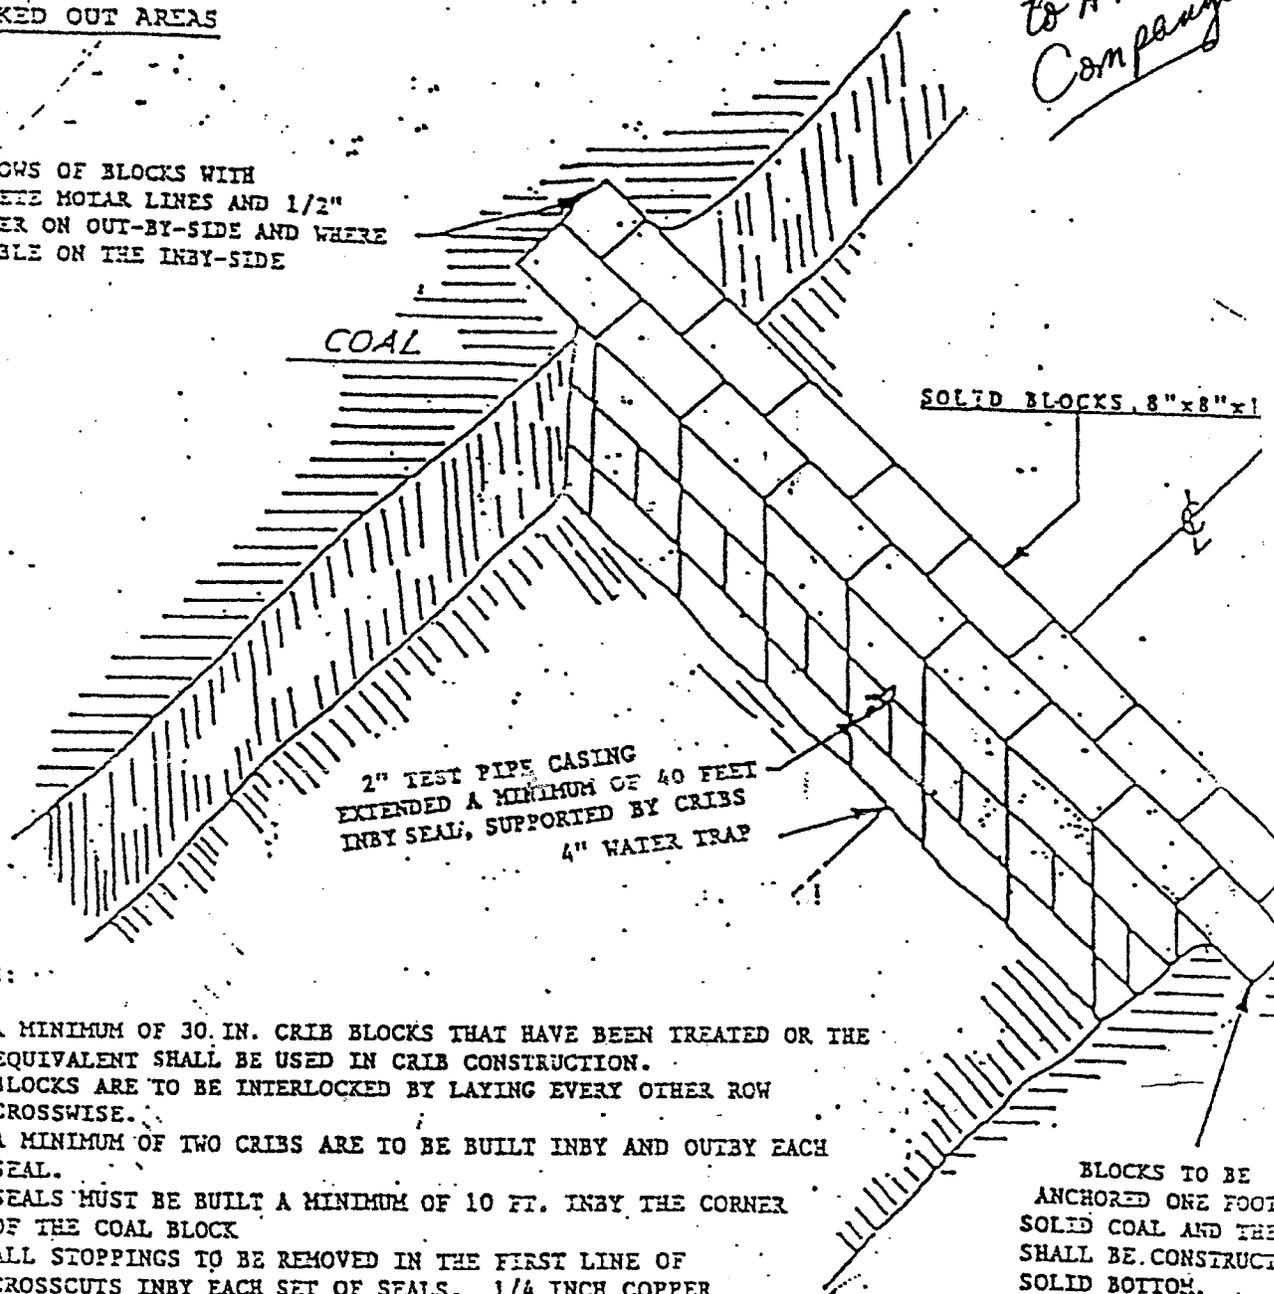
10 ROWS OF BLOCKS WITH
CONCRETE MORTAR LINES AND 1/2"
PLASTER ON OUT-BY-SIDE AND WHERE
POSSIBLE ON THE INBY-SIDE

- A MINIMUM OF 30. IN. CRIB BLOCKS THAT HAVE BEEN TREATED OR THE EQUIVALENT SHALL BE USED IN CRIB CONSTRUCTION.
- BLOCKS ARE TO BE INTERLOCKED BY LAYING EVERY OTHER ROW CROSSWISE.
- A MINIMUM OF TWO CRIBS ARE TO BE BUILT INBY AND OUTBY EACH SEAL.
- SEALS MUST BE BUILT A MINIMUM OF 10 FT. INBY THE CORNER OF THE COAL BLOCK
- ALL STOPPINGS TO BE REMOVED IN THE FIRST LINE OF CROSSCUTS INBY EACH SET OF SEALS. 1/4 INCH COPPER TUBING IS TO BE INSTALLED THROUGH THE ENTIRE LENGTH OF THE 2" TEST PIPE CASING.
- EACH OF THE ABOVE PIPES MUST BE INSTALLED IN EACH SET OF SEALS. THE 2" TEST PIPE CASING MUST BE IN THE SEAL OF THE HIGHEST ELEVATION AND THE WATER TRAP IN THE SEAL OF LOWEST ELEVATION.
- THE DIVISION OFFICE SHALL BE NOTIFIED BEFORE THE SEALS ARE FINISHED SO THAT THE DISTRICT INSPECTOR CAN CHECK TO SEE IF THE SEALS HAVE BEEN CONSTRUCTED TO SPECIFICATIONS.
