FINAL REPORT OF MINE EXPLOSION  
MINE NO. 47, PEABODY COAL COMPANY  
HARCO, SALINE COUNTY, ILLINOIS

12-28-41

L. H. McGuire  
Associate Mining Engineer

UNITED STATES  
DEPARTMENT OF THE INTERIOR  
BUREAU OF MINES

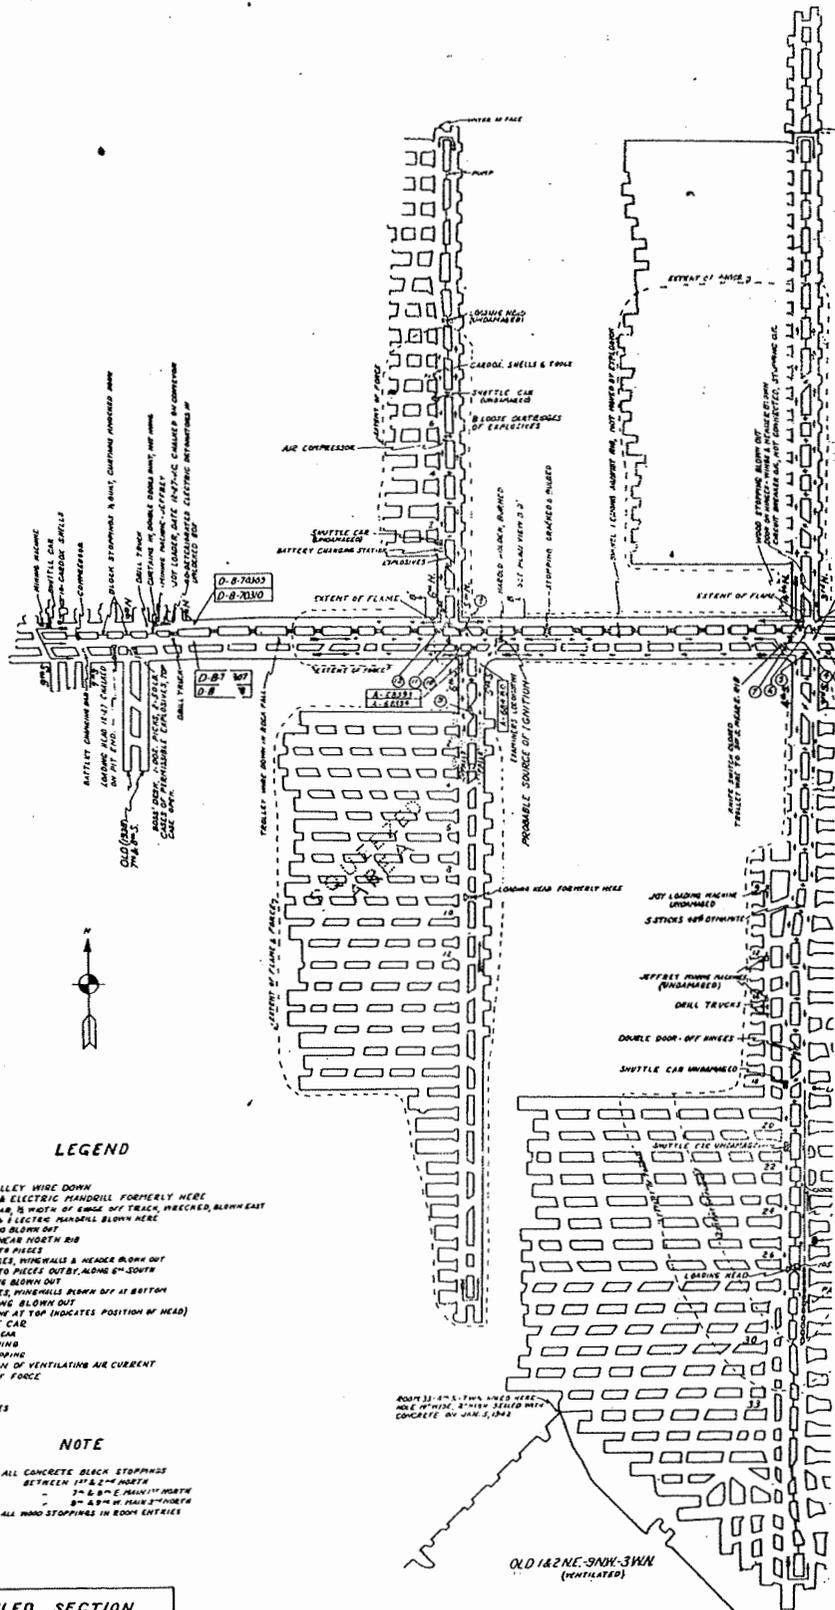
- ① DOUBLE TROLLEY WIRE DOWN
- ② WORK BENCH & ELECTRIC HANDDRILL FORMERLY HERE
- ③ EMPTY PIT CAR, 1/2 WIDTH OF EDGE OF TRACK, RECORDED, BURNED EAST
- ④ WORK BENCH & ELECTRIC HANDDRILL BLOWN HERE
- ⑤ WOOD STOPPING BLOWN OUT
- ⑥ TELEPHONE NEAR HOLE IN RIS
- ⑦ DOOR BLOWN TO PIECES
- ⑧ DOOR ON HINGES, MINERALS BLOWN AWAY OUT
- ⑨ DOOR BLOWN TO PIECES OUTSIDE, ALONG 2nd JOINT
- ⑩ WOOD STOPPING BLOWN OUT
- ⑪ DOOR ON HINGES, MINERALS BLOWN OFF IN BITTON
- ⑫ WOOD STOPPING BLOWN OUT
- ⑬ MAN DEAD (LINE AT TOP INDICATES POSITION OF HEAD)
- ⑭ LOADED HIVE CAR
- ⑮ BOARD STOPPING
- ⑯ HONEY STOPPING
- ⑰ ——— DIRECTION OF VENTILATING AIR CURRENT
- ⑱ ——— DIRECTION OF FORCE
- ⑲ AIR SAMPLES
- ⑳ DUST SAMPLES

- ⑪ NORMAL DIRECTION OF OPENING DOOR
- ⑫ TRACK MOUNTED COMPRESSOR UNDAMAGED.
- ⑬ CHARLES PEMBERTON BURNED
- ⑭ FOUR OLD 30 LB. RAILS, WITH TWO ALUMINUM DINNER PAILS WRAPPED AROUND THEM

- ⑮ TELEPHONE, - CHARRED MOUTH PIECE & RECEIVER
- ⑯ ROY DONALDSON, BURNED & MUTILATED
- ⑰ TWO BATTERY CARS ON TRACK
- ⑱ SIX TON GOODMAN LOCOMOTIVE OFF TRACK, CONTROLLER OFF & TROLLEY POLE BROKEN

- ⑲ NAIL KEG, WITH EMPTY PAPER BOX ON TOP, NOT MOVED BY EXPLOSION
- ⑳ STEEL COVER BLOW OFF TOP OF THIS CAR
- ㉑ TWO BATTERY CARS ON TRACK
- ㉒ ORVAL DAUGHERTY, BURNED

- ㉗ WILLIAM STRANGE BURNED
- ㉘ FOUR SPARE TIRES & WHEELS FOR SHUTTLE CARS. NOT MOVED BY BLAST
- ㉙ PILE OF ROCK DUST IN PAPER BAGS
- ㉚ VISE & MOTOR GRINDER BENCH, MOTOR GRINDER MOVED OUTBY

- ① TROLLEY WIRE FROG - TWO FLASH POINTS
- ② CONCRETE BLOCK STOPPINGS O.K.
- ③ EXAMINER'S SAFETY CAP FOUND NEAR RIB LINE
- ④ EXAMINER'S ELECTRIC CAP LAMP & BATTERY NEAR NORTH RAIL

- ⑤ HAROLD HOLDEN, EXAMINER, BODY & CLOTHING BURNED
- ⑥ LOCOMOTIVE; SAFETY LAMP HANGING ON IT; BRAKE SET; ON TRACK; TROLLEY POLE O.K.
- ⑦ 2-JEFFREY MINING MACHINES PULLED OUT & LEFT HERE

- ⑧ KNIFE SWITCH ON TROLLEY WIRE TO 5th SOUTH FOUND PARTLY CLOSED
- ⑨ CONCRETE BLOCK STOPPING O.K.
- ⑩ 65-70 CARDOX SHELLS
- ⑪ SAND BOX BLOWN 19' TO HERE
- ⑫ KNIFE SWITCH ON TROLLEY WIRE TO 5th NORTH FOUND CLOSED

- ㉓ AIR COMPRESSOR BLOWN OUTBY
- ㉔ REELS OF CABLE, TROLLEY WIRE, TOOLS ETC.; SWEEP OUTBY FROM TOP OF EQUIPMENT
- ㉕ 2- SHUTTLE CARS UNDAAGED
- ㉖ LOADING HEAD, FRONT WHEELS ONLY OFF TRACK, PAN END SLIGHTLY DAMAGED
