*Report on a Mine Explosion That
Occurred at the Smith Mine,
Washoe, Montana, on
February 27, 1943*

MONTANA COAL & IRON COMPANY
BILLINGS, MONTANA

June 10, 1943

Prepared by
J. M. FREEMAN,
Vice President and General Manager

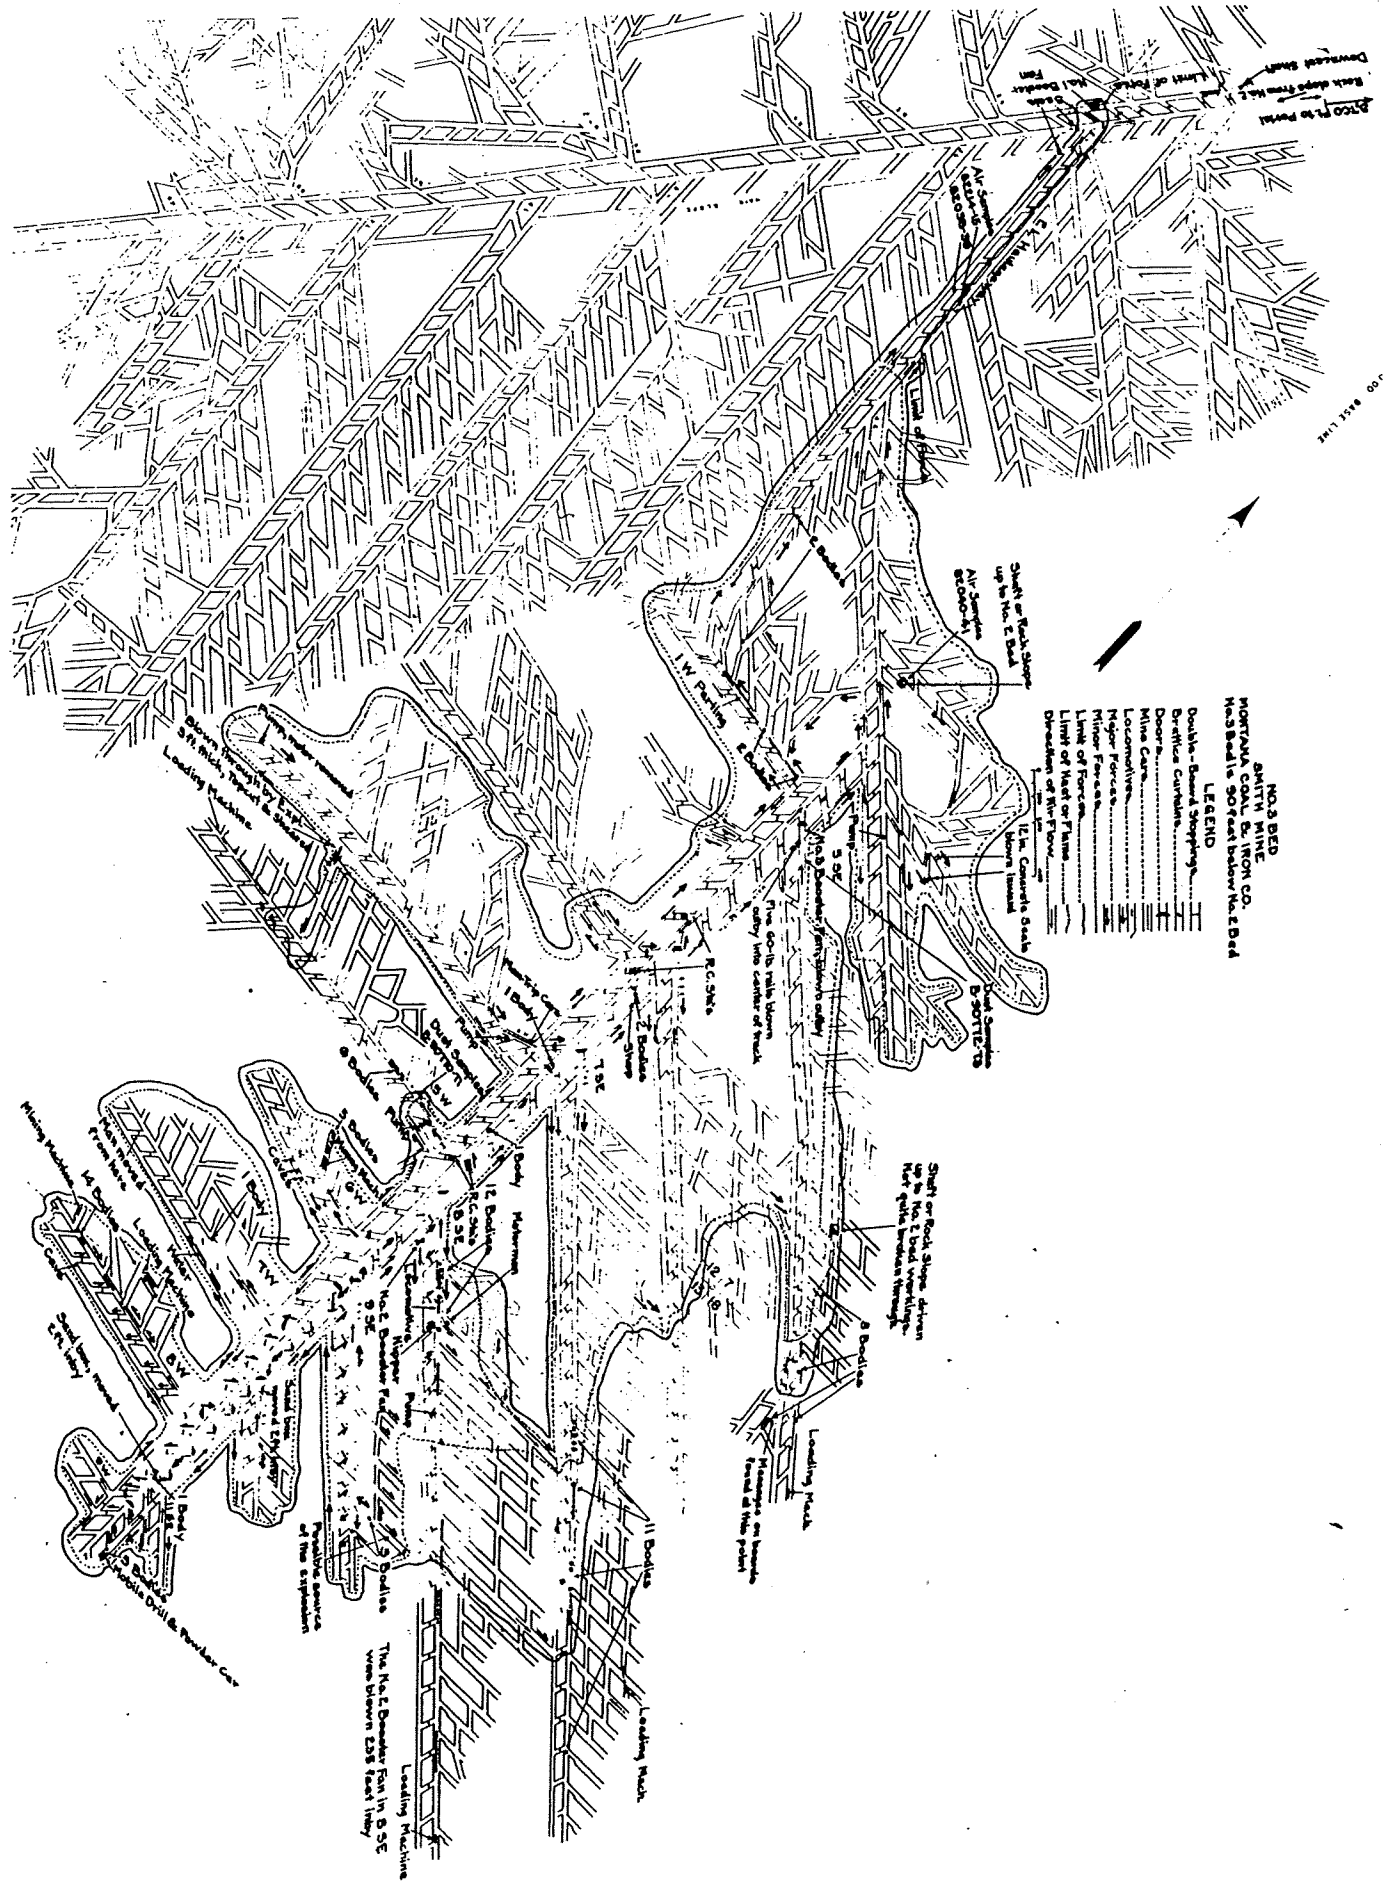
Shift on Rock Slope, driven
up to No. 3 Bed, working
here with board through

Loading Truck
Passages are located
around at this point

The No. 3 Bed, driven
from 125 feet below

Passage source
of the shipment
