REPORT OF FATAL COAL MINE ROOF-FALL ACCIDENT  
NEWFIELD MINE  
REPUBLIC STEEL CORPORATION  
NORTHERN COAL MINES DISTRICT  
NEWFIELD, ALLEGHENY COUNTY, PENNSYLVANIA  
(Post Office - Verona, Allegheny County, Pennsylvania)

August 26, 1968

J. W. Holcomb  
Federal Coal Mine Inspector

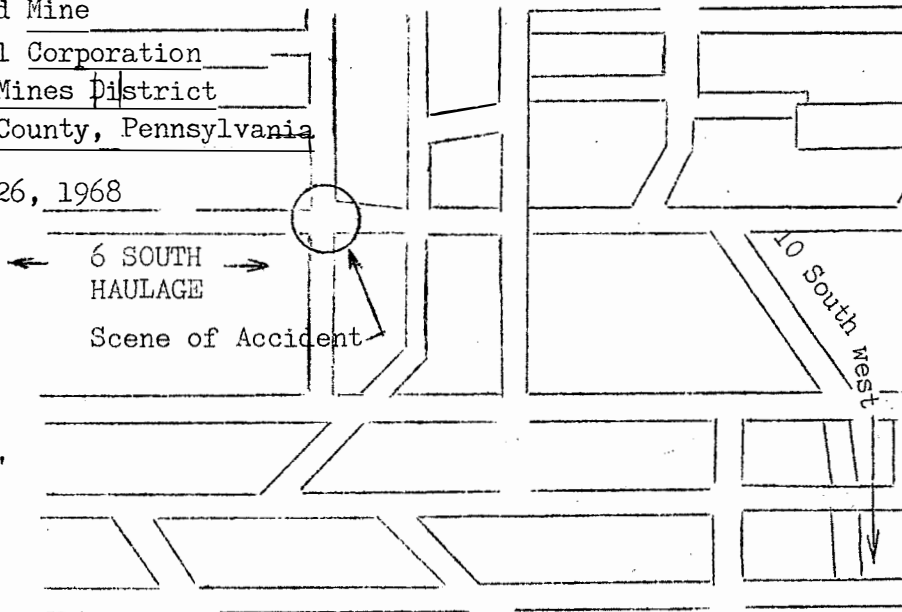
This accident resulted because of the dislodgment of the trolley and feeder wires by a fall of timbers and roof material. The wires contacted the victim's (employee) body while he was trapped under the fall. Factors which could have contributed to the accident were: (1) Failure to guard or deenergize the power wires when working around or under such wires, (2) improper evaluation of a dangerous condition, and (3) failure to install temporary roof supports while retimbering doubtful roof.

1. When reinforcing heavily overburdened timbers, better evaluation should be made concerning the hazards relevant thereto.
2. Temporary safety supports, such as posts or safety jacks, should be installed when necessary for safety before other operations are begun and as needed thereafter.
3. Heavily overburdened timbers along haulage roads should be unloaded or taken down and the material loaded out.
4. Energized trolley and trolley feeder wires should be insulated adequately or deenergized when work such as timbering is done in the vicinage of such wires.
5. All persons working around uninsulated energized power wires should be familiar with such circuits, including the location of cutout and power-control switches for the circuits.
