# COAL FATAL

REPORT OF FATAL (MULTIPLE) ROOF-FALL ACCIDENT  
SOMERSET MINE  
UNITED STATES STEEL CORPORATION  
WESTERN DISTRICT-COAL  
SOMERSET, GUNNISON COUNTY, COLORADO

September 19, 1968

Originating Office - Bureau of Mines  
P. O. Box 15037, Denver, Colorado 80215  
E. W. Felegy, District Manager  
Health and Safety District E

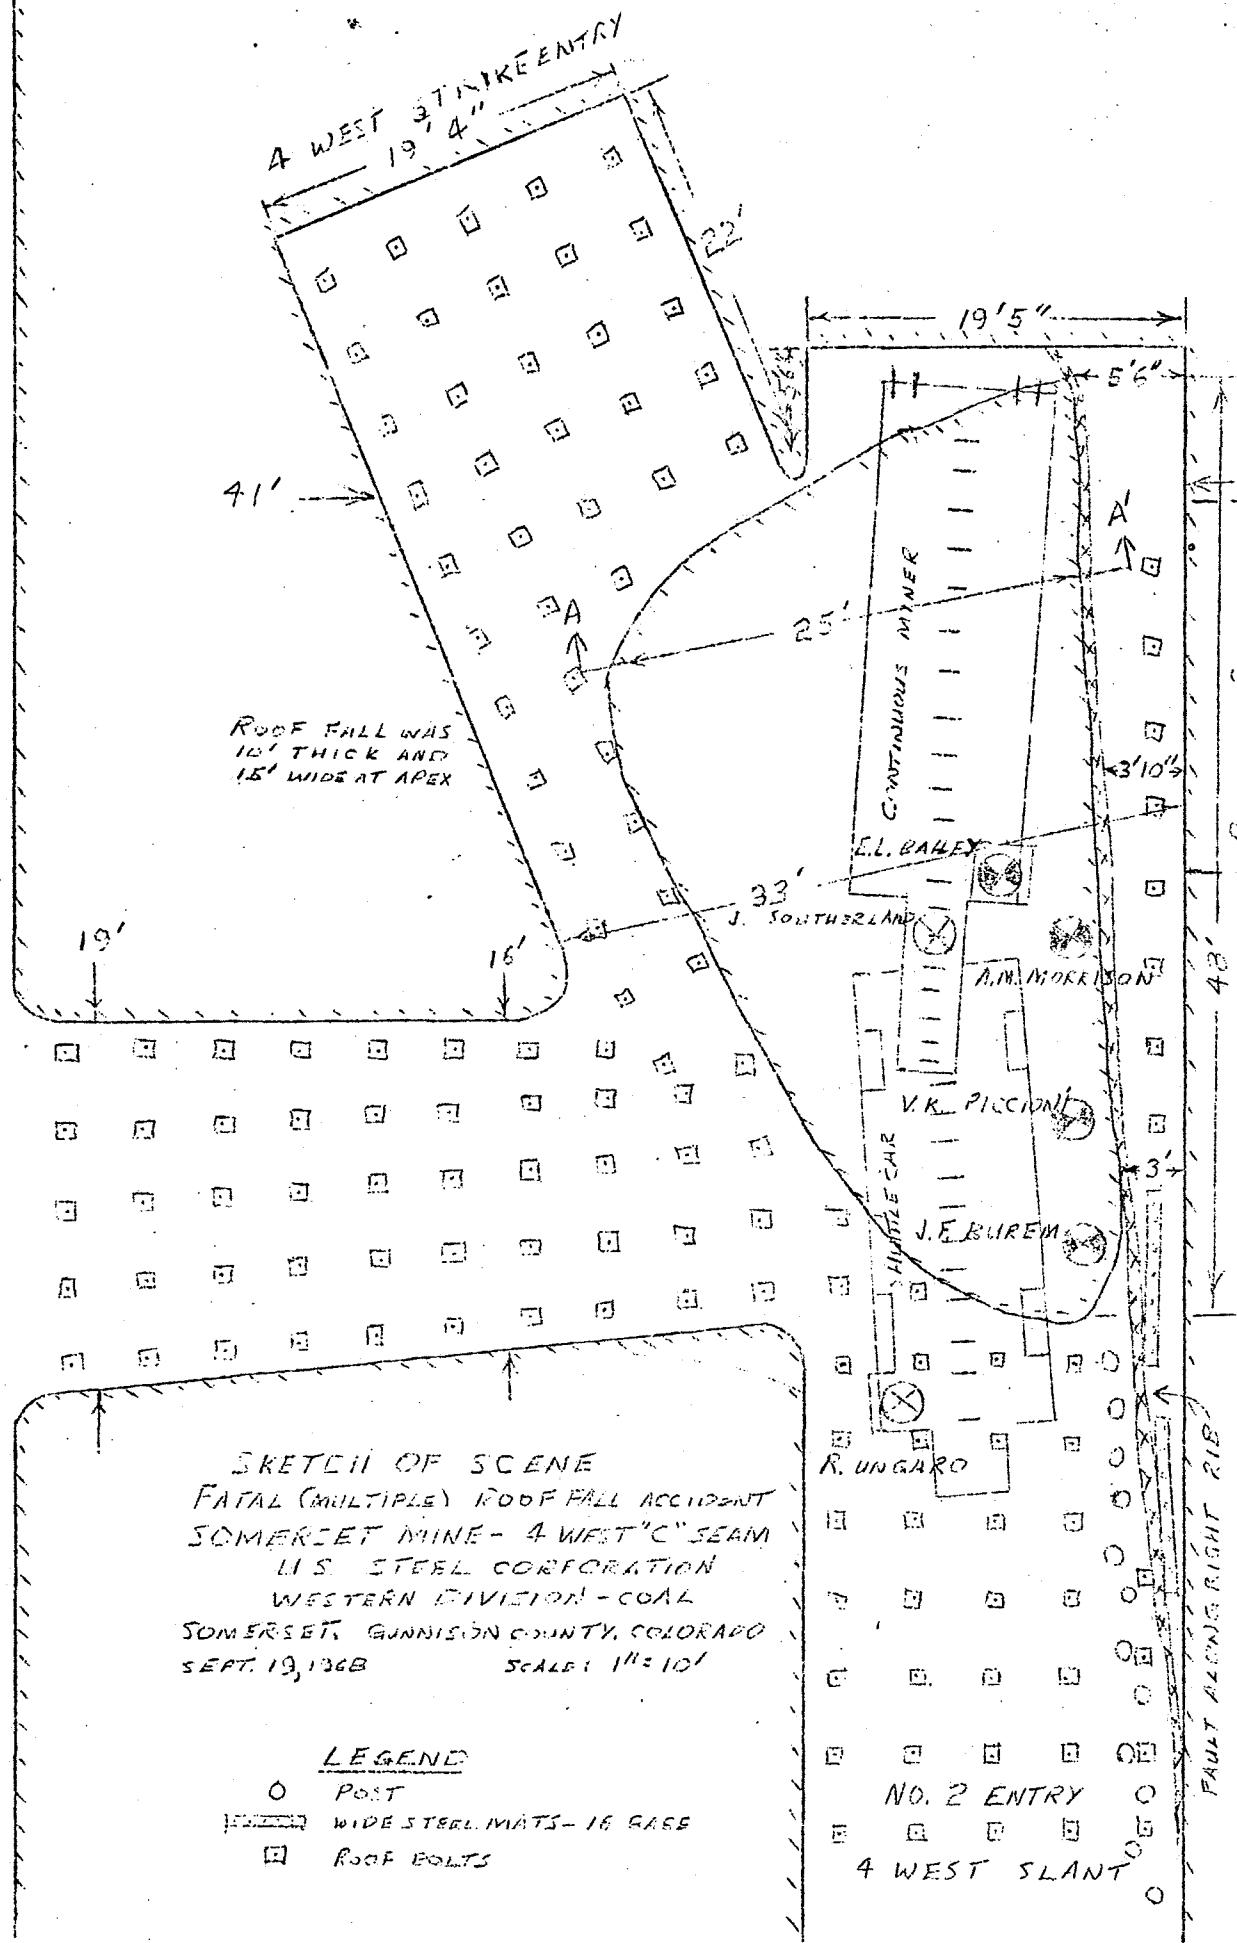
SKETCH OF AREA  
 FATAL (MULTIPLE) ROOF FALL  
 SOMERSET MINE - 4 WEST 'C' SEAM  
 U.S. STEEL CORPORATION  
 WESTERN DISTRICT - COAL  
 SOMERSET, GUNNISON COUNTY, COLORADO  
 SEPT. 19, 1968

The fall of roof was bounded on one side by a fault plane with slickensides, along the right rib of No. 2 entry. Transverse slips and bedding planes were also noted. This created an abnormal roof and rib condition where the accident occurred. The fault plane extended from the face of the entry outby for a distance of about 180 feet. The fireboss report of September 18, 1968, revealed that a "bad slip" along the right rib was supported; wide steel sheets in combination with bolts were installed

1. Turning No. 2 entry to the strike where abnormal conditions existed.
2. Presence of hidden slickensides in the strata.
3. Excessive width at intersections.
4. Not appraising accurately roof and rib conditions where abnormal conditions were evident.

1. Where faults or other disturbances are encountered, engineering projection changes should be made.
2. Employees and officials should be extremely careful in faulted roof areas, as this mine roof is known to contain numerous hidden slips, pots, and slickensides.
3. Width of mine openings at intersections should be kept to a minimum to avoid abnormal stress of the mine roof.
4. When mining in the vicinity of faults or other abnormal areas, roof and rib conditions should be appraised carefully and proper precautions taken such as installing additional support.
