Jamison #9 Mine

UNITED STATES
DEPARTMENT OF THE INTERIOR
BUREAU OF MINES

FINAL REPORT ON MAJOR EXPLOSION AND FIRE DISASTER
NO. 9 MINE
JAMISON COAL AND COKE COMPANY
FARMINGTON, MARION COUNTY, WEST VIRGINIA

November 13, 1954

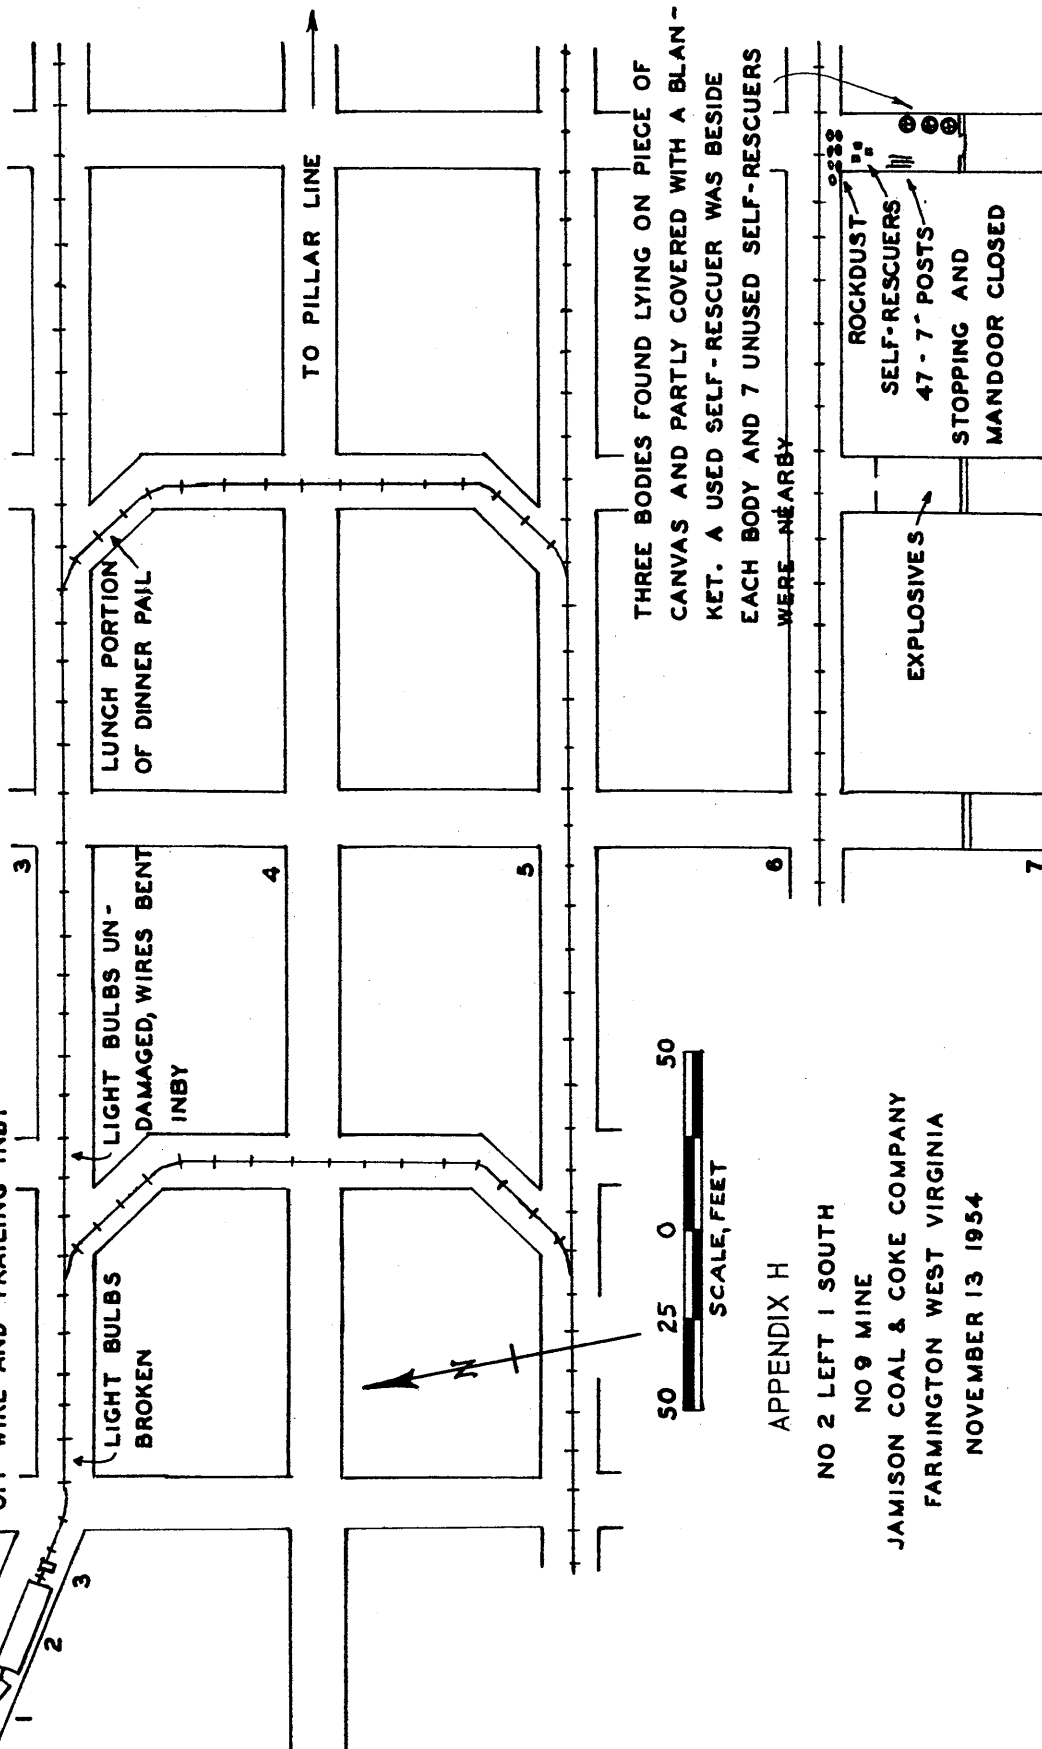
APPENDIX H

JEEP 1 AGAINST LOCOMOTIVE 2, OUTBY TRUCKS OF JEEP OFF TRACK
 FULL TOOL BOX 3. CONTROLLERS WERE OFF, BRAKES SET, TROLLEY POLES
 OFF WIRE AND TRAILING INBY
