**ACCIDENT INVESTIGATION REPORT
SURFACE NONMETAL MINE
FATAL FALL OF HIGHWALL ACCIDENT**

**Portable Crusher #2, ID No. 45-03226
Lloyd Logging, Inc.
Wenatchee, Chelan County, Washington**

May 19, 1995

INVESTIGATION OF MASSIVE SLOPE FAILURE
PORTABLE CRUSHER NO. 2 (ID NO. 45-03226)

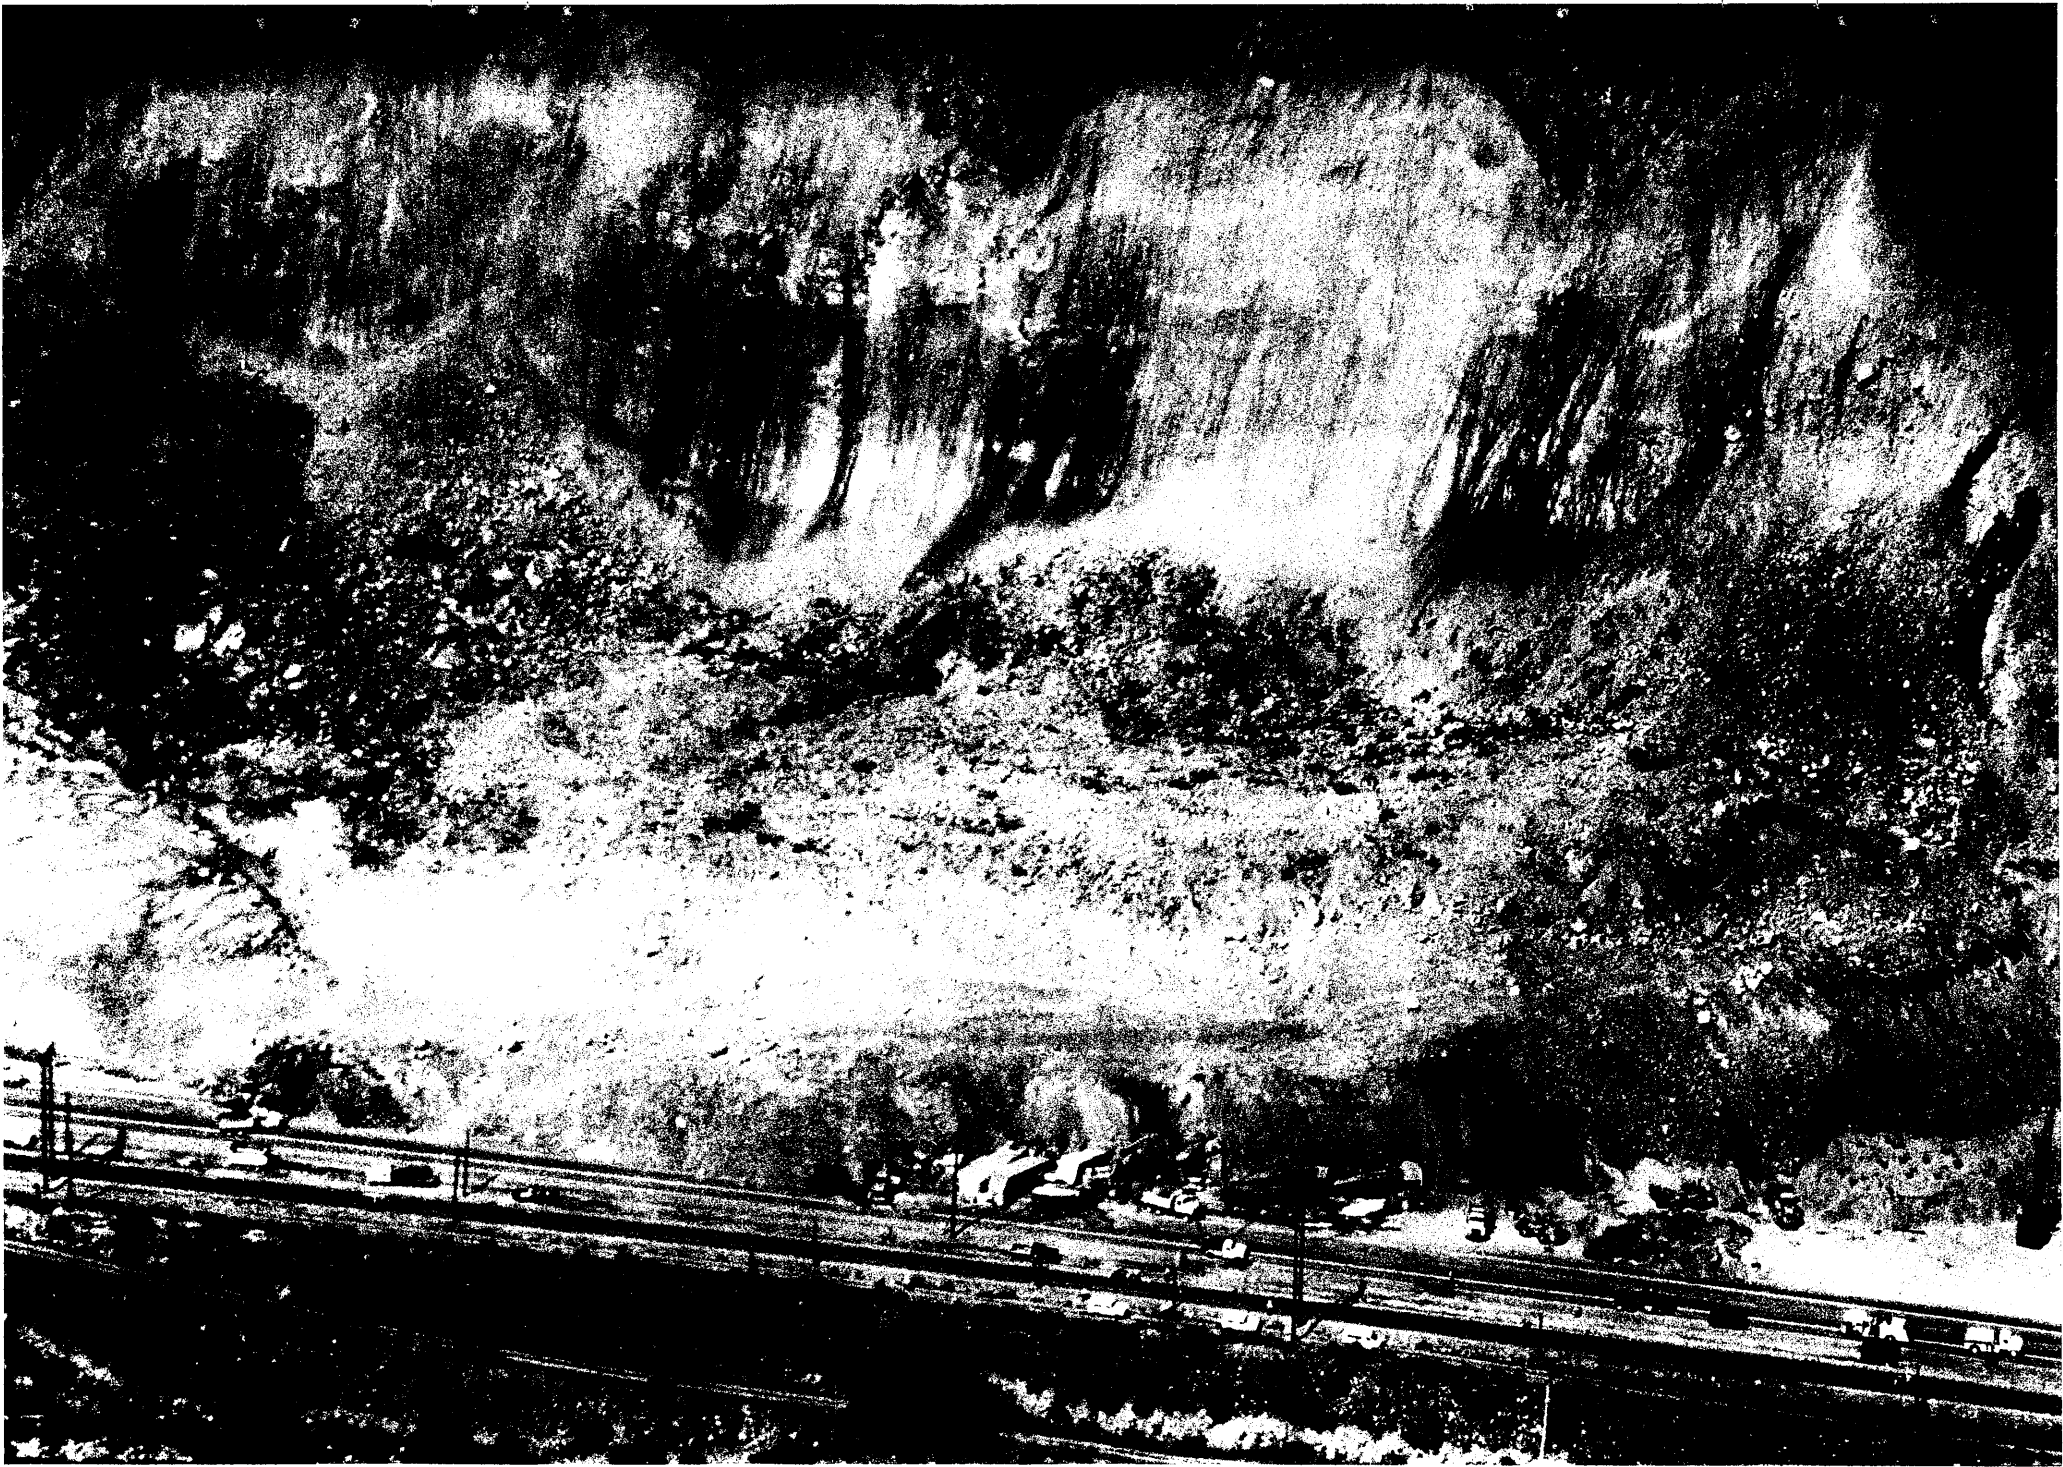
AERIAL PHOTO OF ACCIDENT SITE. LLOYD LOGGING, INC., MAY 19, 1995

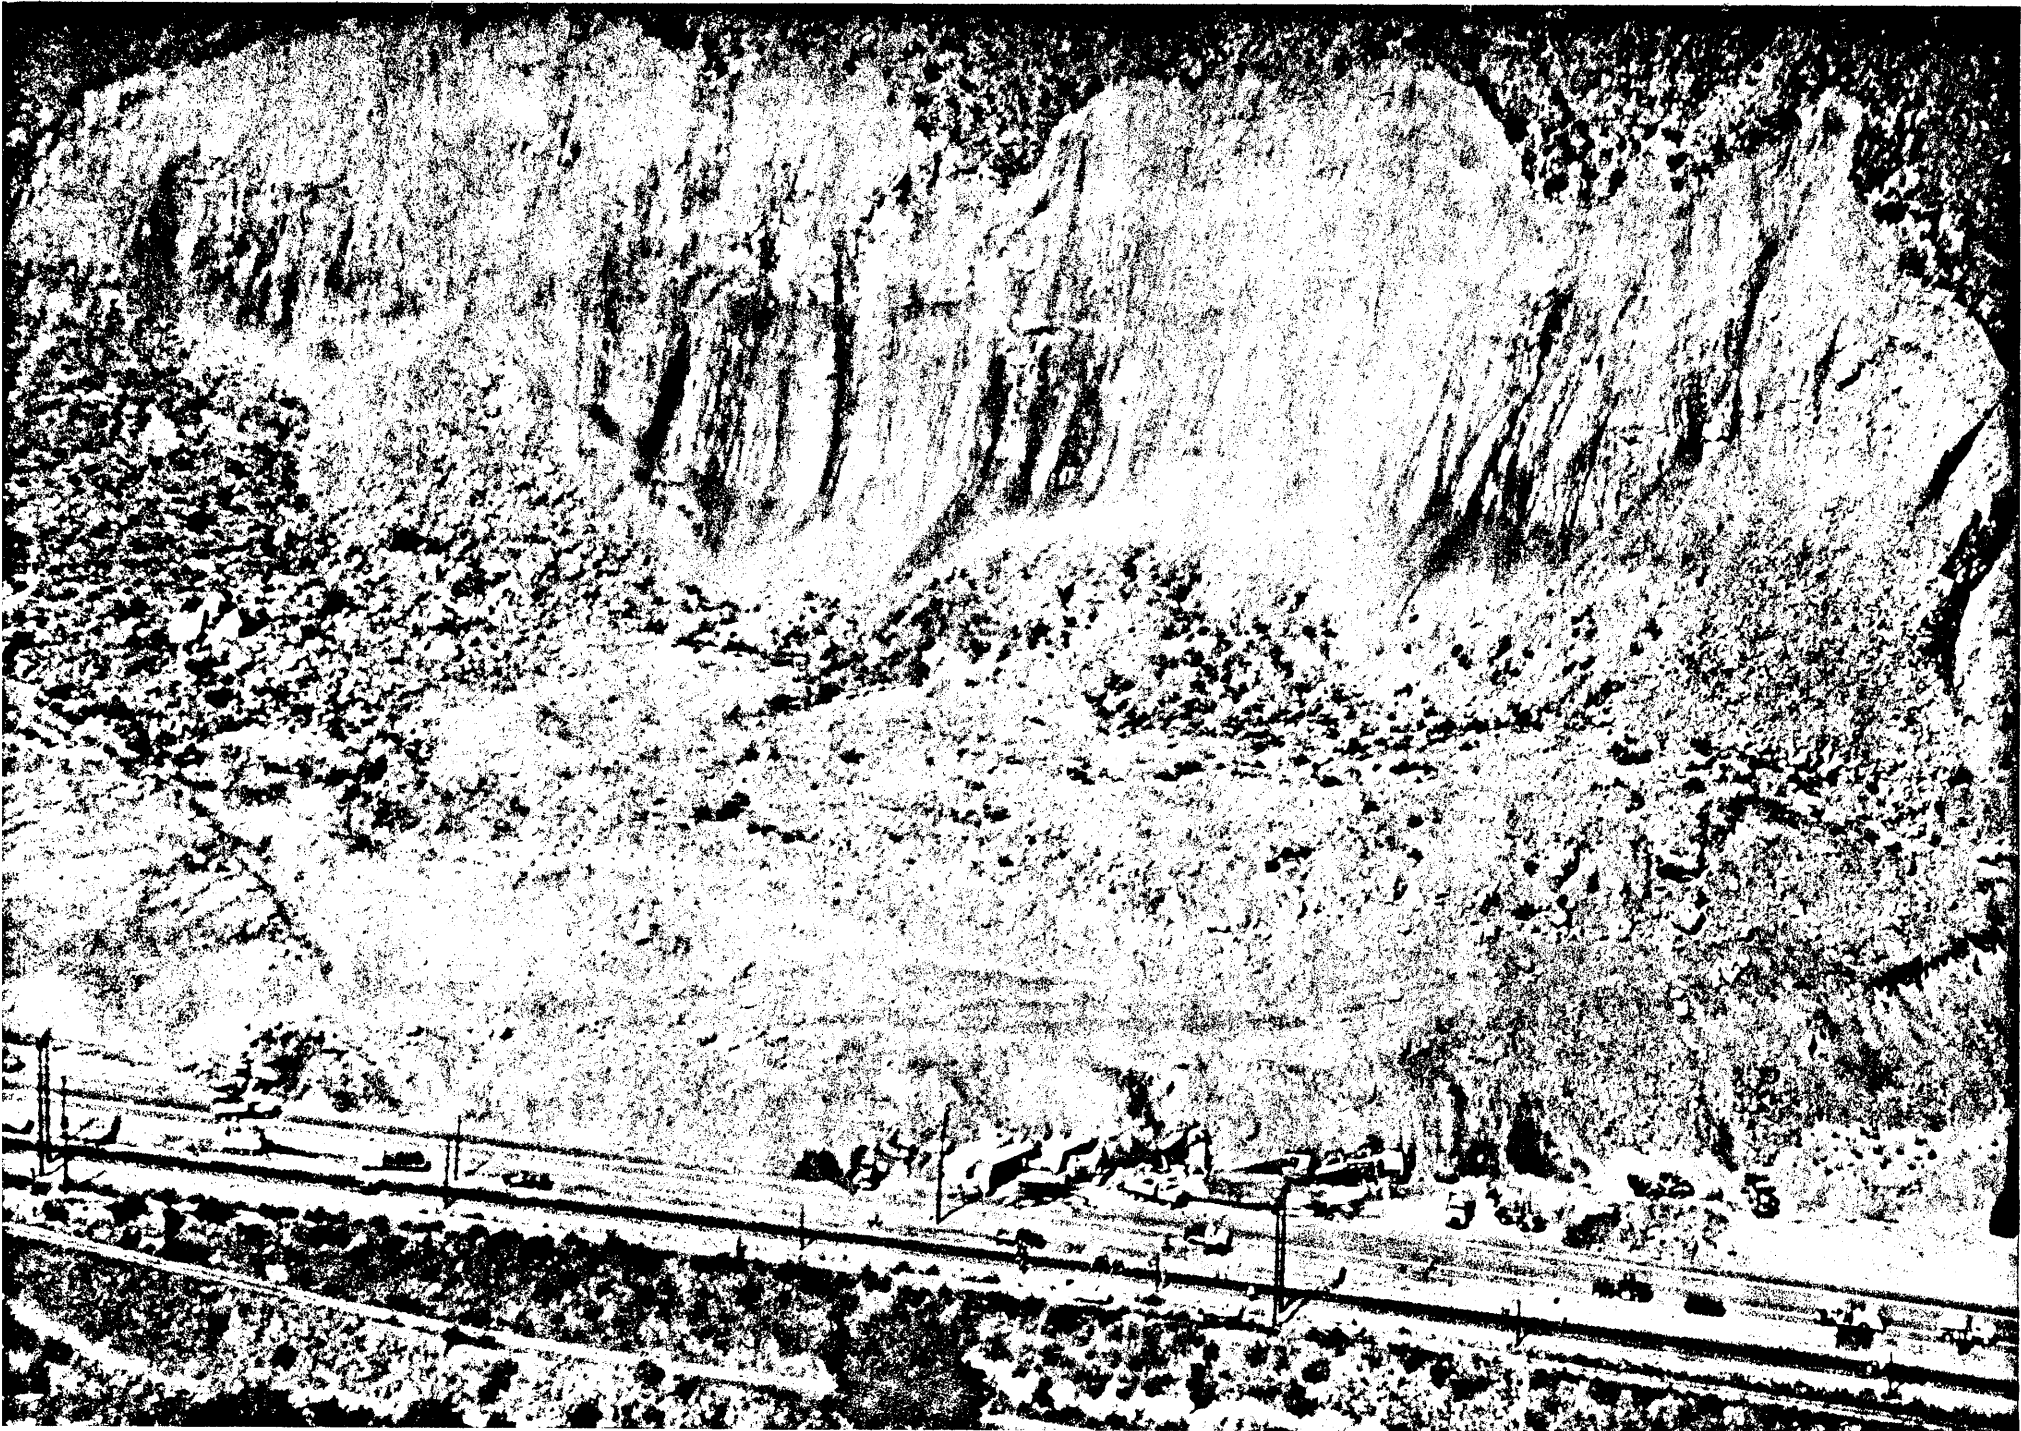
AERIAL PHOTO OF ACCIDENT SITE. LLOYD LOGGING, INC., MAY 19, 1995

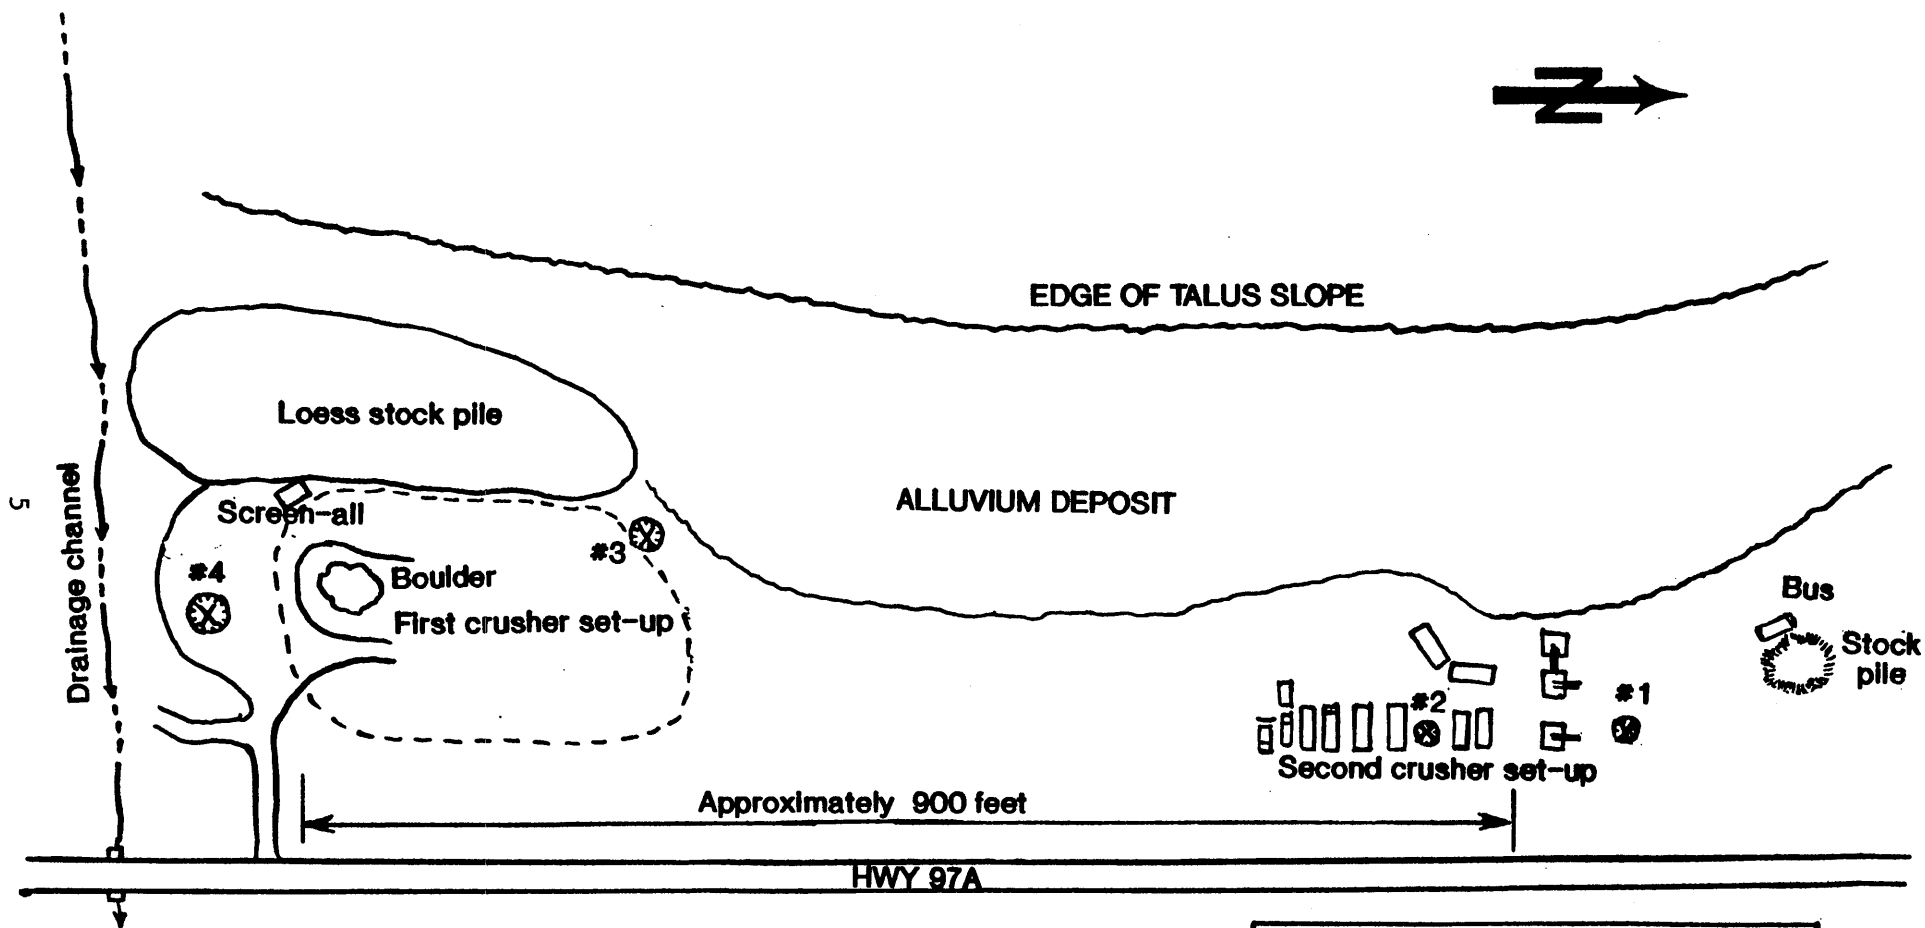
FIGURE - 2
APPROXIMATE LOCATION
OF CRUSHER SET-UP
AND EXPLORATION PITS
LLOYD LOGGING, INC.

Exploration pits are numbered 1 to 4

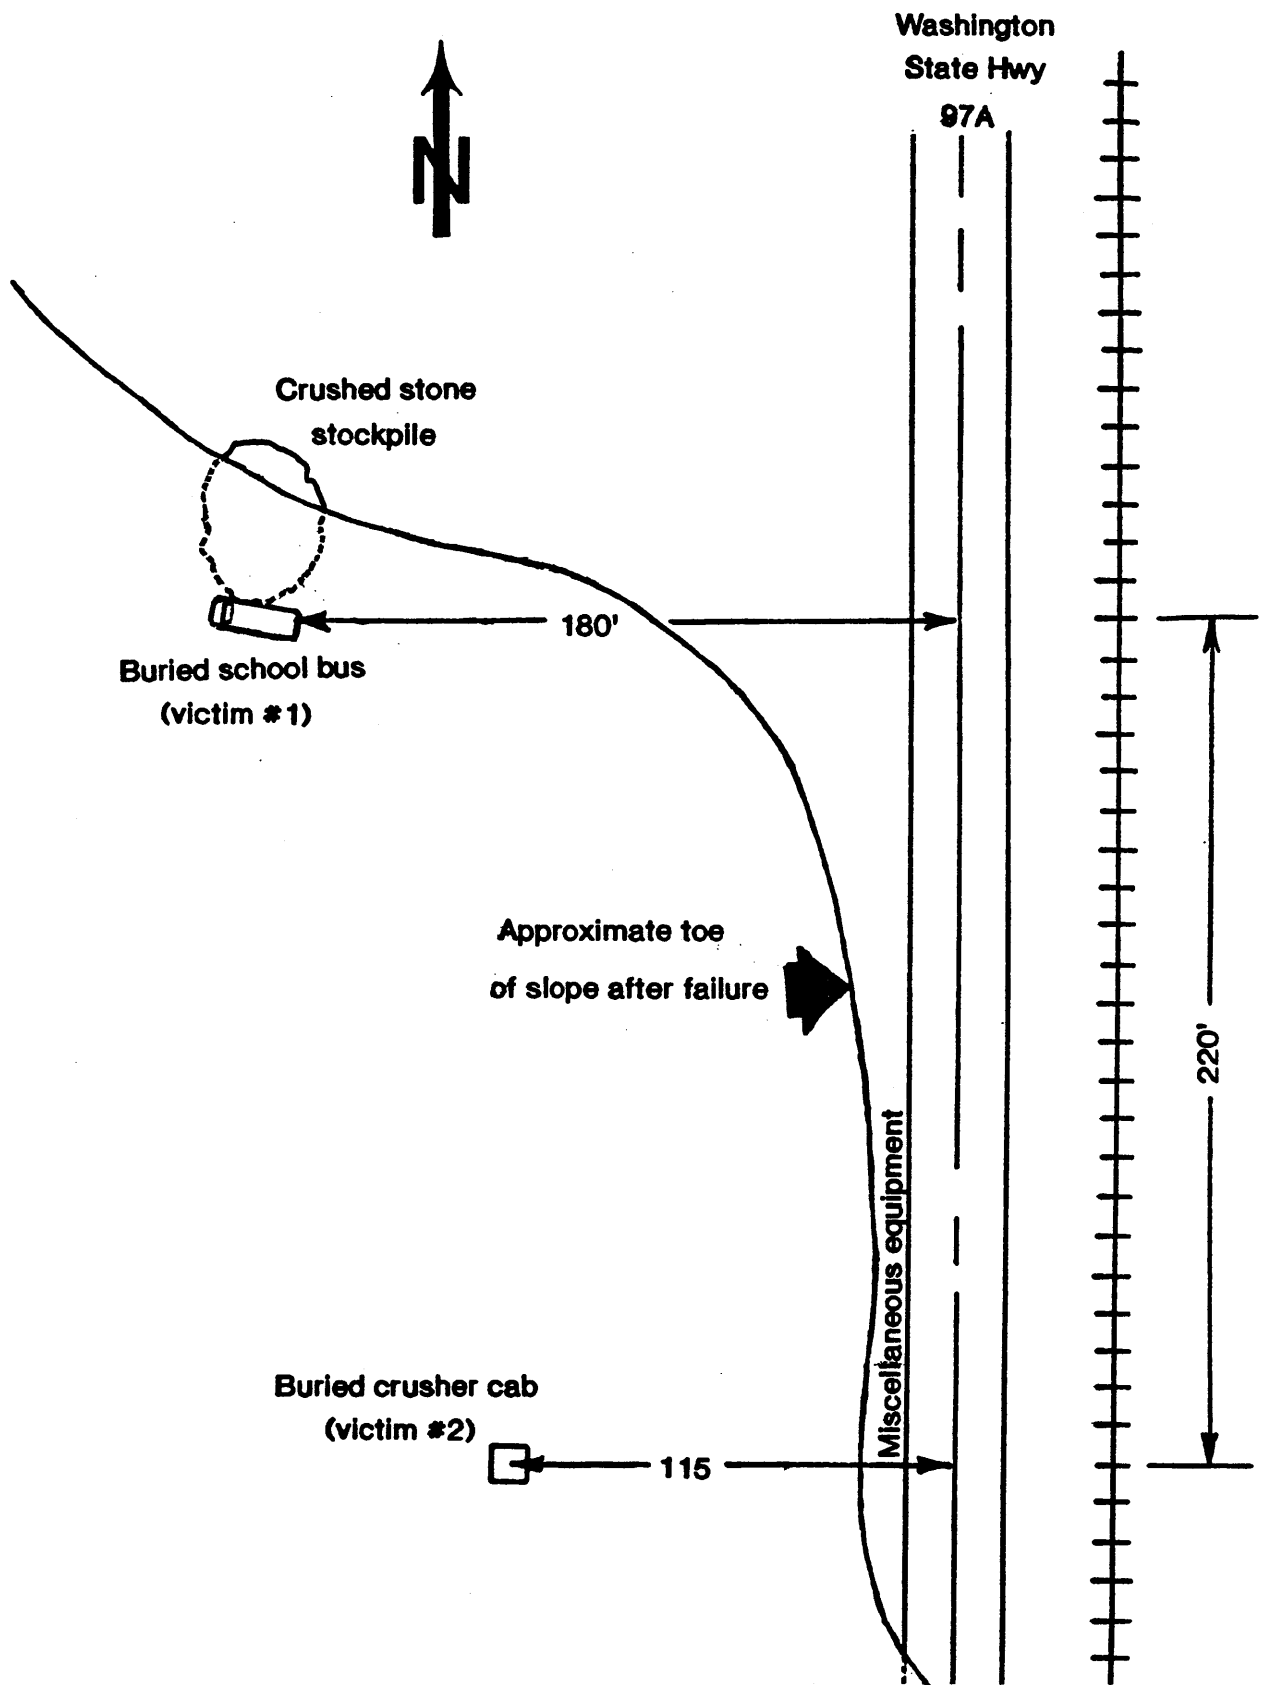
FIGURE - 3

A massive recovery effort was begun almost immediately after the failure to search for victims. The first victim was recovered the next day, the second was recovered a day later (figure 3). Recovery photos 1, 2 and 3 show the condition under which the victims were buried. An investigation into the cause of the slope failure was begun on May 22, 1995.

LOCATION OF ACCIDENT VICTIMS
LLOYD LOGGING, INC.

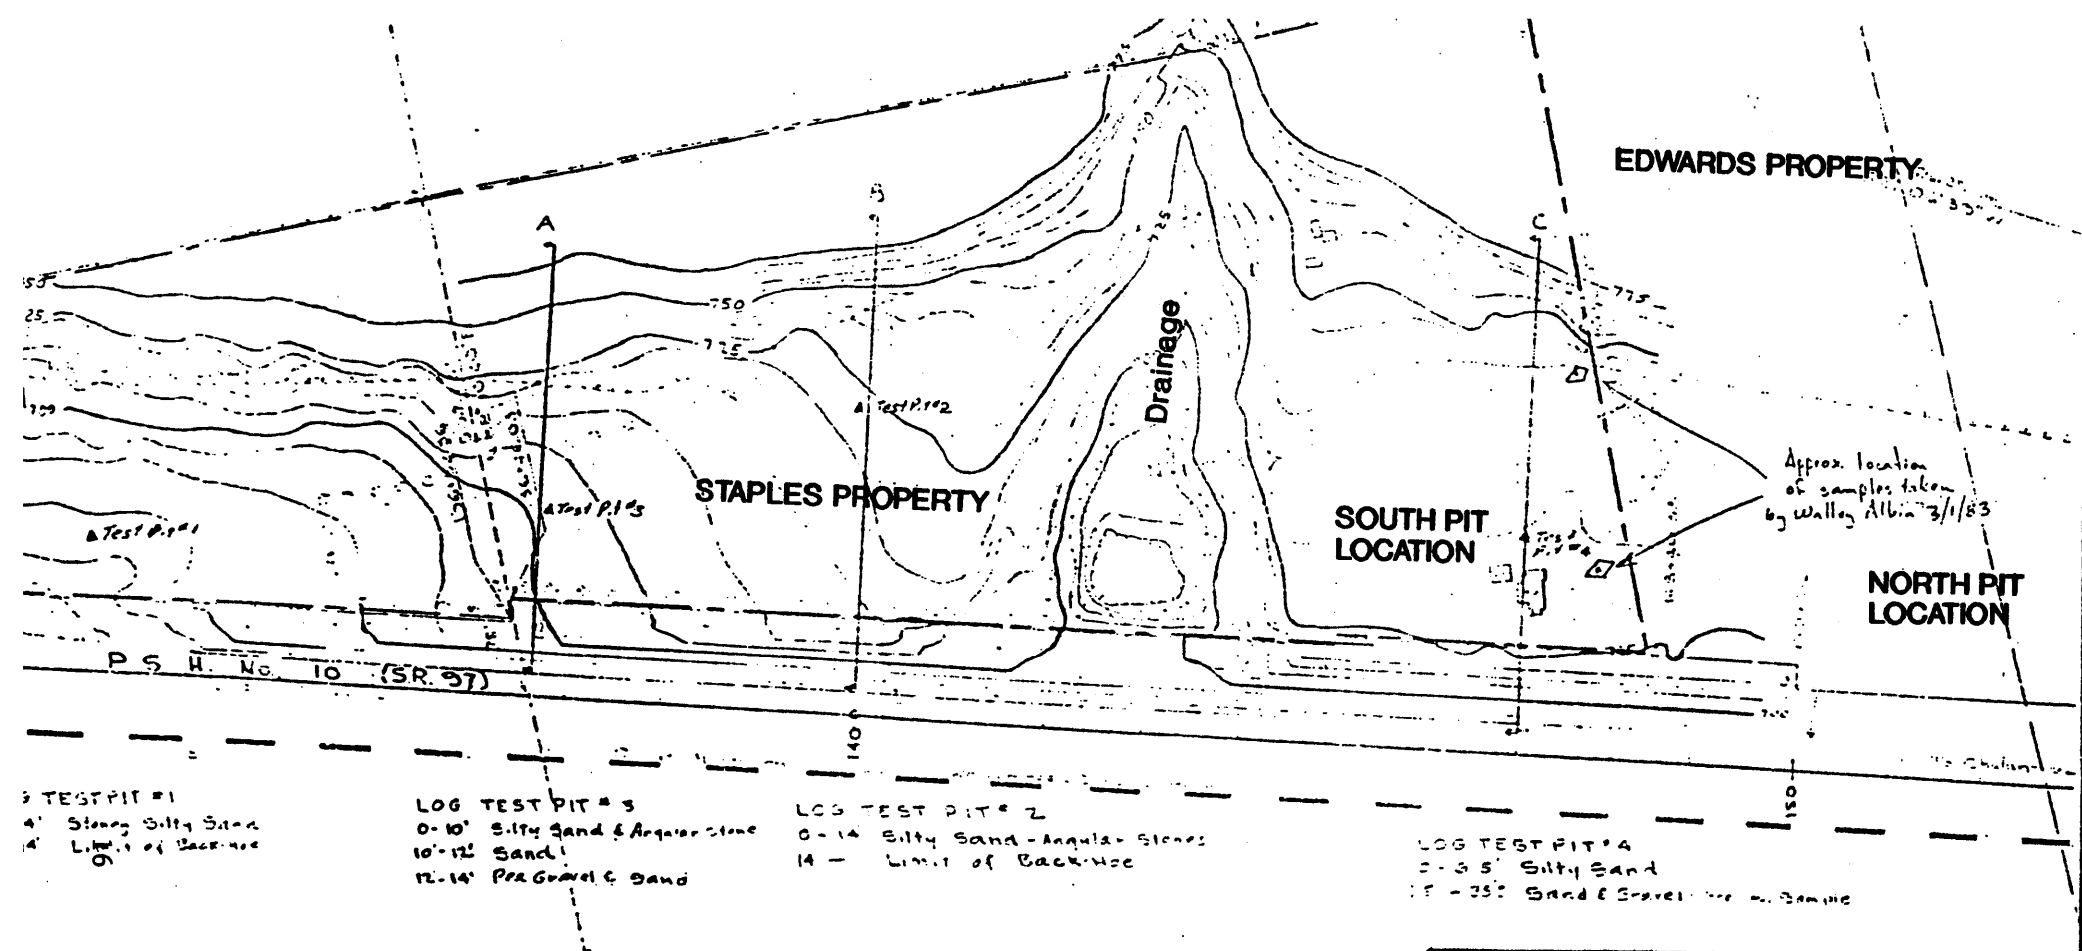
FIGURE 6

**PROPERTY BOUNDARY BETWEEN
STAPLES AND EDWARDS TRACTS**

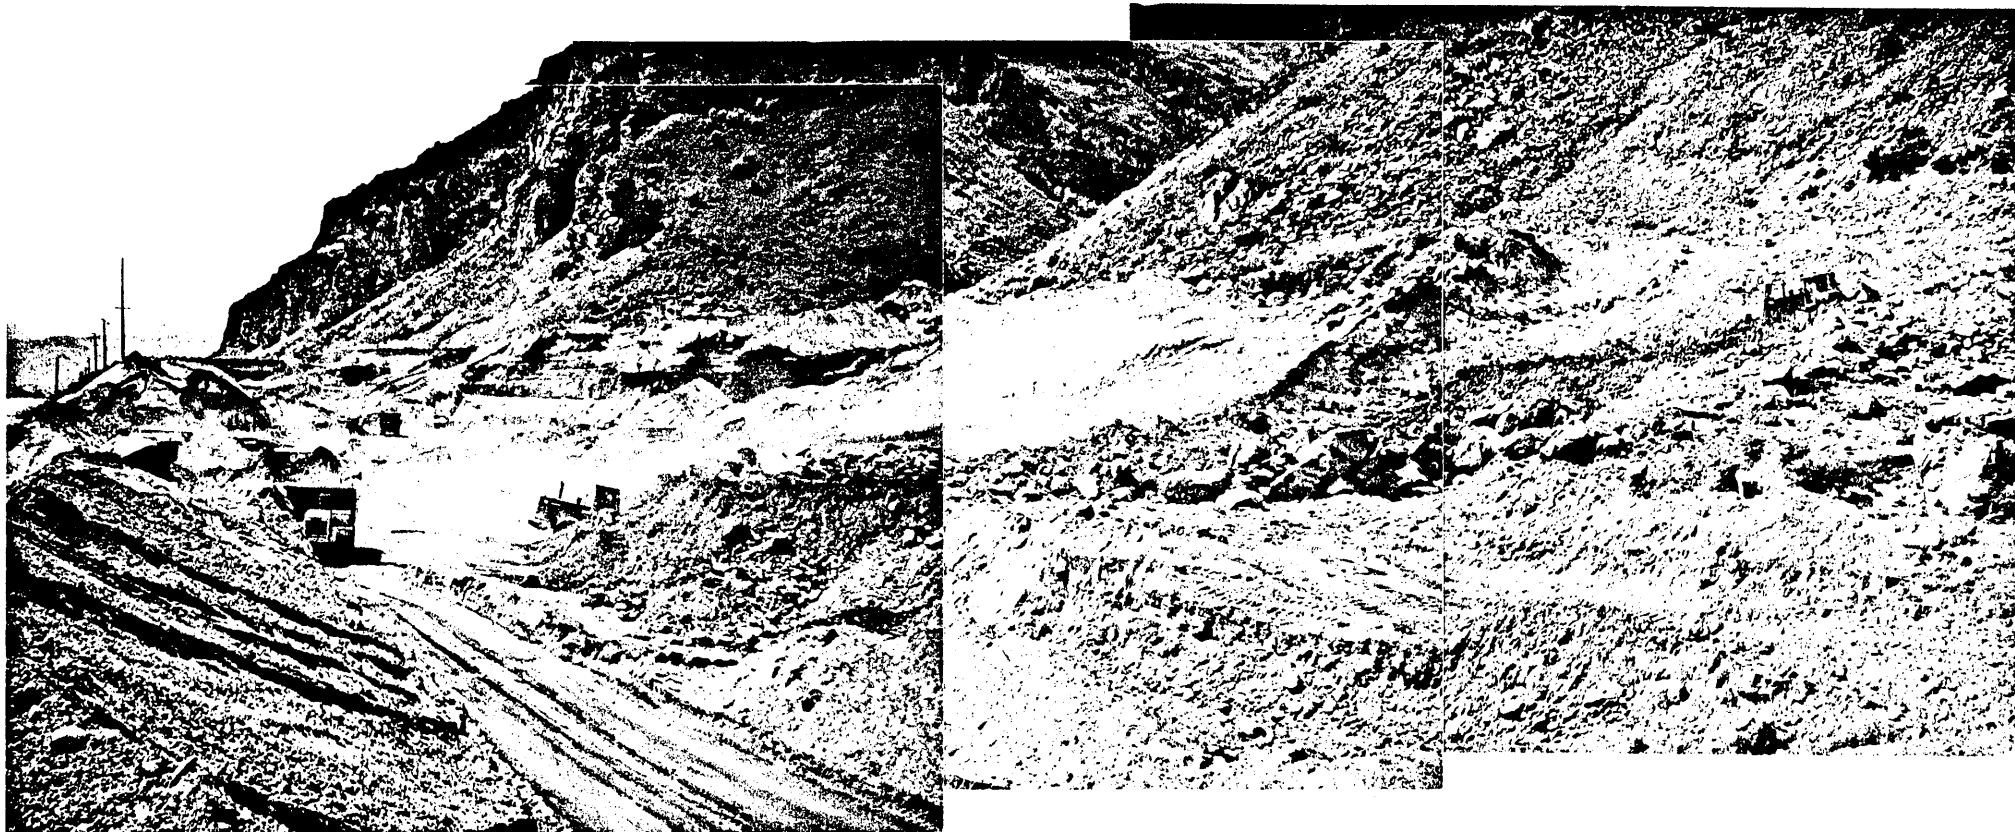
Aerial photos taken by the Washington Department of Transportation (strip photo) in May 1992 and by the U.S. Forest Service (stereo pair) in July 1992 indicate two separate pits with an unmined area of the gravel bench between. This unmined area would have acted as a buttress against the talus slope. Production records provided by Morrill Asphalt Company indicate a volume of about 160,000 cubic yards has been removed since 1992 although there is no indicated production in May, June or July 1992. What has become the north pit was initially operated in the 1950's during construction of Rocky Reach Dam. The south pit has been operated since about 1983. Production volume from previous operators in both pits could not be determined. Photos taken at the south pit 2 weeks prior to the failure indicate that most of the remnant bench area between the north and south pits had been removed (photo 14). A photo taken from across the river the day before the failure also indicates that most of the remnant bench had been removed (photo 15).

PHOTO 14. - Panorama shot of the south pit approximately 2 weeks prior to the slope failure. The gravel bench that originally separated the north and south pits has been largely mined out. (Washington State Department of Natural Resources).

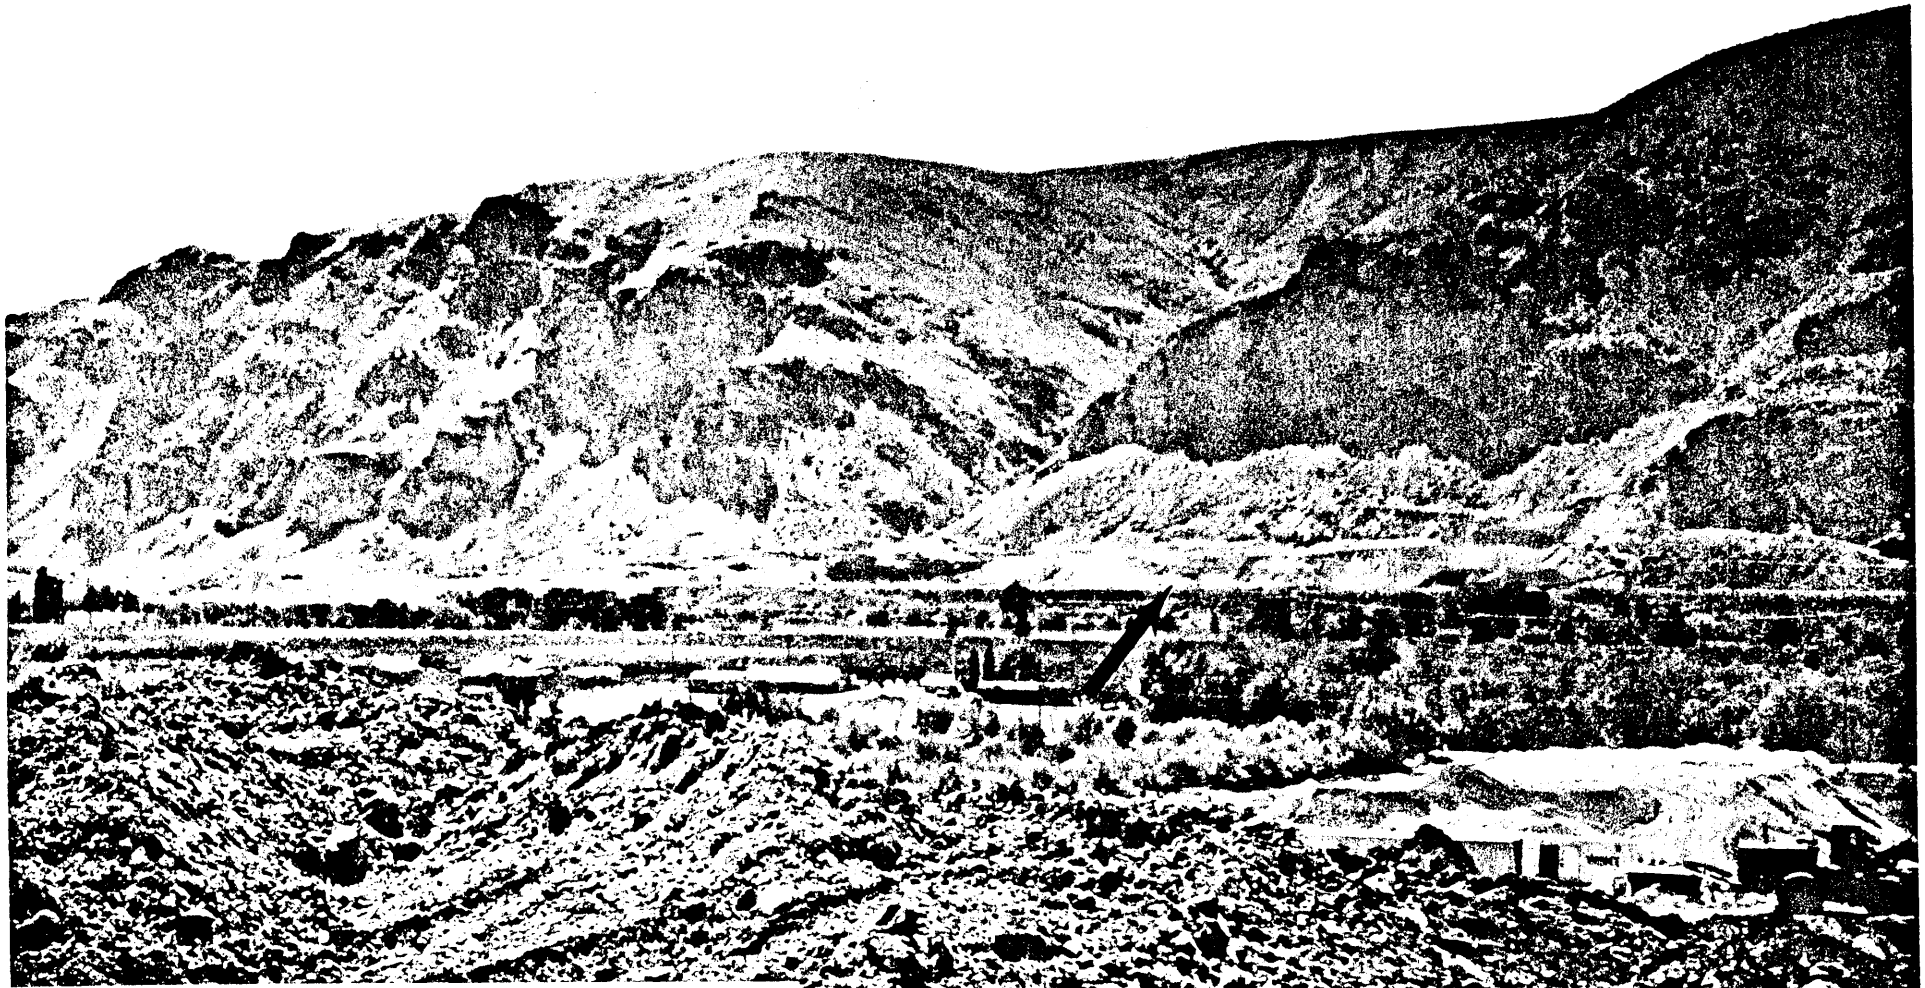
PHOTO 15. - Looking west from the east side of the Columbia River toward the gravel pit. (Taken the day before the slope failure). Arrow points to the plant set-up in the pit. Upper part of talus slope is in the shadow. (Washington State Department of Natural Resources).

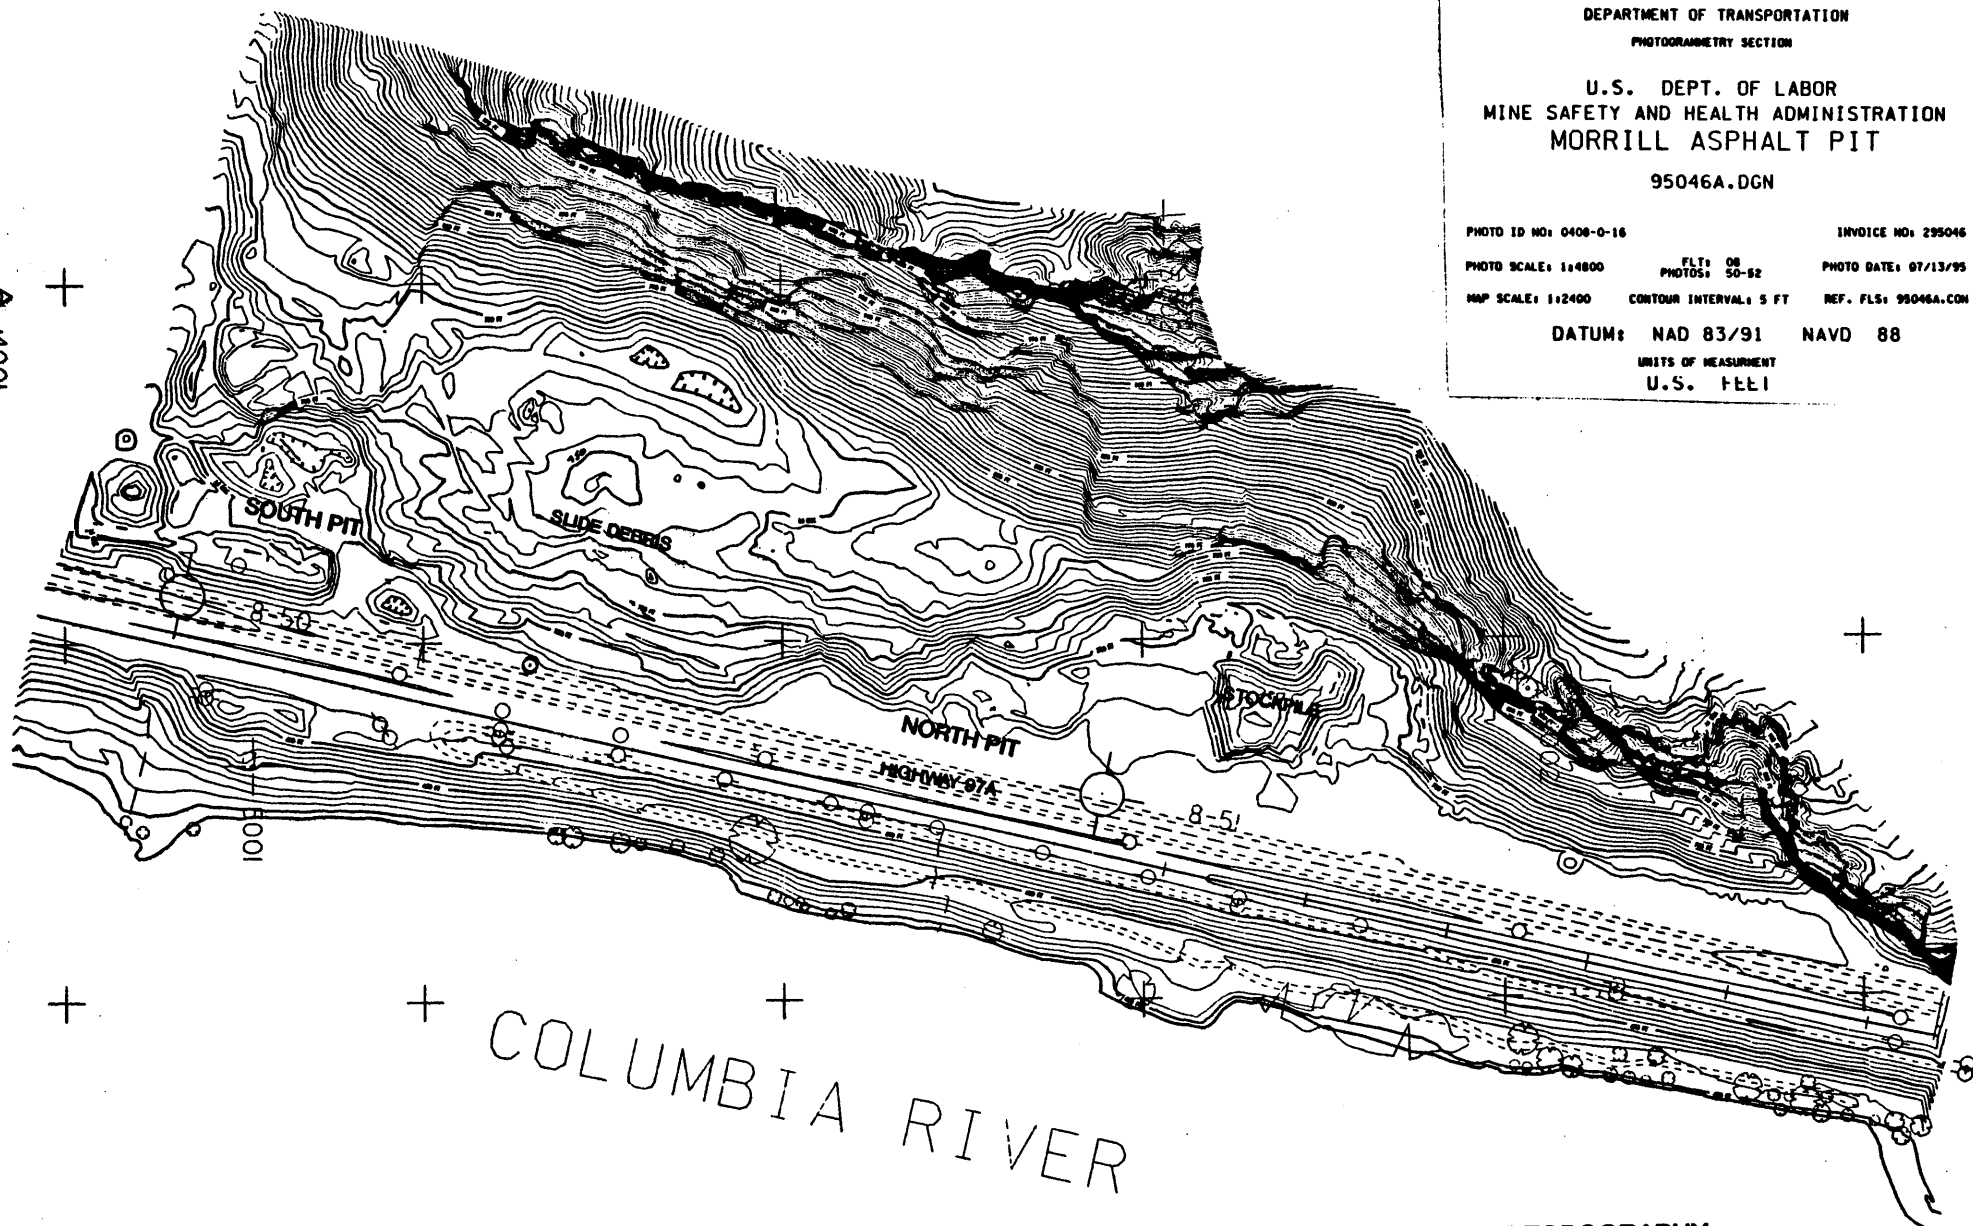
B - 2

POSTFAILURE TOPOGRAPHY
