FINAL REPORT OF MAJOR ROOF-FALL DISASTER

LUNDALE MINE
AMHERST COAL COMPANY
LUNDALE, LOGAN COUNTY, WEST VIRGINIA

February 12, 1958

James T. Whalen
Federal Coal-Mine Inspector

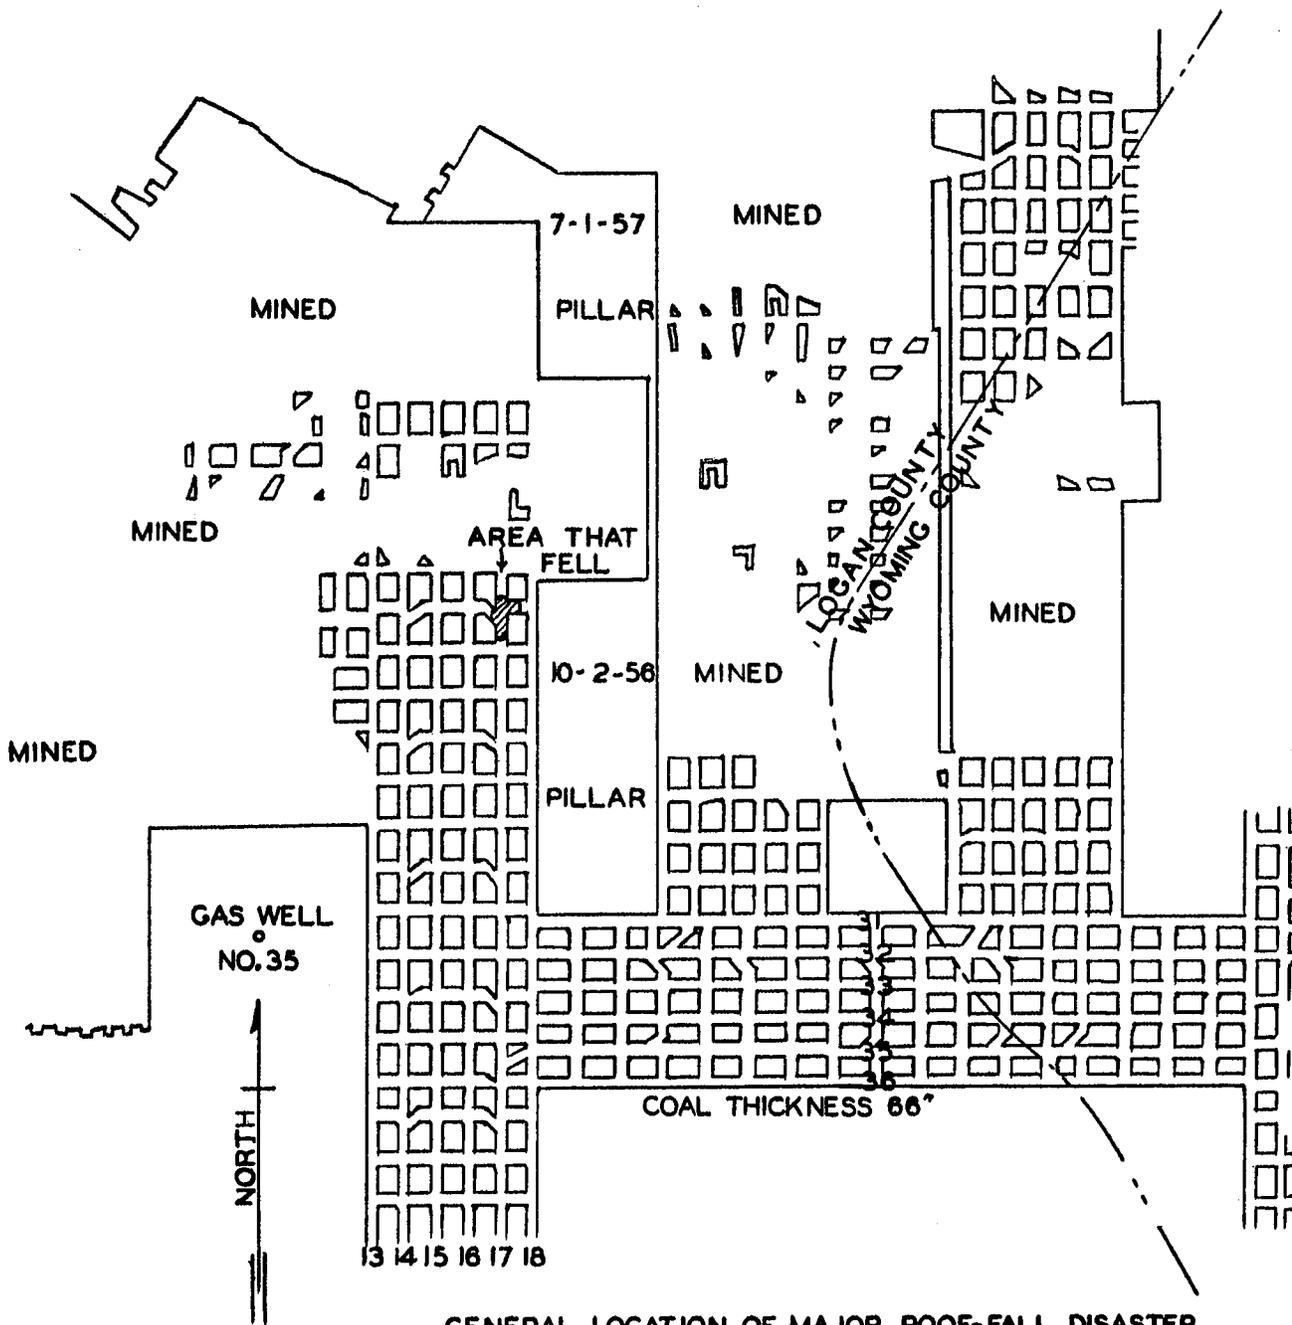
GENERAL LOCATION OF MAJOR ROOF-FALL DISASTER
 LUNDALE MINE, AMHERST COAL COMPANY,
 LUNDALE, LOGAN COUNTY, WEST VIRGINIA. FEBRUARY 12, 1958.
