UNITED STATES  
DEPARTMENT OF LABOR  
MINE SAFETY AND HEALTH ADMINISTRATION  
COAL MINE SAFETY AND HEALTH

REPORT OF INVESTIGATION  
Fatal Shaft Sinking Explosion  
January 22, 2003

McElroy Mine  
McElroy Coal Company  
(Subsidiary of CONSOL Energy Incorporated)  
Cameron, Marshall County, West Virginia  
ID No. 46-01437

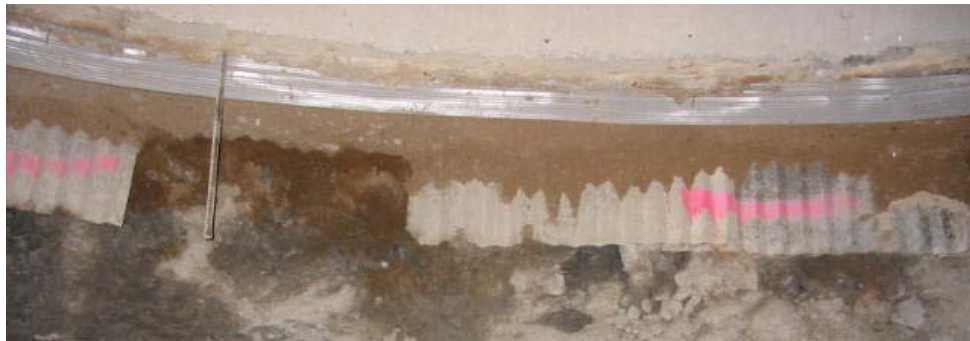
Belly band, rebar, and water seal gasket protruding from concrete shaft lining

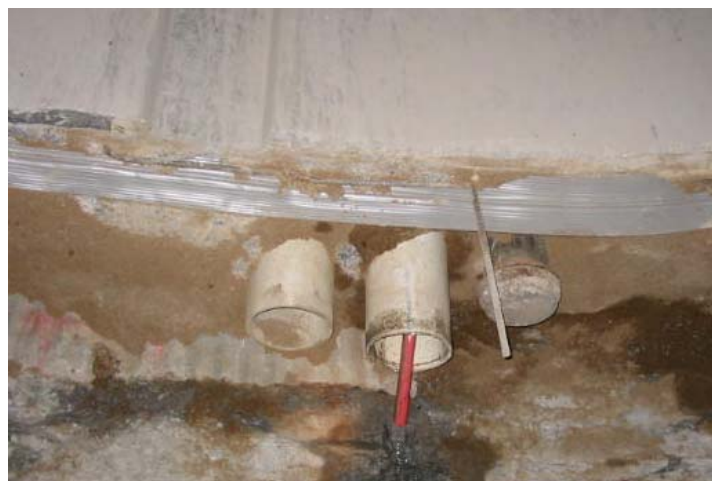
Two PVC and a steel pipe protruding from concrete shaft lining

Four pipes were installed within the shaft wall and extended from the collar to the bottom of the shaft. Three of the pipes were 8-inch diameter PVC pipes and the fourth was a 6-inch diameter steel pipe. These were intended to be used for mine utilities and de-watering. Methane was discovered flowing from the pipes on February 5, 2003. The levels found varied. The dates and levels are provided below.

It was initially thought that the methane found in the pipes was flowing from the Pittsburgh Coal seam, through the muck pile in which the pipes were buried, and into the uncapped inby ends of the pipes. However, on February 11, 2003, the inby ends of the pipes were dug out by the investigators exposing the end of each pipe and no methane source was found.

Subsequent tests were performed on February 12, 2003, to try to determine the source of the methane. During one test, the end of the PVC pipe liberating the highest detected quantities of methane was capped in the shaft with a plastic seal. A pressure of 1.15 inches was measured across the seal. Methane was measured in the pipe at the top of the shaft. The methane concentration substantially increased to 6.8% after a short period of time. This increase caused the investigation team to believe that the pipe(s) could have been fractured during shaft construction. A down-hole camera was brought to the site on February 13<sup>th</sup>, and used to film the entire length of the pipe. Openings and cracks in the PVC pipe were found in four places that would have permitted methane to enter the pipe. At a depth of approximately 220 feet, a 1-foot crack was found, at 415 feet, a 2-inch crack, at 505 feet a separation, and at 690 feet, a large crack. It is reasonable to expect that methane entered the other pipes where openings and cracks existed and where the joints were not sealed.

The PVC pipe containing the blasting wires was of particular concern because measured methane concentrations approached dangerous levels. To eliminate the methane hazard, CCD was required to not cap or plug either end during the completion of the shaft construction.
