REPORT OF FATAL COAL MINE RIB-FALL ACCIDENT
BANNING NO. 4 MINE
REPUBLIC STEEL CORPORATION
NORTHERN COAL MINES DISTRICT
WEST NEWTON, WESTMORELAND COUNTY, PENNSYLVANIA

September 12, 1967

Everett Turner
Federal Coal Mine Inspection Supervisor

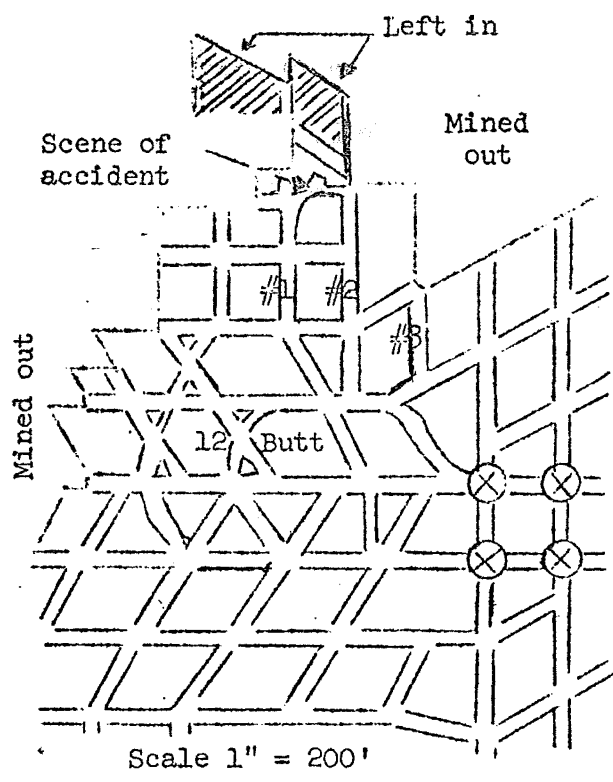
Sketch "A"

During the investigation, about 3 hours after the accident, it was evident that extraordinary stresses were present on the ribs of the accident area and surrounding area. Considerable crushing and spalling of the ribs were observed. The abandoned gob areas were in proximity to the block being mined (see sketch B); It was also evident that abnormal height existed in the accident area due partially to the unusual thickness of the draw slate.

At the scene of the accident the thickness of the coalbed being mined, including the draw slate, was 9-1/2 feet. The draw slate was 22 inches thick. The slate that toppled over and was involved in the accident was 42 by 22 by 24 inches; however, it was broken in two and it could not be ascertained whether all or only a portion of the slate struck the victim.

extraordinary stresses on the ribs crushing the coal and causing the slate to topple over. Contributing factors could have been improper or inadequate examination and tests and failure to detect and evaluate properly a dangerous condition. Another contributing factor could have been a condition created by two inaccessible pillars (see sketches) that had been left during previous mining.

1. A more thorough examination of areas where abnormal conditions exist should be made by officials and employees so that a better evaluation of hazardous conditions can be made and necessary safety precautions taken. If an unsafe condition is detected and cannot be corrected, the place should be vacated.
2. When unusual or abnormal conditions are encountered, such as excessive pressure causing spalling of the ribs and where the thickness of the coalbed including the draw slate is abnormal adding height to the ribs as in the accident area, special safety precautions should be taken to protect employees from falls of such ribs.
