REPORT OF INVESTIGATION

Underground Metal Mine
(Silver Ore)

Fatal Explosives and Blasting Agents Accident
November 17, 2013

Star Mine Operations LLC
Revenue Mine
Ouray, Ouray County, Colorado
Mine ID No. 05-03528

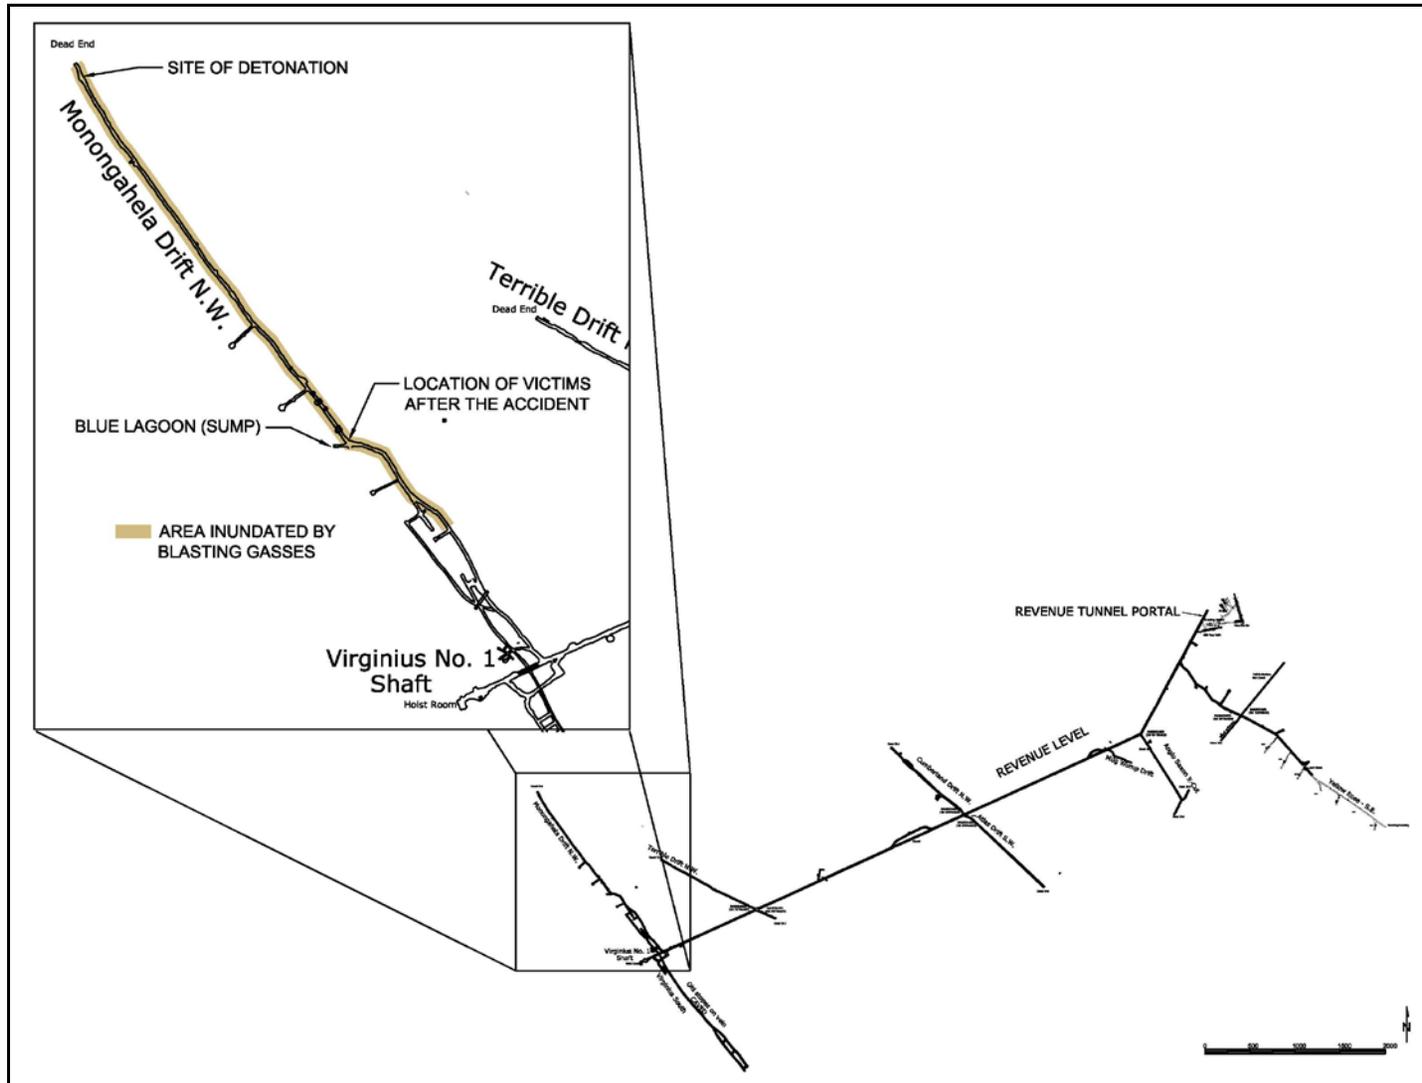
Figure 1 – Location of the Accident

The accident occurred in the Monogahela drift of the Revenue Mine. The Monogahela drift extends 2,300 feet from the Revenue tunnel to the dead end face. The average dimension of the drift is 10 feet high by 9 feet wide. Figure 1 depicts the location of the Monogahela drift as it relates to the entire mine workings. The location of the two victims at the time of recovery is shown on the map. The highlighted accident area also includes the entire area inundated by

blasting gasses. In addition to the victims, 20 other miners were exposed to toxic and noxious gasses at various locations throughout the drift.

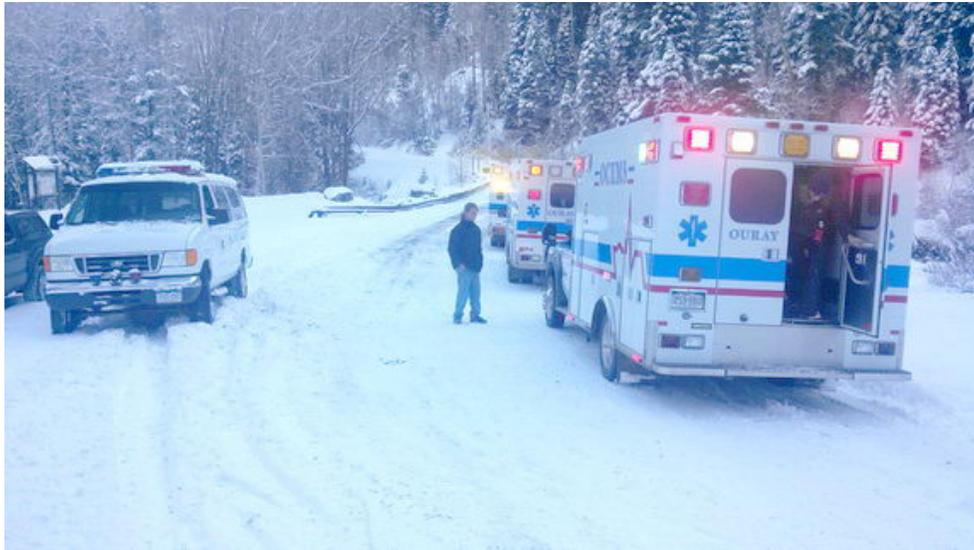
Figure 2 - Ambulance Staging Area at Angel Creek on November 17, 2013

On the day of the accident, the weather at the mine was snowing and the average temperature was 34° Fahrenheit. The road to the mine was snow covered and initially did not allow ambulance access to the mine (see Figure 2). A county plow truck operator saw emergency crews traveling toward the mine, came to their aid, and plowed the road to the mine. Weather was not considered to be a contributing factor to the accident.
