REPORT OF INVESTIGATION

**Fatal Underground Mine Explosion
April 5, 2010**

**Upper Big Branch Mine-South, Performance Coal Company
Montcoal, Raleigh County, West Virginia, ID No. 46-08436**

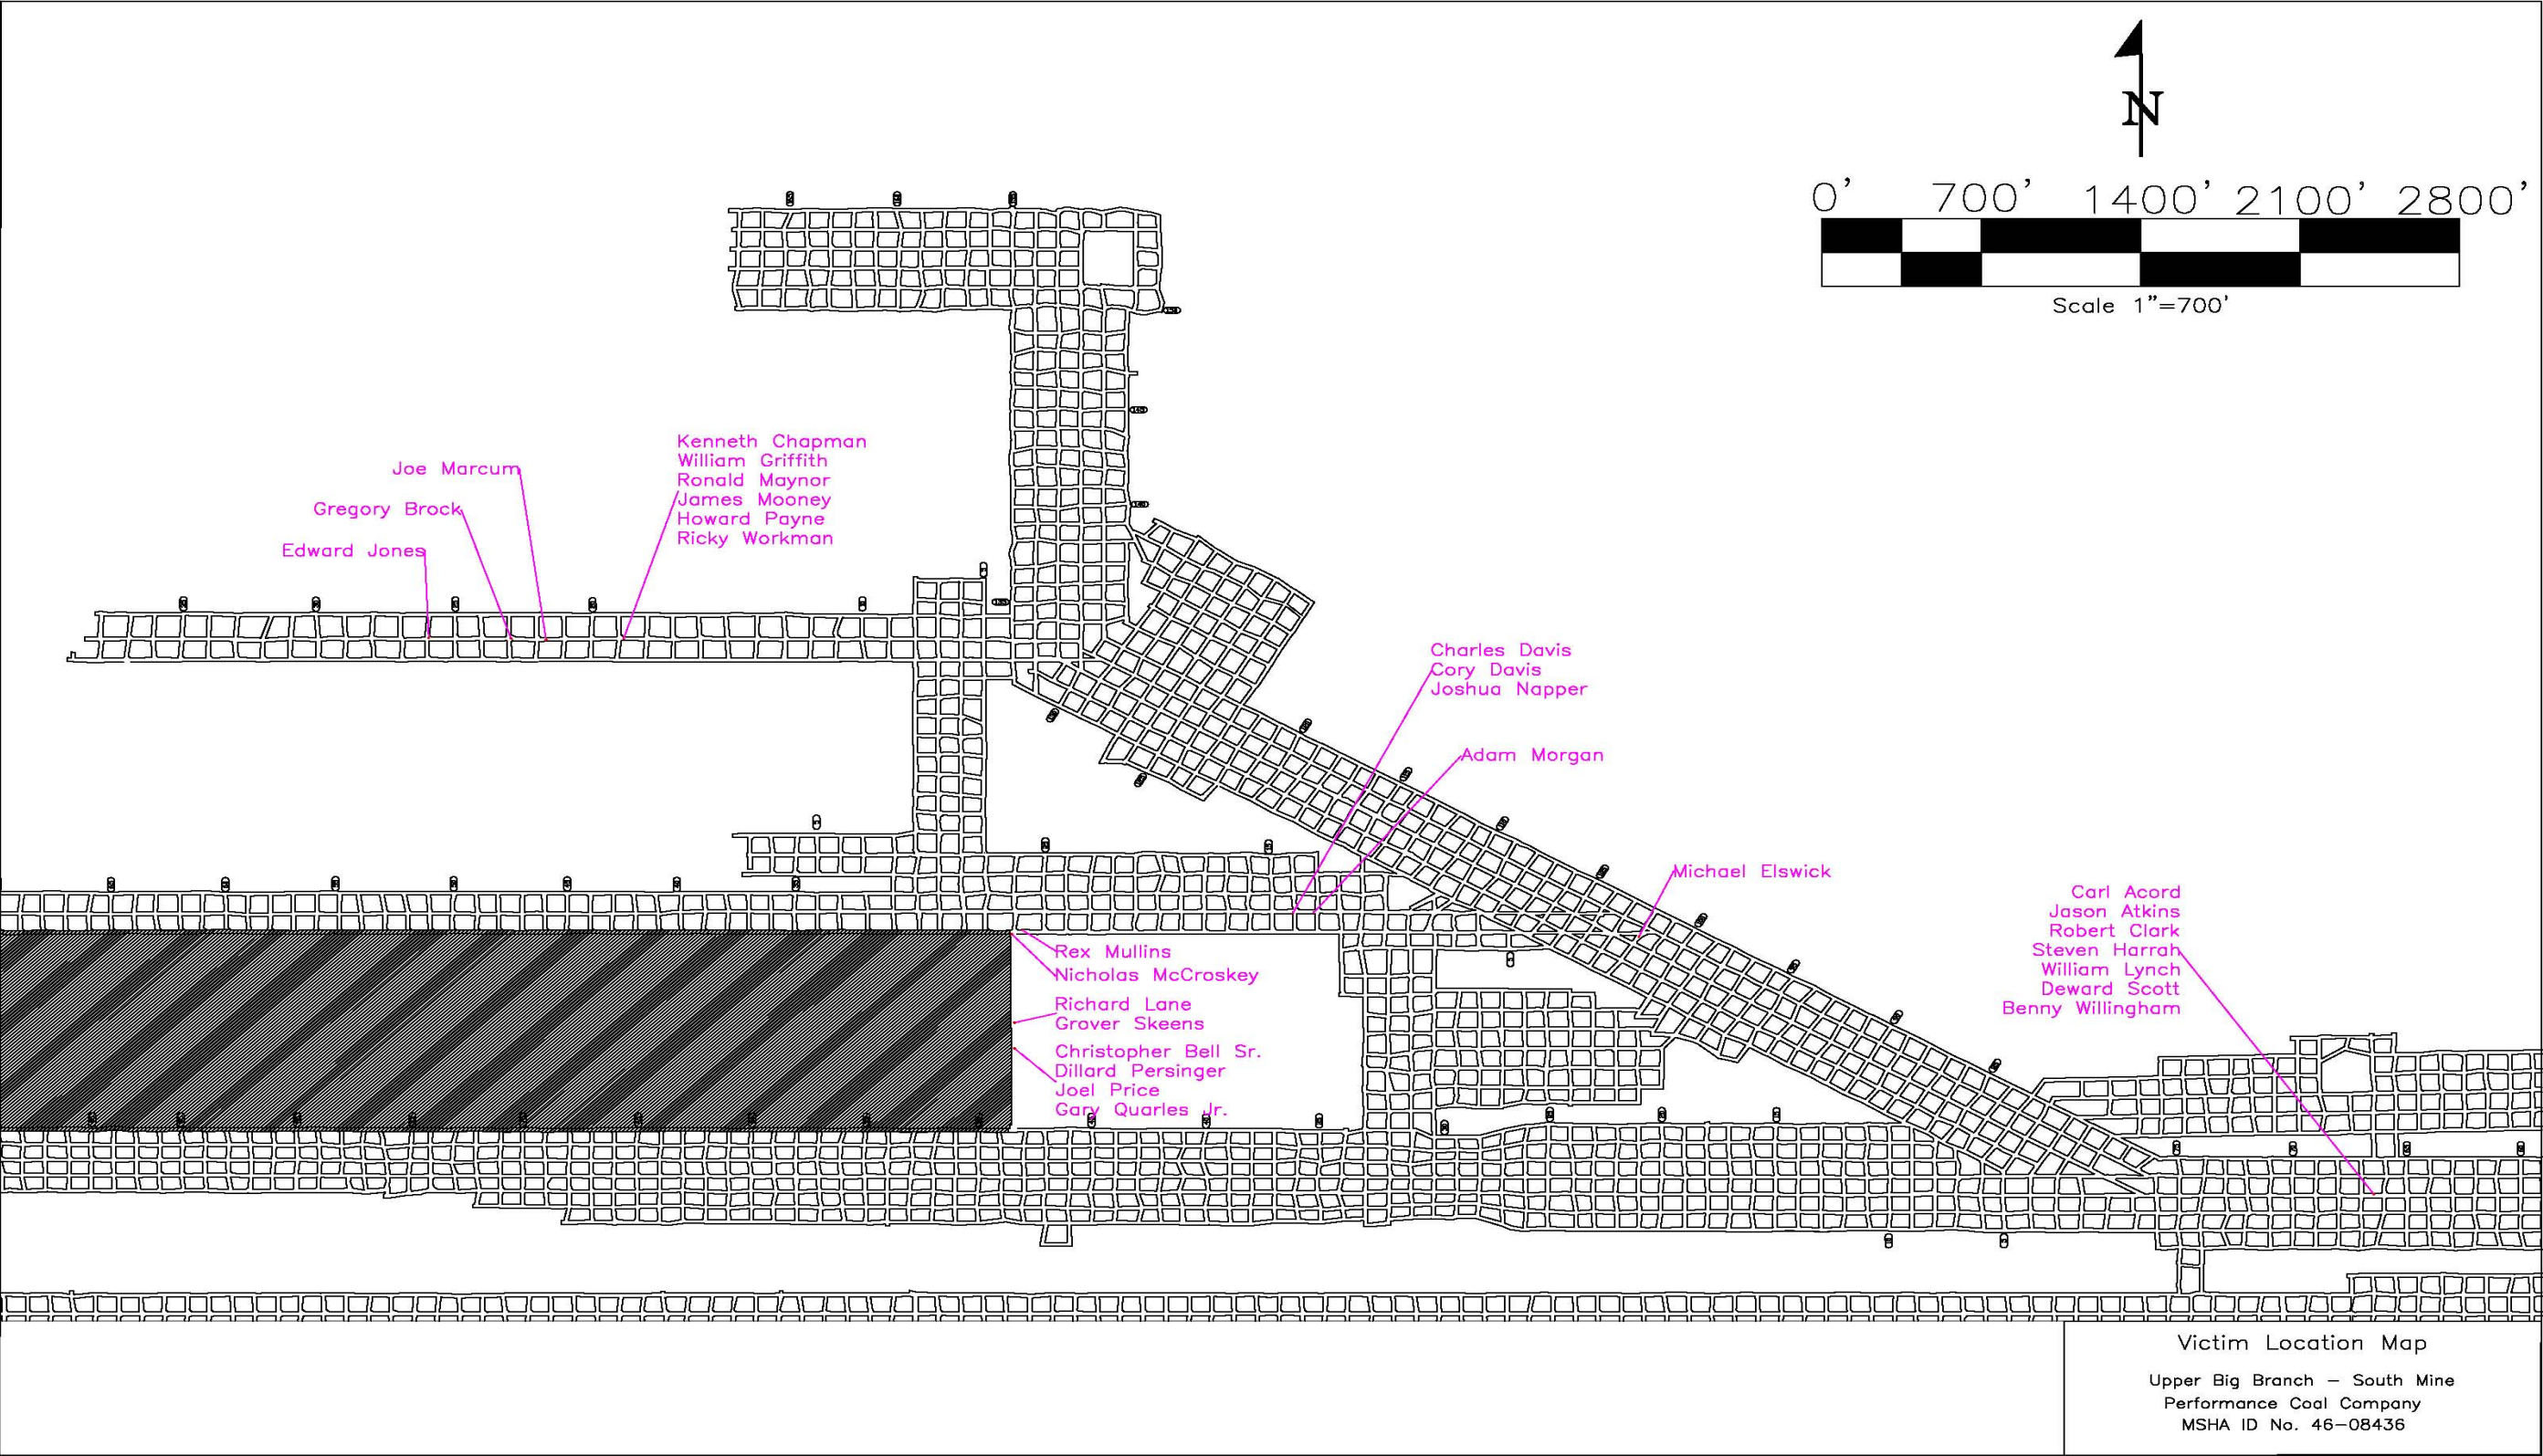
Figure 1: Victim Location Map

Victim locations are depicted in Figure 1.

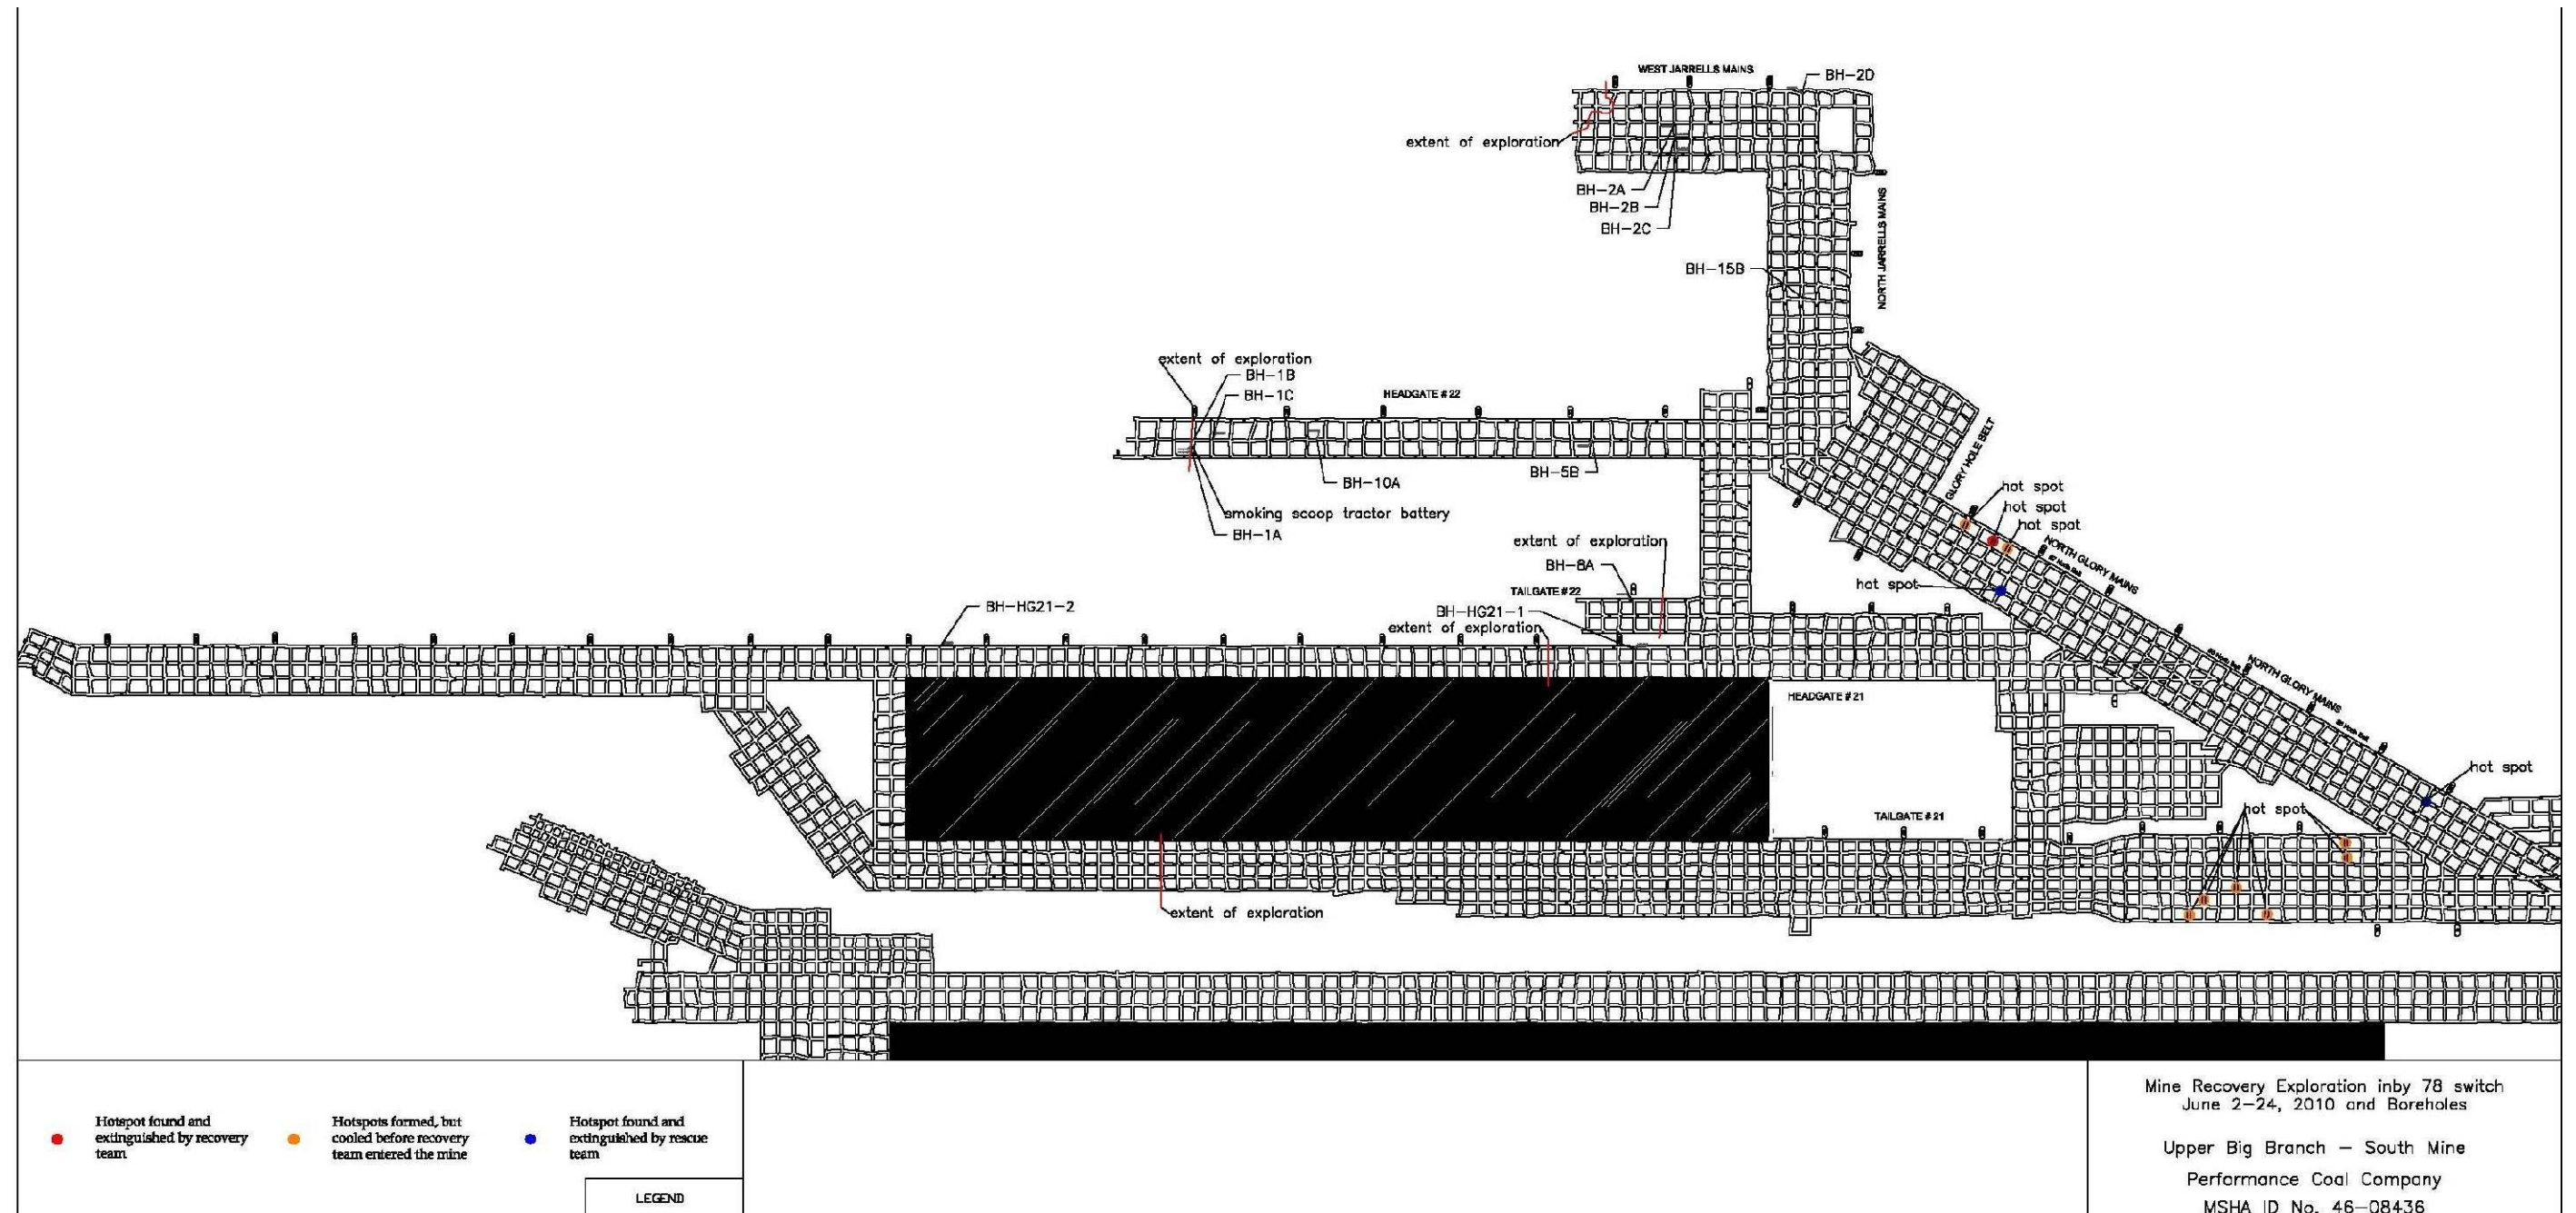
Several boreholes were drilled, some of which missed the intended mine entry, as shown on Figure 2. Other boreholes were stopped during drilling and never completed. See Appendix F for a description of each borehole drilled post accident at UBB.

Figure 2. Map of borehole locations and “hot spots” encountered during recovery exploration

Another re-entry plan was submitted by PCC on June 7 and MSHA modified the Section 103(k) Order to allow for additional exploration of the mine. This plan allowed for an orderly exploration progressing through the entire mine. A potentially hazardous elevated temperature area ("hot spot") was found on the mine floor/coal rib interface in crosscut 118, between the No. 4 and No. 5 entry in the North Glory Mains. This hot spot required water to be piped from the surface down borehole 15B so that rescue team members could apply water in sufficient quantities to eliminate the hot spot hazard. Also, two additional hot spots identified by mine rescue teams after the explosion were checked and found to be at ambient mine temperature. Eight other areas in the mine were previously identified as having had elevated temperatures but had subsequently cooled to ambient mine temperatures. Six of these areas were found in Tailgate 1 North between crosscuts 11 and 24.

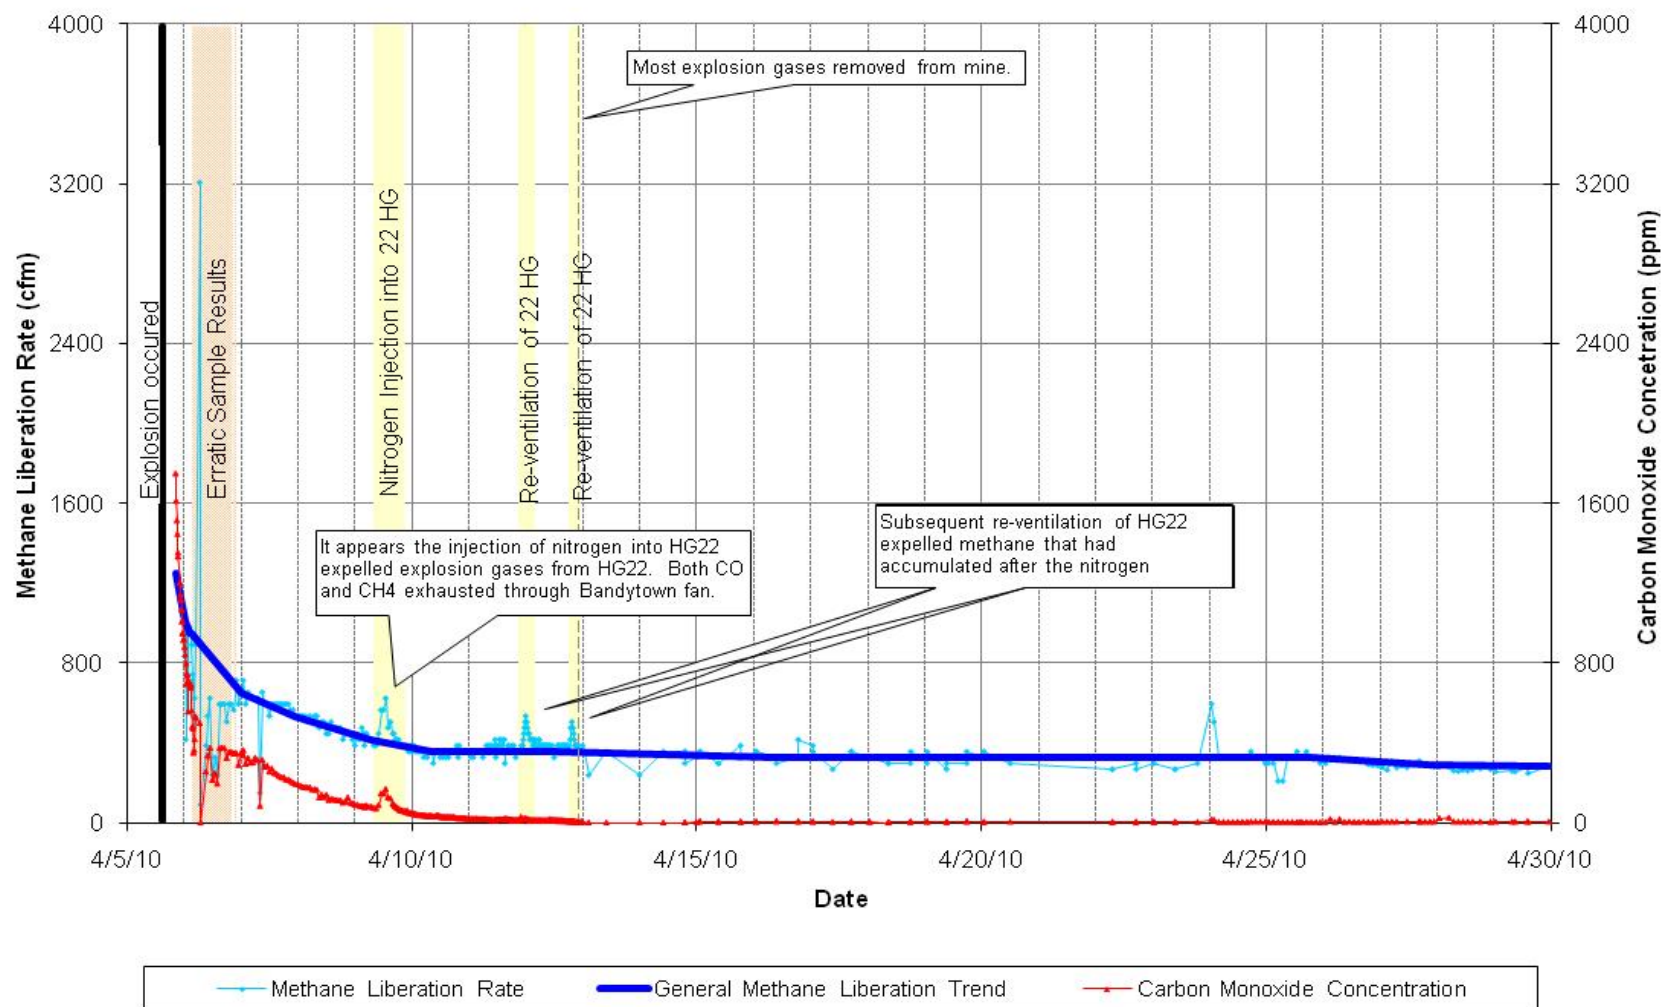
Beginning at 8:30 p.m. on April 5, 2010, air samples were collected regularly at the Bandytown fan for analysis using a gas chromatograph, which is not susceptible to the cross-sensitivity of gases. Figure 10 contains a graph depicting methane liberation rate versus carbon monoxide concentrations for samples collected from Bandytown fan from April 5 – 30, 2010. Sample results indicated that the total volume of methane that exited at the Bandytown fan at 8:30 p.m. was about 1,250 cfm. The methane liberation rate declined to 890 cfm by 5:00 a.m. on April 6, 2010.

Figure 10: Methane Liberation Rate versus Carbon Monoxide Concentrations for Samples Collected from Bandytown fan from April 5 – 30, 2010

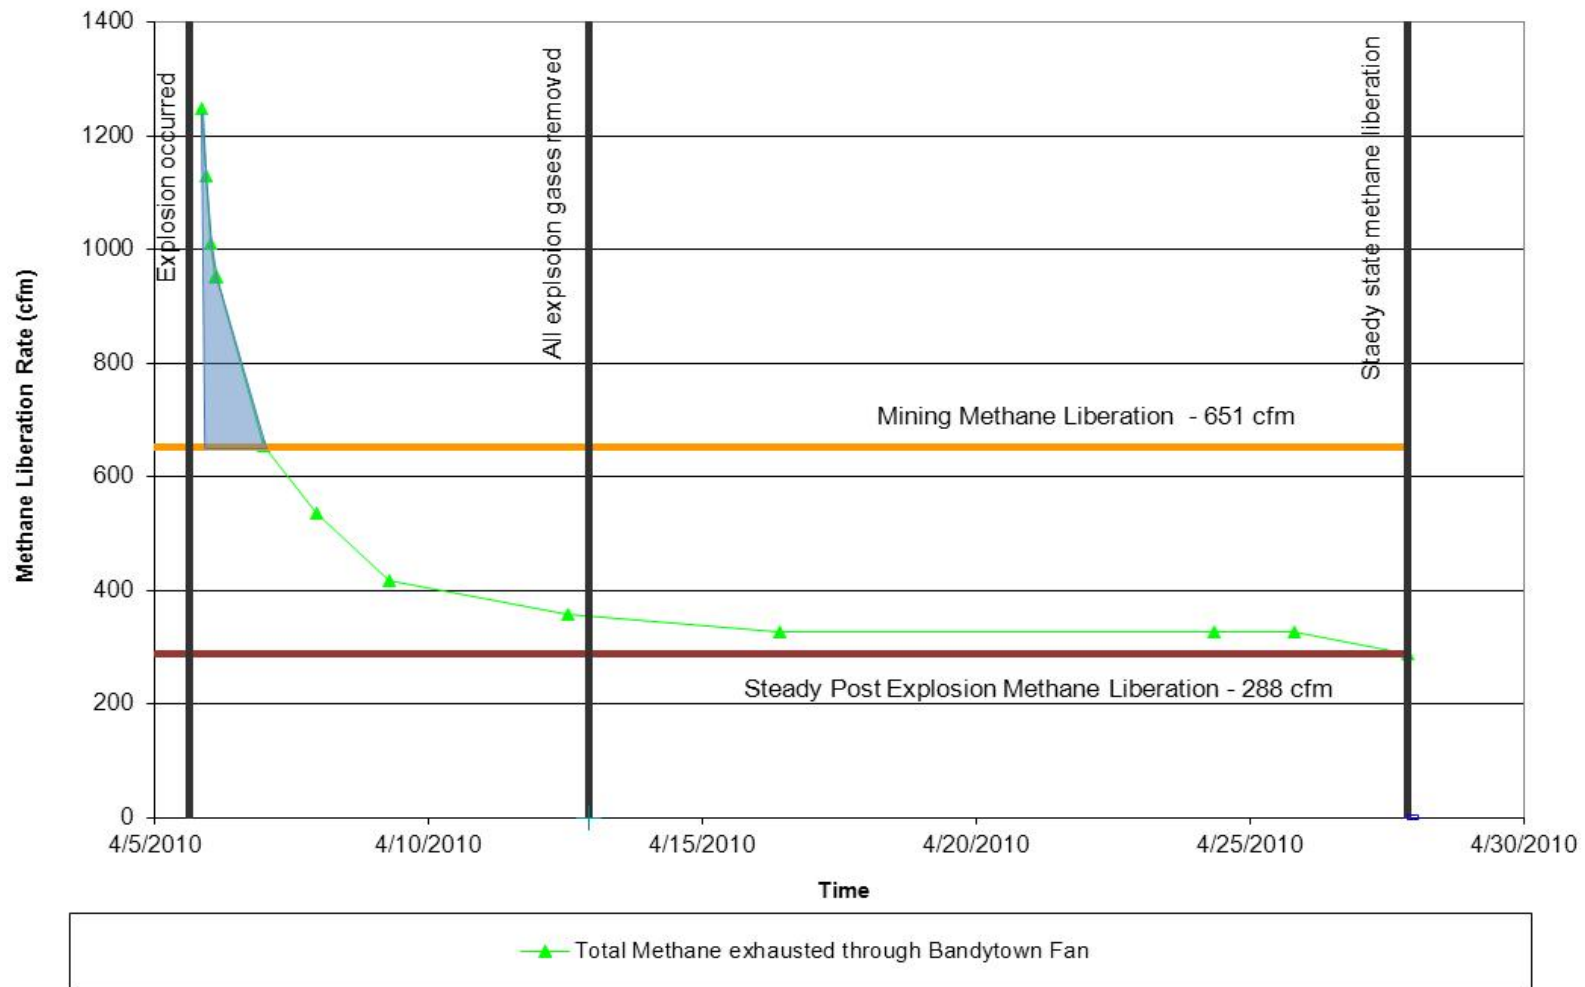
Figures 11 and 12 show graphical depictions of methane liberation rates from the Bandytown fan, based on information collected beginning 8:30 p.m. on April 5, 2010. The curve represents the total methane exhausted from the Bandytown fan from 8:30 p.m. on April 5, 2010 to April 30, 2010. The blue shaded area shown on Figure 11 represents the amount of methane exhausted as compared to the pre-explosion methane liberation. This represents the minimum amount of excess methane exiting Bandytown fan during the sampling period after the explosion. Figure 12 depicts the excess methane exhausted as compared to the post explosion steady-state methane liberation. This represents the maximum amount of methane exiting Bandytown fan during the sampling period after the explosion. Because the rate at which methane liberation from mining declines to the steady state non-mining rate is unknown, the actual amount of excess methane removed from the mine post-explosion would be between the two amounts shown on the graphs.

Figure 11. Graph of methane that was exhausted through the Bandytown fan for the period between April 5 and April 30, 2010. The area shaded in blue represents methane in excess of pre-explosion liberation levels.

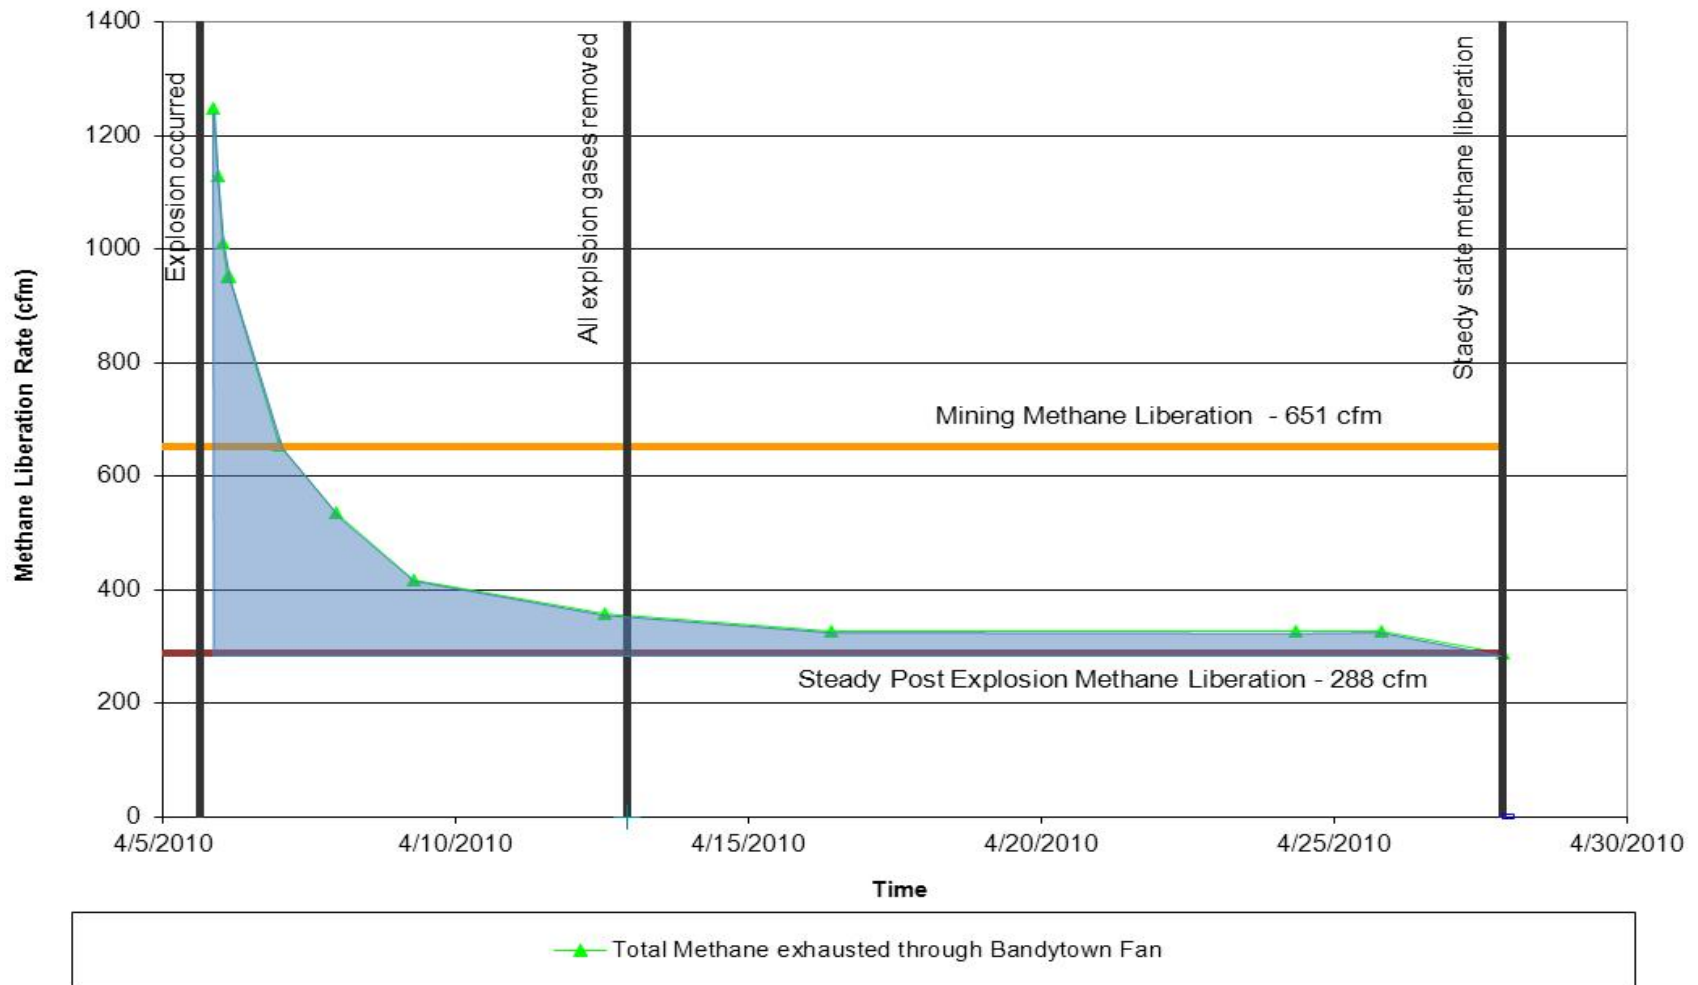
Figure 12. Graph of methane that was exhausted through the Bandytown fan for the period between April 5 and April 30, 2010. The area shaded in blue represents post-explosion methane versus steady state liberation levels.

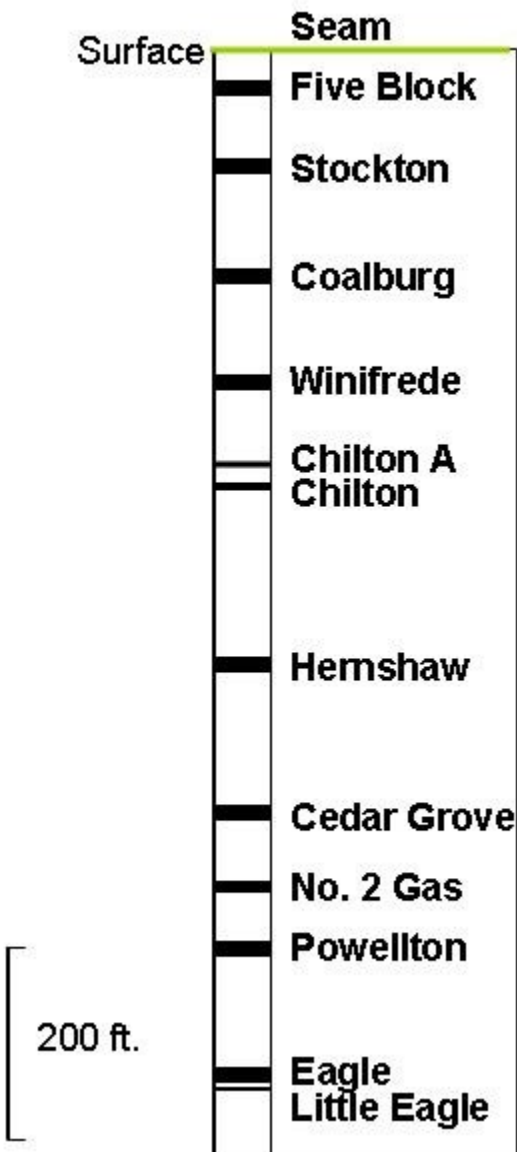
The face of the 1 North Panel is beneath approximately 1,075 feet of overburden at mid-face, with maximum overburden of 1,275 feet encountered near the start-up room at the back of the panel. Review of mine map overlays indicates that a remnant pillar configuration is present above the southern quarter of the current position of the longwall face, characterized by two rows of pillars flanked by gob represented by split pillars in the Powellton seam (determined to be the No. 2 Gas seam by the West Virginia Geologic and Economic Survey (WVGES)), 170 feet above. Three thick layers of massive sandstone, each 20-30 feet, are present between the Eagle and Powellton seams, although floor heave and roof potting in UBB can often be correlated to remnant pillars surrounded by gob in the overlying Powellton seam. Additionally, there are several other mined coal seams above; see Figure 14 below.

Figure 14. Stratigraphic column of coal seams present above the 1 North Panel longwall face. Note that WVGES names are offset, beginning with the Powellton.

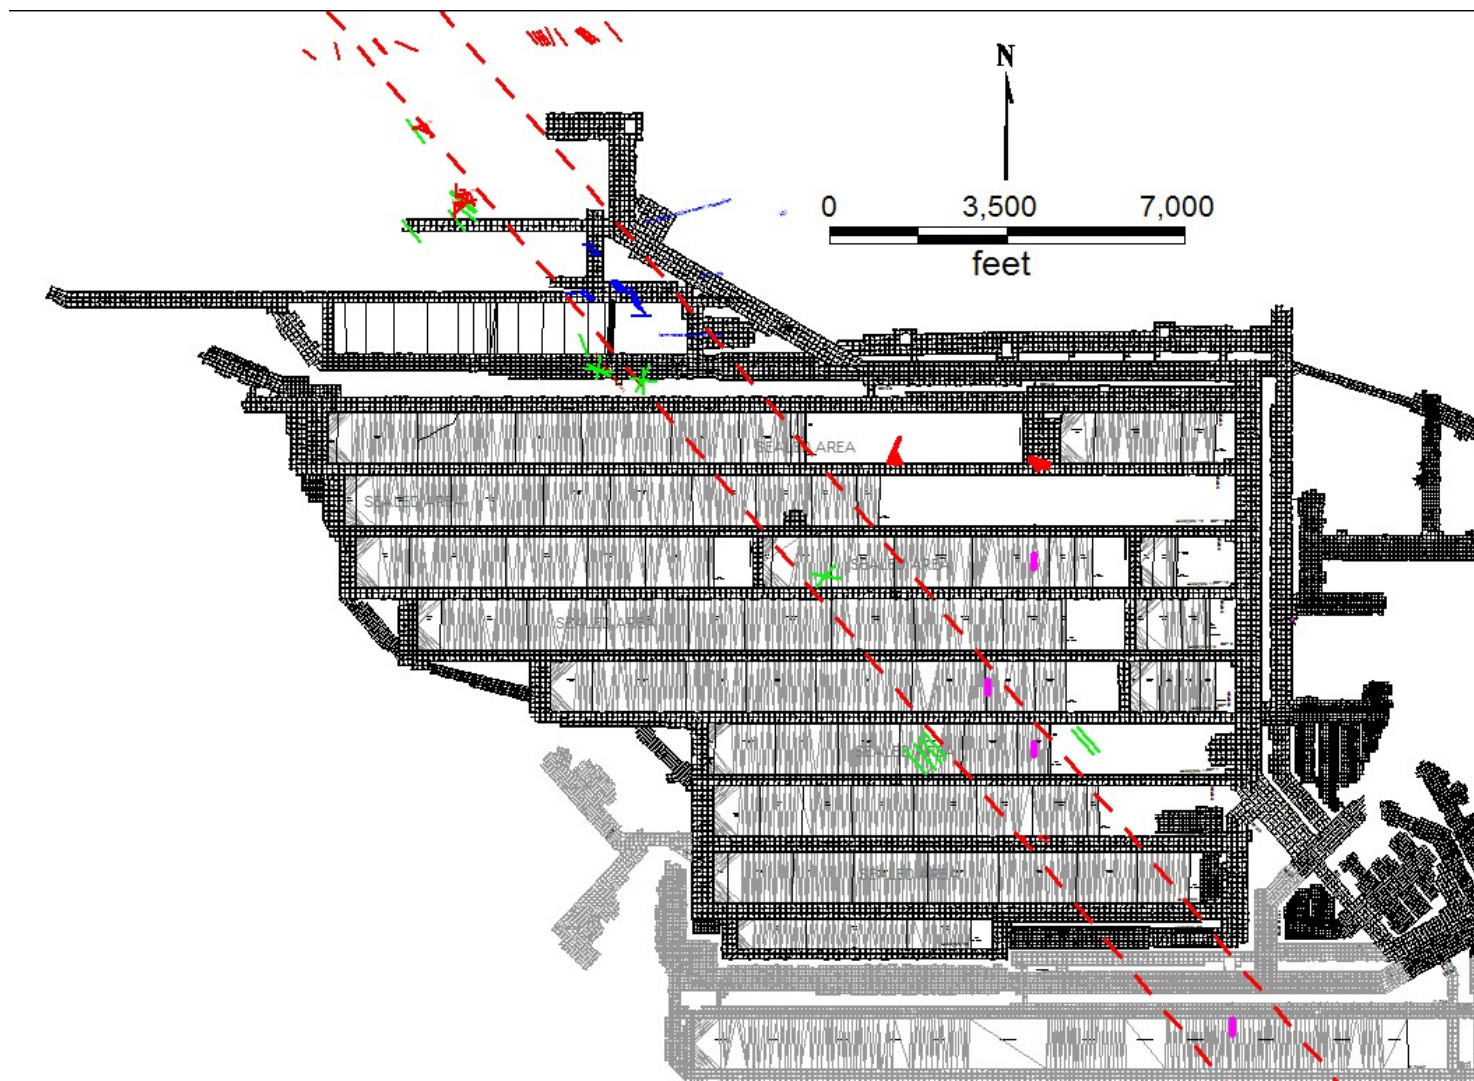
The investigation team concluded that a fault zone trends N 40° W across UBB, and dips 30° to the northeast (Figure 15). This is based on: 1) the locations of gas outbursts or explosions in 1997, 2003, and 2004, discussed above; 2) underground observations conducted at UBB in the 18 Headgate during the 2004 investigation; 3) extensive underground observations conducted between July 2010 and October 2010; 4) the face positions of Longwall Panels 11 and 12 when they were terminated; 5) observations of structural features in the overlying Powellton (Castle Mine) and Coalburg (Black Knight II Mine) seams; and 6) observations of structural features on the surface. To understand the conditions associated with the initial gas release, it is also critical to understand the interplay between the fault zone, the depth of overburden, and the redistribution of stress caused by longwall mining.

Figure 15. Upper Big Branch Mine with projected fault zone, and locations of joints (green, blue), slickensides (red), and floor burst locations (purple) used to constrain the location and trend of the fault zone.

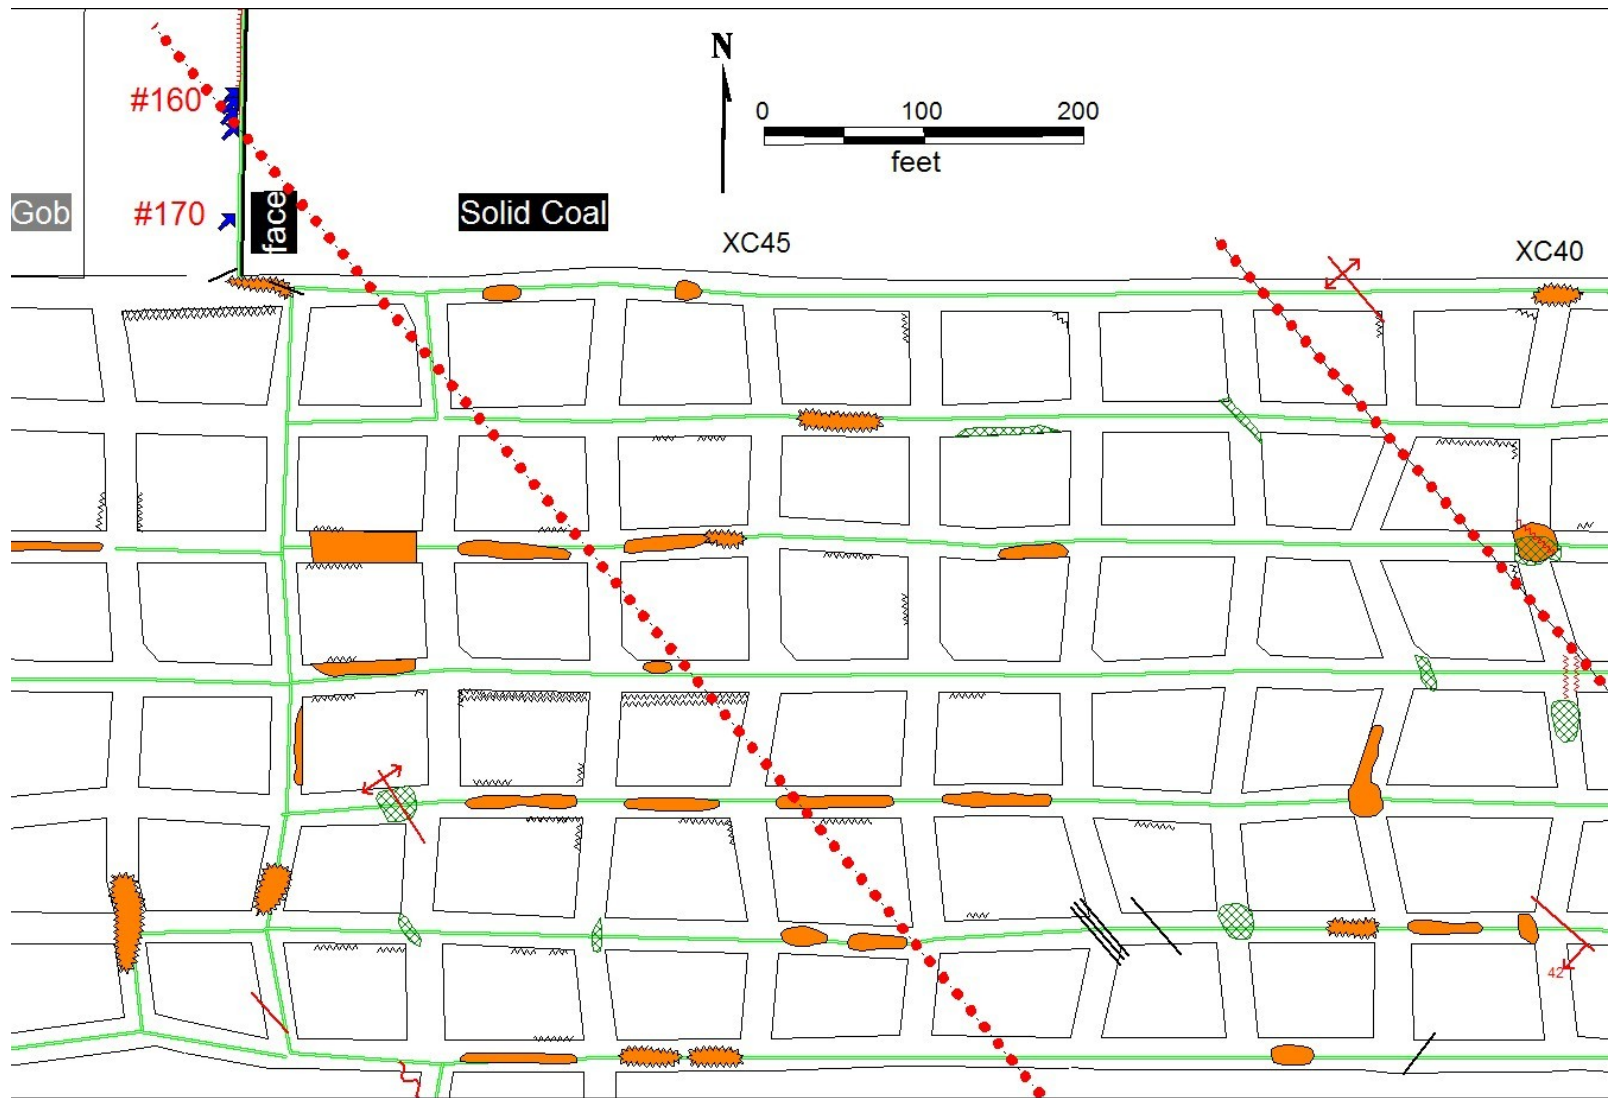
jointing, which also strike N 40° W, are present in thick sandstone layers that overlie the coal seams. The zone also localizes linear pot-outs in the roof and zones of floor heave (Figure 16).

Figure 16. Detailed mapping in Tailgate 1 North, showing trend of floor heave (orange), joints (heavy black lines), pot-outs (green hatch), rib sloughing (jagged lines), and slickensides (red lines) projecting into the longwall shield 160-171 gas feeder zone. Heavy red, dashed lines indicate individual fault zone projections. Blue arrow symbols represent floor feeders in by longwall face.

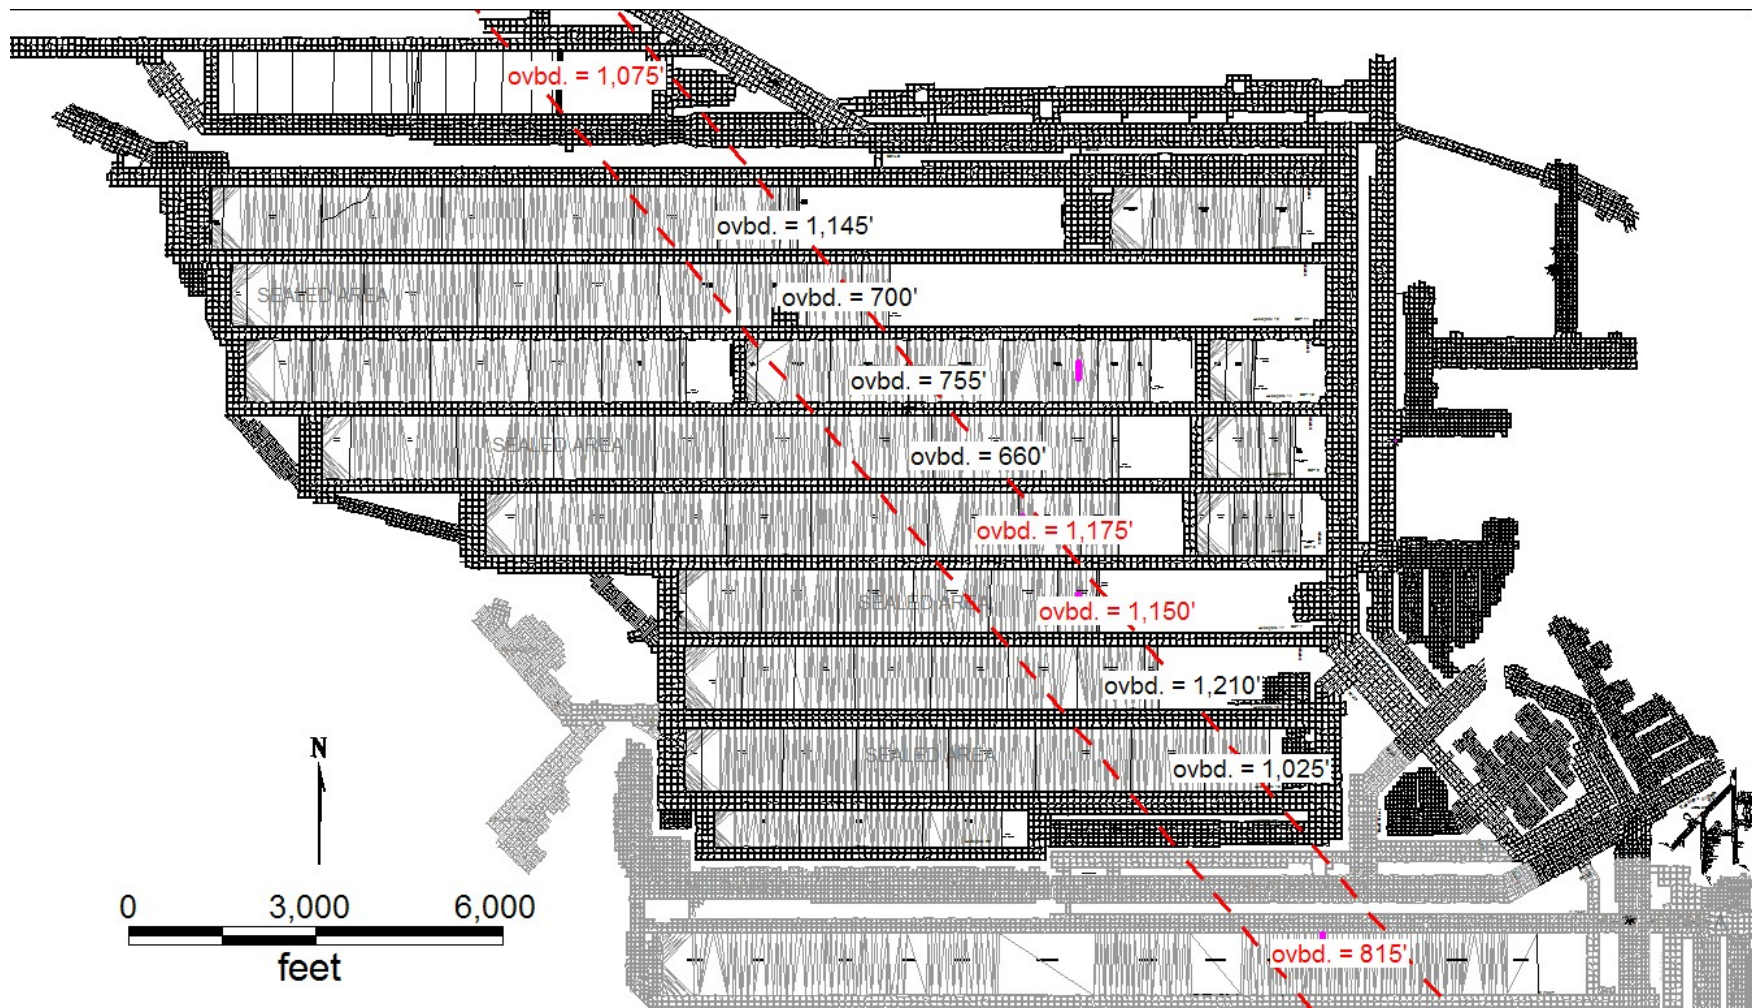
Another factor (discussed further below) in the release of methane appears to be the overburden present above the fault zone. While other panels mined through the fault zone without experiencing a methane outburst, those panels encountered overburden depths much less than 1,000 feet within the fault zone. The panels that experienced methane outbursts encountered overburden values of over 1,150 feet. It appears that several longwall panels, including Longwall Panels 11, 12, and 18 and Longwall Panels 16 and 17, were terminated in the vicinity where the projection of the fault zone intersected the 2,000-foot topographic contour. This corresponds to between 1,125 and 1,200 feet of overburden, depending on seam elevation (Figure 17).

Figure 17. Panels in which outbursts or explosions occurred are highlighted in red and lie along projected fault zone. Several panels were terminated upon intersecting the fault zone. Panels that encountered overburden of only 660-755 feet appear to have crossed the fault zone without incident, suggesting a critical overburden depth of 1,150 feet related to stress.

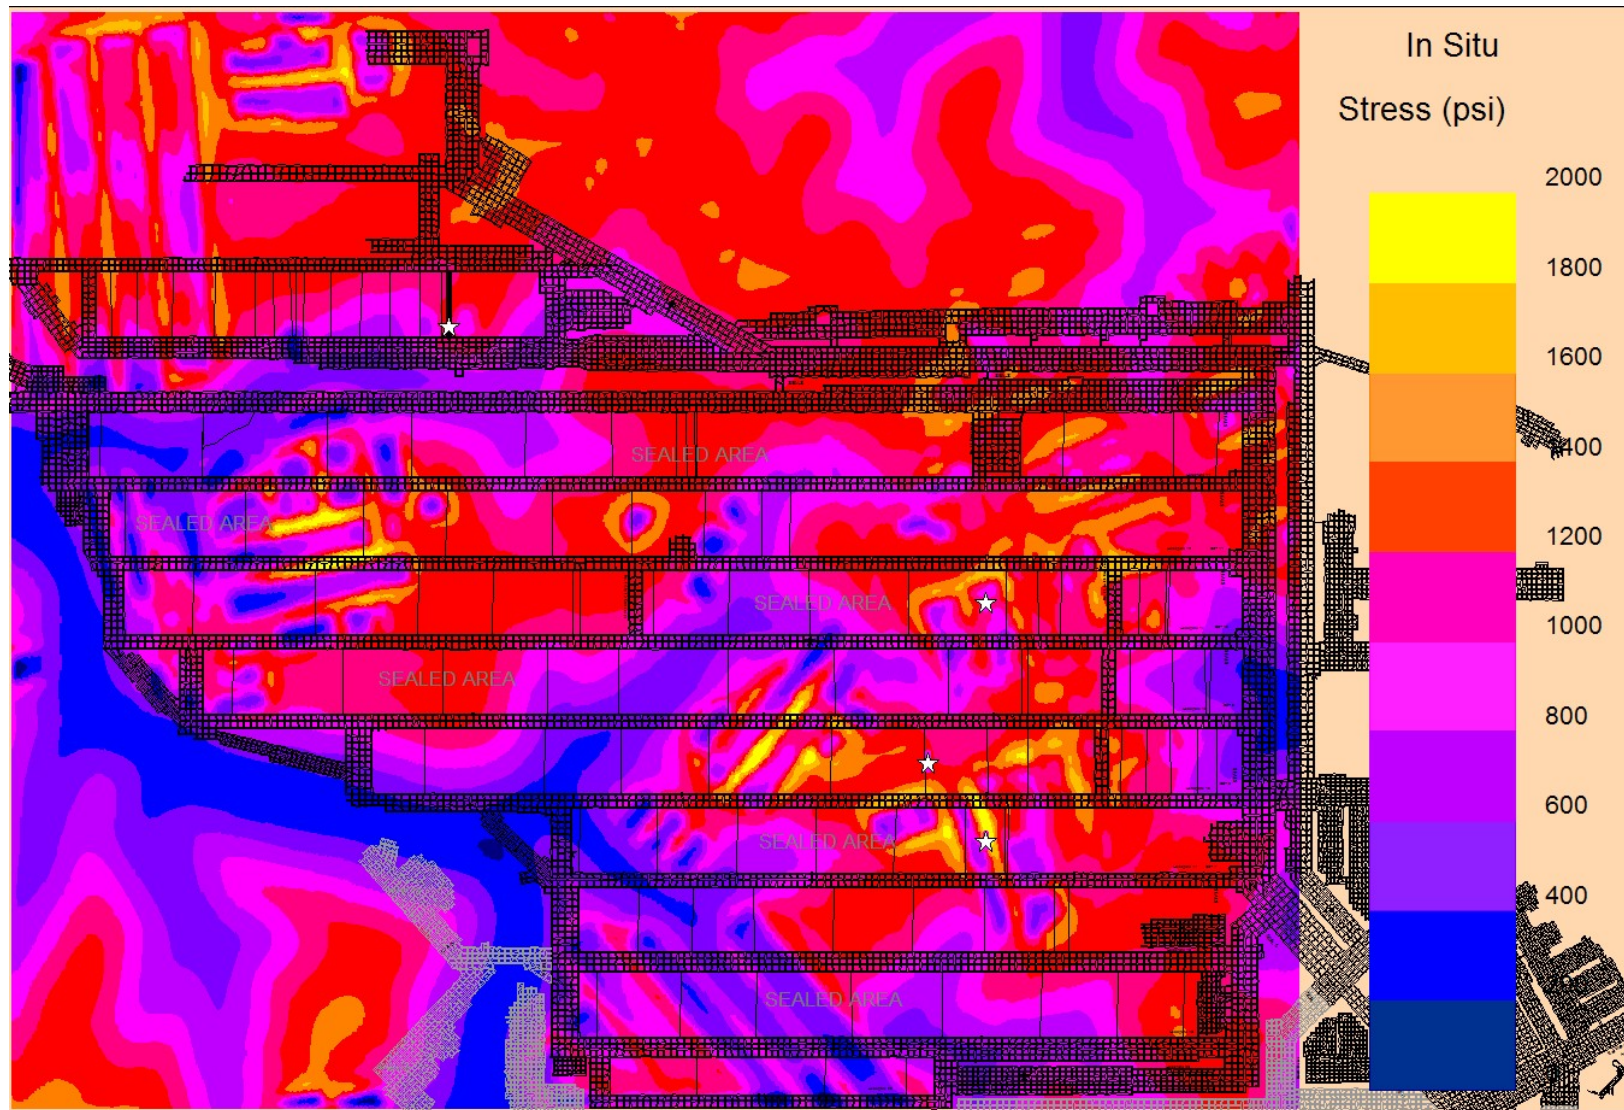
Dr. Heasley's model was used to assess the in-situ (in place) stress on the Eagle seam prior to mining to identify any high-stress areas and to assess any correlation between high stress areas and floor gas outbursts. Figure 18 represents a map of in-situ stress on the Eagle seam, including the vertical stress derived from the weight of overlying rock combined with stress associated with multiple seam interaction with the overlying Powellton seam mining. Although there appears to be a loose correlation between in-situ stress exceeding 1,200 pounds per square inch (psi) and the locations of the 2003 and 2004 gas feeder events, they are not associated with the highest stress values of 1,800 psi or greater.

At the time of the April 5 explosion, the longwall face was beneath a narrow swath of greater-than-1,200 psi stress associated with two rows of remnant pillars flanked by gob or thin, split pillars. Therefore, the documented outburst locations do not correspond to the highest stresses (>1,800 psi), and therefore, do not appear to be entirely stress-driven.

Figure 18. Map of in-situ stress on the Eagle seam, incorporating stress attributable to overburden and multiple seam interactions with the Powellton seam. White stars indicate locations of gas outbursts, with heavy black line on 1 North Panel (label), representing April 5, 2010 face position. Bright yellow patches represent >1,800 psi, with subsequent colors spaced at 200 psi intervals.
