REPORT OF INVESTIGATION

**Fatal Underground Mine Explosion
April 5, 2010**

**Upper Big Branch Mine-South, Performance Coal Company
Montcoal, Raleigh County, West Virginia, ID No. 46-08436**

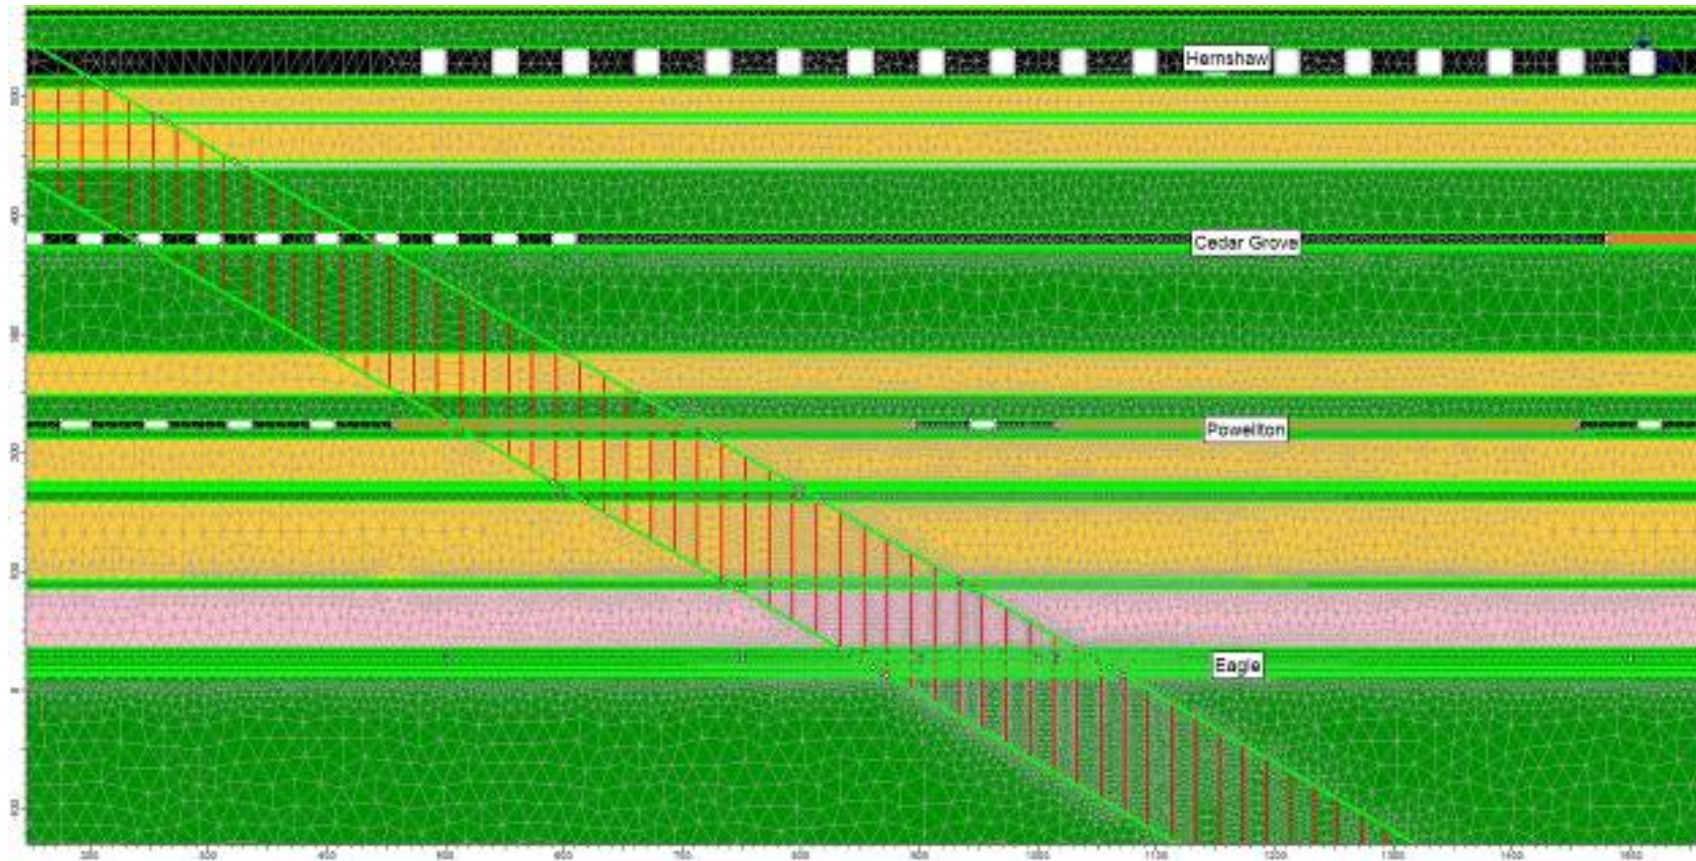
Investigators simulated the fault zone with a 100-foot thick zone, consisting of vertical joints, that dips 30° across the stratigraphic sequence (rock layers), resulting in an intercept width of 200 feet for each layer of strata (Figure 19). This configuration matches closely the geological observations, i.e. intact rock hosting widely spaced joints or other geological structures within the shallowly dipping fault zone. Simulated vertical joints were spaced 20 feet apart within the 30° dipping zone and given a friction angle of 28°, with no tensile strength or cohesion. Joint ends were specified as being open at excavation boundaries.

Figure 19. Stratigraphy in Rocscience showing incorporation of 30° dipping fault zone that is comprised of vertical joints spaced 20 feet apart for 1 North Panel cross section.

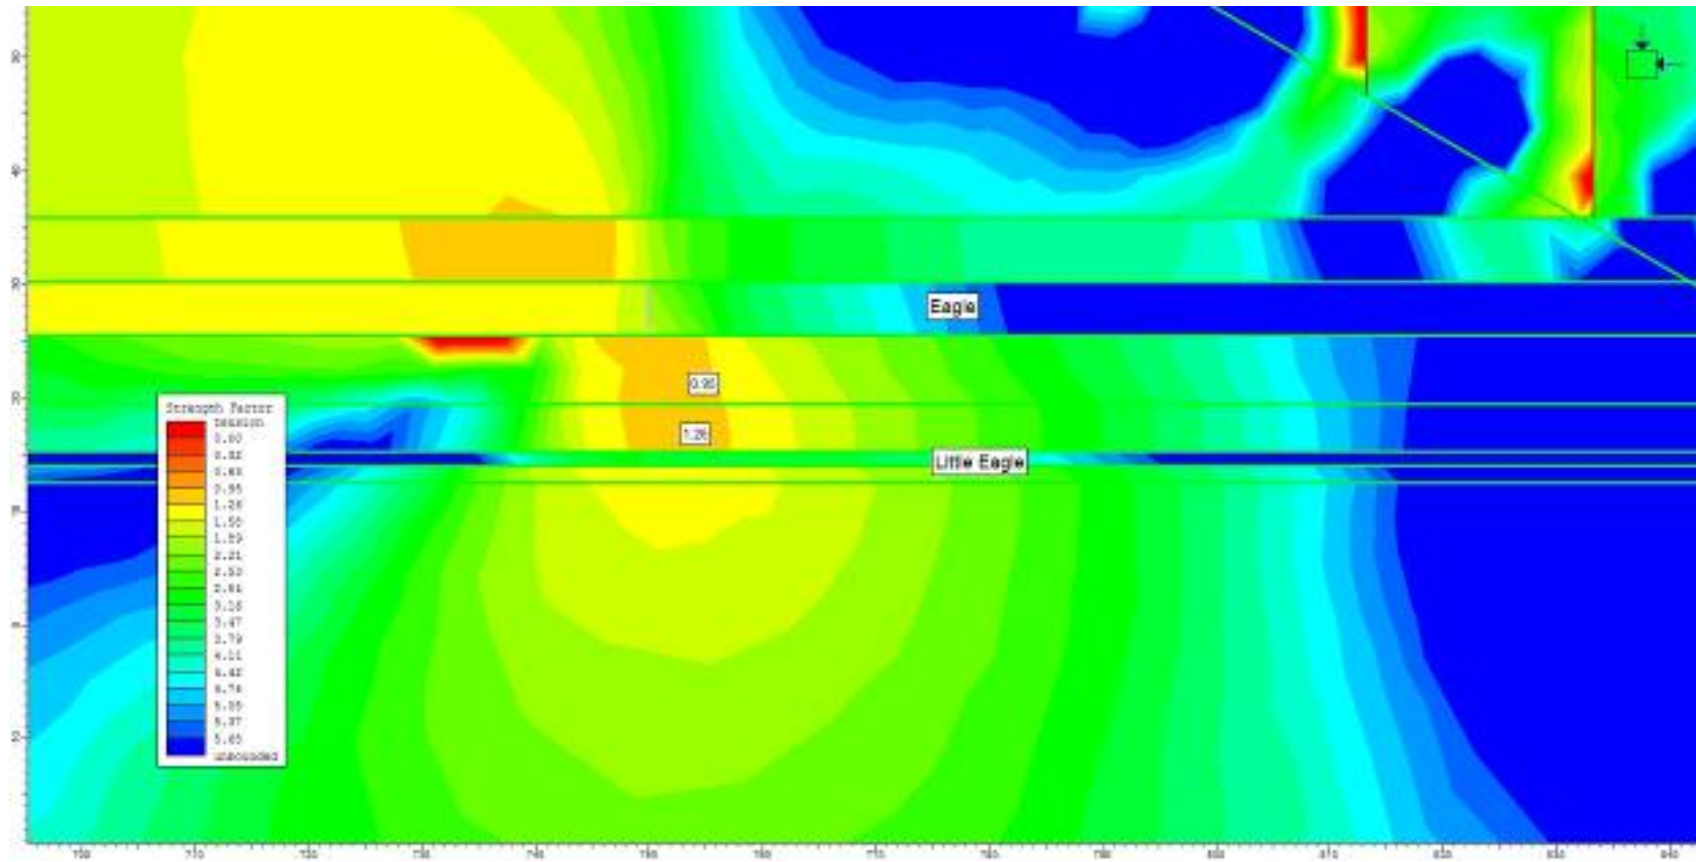
Areas outside the fault zone did not incorporate joints, and when the simulated longwall face position was 250 feet in by the April 5, 2010 position, strength factors less than one extend only a calculated five feet into the floor, approximately halfway to the Little Eagle seam (Figure 20 and 21). When the longwall face had reached its April 5, 2010 position, such that the 30°- dipping fault zone was cantilevered over the face, zones of tension extend a predicted 25 feet into the floor along joint zones, and a zone of strength factors less than one extends 15 feet into the floor. This fully encompasses the Little Eagle seam and intervening interburden to the Eagle seam, with the zone extending beneath the Little Eagle seam for a short depth.

Figure 20. Distribution of strength factors when 1 North Panel longwall face is 250 feet in by the April 5, 2010 face position, outside the projected fault zone. Strength factors less than one are calculated to extend only five feet into the floor beneath the face.

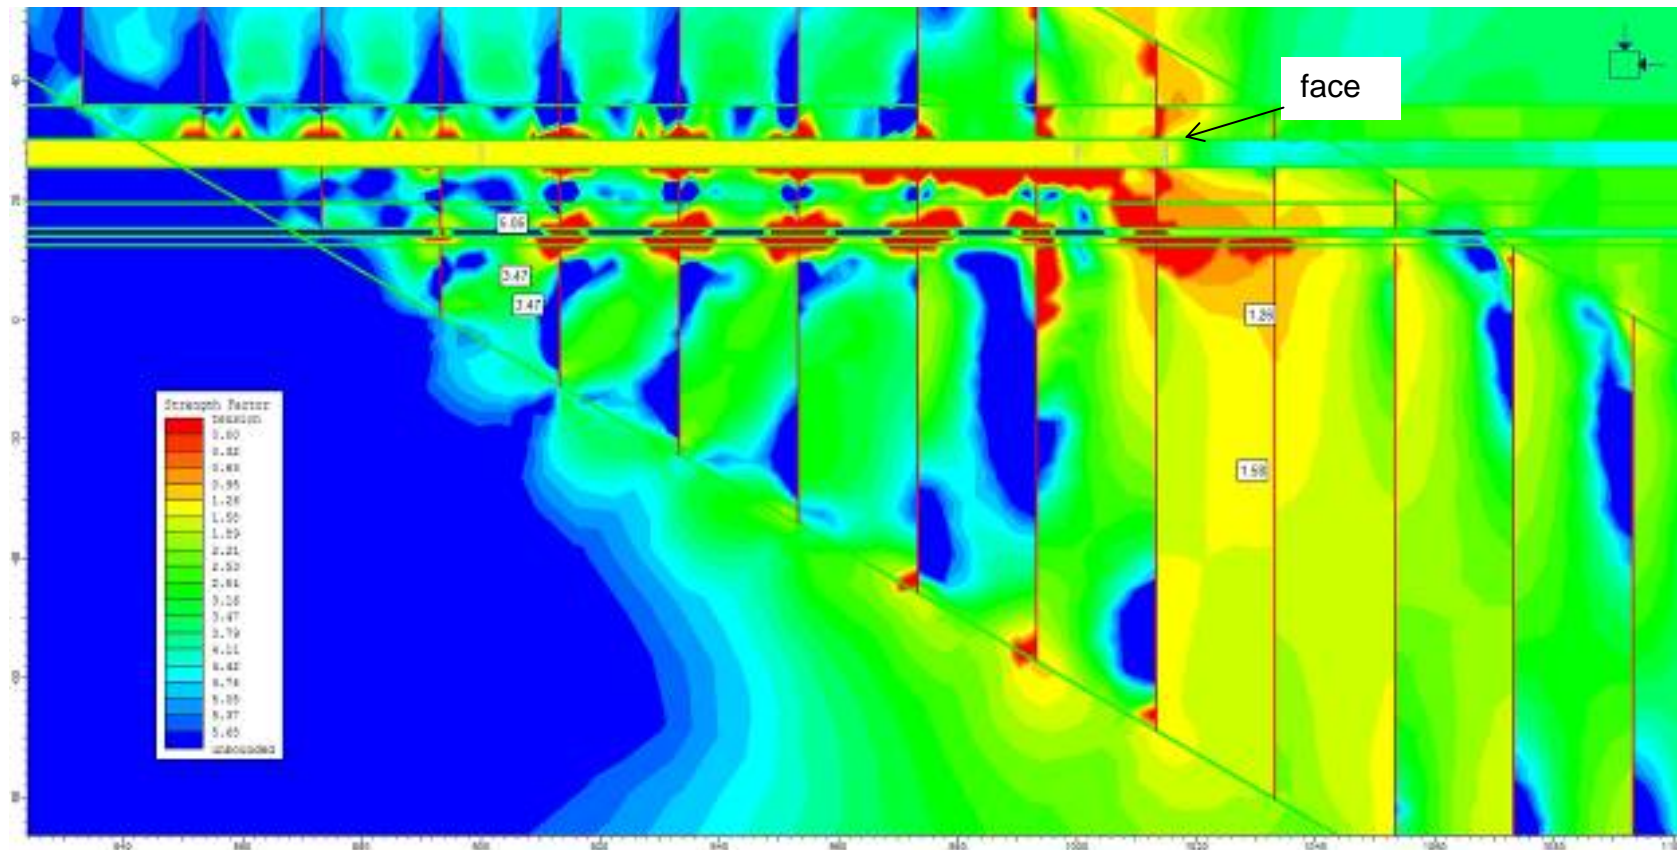
Thus, investigators concluded that the most likely explanation for the failure mechanism associated with the gas inflow at shields 160-171 is that mining into the fault zone beneath the two rows of remnant barriers at over 1,000 feet of depth resulted in a unique overlap of factors that caused the development of tension zones along pre-existing geologic structures for a calculated 25 feet into the floor.

Figure 21. Distribution of strength factors when the 1 North Panel longwall face is at its April 5, 2010 position. Zones of tension are developed along joints below the Little Eagle seam, with large swath of strength factors less than one extending 25 feet into the floor, which encompasses the Little Eagle seam and underlying strata.

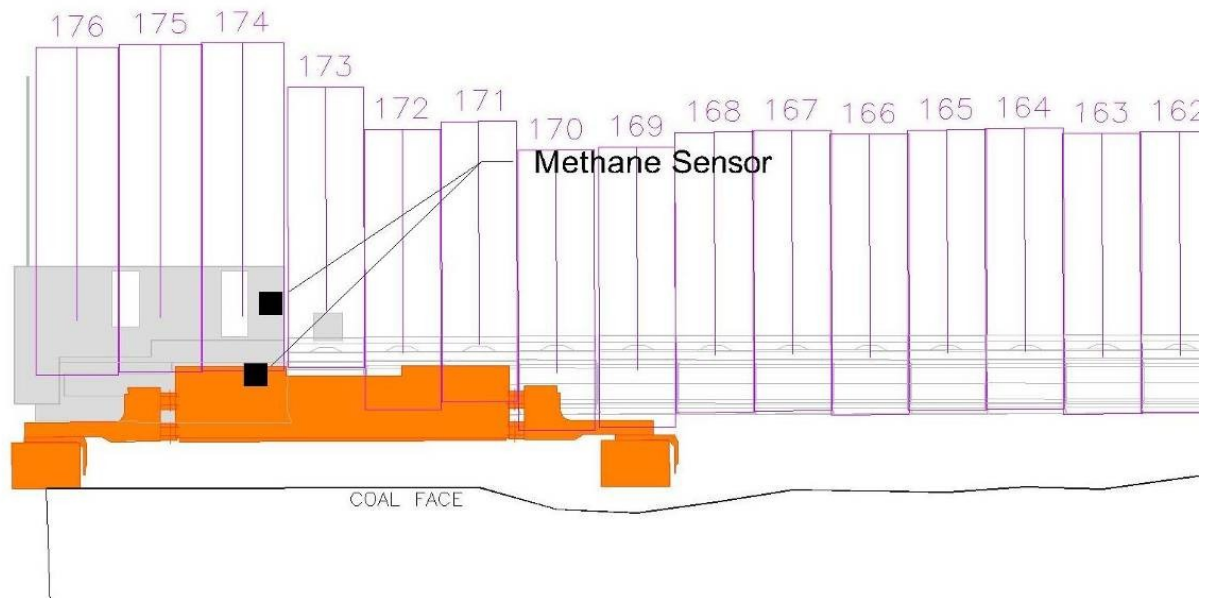
Figure 22. Diagram of UBB longwall face, showing locations of methane sensors mounted on the shearer and on the tailgate drive.

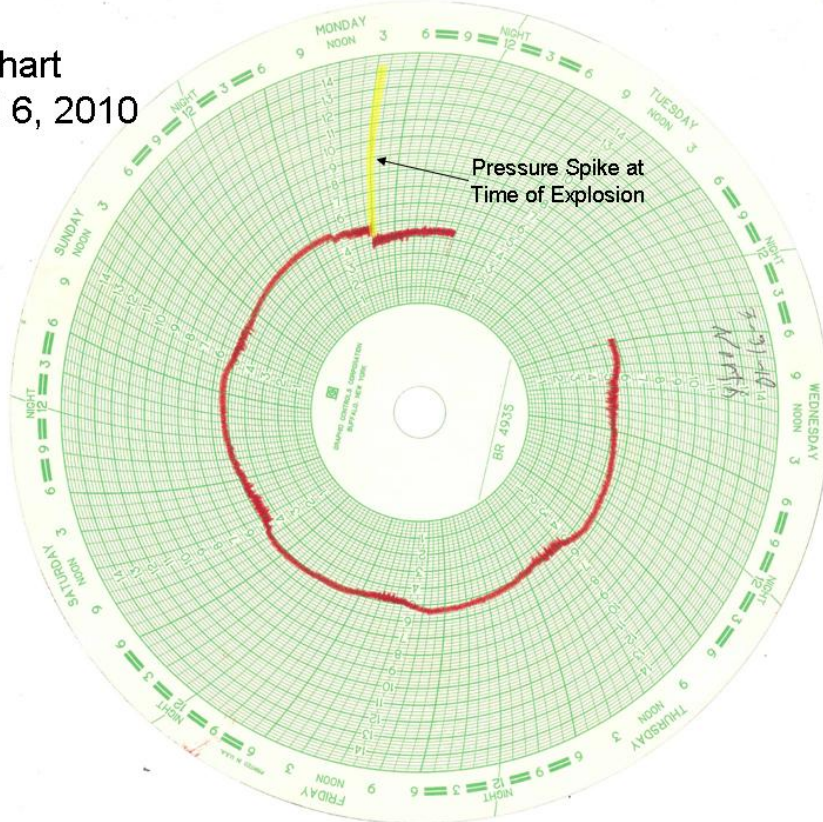
North Fan Chart
March 31 – April 6, 2010

UBB was ventilated with two blowing fans and one exhausting main mine fan. The North Portal blowing fan was a Joy, Model Number 12065D, Serial No. MF4110, ten-foot axial vane fan. The fan was operated with a 1,000-horsepower, 4160 volt, 900 revolutions per minute (rpm) motor. Figure 24 is a copy of the North fan chart which was on the fan pressure recorder when the explosion occurred and shows the fan was operating at about 4.8 inches of water gauge (in. w.g.).

Figure 24. Chart for North Fan, showing pressure spike at time of explosion.

Although the fan charts shown in Figures 24 to 26 were not aligned correctly on the pressure recorder to correspond with actual time, each fan chart shows the pressure spike from the explosion. The North fan recorded a spike of over 9 in. w.g. over its normal pressure of 4.8 in. w.g. The South fan recorded a spike of 2 in. w.g. over its normal pressure of 1.4 in. w.g. The Bandytown fan spike went downward off the chart because this fan was exhausting and the pressure spike was positive. The magnitude of the spike cannot be determined but it was greater than the fan operating pressure. Several small variations in fan pressure were noted on the Bandytown fan chart following the explosion, although persons who were underground during that time reported no additional explosions.

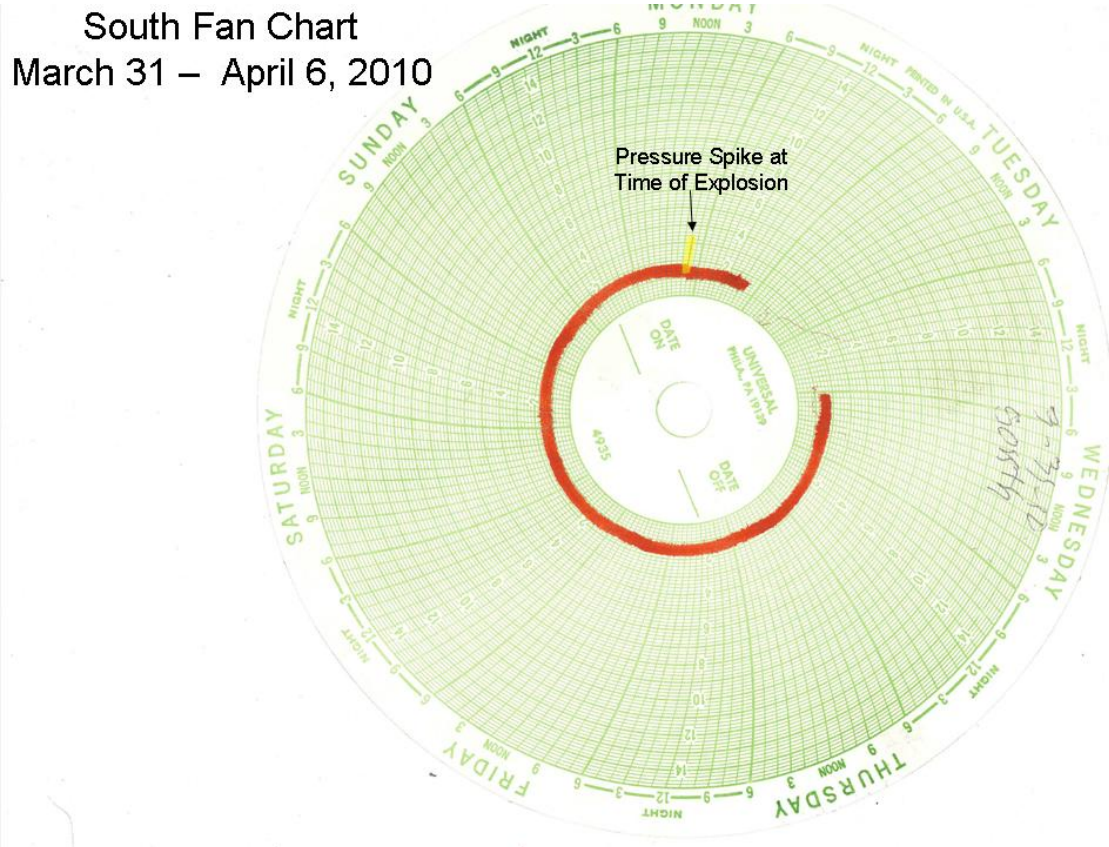
The South Portal blowing fan was an Industrial Welding Buffalo, six-foot diameter axial vane fan. The fan was operated with a 200 horsepower, 480 volt, 1,200 rpm motor. Figure 25 is a copy of the South fan chart which was on the fan pressure recorder when the explosion occurred and shows the fan was operating at about 1.4 in. w.g.

Figure 25. Chart for South Fan, showing pressure spike at time of explosion.

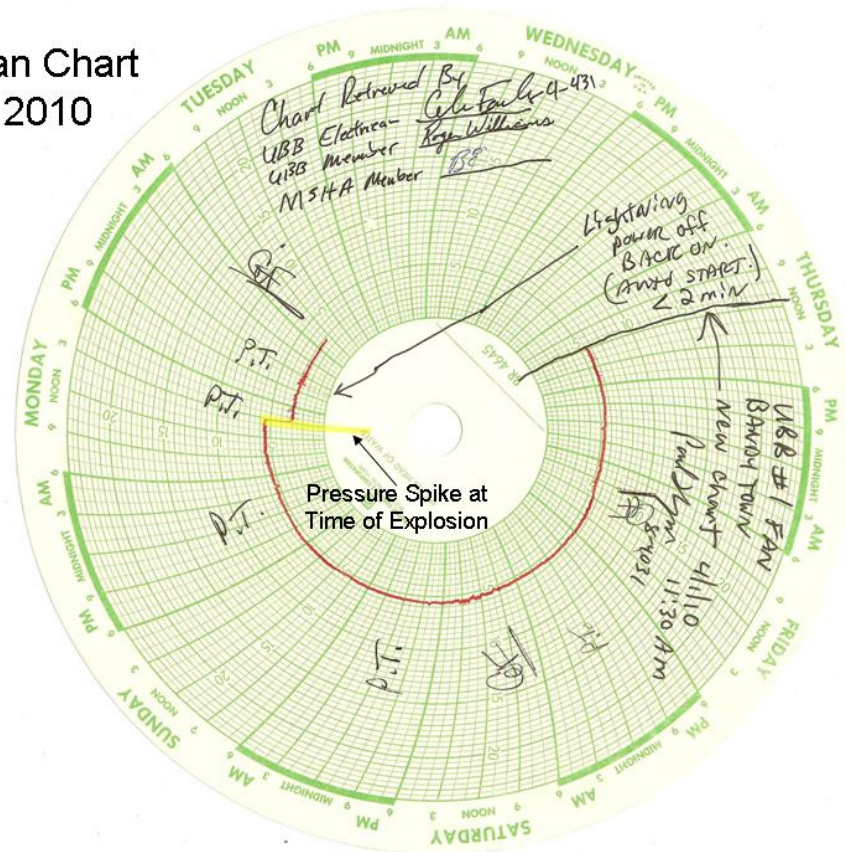
Figure 26. Chart for Bandytown fan showing pressure spike at the time of the explosion.

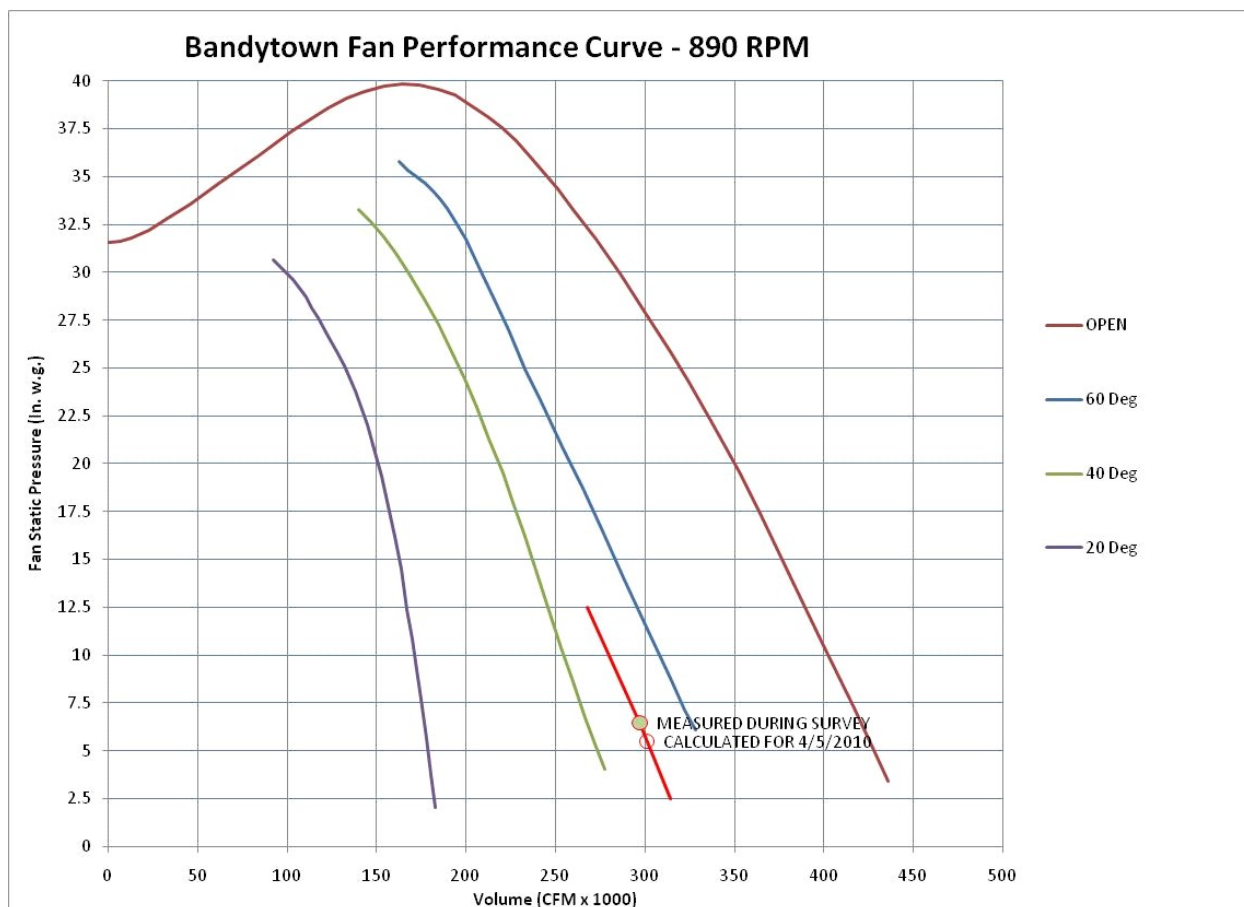
The in-mine survey determined an air quantity of approximately 297,000 cfm reported to Bandytown fan. Records indicated that the fan had not been altered since the explosion and was not affected by the explosion. The operating point for the fan was determined from the underground measurements, and the pressure indicated on the fan chart during the pre-survey (6.45 in. w.g.). The pressure taken from the fan recording chart during the survey was compared with the fan pressure recorded on the chart prior to the explosion (Figure 26). The operating point was plotted on a fan performance curve for Bandytown fan. A curve was drawn through the operating point and the pre-explosion pressure was used to determine the quantity at the fan prior to the explosion. The fan performance curve is shown in Figure 27.

Figure 27. Graph of air volume versus fan static pressure, defining the Bandytown fan's performance curve.

The measurement recorded in the record book for Bandytown fan was approximately 400,000 cfm. The air quantity reporting to Bandytown fan during the survey was measured several times by the respective investigation teams as described in the underground mapping protocols, using careful area measurements, individually calibrated anemometers with wands, and the one-half area traverse method. This method is more accurate than typical day-to-day air quantity measurement methods used by mine personnel.

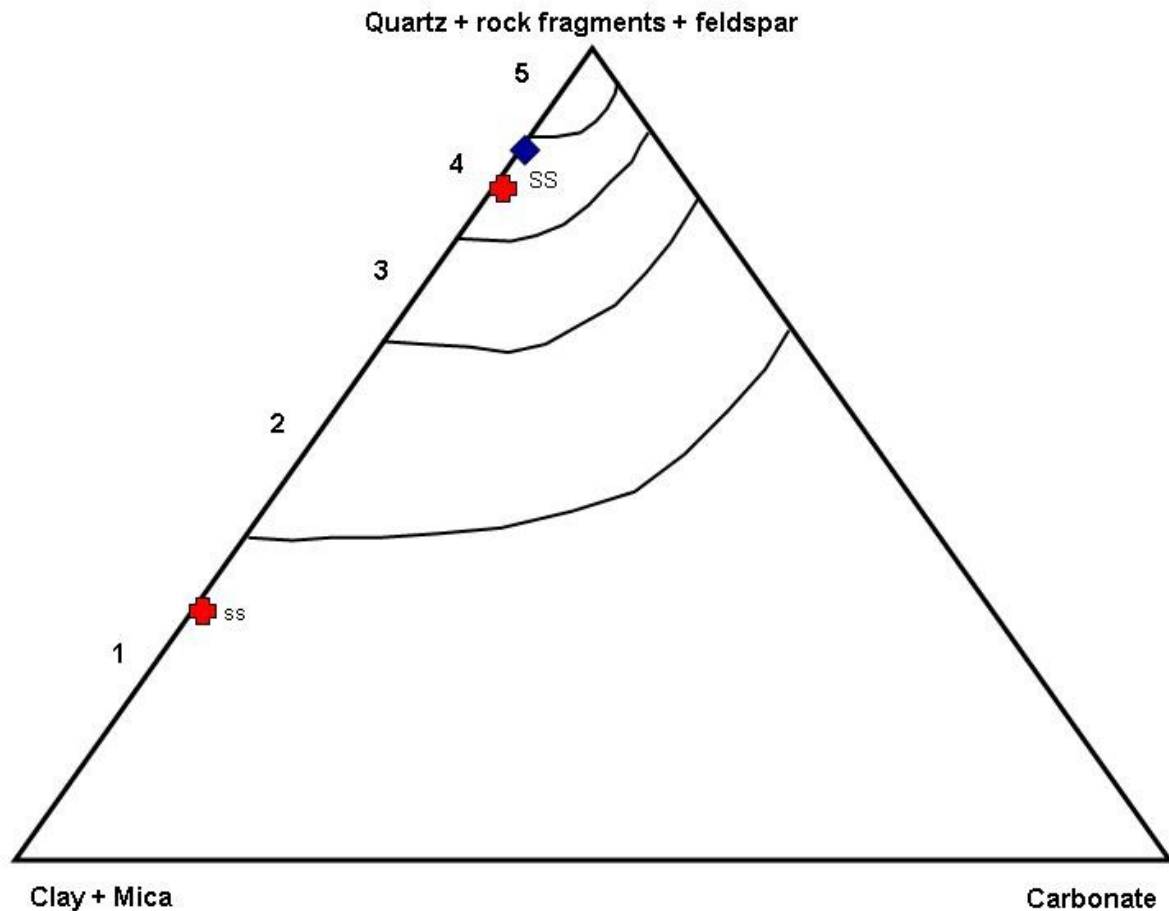
The sandstone that the longwall shearer was cutting into on April 5 had a high potential for frictional ignition. The layers of coarse siltstone, which contain high mica content, plot in Category 1, indicating a low potential for frictional ignition. In contrast, the sandstone plots in Category 4 indicating a high potential for frictional ignition. The floor sandstone very nearly plots in the Category 5 zone, because of its high quartz content. Compared to the sample collected from the roof, the floor sample contains much greater quartz, and is characterized by a much greater degree of grain interlocking. Rocks with an incendivity index of 4-5 were shown in tests to have a high potential for frictional ignition, for rock-on-rock and metal-on-rock ignitions.

Figure 28. Diagram showing relation of UBB roof (red crosses) and floor (blue diamond) sandstone (SS) and siltstone (ss) to contour lines of incendiarity index.

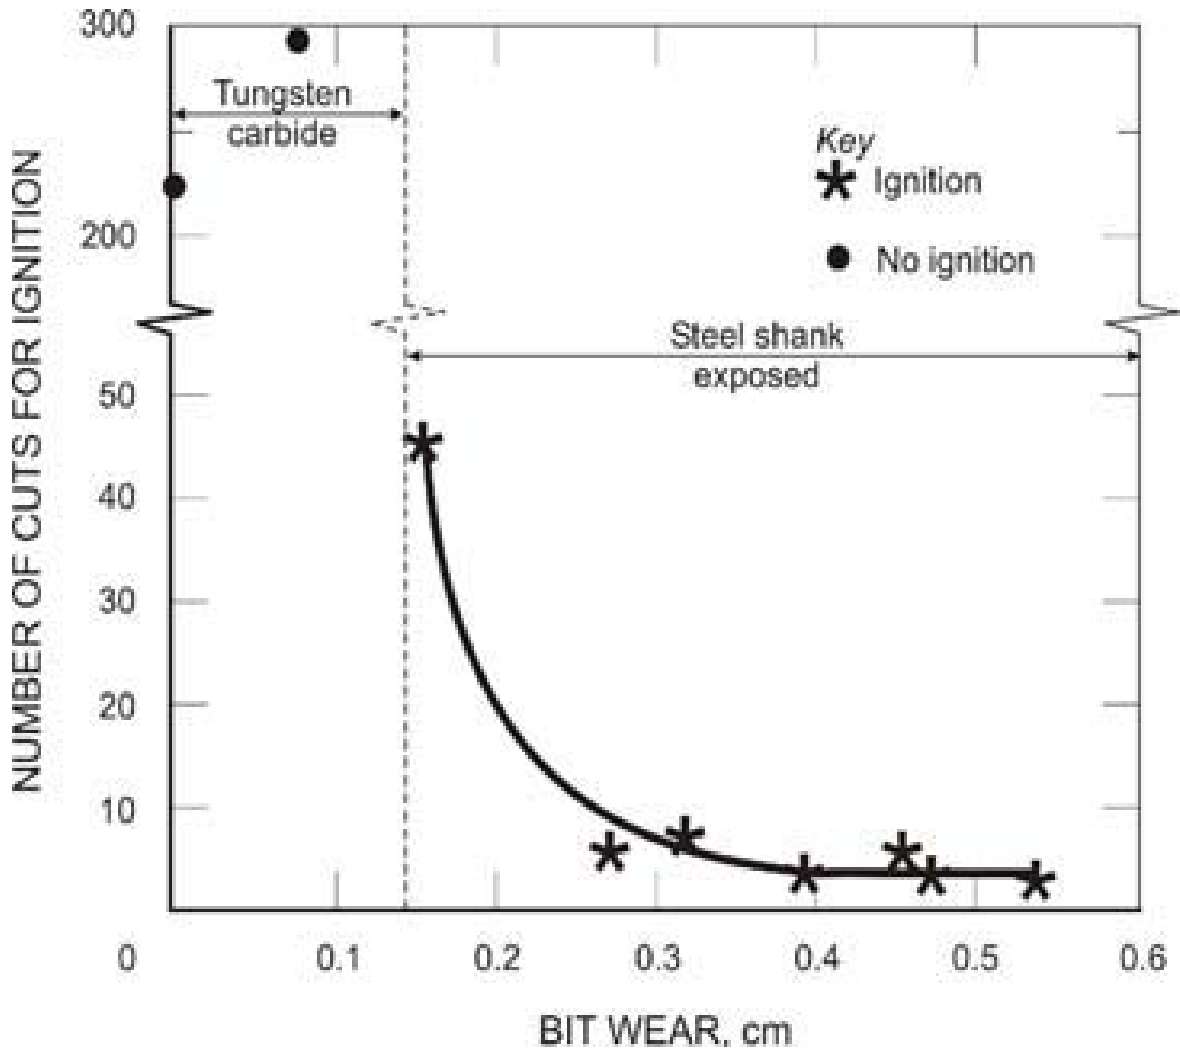
In addition, experiments have revealed that bit surface area is significantly related to the incendiary potential of a hot streak. Large wear flats on the cutting bits are more likely to cause an ignition, especially when the carbide tip has worn off and as little as 3 mm of the steel shank has been abraded away (Figure 29).

Figure 29. Relation between bit wear, in centimeters, and the number of cuts required to induce a frictional ignition, from Kissell et al. (2007).

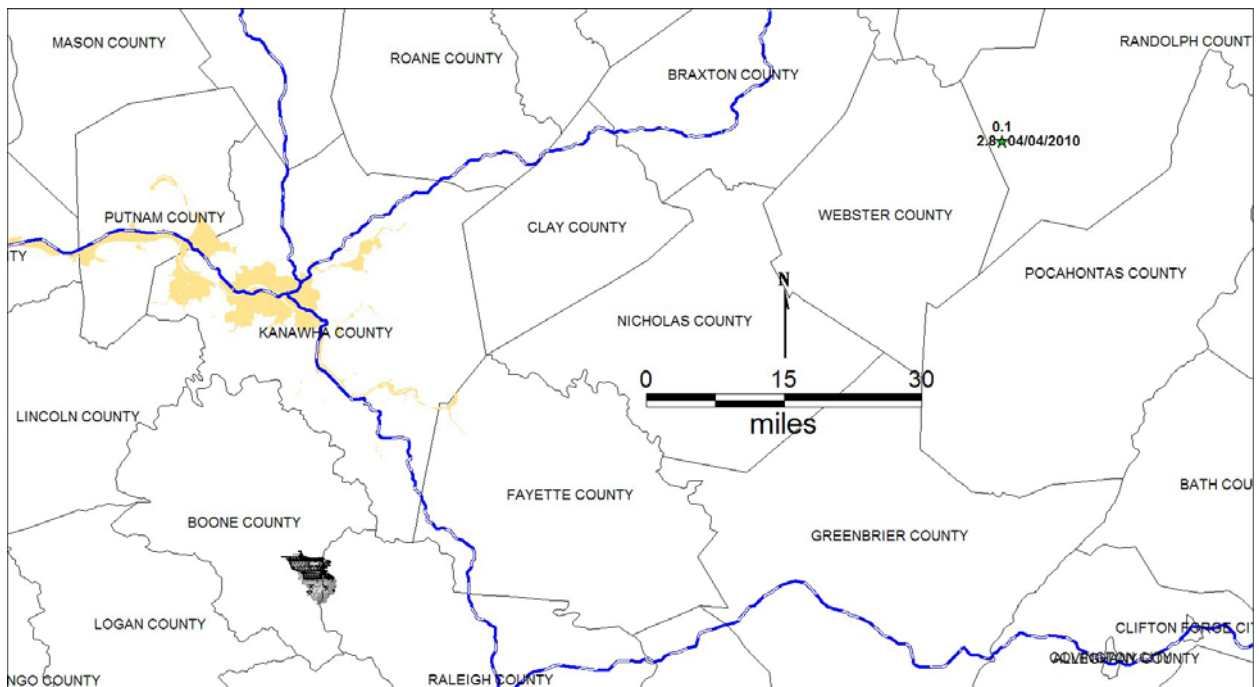
The second seismic event occurred on April 4, 2010 in Braxton County, approximately 60 miles from the face of the 1 North Panel, UBB (Figure M-1). Despite the seemingly close temporal relation between the April 4 seismic event (05:19:14), and the April 5 explosion (15:02), the 60 mile interval and 34-hour time difference does not support any recognizable relationship between the two events. After the April 5, 2010 explosion, seismic events continued to be recorded in the Upshur/Randolph County area. A 2.5 magnitude seismic event was reported on August 21, 2010, with the hypocenter exactly coinciding with a gas well that is exploiting the Devonian-aged Marcellus Shale (API # 47-09703326), with a neighboring well also reported as developed to the Marcellus Shale (API # 47-09703622) (Figure M-2). Following the April 5, 2010 explosion, several seismic events were recorded in central West Virginia. A search of seismic events within 200 km of UBB indicated that six seismic events were recorded in 2010 along the crest of the Gassaway Anticline (Figure M-3). Because several of those events were reported as occurring at 0 km depth, the localized seismic activity is interpreted to be associated in some fashion with the recent increase in gas drilling in the state, and does not appear to have any recognizable association with UBB.

Figure M-1. Location of Randolph County 2.8 M “seismic event,” in relation to UBB, that occurred on April 4, 2010. The event was essentially at the surface, only 0.1 km deep and located over 60 miles away.

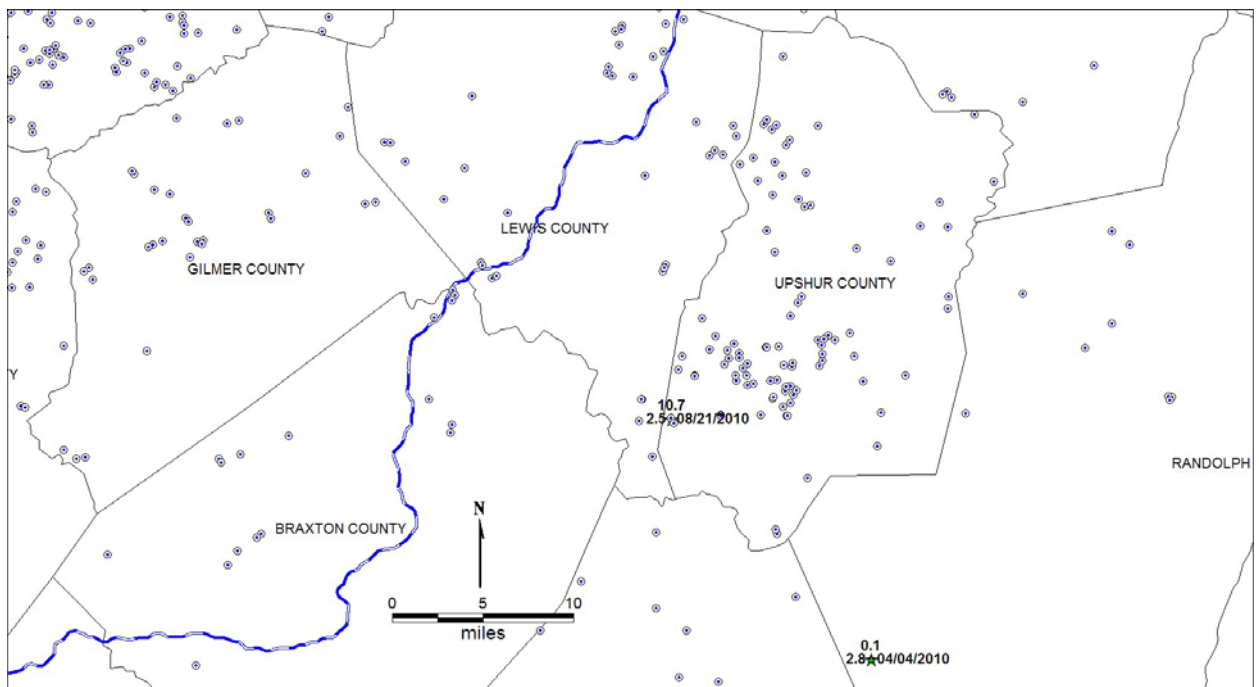
Figure M-2. Locations of seismic events in the vicinity of Upshur County shown in relation to the locations of gas wells developed to the Marcellus Shale. Event on August 21, 2010 plots directly on top of a gas well location, suggesting that increased drilling activity, possibly associated with fluid injection, is related to the increase in recorded seismic events.

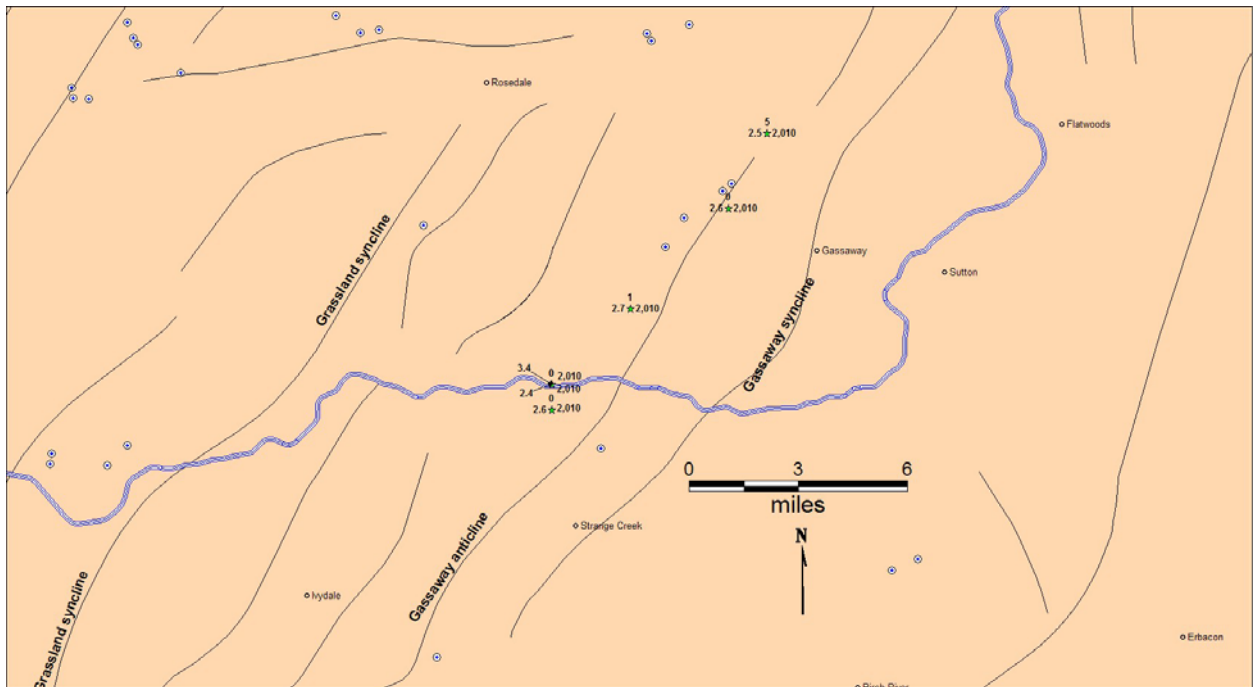
Figure M-3. Map of seismic events recorded by the USGS in 2010 in West Virginia are located along the axis of the Gassaway Anticline, dominantly occurring essentially at the ground surface. Location along anticline axis is suggestive of gas drilling-related activity. Blue circles represent the locations of gas wells drilled to the Marcellus Shale.

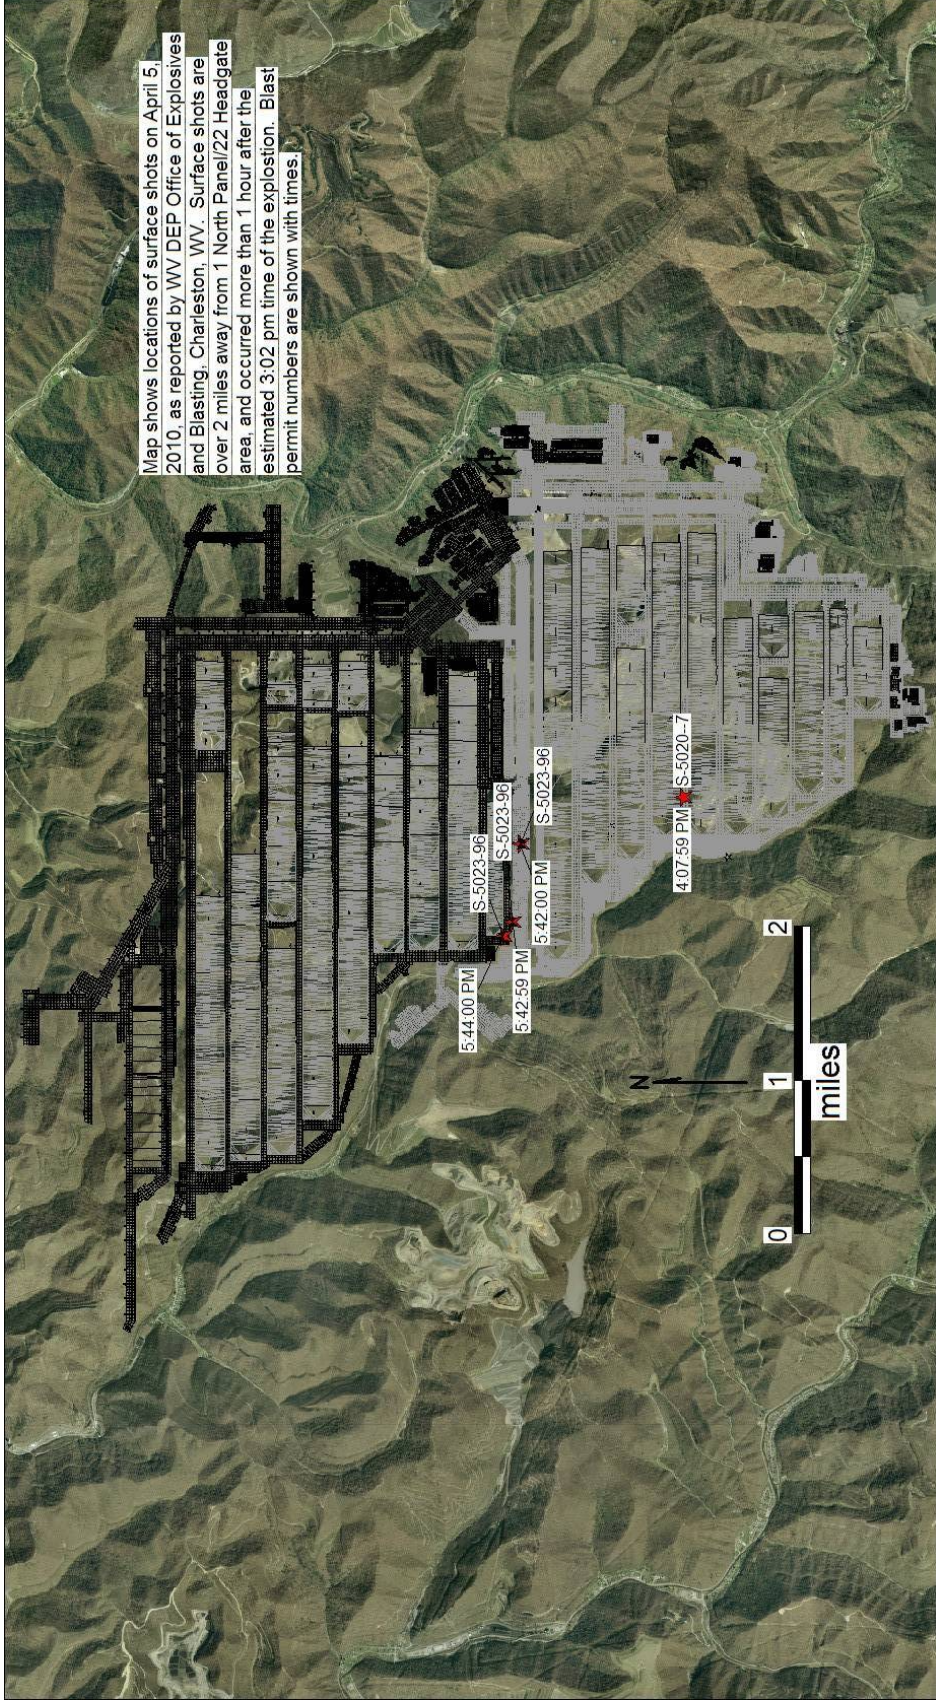
Although the US Geological Survey does not report events that are less than 1.0 Magnitude, the possibility of an association with surface blasting was assessed by portraying UBB workings in relation to surface mines on georeferenced air photos. The nearest surface operation is located nearly two miles from the vicinity of HG 22 and/or the 1 North Panel face. Surface shots conducted on April 5, 2010, the day of the explosion, were recorded by seismographs monitored by the West Virginia Department of Environmental Protection's (WVDEP) Office of Explosives and Blasting. The locations of surface blasts were plotted in a Geographic Information System (GIS) using coordinates provided by the WVDEP Office of Explosives and Blasting, along with the times of surface blasting. Four surface blasts were recorded approximately 2 ½ miles from the face of the 1 North Panel, but the earliest was over one hour after the 3:02 p.m. time of the explosion. The WVDEP was requested to provide the locations and times of all surface blasts for the week prior to the explosion, within a five mile radius of the 1 North Panel face. Discussions with David Vande Linde (Office of Explosives and Blasting) conducted on April 29-30, 2010, revealed that seismographs were located at Lindytown and Synergy, and agreed with the time data provided by the company, although located 1,500-2,000 feet away from the blast (Figure N-1). Mr. Vande Linde indicated that at that distance, the seismic magnitudes resulting from the surface shots were 0.01-0.06 Magnitude, representing very small events.

Figure N-1. UBB in relation to surface blasting events on April 5, 2010. Surface shots all occurred at least one hour after the 3:02 p.m. time of the explosion, and were located more than two miles south of the 1 North panel.

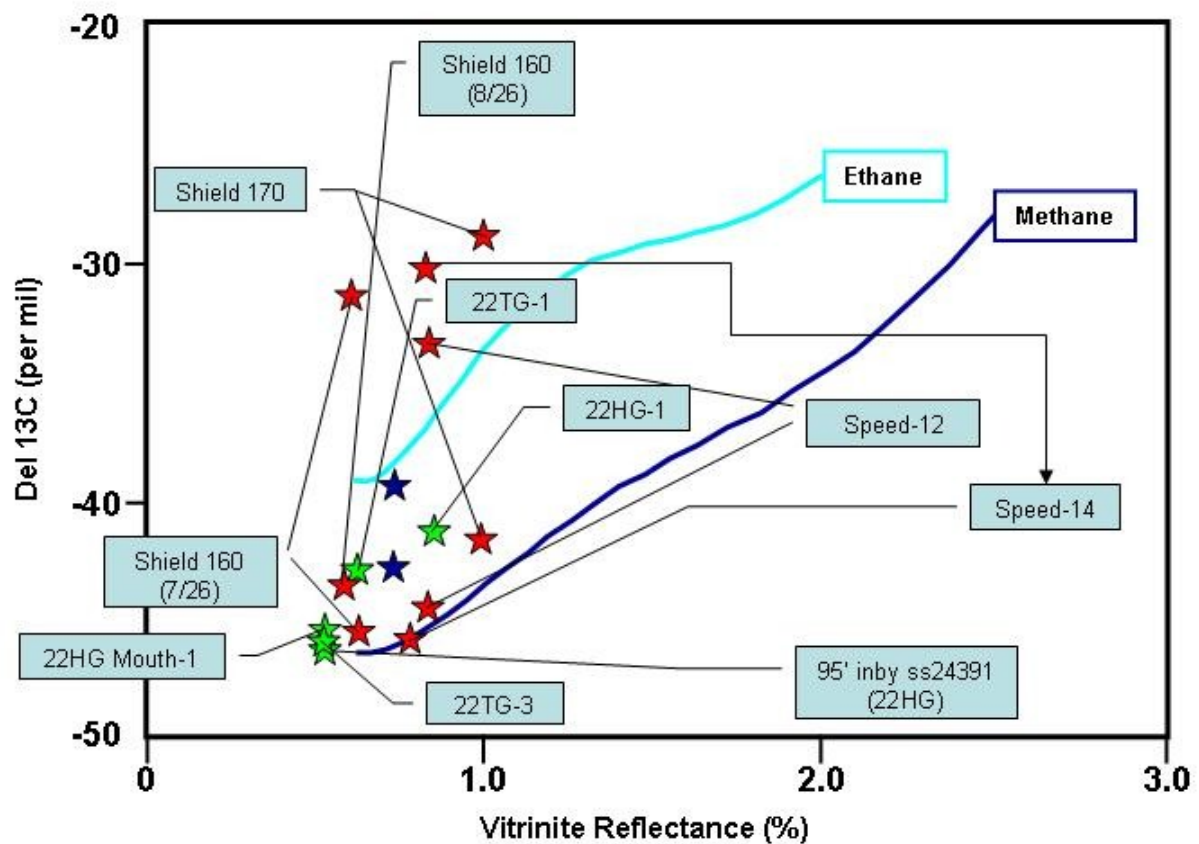
Figure O-1. Plot of collected gas samples for $\delta^{13}\text{C}$ for methane (‰) and ethane versus vitrinite reflectance, after Berner and Faber (1996), indicating derivation from Type II kerogen, such as expected for organic shale. Vitrinite reflectance is unknown for Marcellus Shale beneath UBB, but values of 0.8% and 0.6% for samples collected from the American Eagle Mine and UBB, respectively, are based on Figure 46. Published data for area coal seams in the southern Appalachian Basin suggest that vitrinite reflectance may be as high as 0.9%. For both samples, values lie along the curve defined for methane, but diverge significantly from the curve defined for ethane. Red stars indicate samples that contain C₂₊ hydrocarbons; green stars indicate samples with little or no C₂₊ hydrocarbons. Blue stars indicate composition of natural gas produced from the Marcellus Shale.

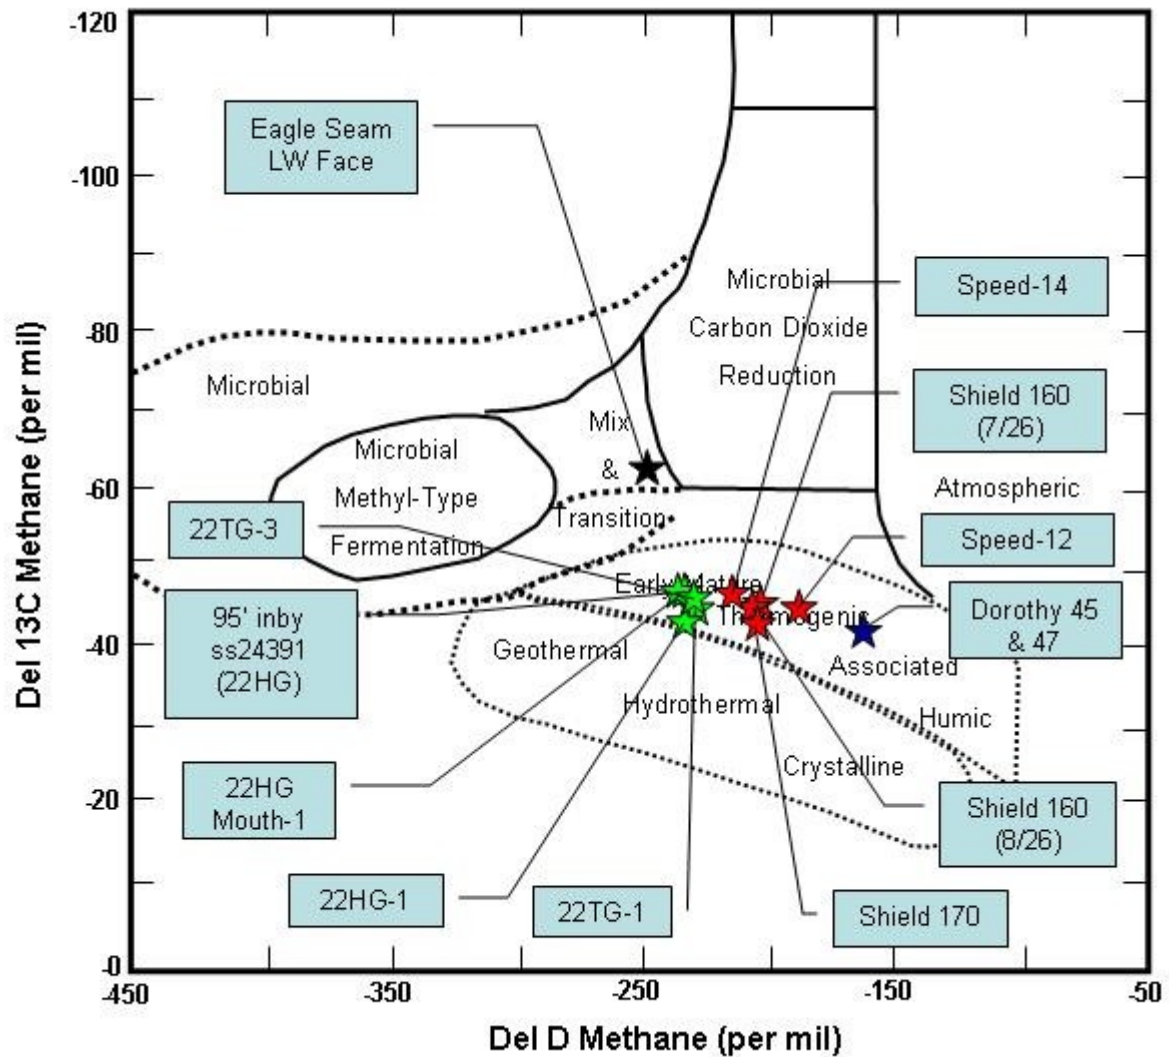
Figure O-2. Discrimination diagram from Whiticar (1996) showing gas fields based on plotting $\delta^{13}\text{C}$ for methane (‰) versus δD for methane (‰). Red stars indicate samples that contain C_{2+} hydrocarbons; green stars indicate samples with little or no C_{2+} hydrocarbons. Blue star indicates samples that were obtained from the Dorothy 45 and Dorothy 47 wells, which produce natural gas from the Marcellus Shale.

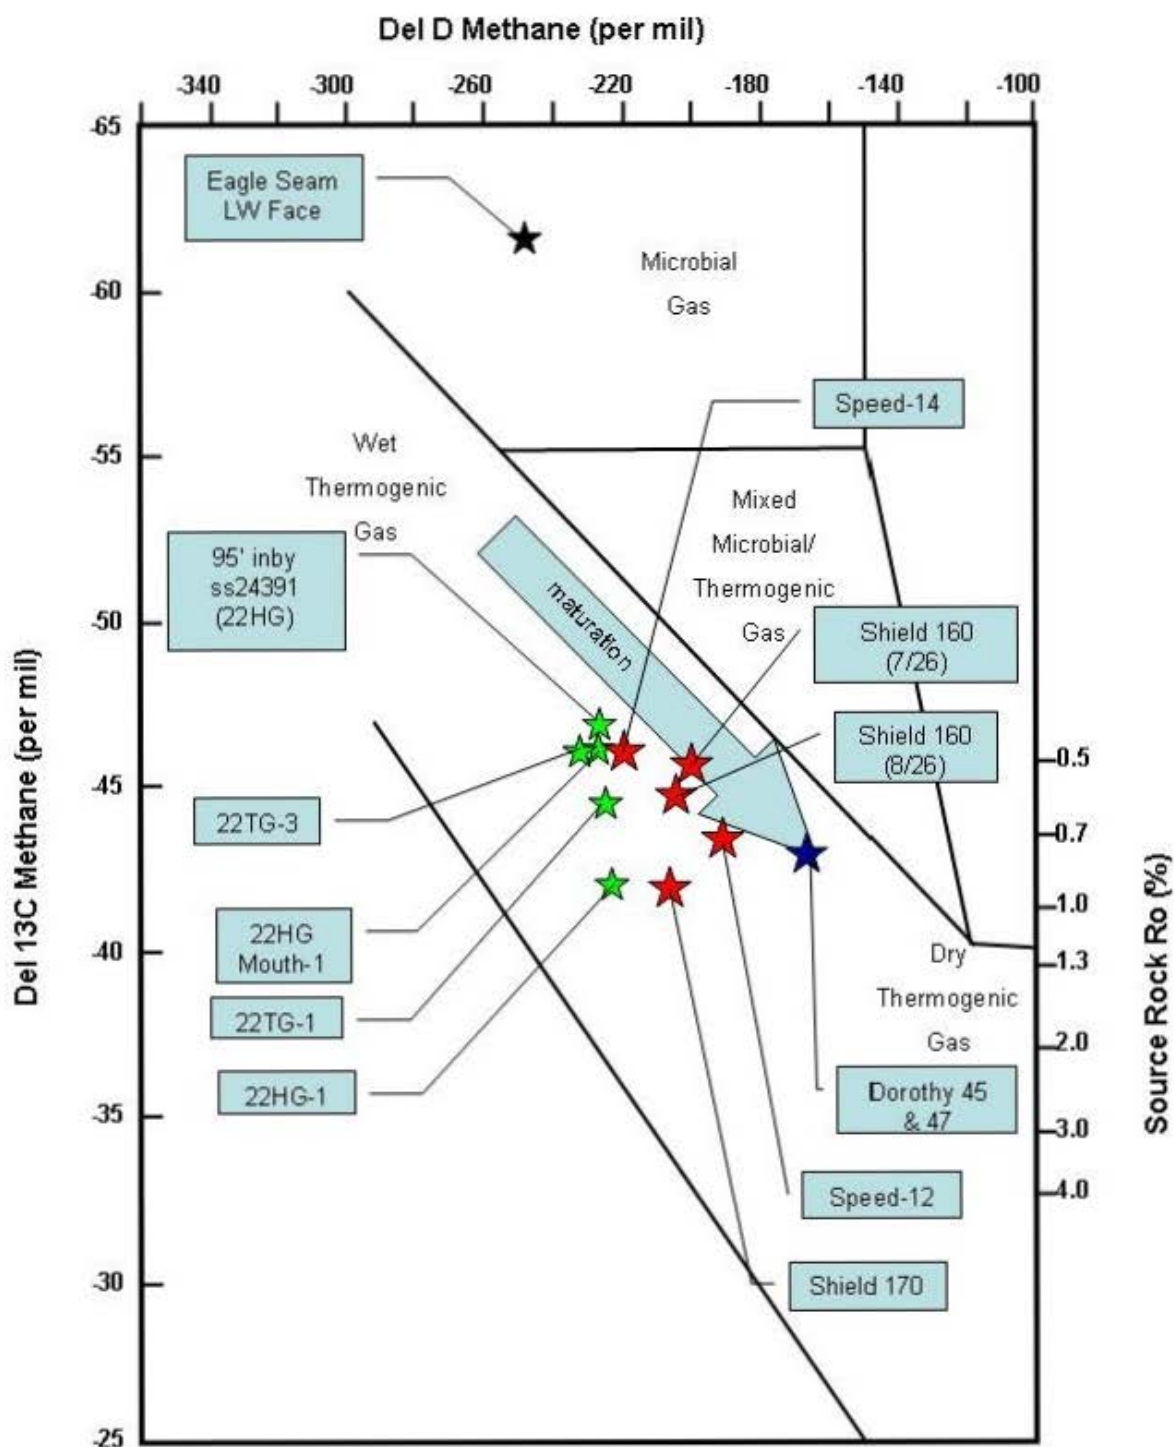
Figure O-3. Discrimination diagram after Jenden et al. (1993) showing fields of microbial and thermogenic gas based on plotting values of $\delta^{13}C$ for methane (‰) and δD for methane (‰). Values for vitrinite reflectance are shown for comparison. Red stars indicate samples that contain C_{2+} hydrocarbons; green stars indicate samples with little or no C_{2+} hydrocarbons. Blue star indicates samples that were obtained from the Dorothy 45 and Dorothy 47 wells, which produce natural gas from the Marcellus Shale.
