REPORT OF INVESTIGATION

**Fatal Underground Mine Explosion
April 5, 2010**

**Upper Big Branch Mine-South, Performance Coal Company
Montcoal, Raleigh County, West Virginia, ID No. 46-08436**

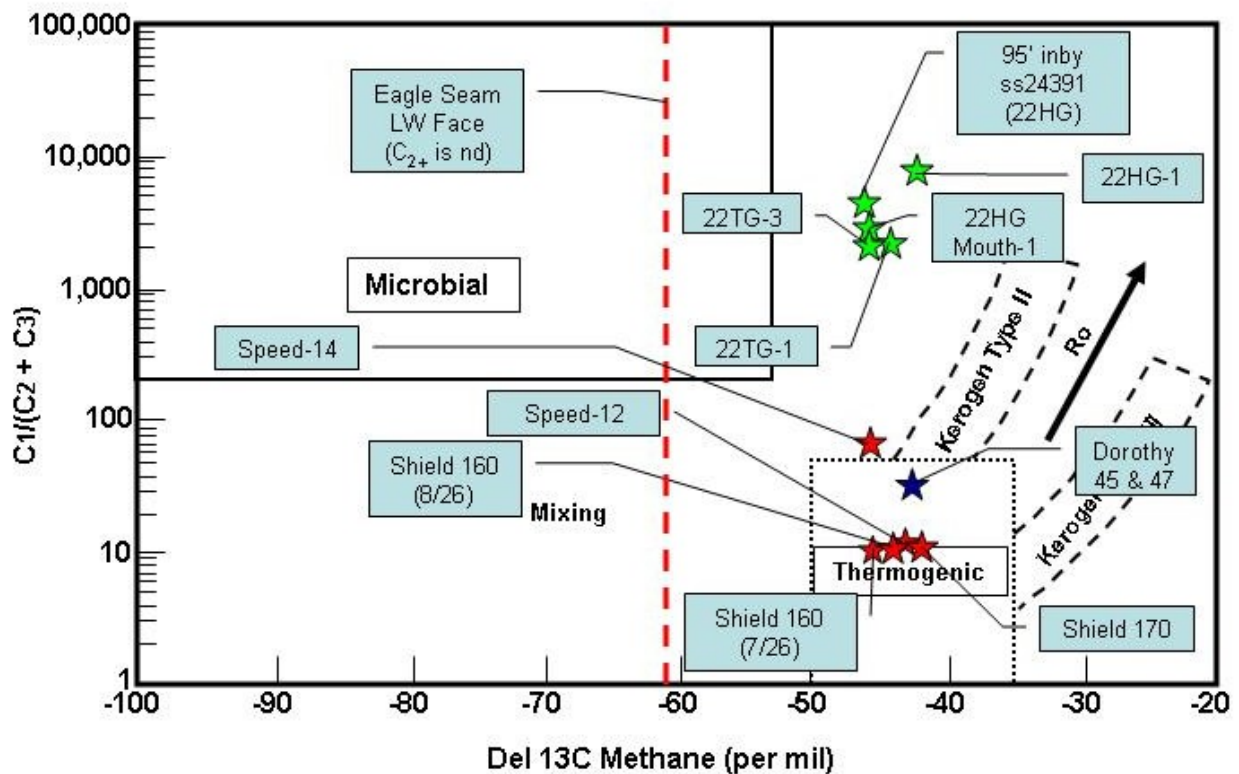
Figure O-4. Discrimination diagram showing fields of gas from microbial and thermogenic sources, based on comparison of C_1 , C_2 , and C_3 hydrocarbons (ratio of methane to combined ethane and propane), compared to $\delta^{13}C$ for methane (‰). Diagram modified from Whiticar, 1996). Red stars indicate samples that contain C_{2+} hydrocarbons; green stars indicate samples with little or no C_{2+} hydrocarbons. Blue star represents samples obtained from the Dorothy 45 and Dorothy 47 wells, which produce natural gas from the Marcellus Shale.

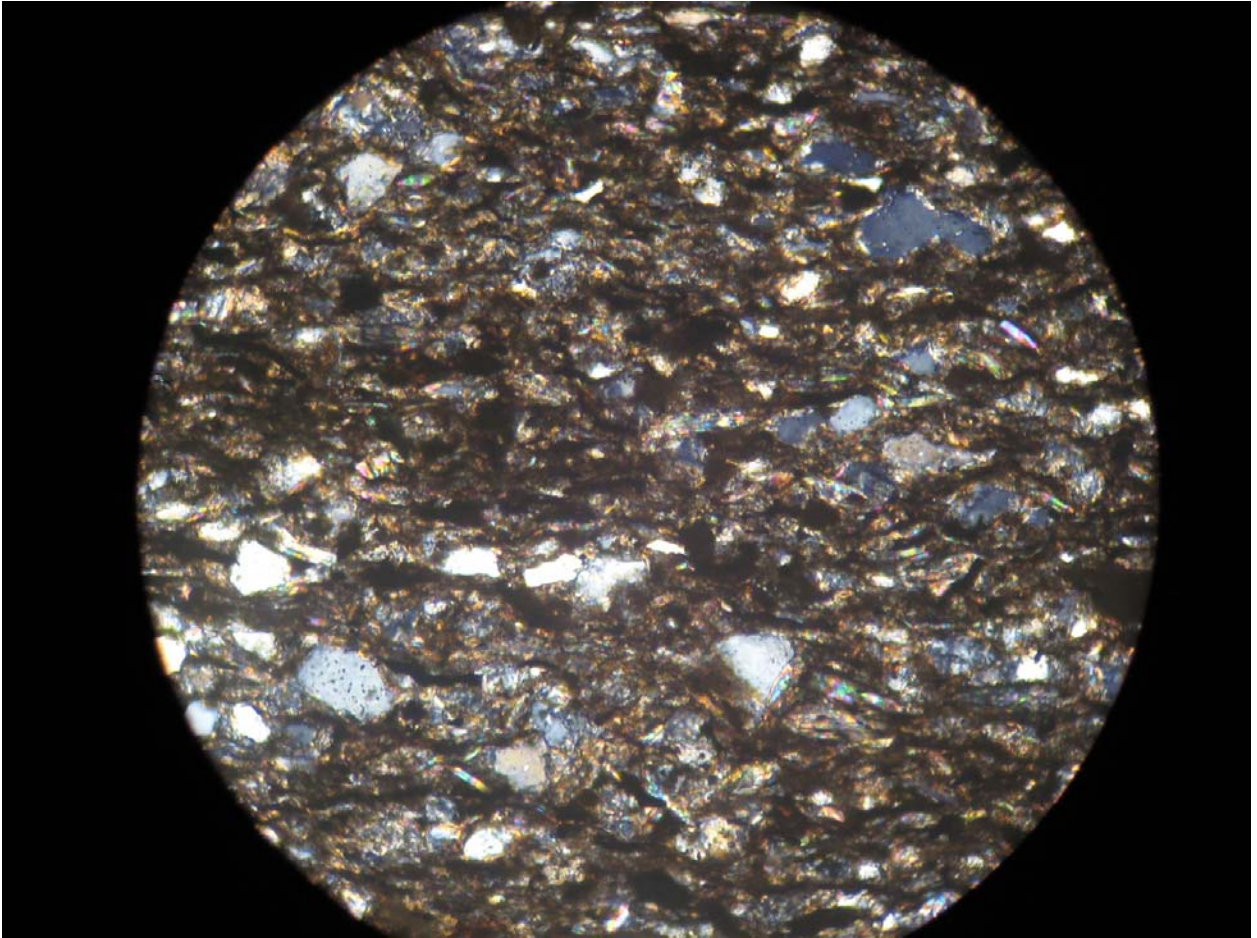
A sample of rock from the face, directly in contact with the top of the coal seam, had been ejected outward onto the tail drive. The sample contains two rock types, coarse-grained micaceous quartzo-feldspathic siltstone interbedded with medium-grained feldspathic wacke (arkose). The siltstone layers are characterized by gradational laminations in color, highlighted by changes in the relative proportions of biotite and quartz + feldspar. Alternating bands of brown coloration are due to the proportion of biotite in bands that are less than 1 mm thick. Angular, commonly jagged grains of quartz (7% content, 0.03-0.2 mm diameter) are sporadically distributed throughout the rock, with individual grains commonly isolated by a matrix of biotite and muscovite lathes (Figure Q-1). Less commonly, quartz grains touch along tangential boundaries. Quartz grains also commonly touch plagioclase grains along tangential boundaries. Angular, jagged-edged grains of plagioclase (25% content, 0.04-0.2 mm diameter) touch along tangential boundaries and commonly show moderate to heavy sericite alteration. Thin, ragged flakes of biotite (15% content, 0.04-0.2 mm diameter) are abundantly distributed, with individual flakes isolated or concentrated in clusters between quartz and plagioclase. Flakes are oriented parallel and their abundance defines color banding in alternating layers (Figure Q-2). Biotite flakes are compacted around angular corners of quartz and plagioclase grains. Rarely, some flakes are completely altered to chlorite. Thin lathes and ragged flakes of muscovite (5% lath content, 48% content including matrix sericite, 0.01-0.1 mm diameter) are sporadically distributed with individual lathes or flakes abundantly intermixed with quartz and plagioclase. Fine-grained flakes represent a matrix that generally surrounds individual grains of quartz and plagioclase and occupies angular interstices. In other layers, individual lathes are isolated between angular grains of sericitized plagioclase.

Figure Q-1. Angular grains of quartz (white, yellow) and plagioclase (gray, with dusty sericite alteration) are generally surrounded by a matrix of biotite (dark brown), muscovite (brightly speckled), and illite or very fine-grained muscovite in this sample of coarse siltstone from the 1 North Panel face roof. Field of view 1 mm at 100X.

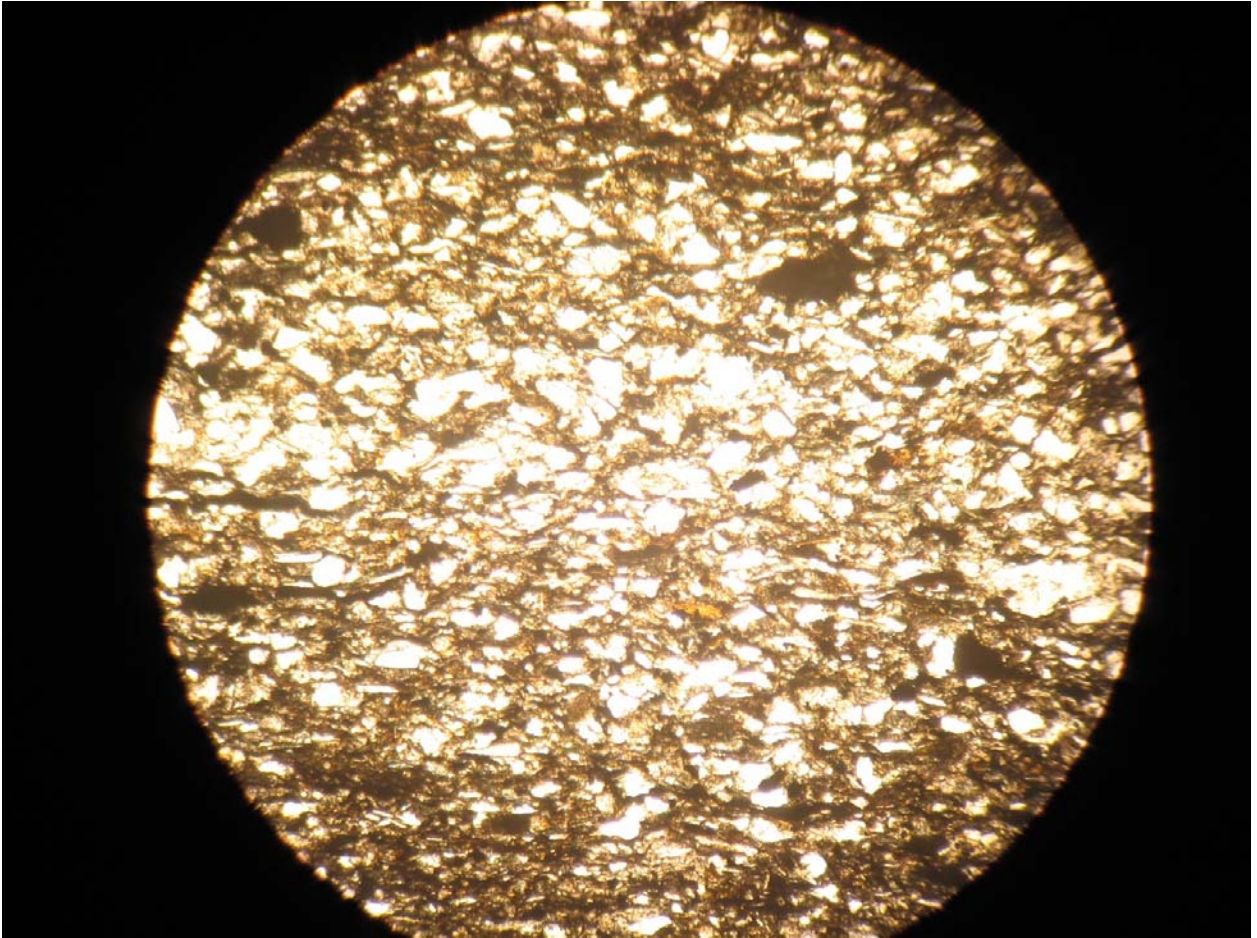
Figure Q-2. The roof rock, viewed in plane polarized light, reveals how changes in the concentration of biotite mica impart the effect of color banding in the coarse siltstone collected from the 1 North Panel face roof. Field of view 1 mm at 100X.

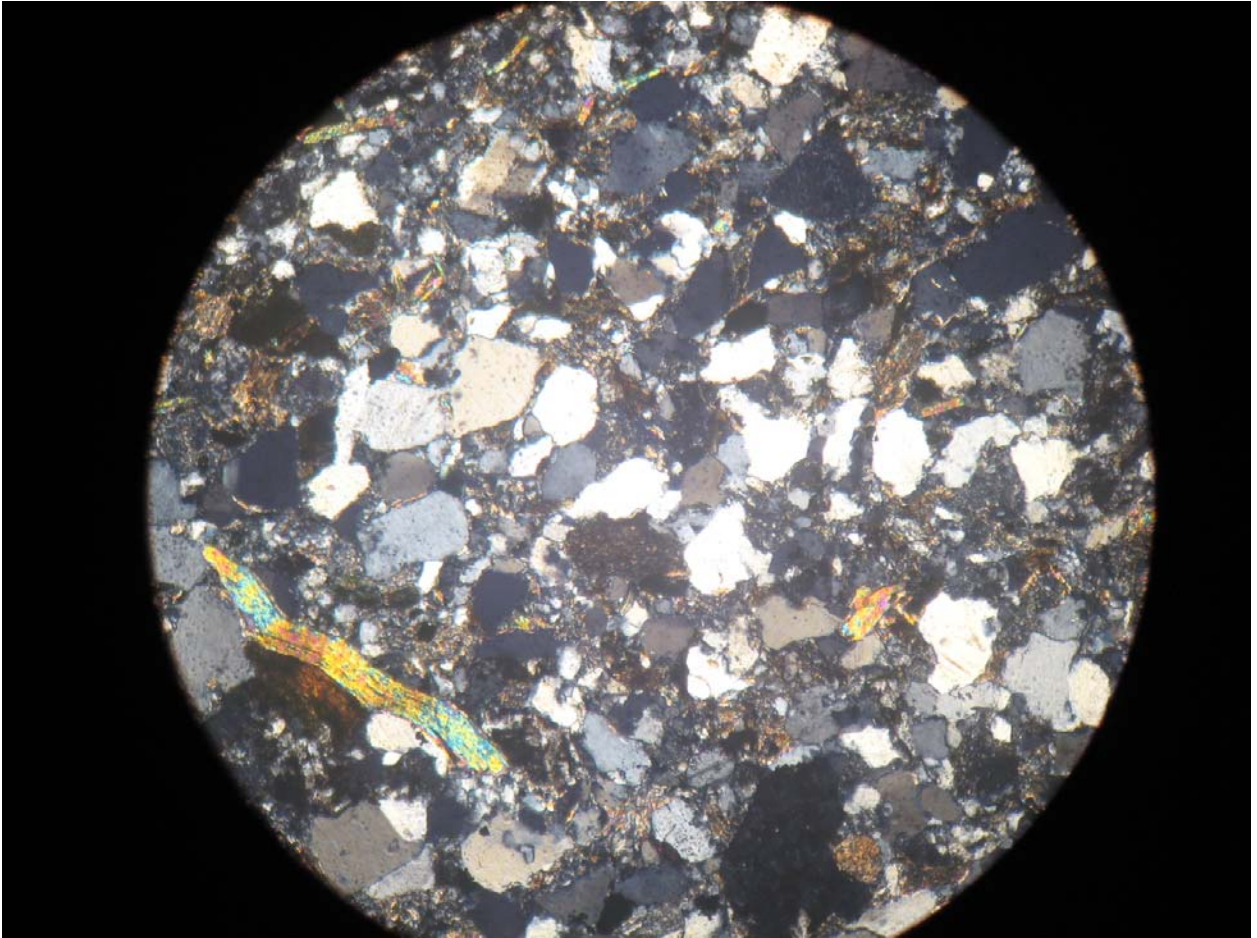
Figure Q-3. Layer of feldspathic arenite interbedded with coarse siltstone from the roof of 1 North Panel face is characterized by angular grains of quartz (white), plagioclase (gray, with dusty sericite alteration), and rare microcline (plaid black and gray) that touch along tangential and concavo-convex boundaries that leave few interstices for illite/muscovite matrix material. Field of view 2.4 mm at 40X.

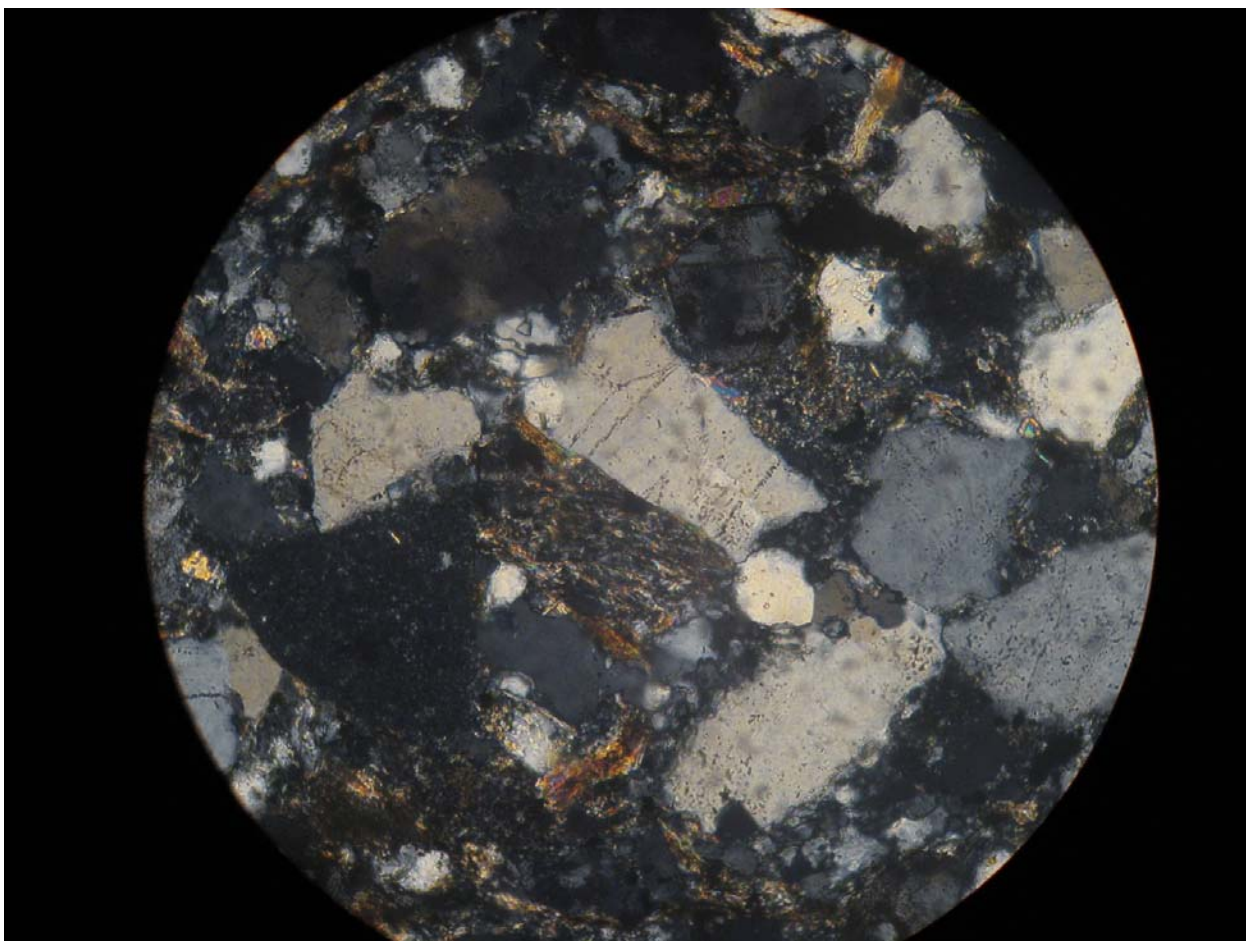
Figure Q-4. Angular grains of quartz (white, shadowed) and plagioclase (gray, with dusty sericite alteration) touch along straight, tangential, and concavo-convex boundaries that leave few interstices for illite/muscovite matrix. Field of view 1 mm at 100X.

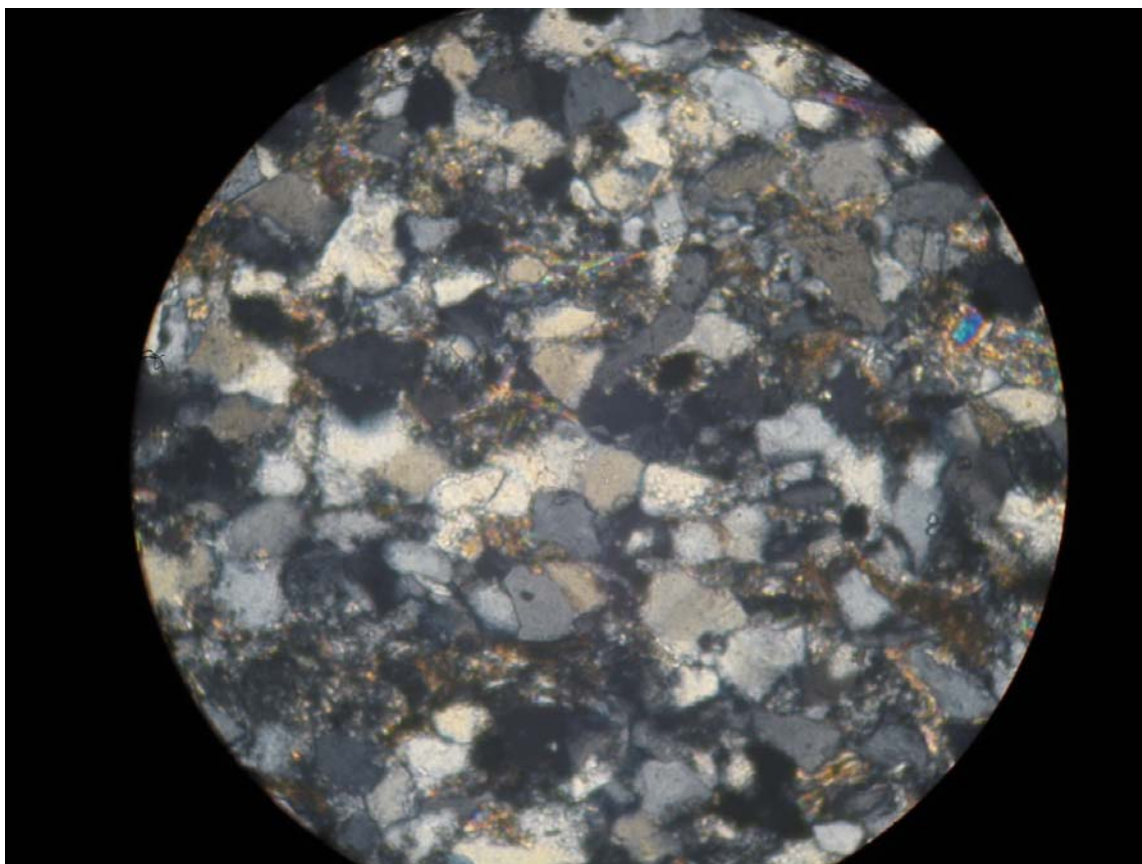
Figure Q-7. In fine-grained feldspathic arenite/subarkose sandstone from floor, angular grains of quartz (yellow, gray) and plagioclase (wavy shades of gray) interlock along straight, concavo-convex, and sutured boundaries, with only minor amounts of mica or sericite in small, rare interstices. Cluster of quartz grains at center of view interlock along sutured boundaries that meet at roughly 120° angles, indicating compaction recrystallization. Field of view 1 mm at 100X.

Compared to the sample collected from the roof, the floor sample contains a much greater quartz content, and is characterized by a much greater degree of grain interlocking, with a significant number of concavo-convex and sutured boundaries. Several areas exhibit sutured boundaries along quartz grains that meet at 120° angles, indicating a degree of diagenetic compaction recrystallization. Similarly, mica flakes are wrapped around obdurate quartz grains due to intense compaction. Due to the higher quartz content in the floor sandstone, it has a higher average Mohs Hardness value of 6.31, compared to a value of 5.83 for the sandstone in the roof, or 3.64 for the dark gray siltstone in the roof. Furthermore, the floor sandstone appears to be more fine-grained, with maximum grains sizes of 0.2 mm compared to grains sizes of 0.4-0.6 mm in the roof sandstone. The grain size distribution also seems more uniform in the floor sandstone.

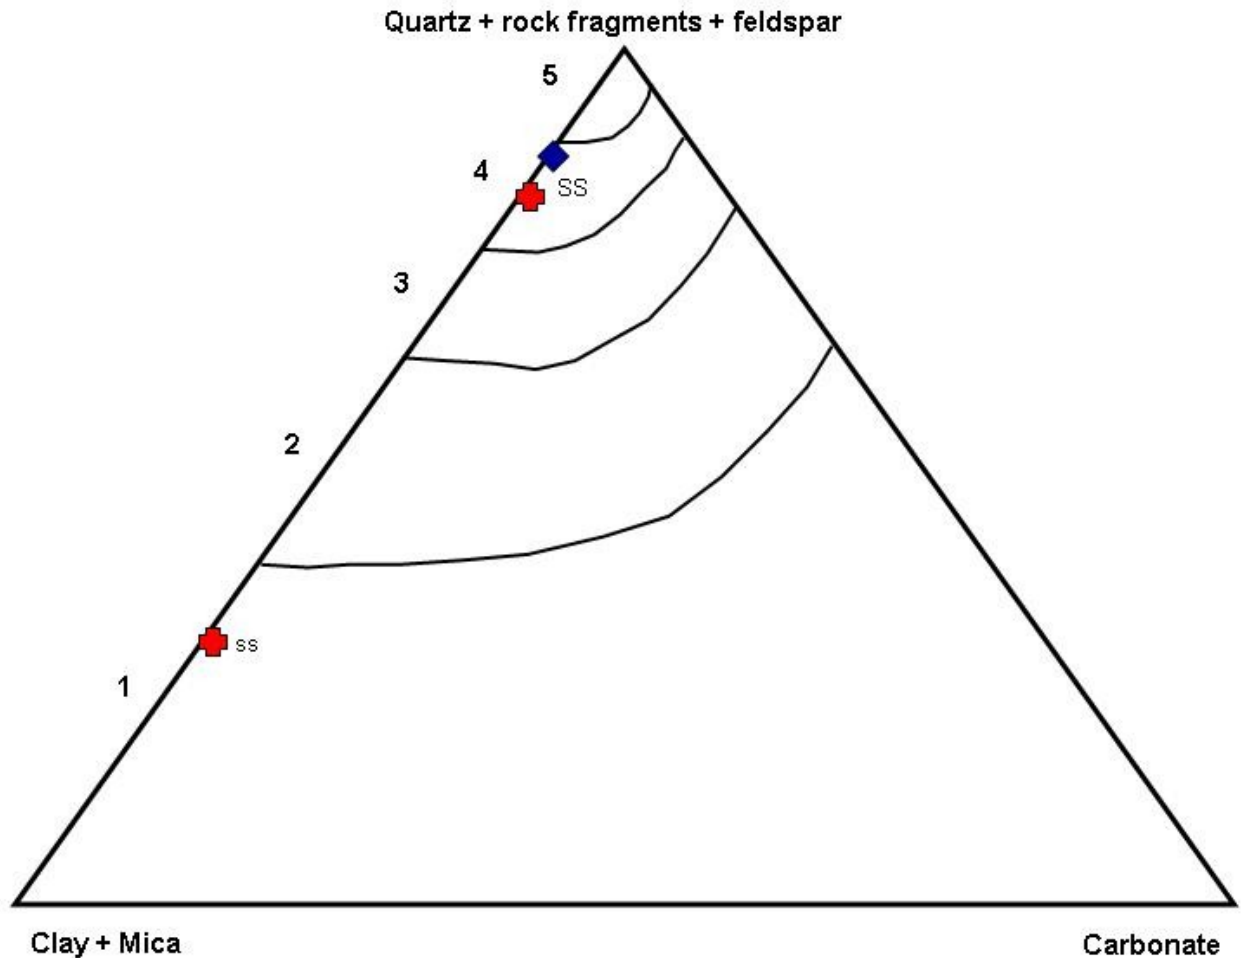
Based on the mineral contents determined by thin section petrography, the samples were plotted on the ternary diagram developed by Ward et al. (2001) for comparison with the incendivity index developed for rocks in Australian coal mines (Figure Q-8). The layers of coarse siltstone, which contain a high mica content, plot in Category 1, indicating a low potential for frictional ignition. In contrast, the sandstone plots in Category 4, indicating a high potential for frictional ignition. The floor sandstone very nearly plots in

the Category 5 zone, due to its high quartz content. It should be noted that the incendivity index applies to rock-on-rock and metal-on-rock ignitions. Thus, sandstone falling in the gob behind the shields, or sandstone being struck by bits on the shearer would both represent potential ignition sources.

Figure Q-8. Ternary diagram after Ward et al. (2001) showing relation of Upper Big Branch roof (red crosses) and floor (blue diamond) sandstone (SS) and siltstone (ss) to contour lines of incendivity index. Rocks with an incendivity index of 4-5 were shown in tests to have a high potential for frictional ignition. Although sandstone from roof and floor have similar incendivity indices, the floor sample is composed dominantly of quartz.

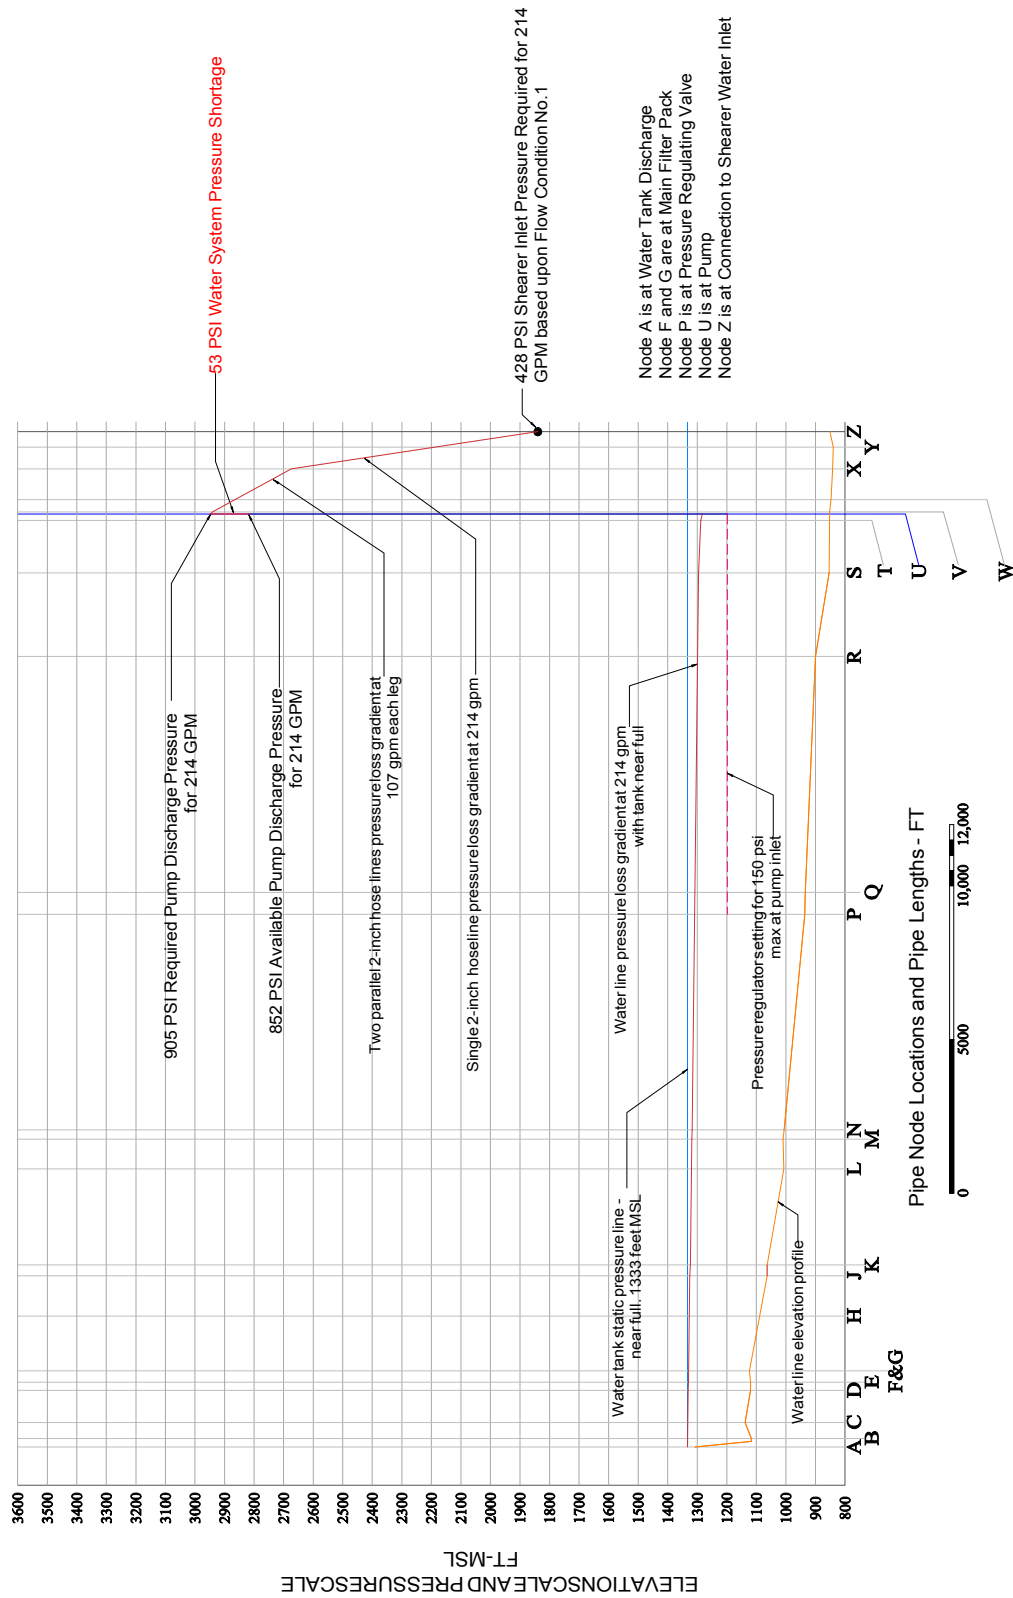
FIGURE R-2 UBB WATER SUPPLY TO LONGWALL HYDRAULIC PROFILE

Scenario 1: This scenario only included the flow of 214 gpm from the Shearer (Flow Condition 1) in the calculations.

Flow Scenario 1
Shearer Flow 214 GPM
Total Flow 214 GPM

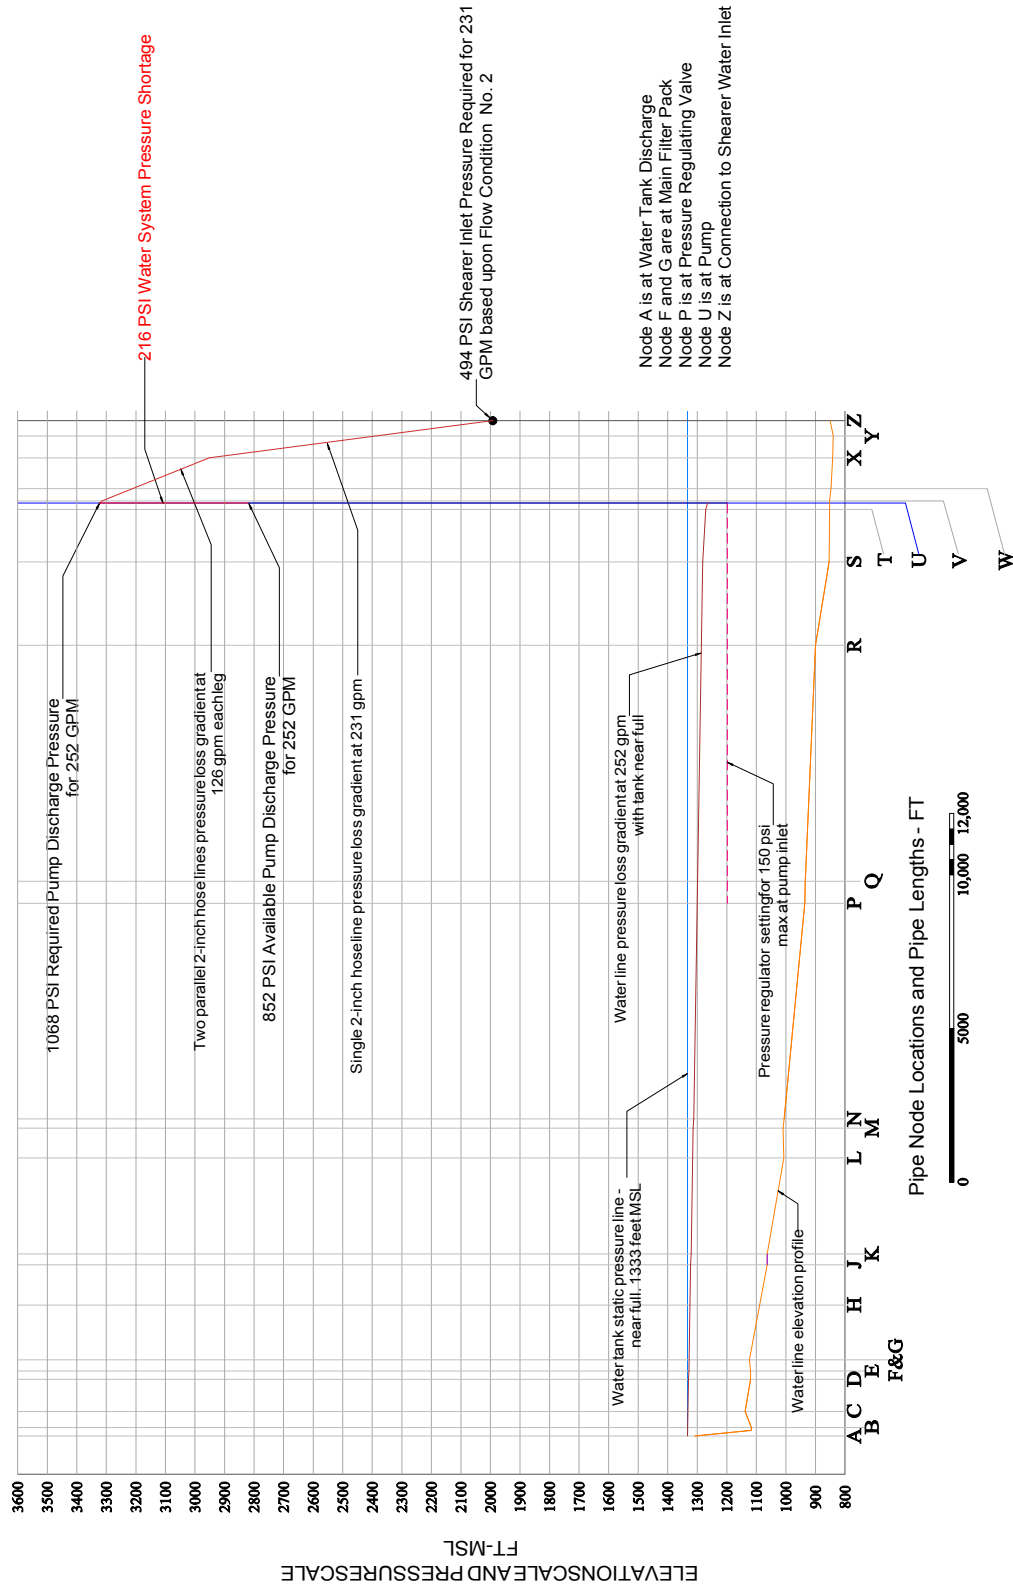
FIGURE R-3 UBB WATER SUPPLY TO LONGWALL HYDRAULIC PROFILE

Flow Scenario 2
Shearer Flow 231 GPM
Total Flow 252 GPM

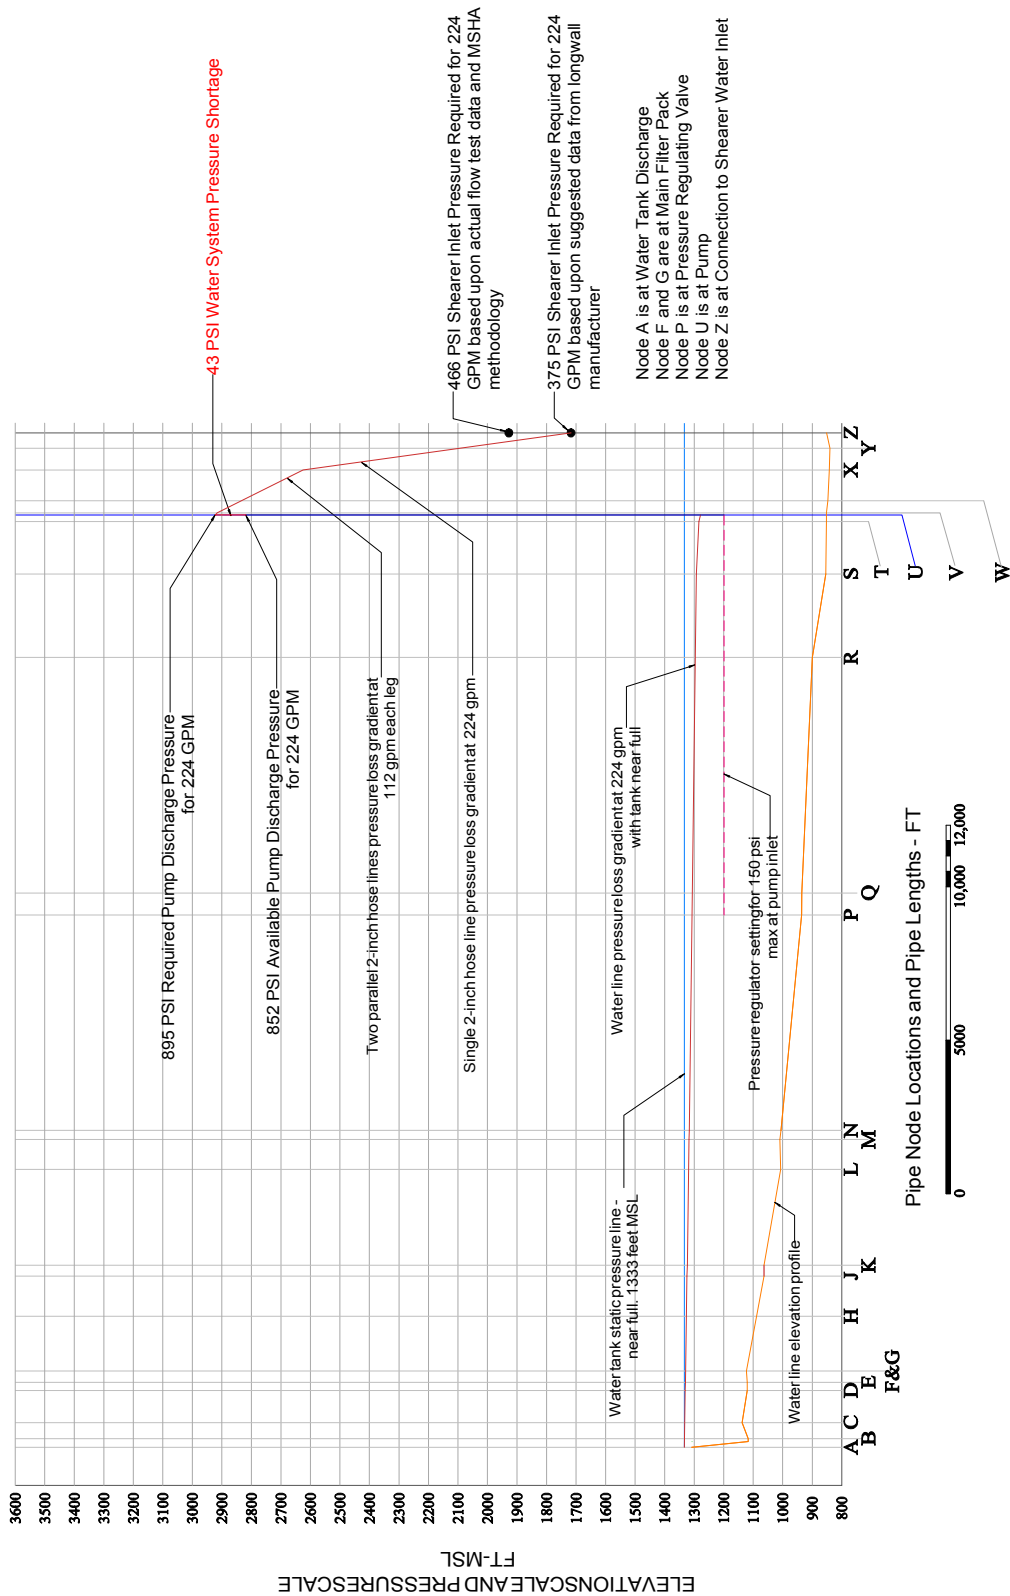
FIGURE R-5 UBB WATER SUPPLY TO LONGWALL HYDRAULIC PROFILE
Flow Scenario 4
Shearer Flow 224 GPM
Total Flow 224 GPM

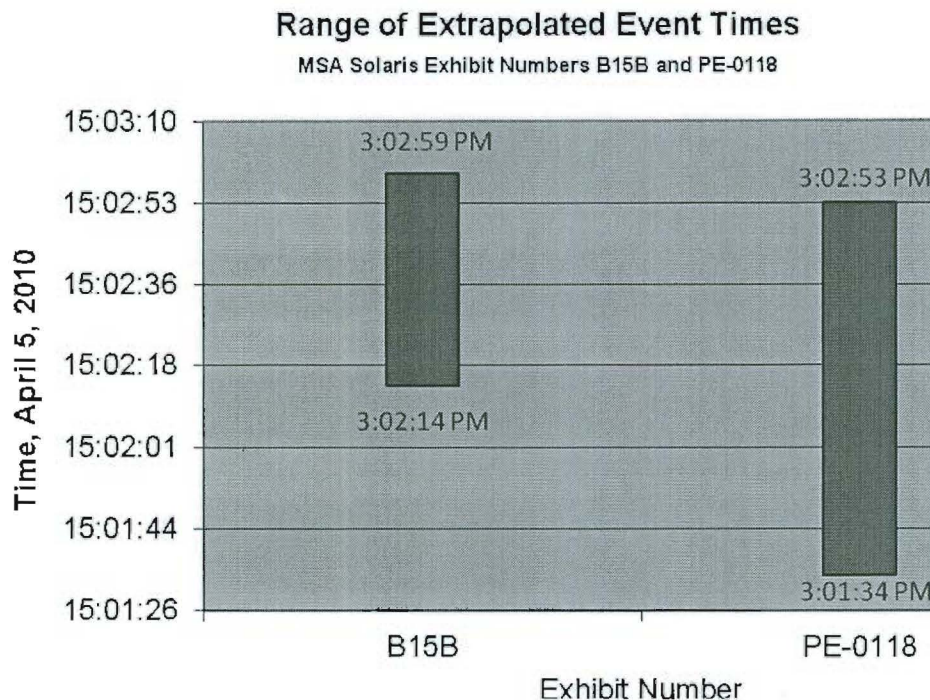
The MSA Solaris Multi-Gas Detector, Exhibit Number B15B recorded an over-range event for combustible gas, oxygen, and carbon monoxide on April 5, 2010. Similarly, on the same date, the MSA Solaris, Exhibit Number PE-0118 recorded an over-range event for oxygen and carbon monoxide, followed by an over-range event for combustible gas at the next recording interval 15 seconds later; it should be noted that these events could have been within as little as 1 second, or as much as 29 seconds. If

the drift was constant from April 5, 2010 until MSHA began taking time measurements, the actual expected time and date for the over-range events is as shown on the graph below.

The difference in the median of these two ranges is most likely due to the differences in the environment of the two detectors. Exhibit Number B15B was received on June 24, 2010, and kept in the climate-controlled MSHA building. Exhibit Number PE-0118 was not received until July 19, 2010. The environment before that date is not known, but has been anecdotally described as non-climate controlled.

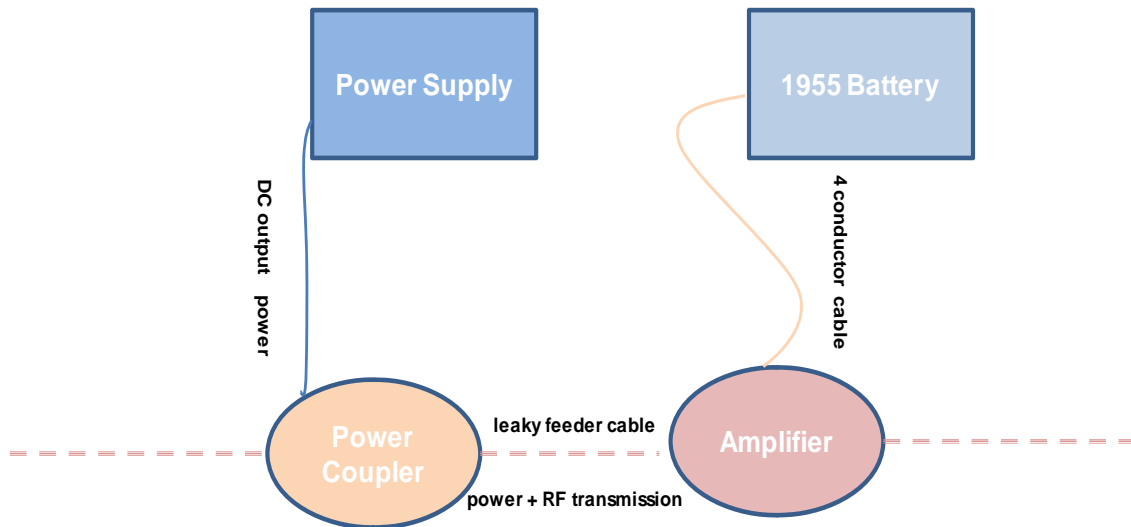
- 2.9.2. Each amplifier in the leaky feeder system has its own 1955 battery backup unit. Amplifiers receive power over the leaky feeder cable from power couplers which are in line with a power supply. The 1955 battery is charged from DC voltage that travels over the leaky feeder cable, through the amplifier circuit, and through the four conductor cable to the 1955 battery charge circuit as shown in Figure 1.

Figure 1 Sketch of Part of the Power Path for the Leaky Feeder System

- 2.9.3. The amplifier circuit includes a non-replaceable (soldered to the printed circuit board) fuse. Reports from field installations indicate that this fuse is susceptible to opening, reportedly due to voltage spikes from the line power source. Even when a 1955 battery is fully charged, an open fuse renders the amplifier inoperable, so communications inby the inoperable amplifier are severed. Although the operation of the tracking readers would be unaffected by the open fuse in the amplifier because they could continue to function on their own standby power source, they would not be able to transmit tracking data to the surface because the open fuse in the amplifier disrupts the operation of the leaky feeder system.

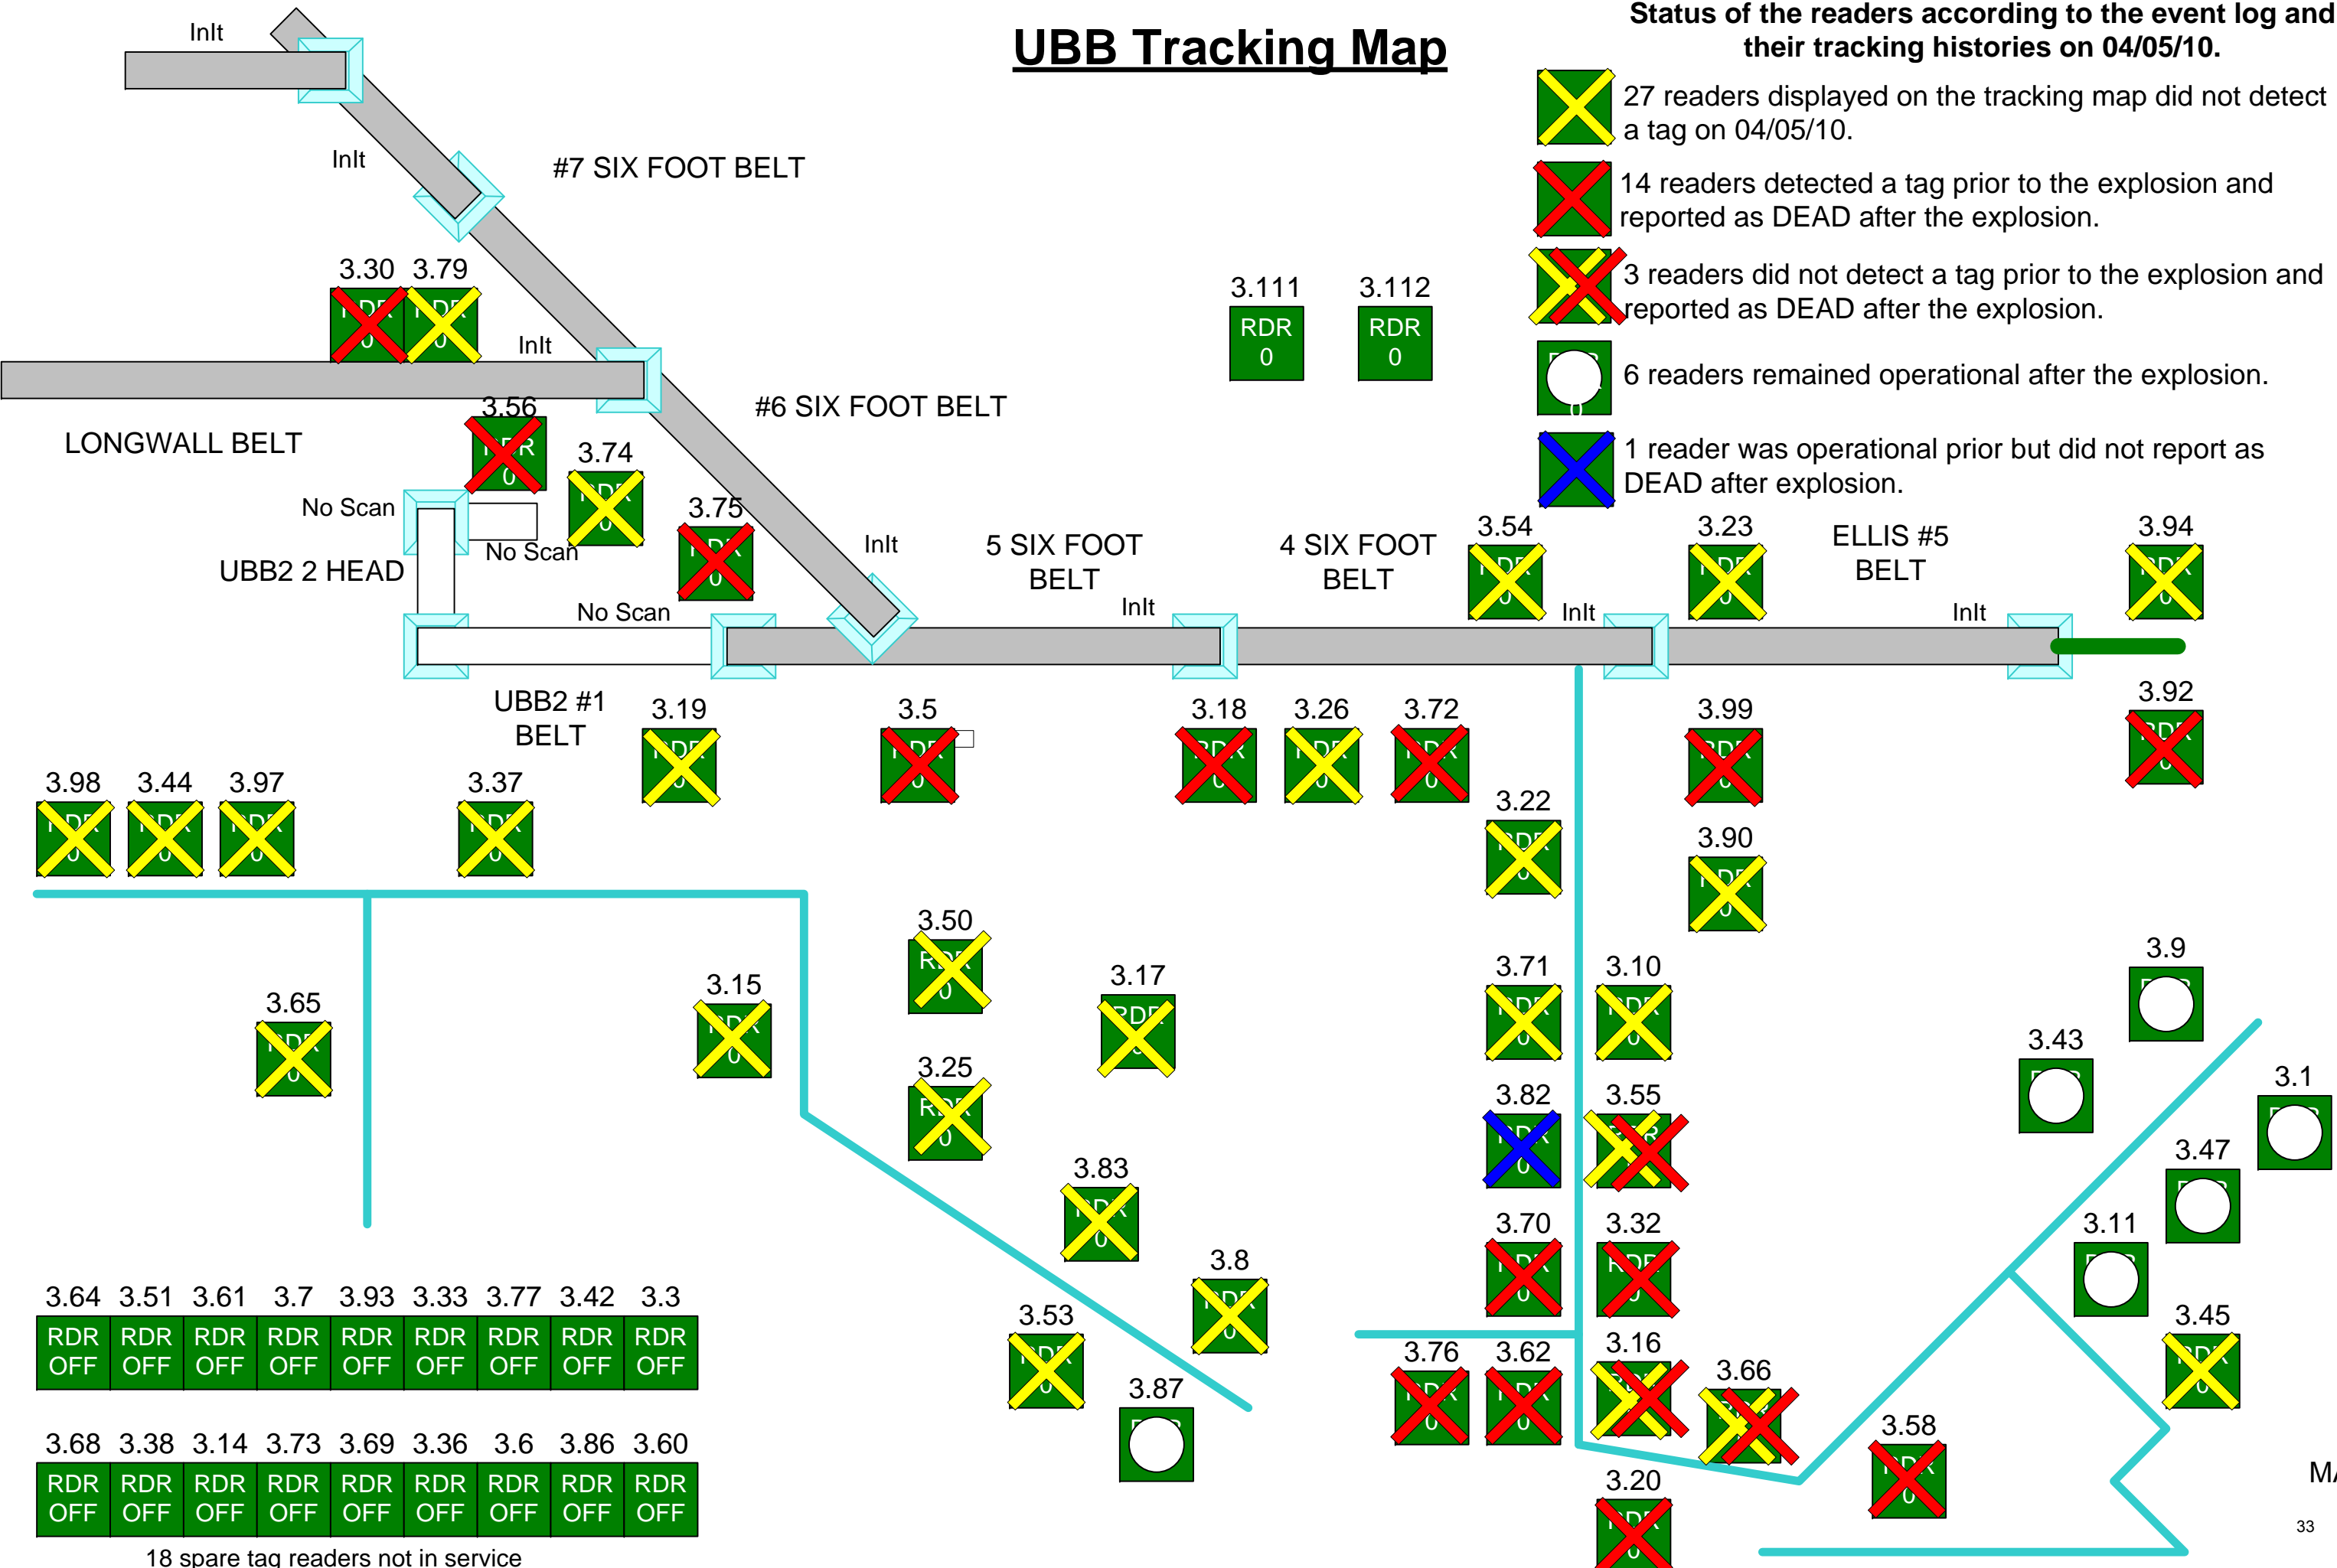
UBB Tracking Map

Status of the readers according to the event log and their tracking histories on 04/05/10.
