REPORT OF INVESTIGATION

**Fatal Underground Mine Explosion
April 5, 2010**

**Upper Big Branch Mine-South, Performance Coal Company
Montcoal, Raleigh County, West Virginia, ID No. 46-08436**

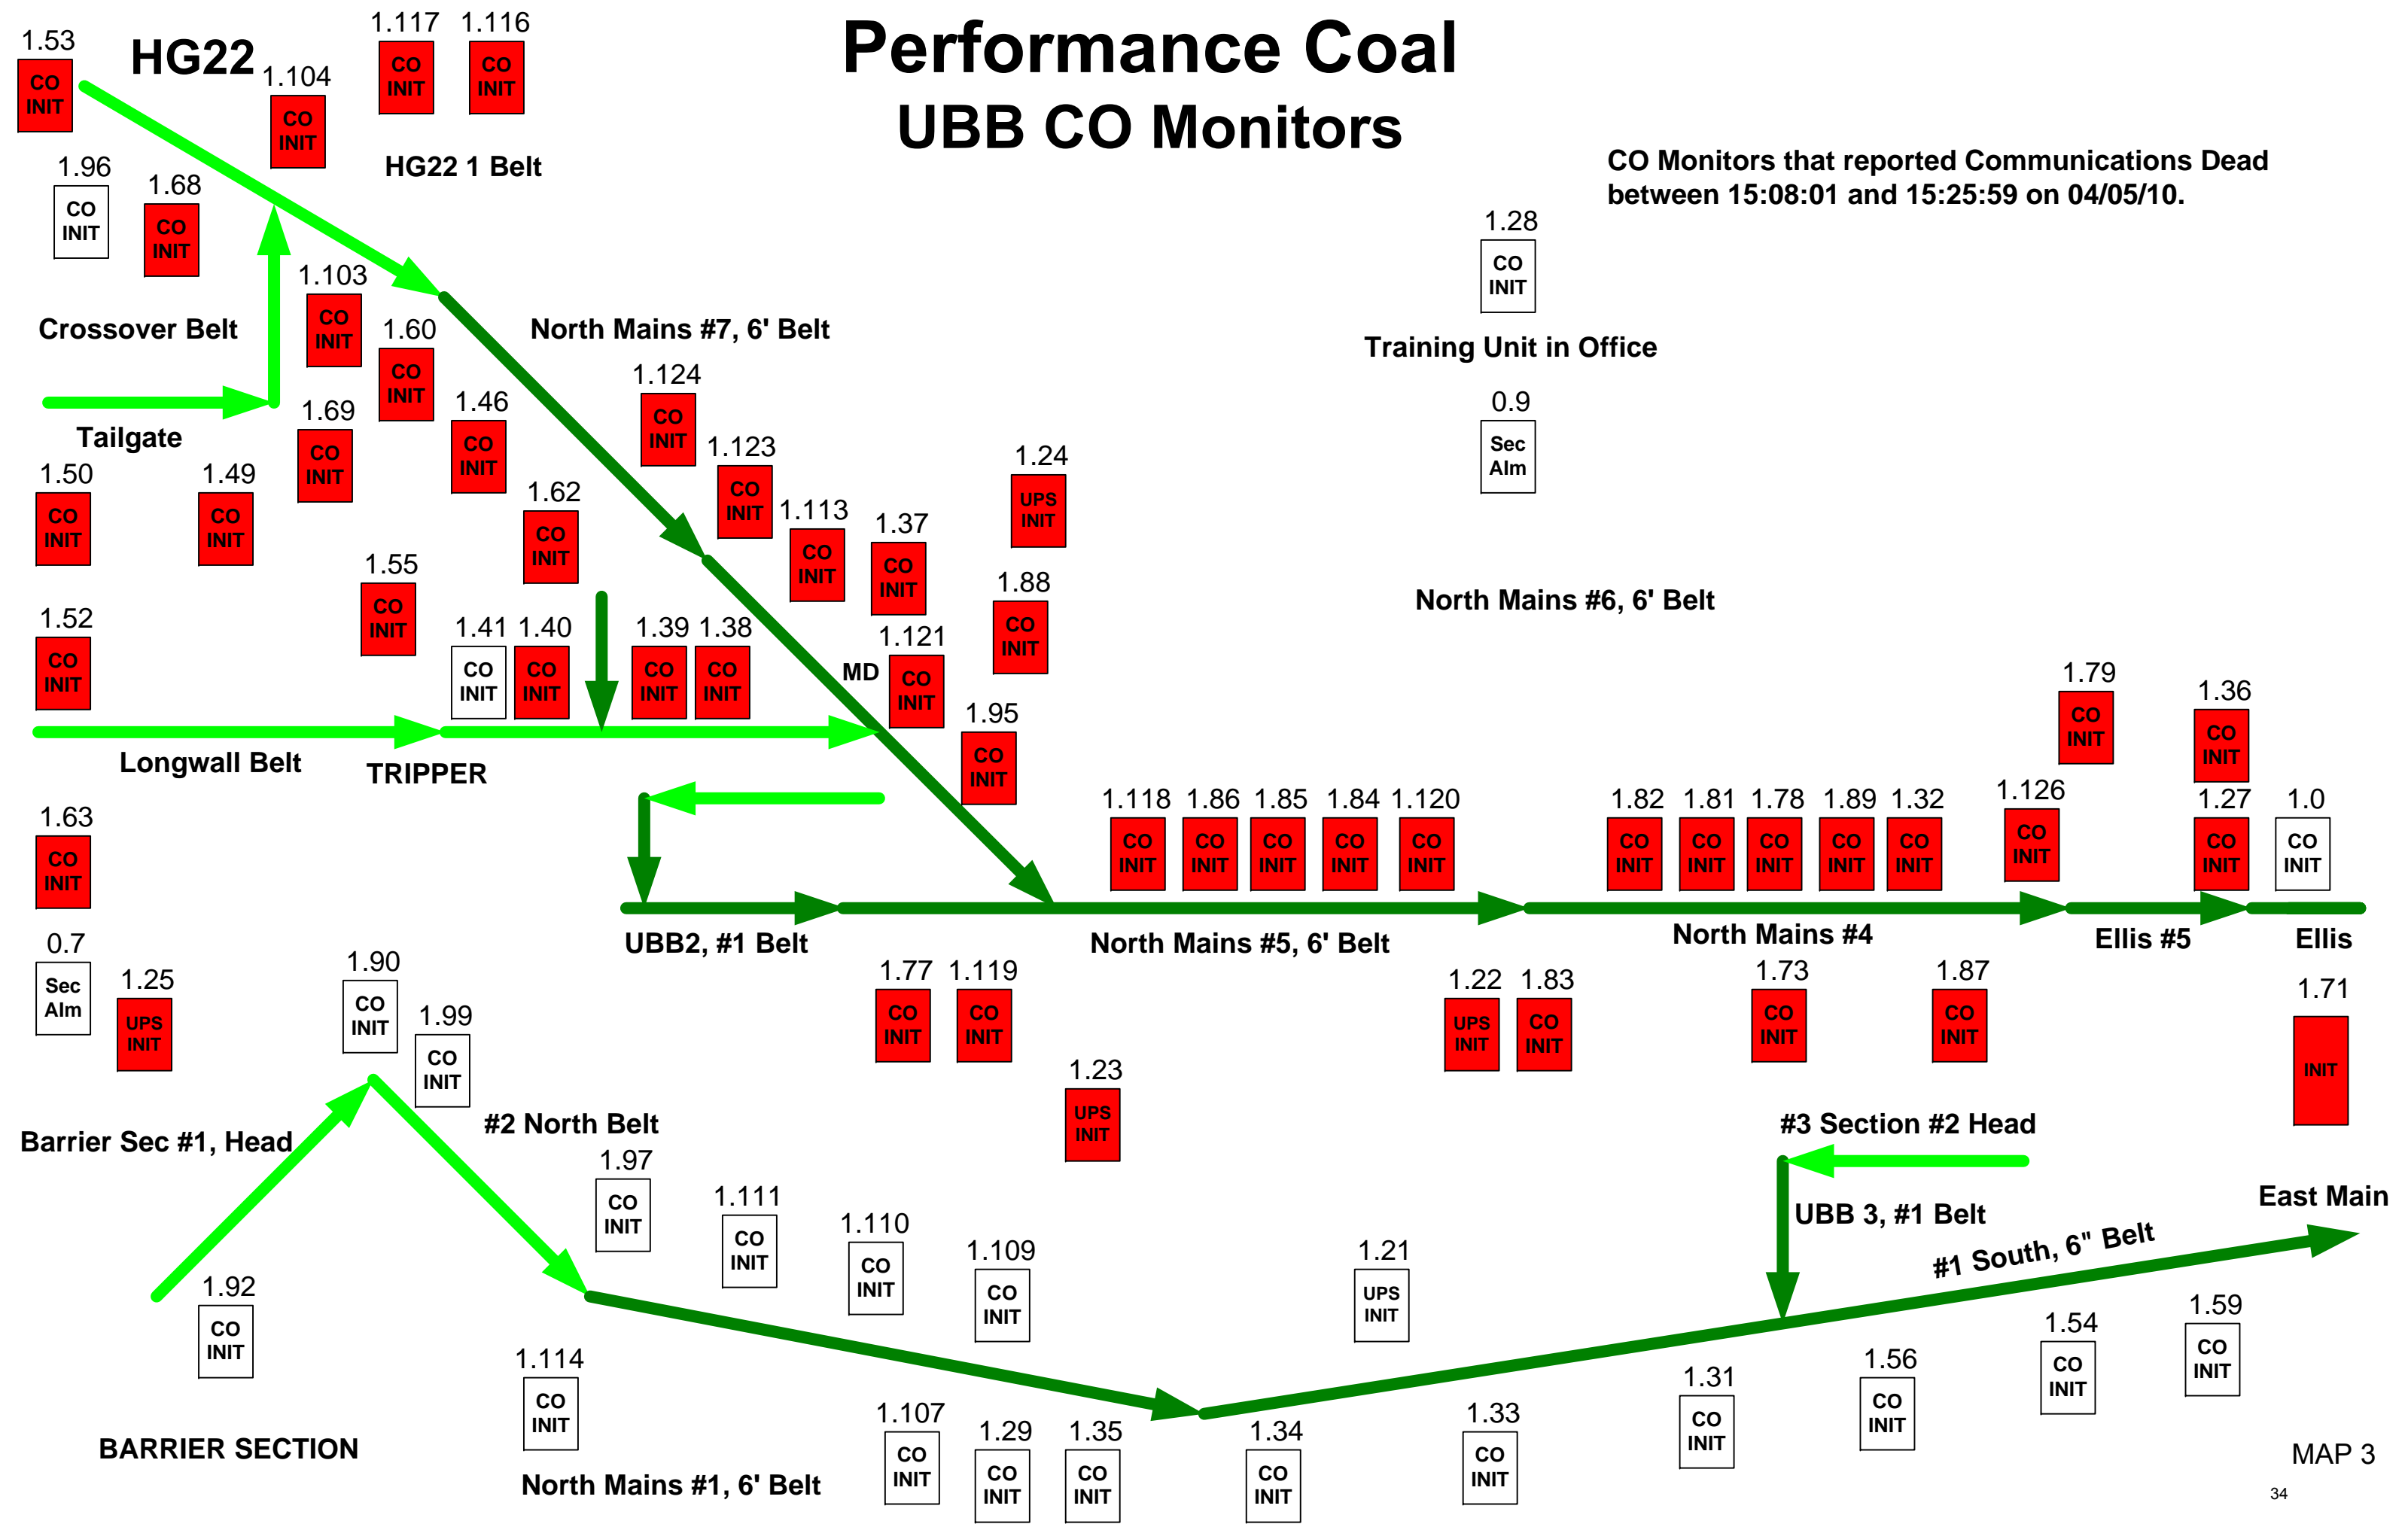
UBB CO Monitors

CO Monitors that reported Communications Dead between 15:08:01 and 15:25:59 on 04/05/10.

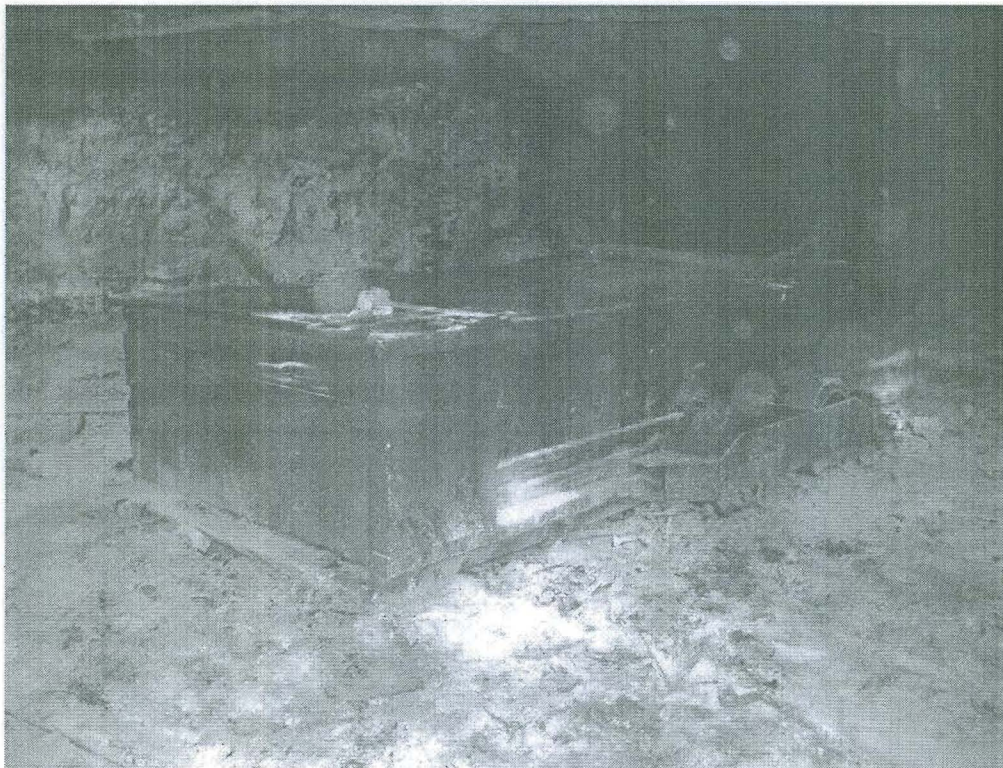
Location: **Headgate 21**
Strata Fresh Air Bay Model M2624-3.5
Serial Number 452043-02

- Side access door showed no visible damage.
- Solaris™ gas detector was located inside this side access door.
- Compressed gas cylinder pressures were within the manufacturer's specifications (4400-4600 psi).
- No corrosion or moisture in cylinder storage compartment.
- The tent inflated (approximately 4 minutes).
- Purge air system was functional.

- The CO2 scrubber fan motor started and ran. No scrubbing chemicals were used.
- The oxygen system functioned.
- The supplies were intact.

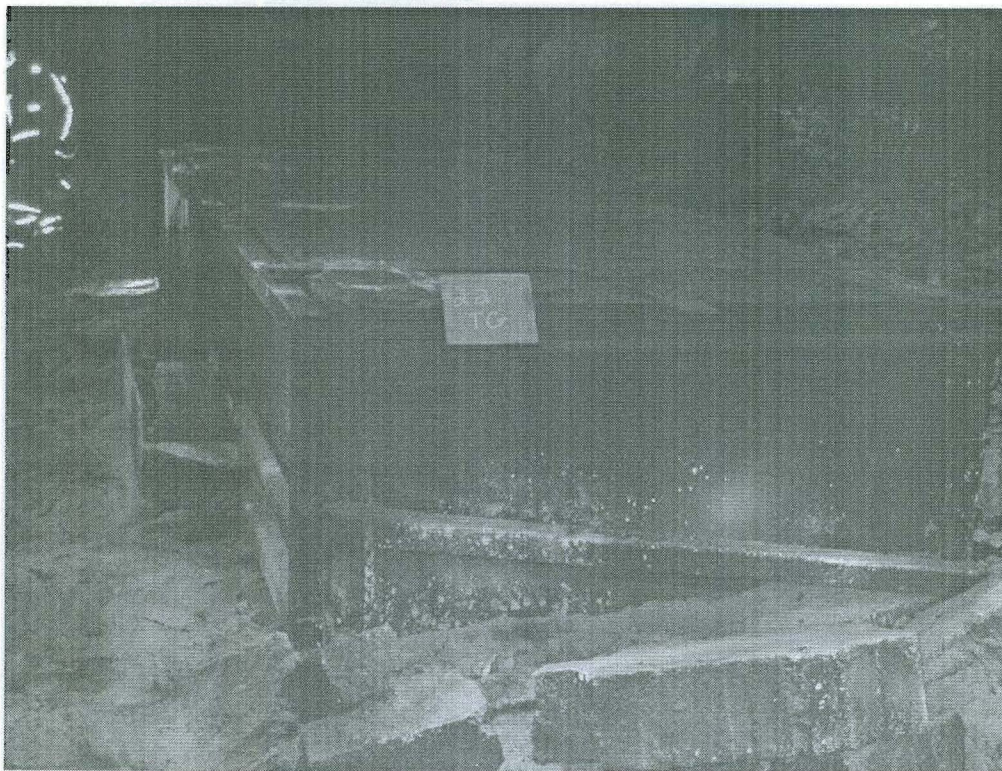
Location: Tailgate 22
Strata Fresh Air Bay Model M2624-3.5
Serial Number 452081-02

- Side access door showed no visible damage.

- No Solaris™ or other gas detector was located on this unit.
- Compressed gas cylinder pressures were within the manufacturer's specifications (4400-4600 psi).
- No corrosion or moisture was evident in cylinder storage location.
- The tent inflated. (approximately 4 minutes).
- Purge air system functioned.
- The CO2 scrubber fan motor started and ran..
- The oxygen system functioned.
- The supplies were intact.
- The tent deployment door would not open fully due to a rib roll. The tent was able to inflate and deploy around the door with no compromise.

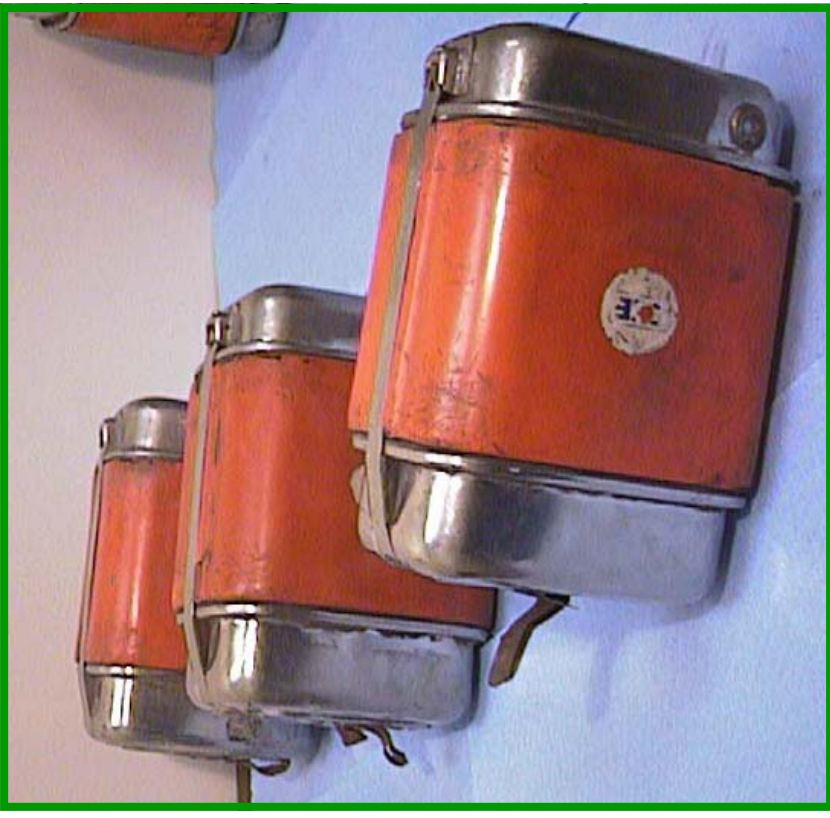
These three units have been in service for approximately six years and show the typical signs of normal wear and tear. The plastic dust covers are abraded on the corners and along the edges. There are also some dents in the top and bottom stainless steel covers.

However, the security bands are in place and the color indicators are blue, indicating no ingress of moisture. The two seals between the top and bottom covers and the chemical canister appear to be securely in place. These units pass the daily and 90-day visual inspection criteria.

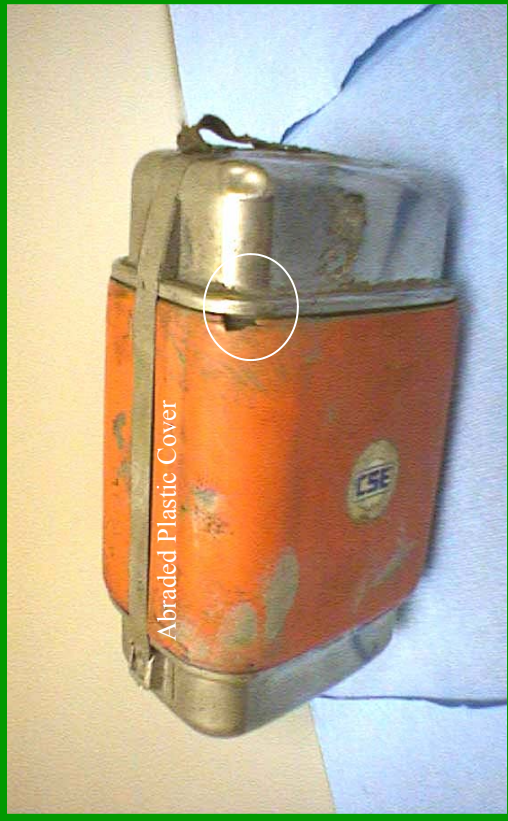
This unit's condition shows normal wear and tear. The abraded corner on the plastic cover and minor dent in the stainless steel top cover do not cause the unit to fail visual inspection. The unit may remain in service if it passes the remainder of the inspection.

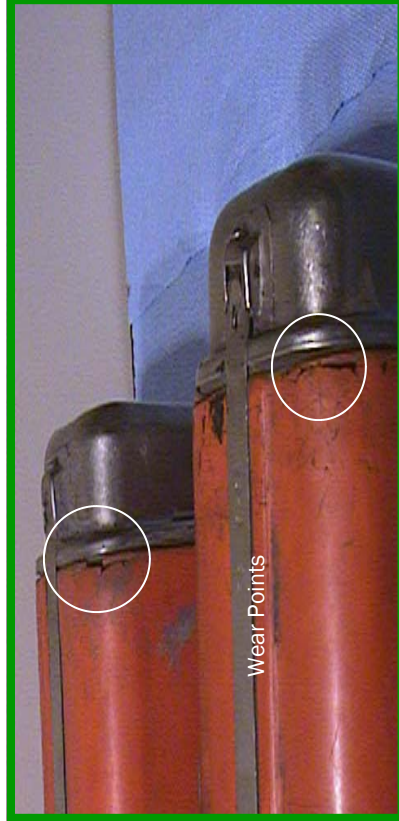
These wear points are the result of abrasion and minor impacts that do not adversely affect the SR-100 performance. These units may remain in service if they pass the remainder of inspection criteria.

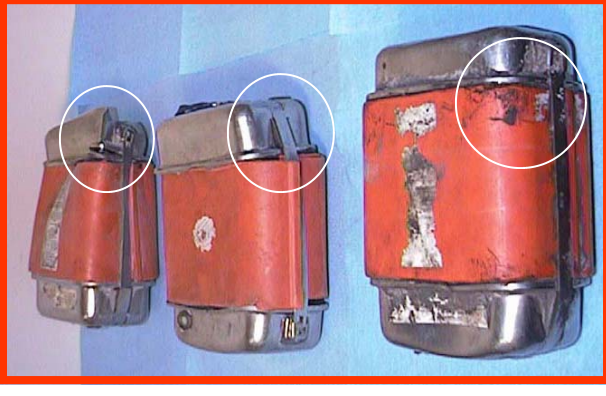
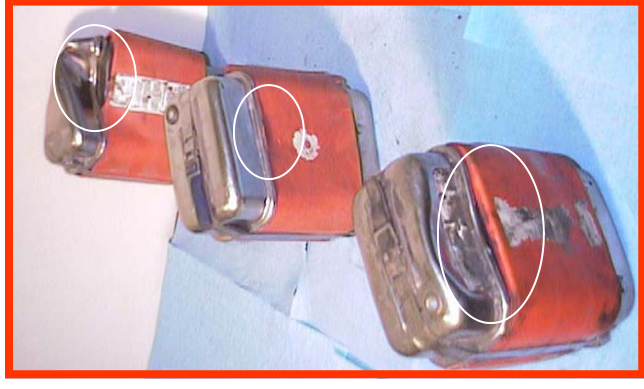
Examples of damaged units.

All units displayed must be removed from service

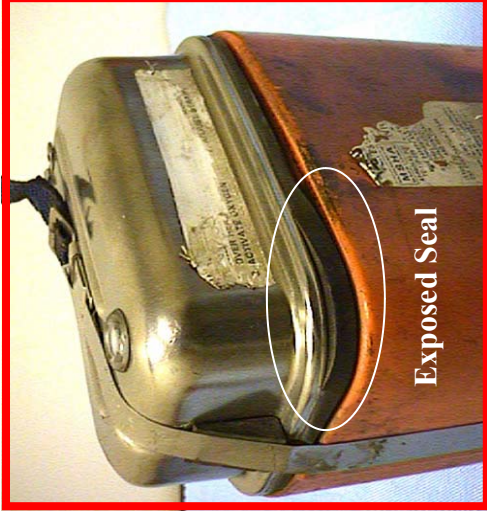
This unit fails the visual inspection because its seal has been displaced and is protruding from under the stainless steel cover.

This unit must be removed from service.

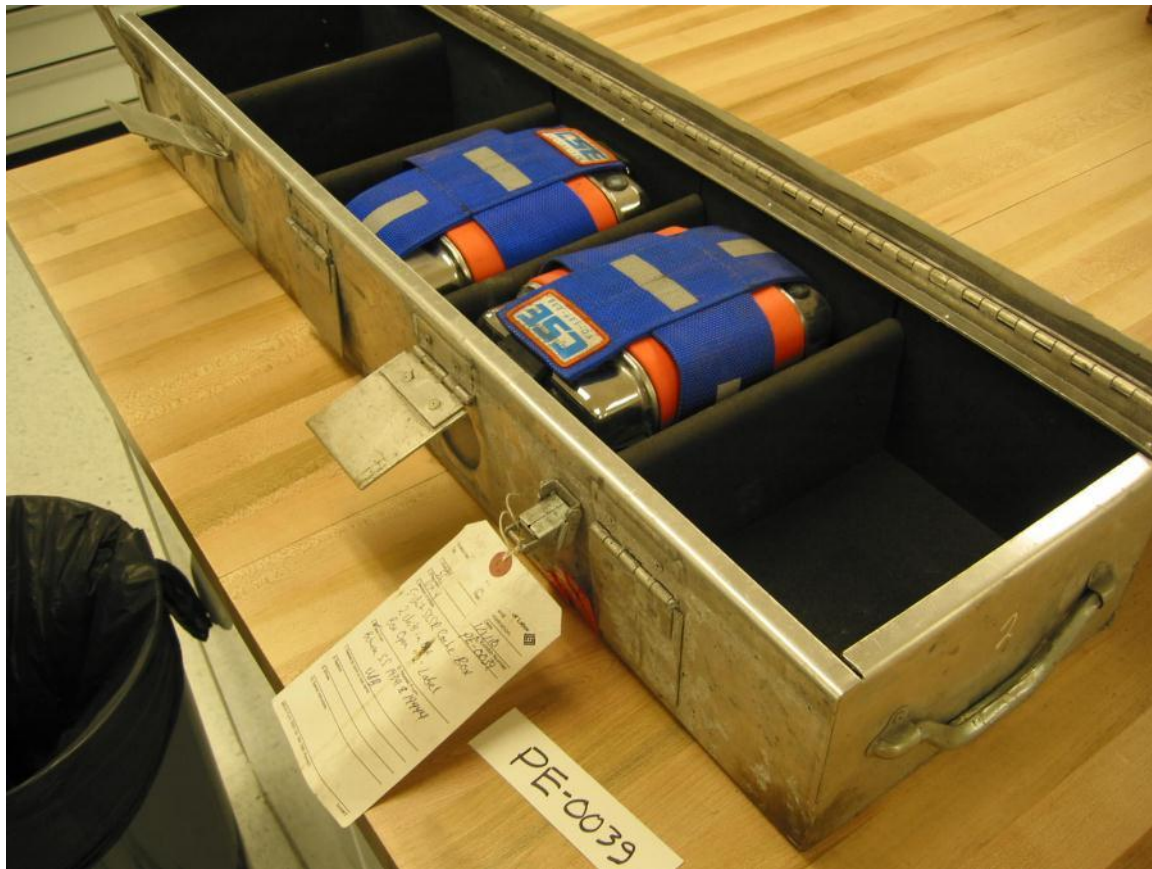
Figure 1 - PE-0039, Units -A and -B in Storage Box

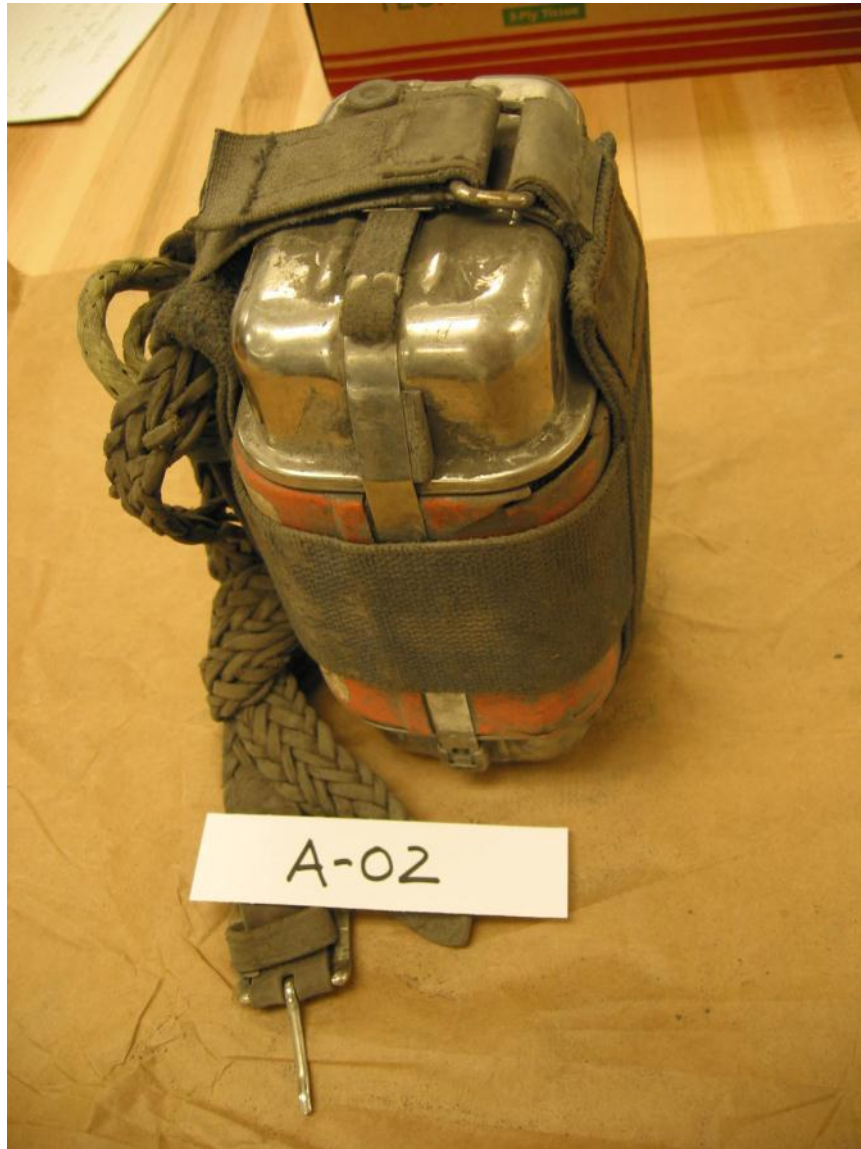
Figure 3 - Unit A-02-A, as Received

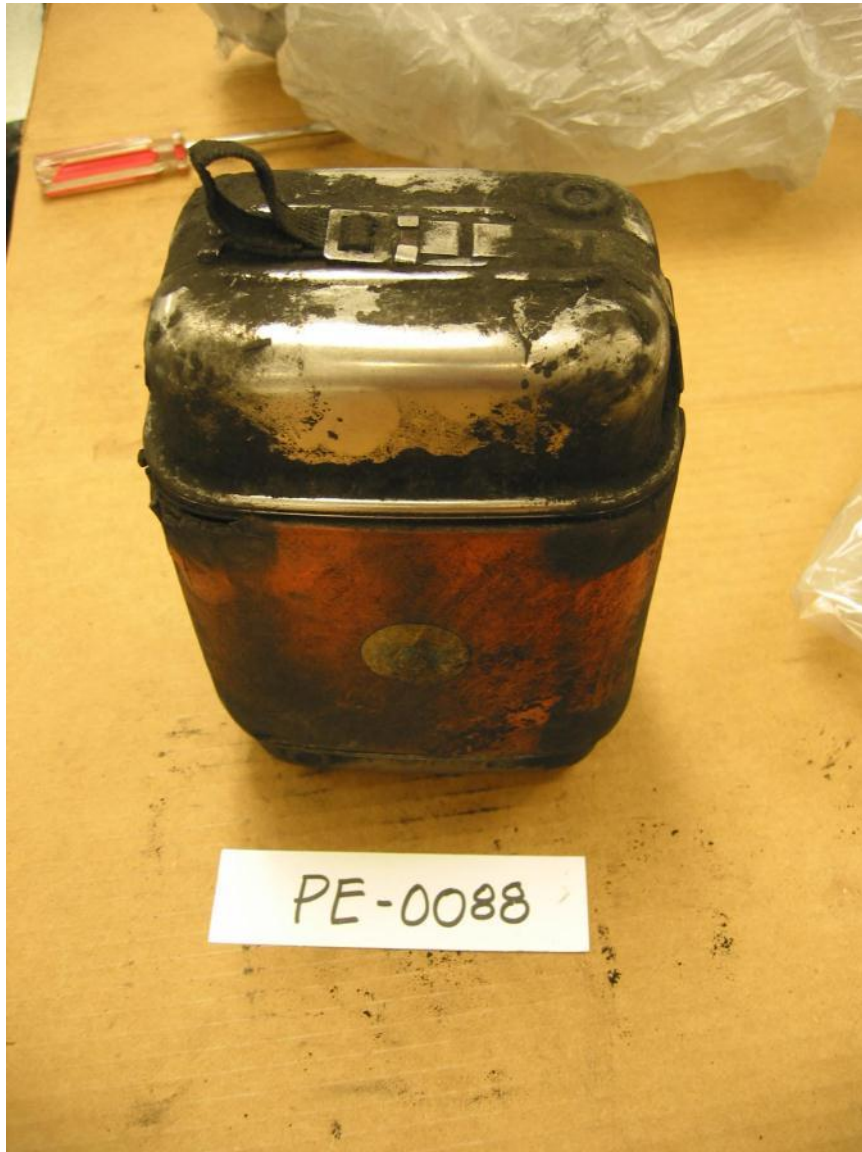
Figure 4 - Unit PE-0088, as Received

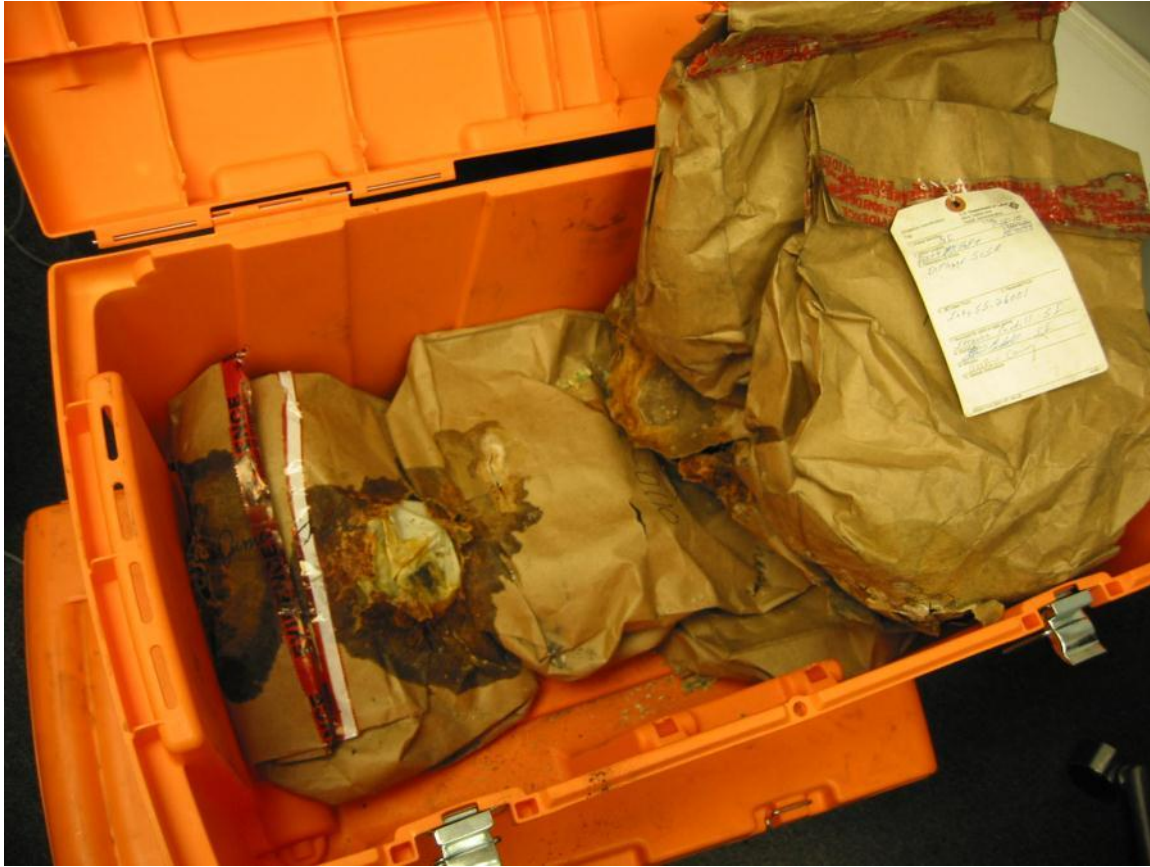
Figure 5 - Units PE-0101, PE-0108, PE-0110, PE-0111, PE-0197, and PE-0198, as Received

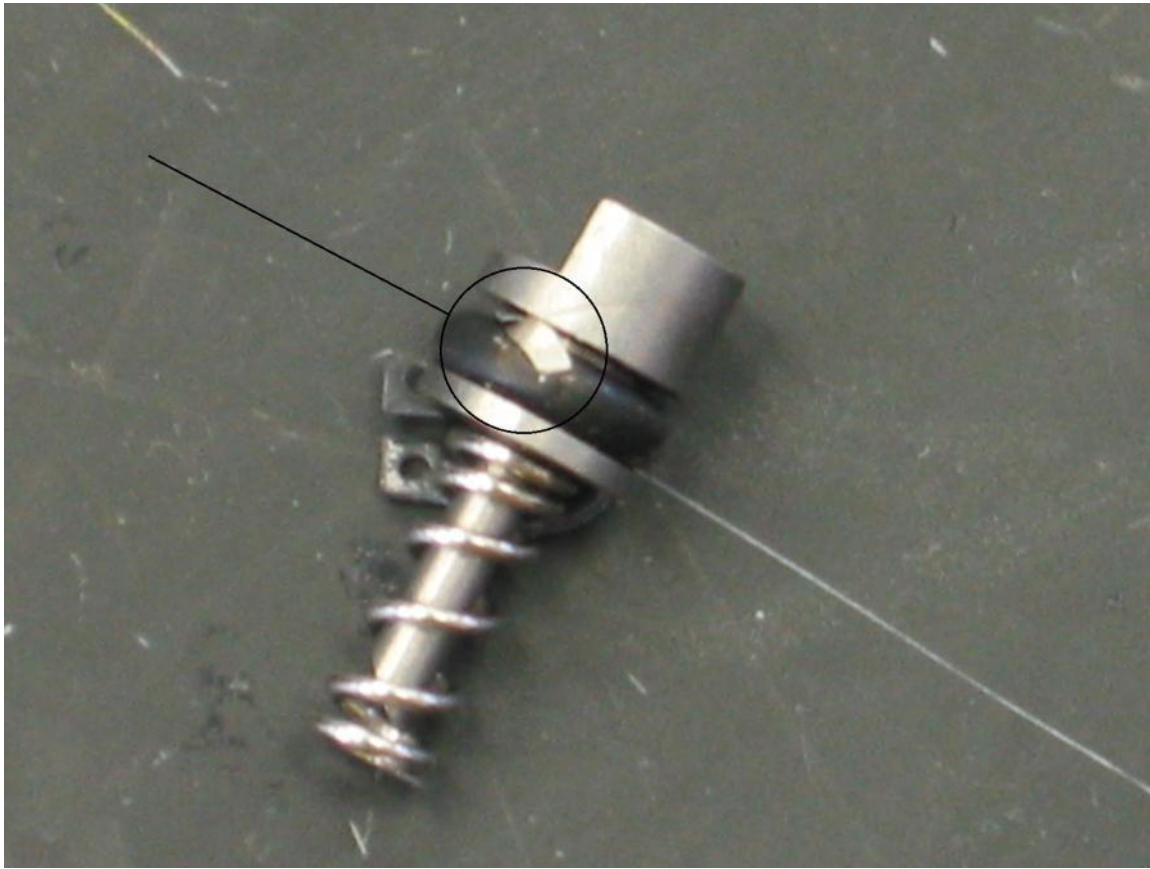
Figure 6 - Starter Plunger from Unit PE-0139-a , Showing Metal Shaving
